MIDDLESEX RESERVOIR DAM

PHASE I INSPECTION REPORT

NATIONAL DAM SAFETY PROGRAM

NJ 00377

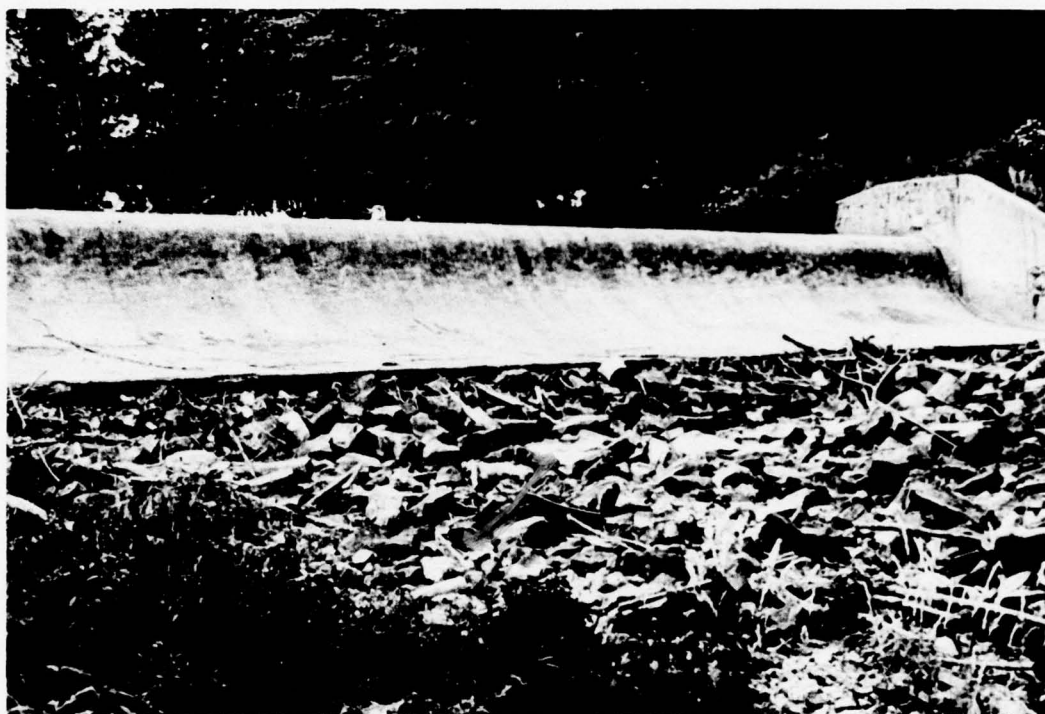
PHOTO 1

Photo 1 - View of Concrete Overflow Spillway and Riprap in Foreground - 21 June 1978.

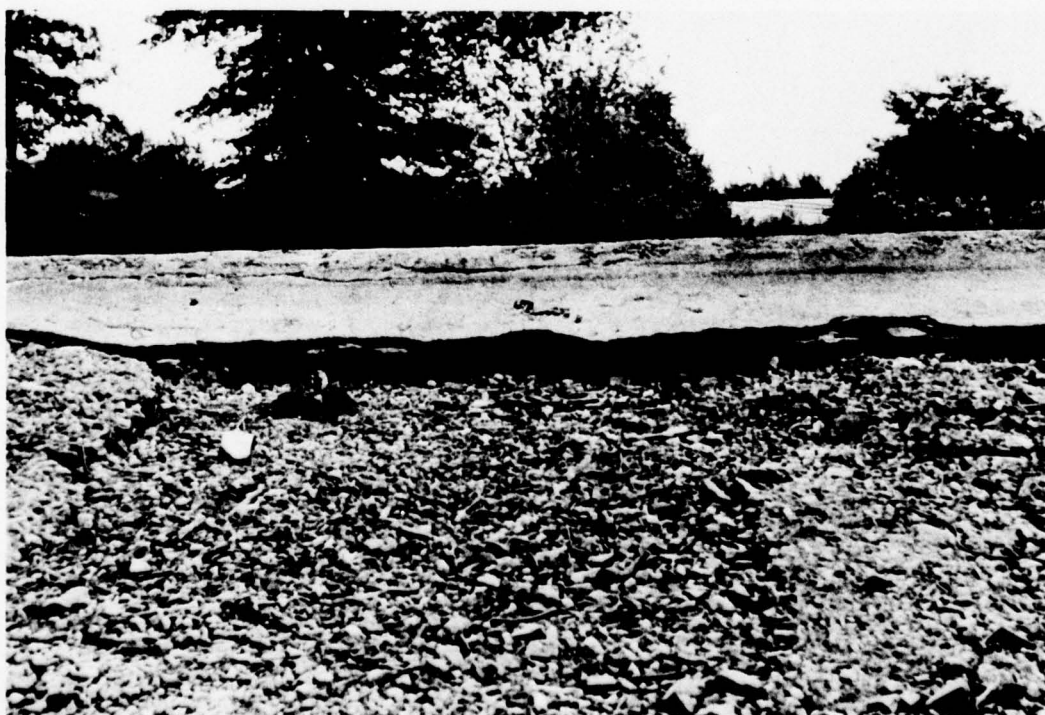
PHOTO 2

Photo 2 - Picture of Spillway Concrete Approach Slab on Upstream Side (Top) and Deteriorated Concrete Grouted Stone Paving Spillway Approach Slope (Foreground) Which Has Eroded Out Causing Undermining of Concrete Approach Slab - 21 June 1978.

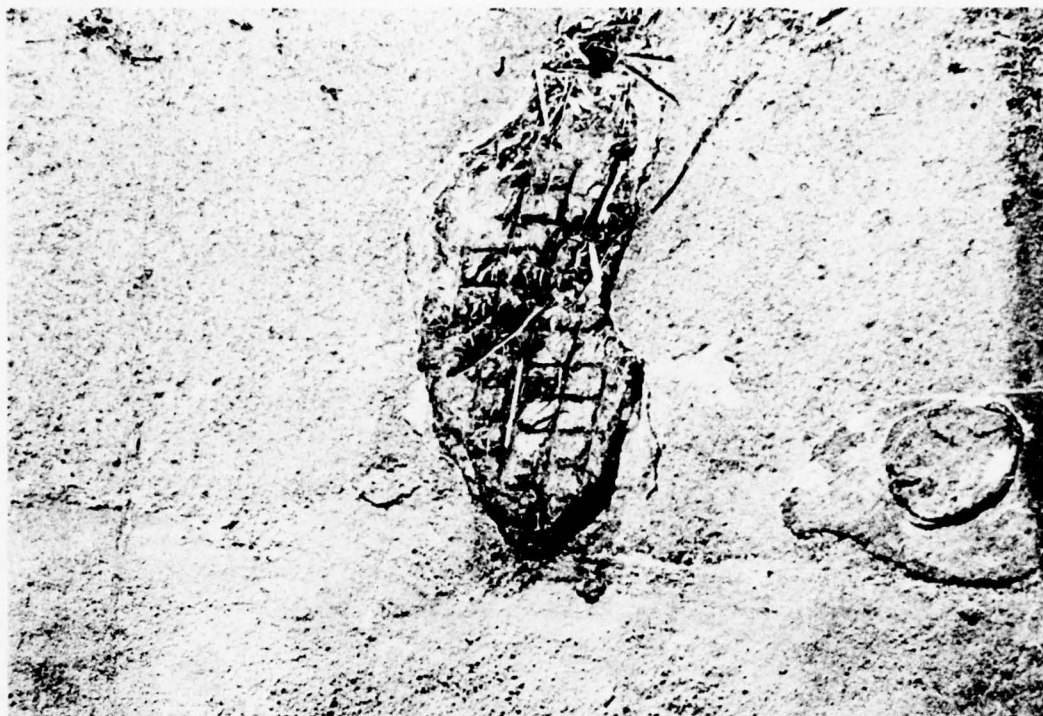
PHOTO 3

Photo 3 - Spalled Area on Spillway Concrete Apron Near Right Wing Wall - 21 June 1978.

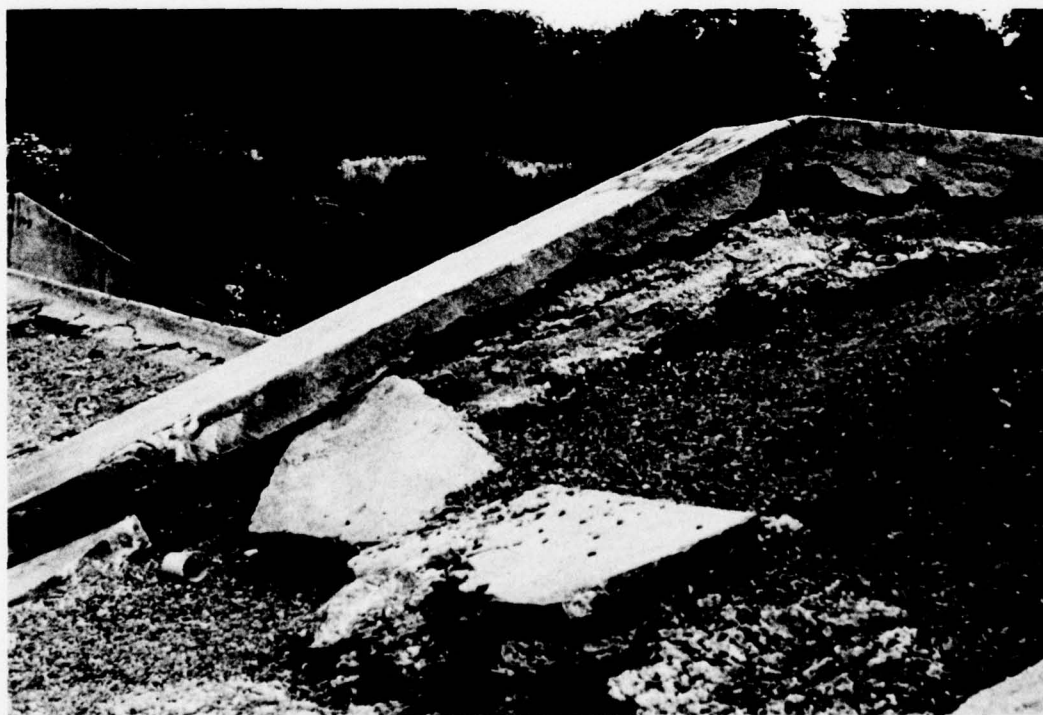
PHOTO 4

Photo 4 - View of Right Wing Wall Showing Guniting Repair and Deteriorated Concrete Below Guniting (Note Eroded Surface of Upstream Embankment Slope and Remains of Concrete Slope Paving on Embankment Slope) - 21 June 1978.

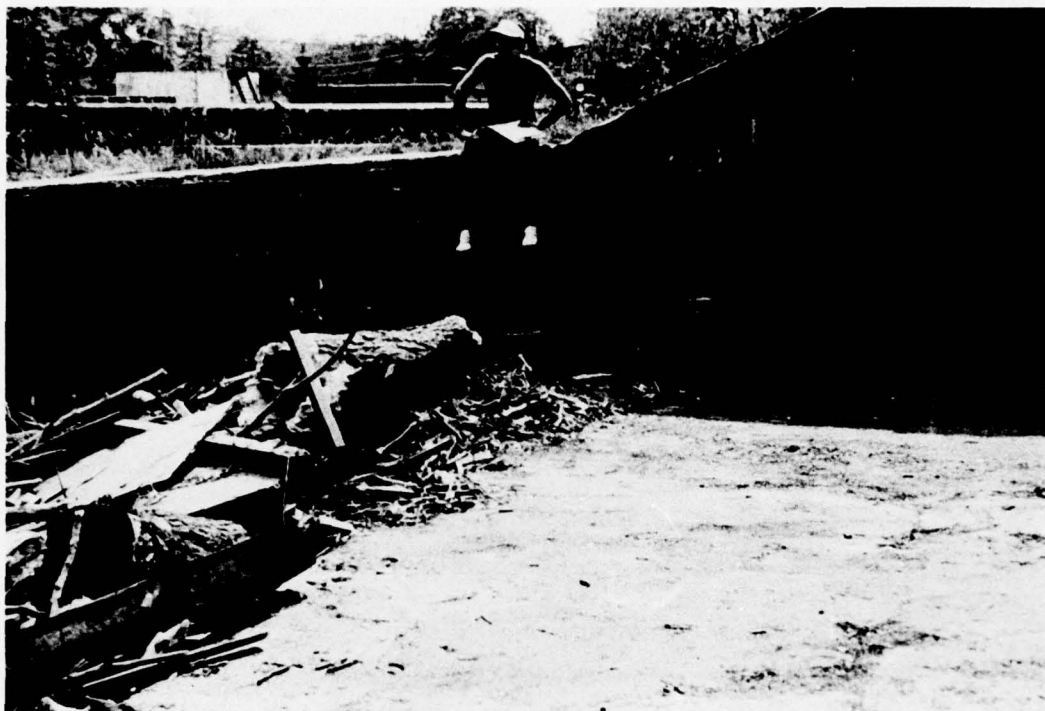
PHOTO 5

Photo 5 - Picture of Spillway Right Wing Wall With Spalling of Guniting and Concrete Apron in Foreground (Debris Is Located at Edge of Concrete Apron) - 21 June 1978.

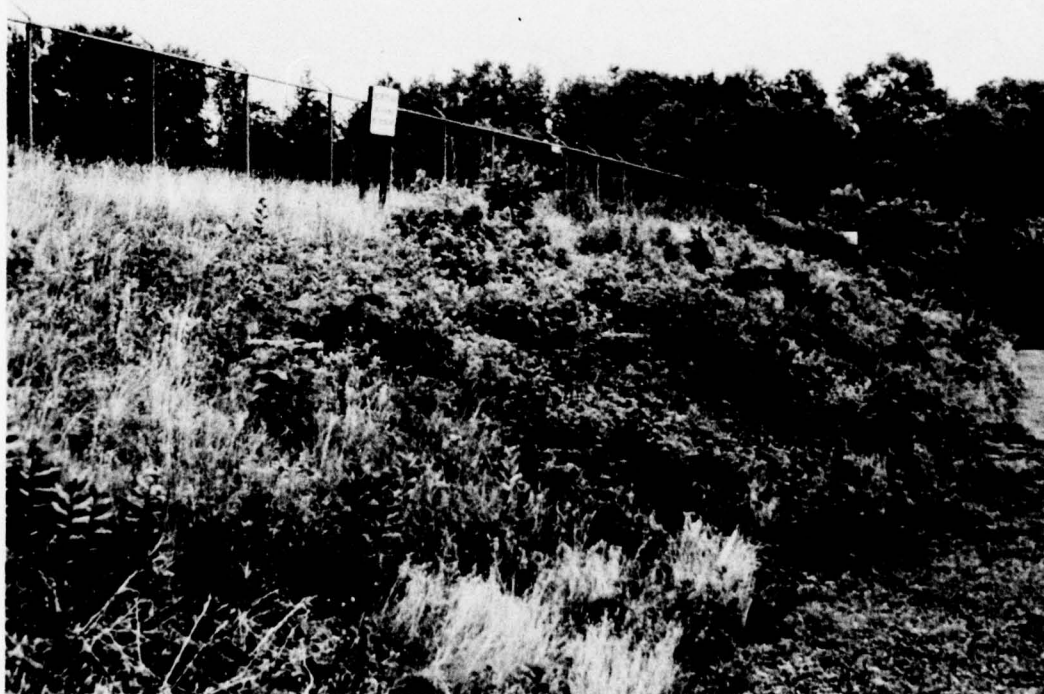
PHOTO 6

Photo 6 - Downstream Embankment Slope Partially Covered With Brush and Small Trees (View Is Toward East or Toward Spillway Not Visible in Picture) - 21 June 1978.

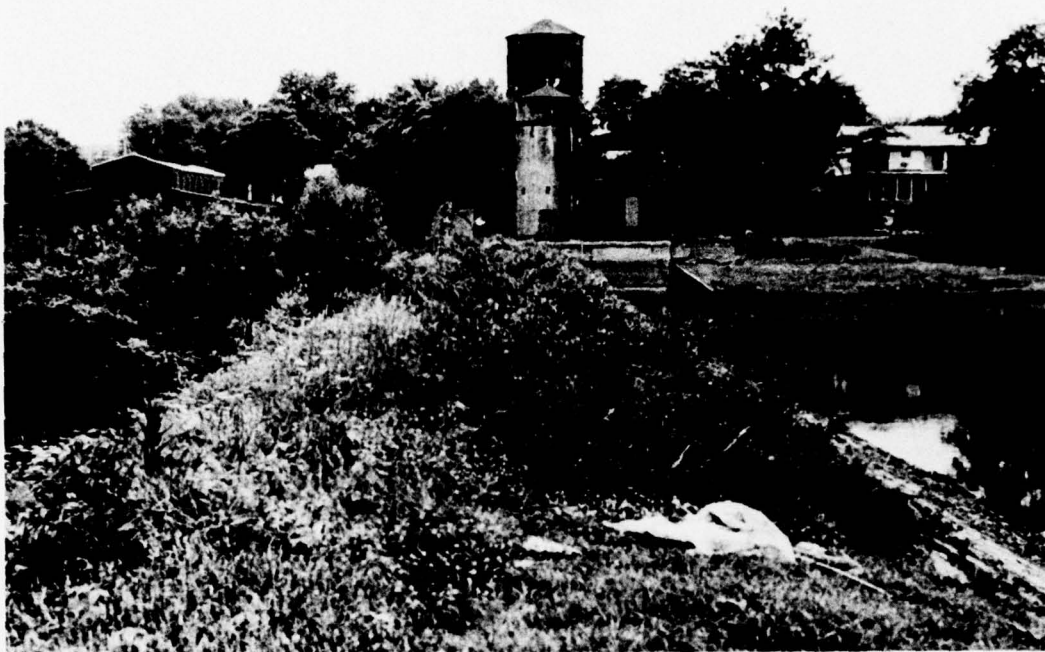
PHOTO 7

Photo 7 - Looking West Across Crest of Embankment Toward Gate House at Right Abutment (Note Small Trees and Brush on Embankment) - 21 June 1978.

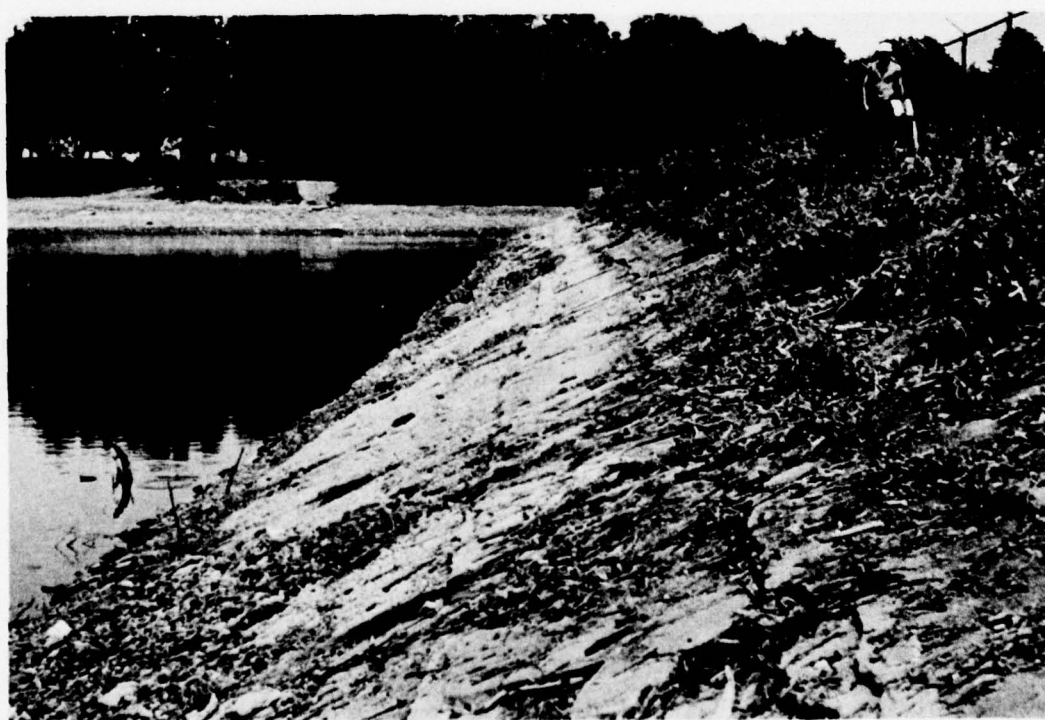
PHOTO 8

Photo 8 - Picture of Deteriorated Concrete Slope Paving on Upstream Side of Embankment (View Is Toward East or Toward Spillway) - 21 June 1978.

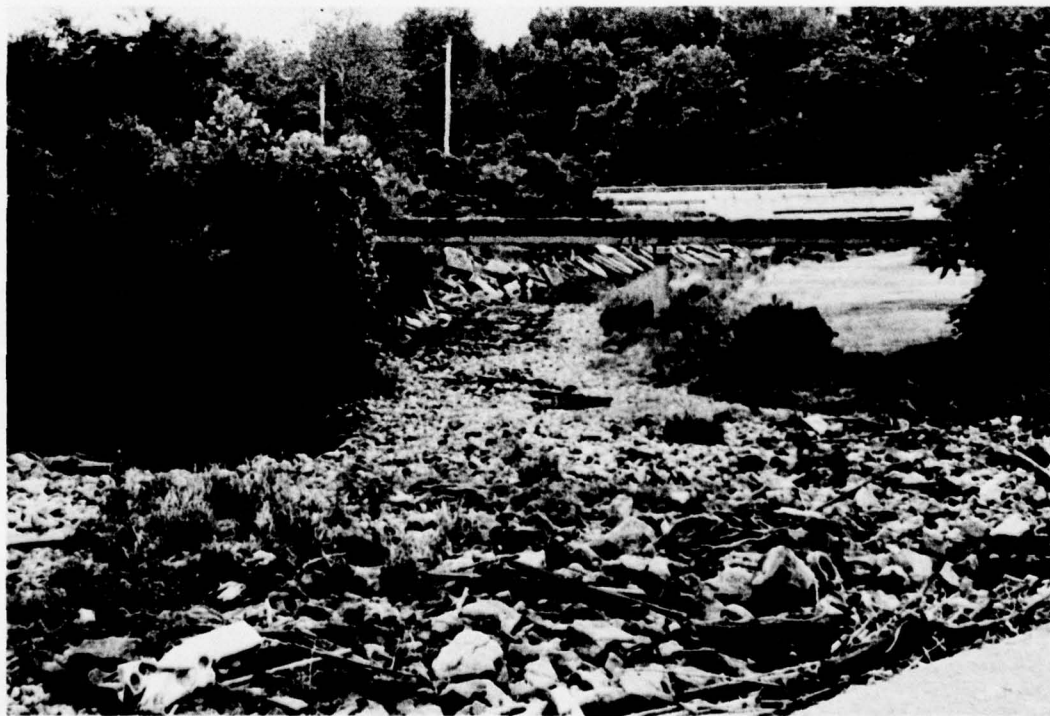
PHOTO 10

Photo 10 - Overall View of Outlet Channel Showing Debris in Foreground and Sanitary Sewer Bridging Stream Channel - 21 June 1978.

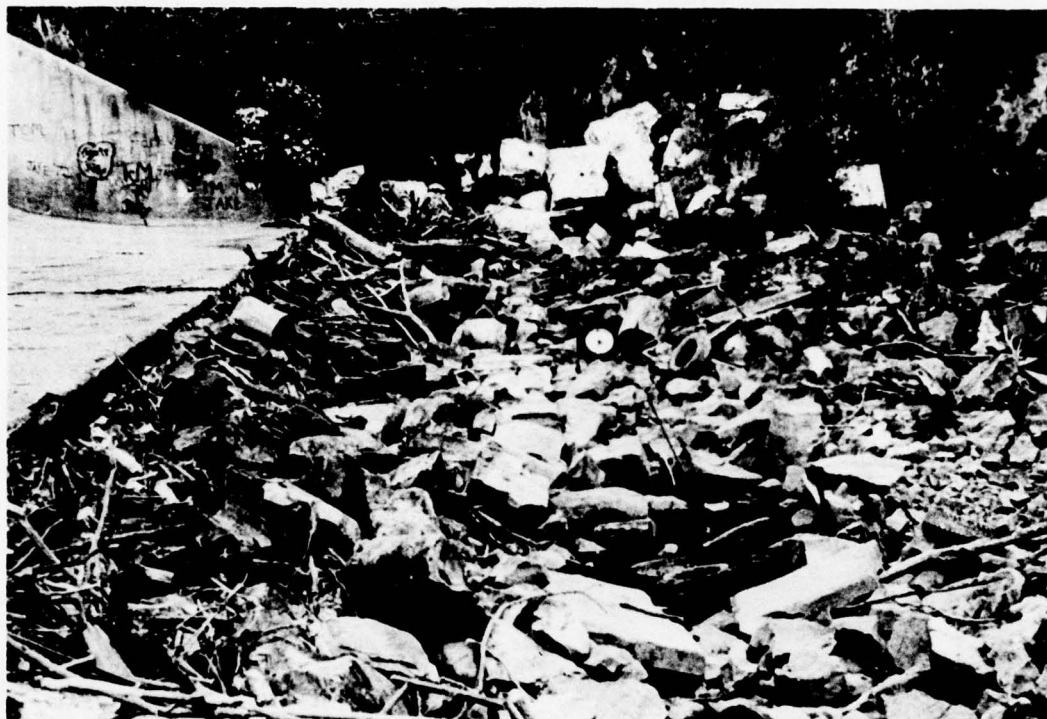
PHOTO 11

Photo 11 - Close-Up of Riprap and Debris Immediately Downstream From Concrete Apron - 21 June 1978.

(1) In the spillway discharge channel, placement of additional large rip-rap in scoured areas is recommended.

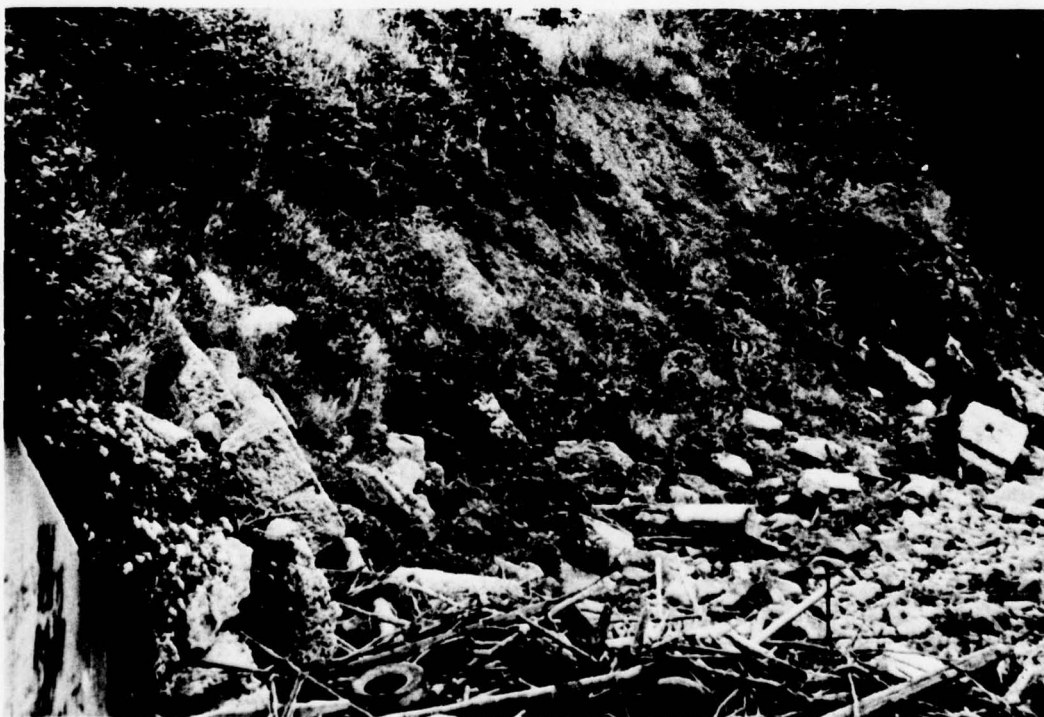
PHOTO 12

Photo 12 - View of Steep (1:1) Outlet Channel Slope With
Sloughage (Note Corner of Left Wing Wall and Debris
in Foreground) - 21 June 1978.

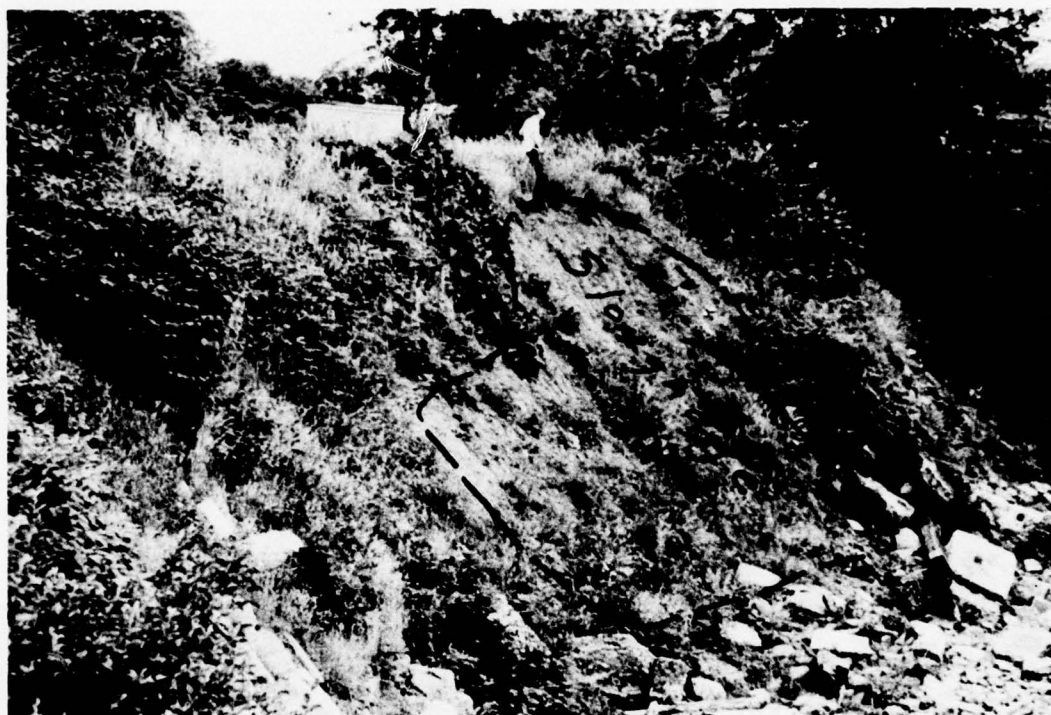
PHOTO 13

Photo 13 - Steep Outlet Channel Slope (1:1) With Sloughage
(Slope Is Approximately 25 Feet High) - 21 June 1978.
