GEIST STORAGE DAM (SPRINGTOWN RESERVOIR)

PHASE I INSPECTION REPORT
NATIONAL DAM SAFETY PROGRAM

GEIST (CRUM CREEK) STORAGE DAM
DELAWARE COUNTY, PENNSYLVANIA
(NATIONAL I.D. NO. PA-00348)

11 May 1978

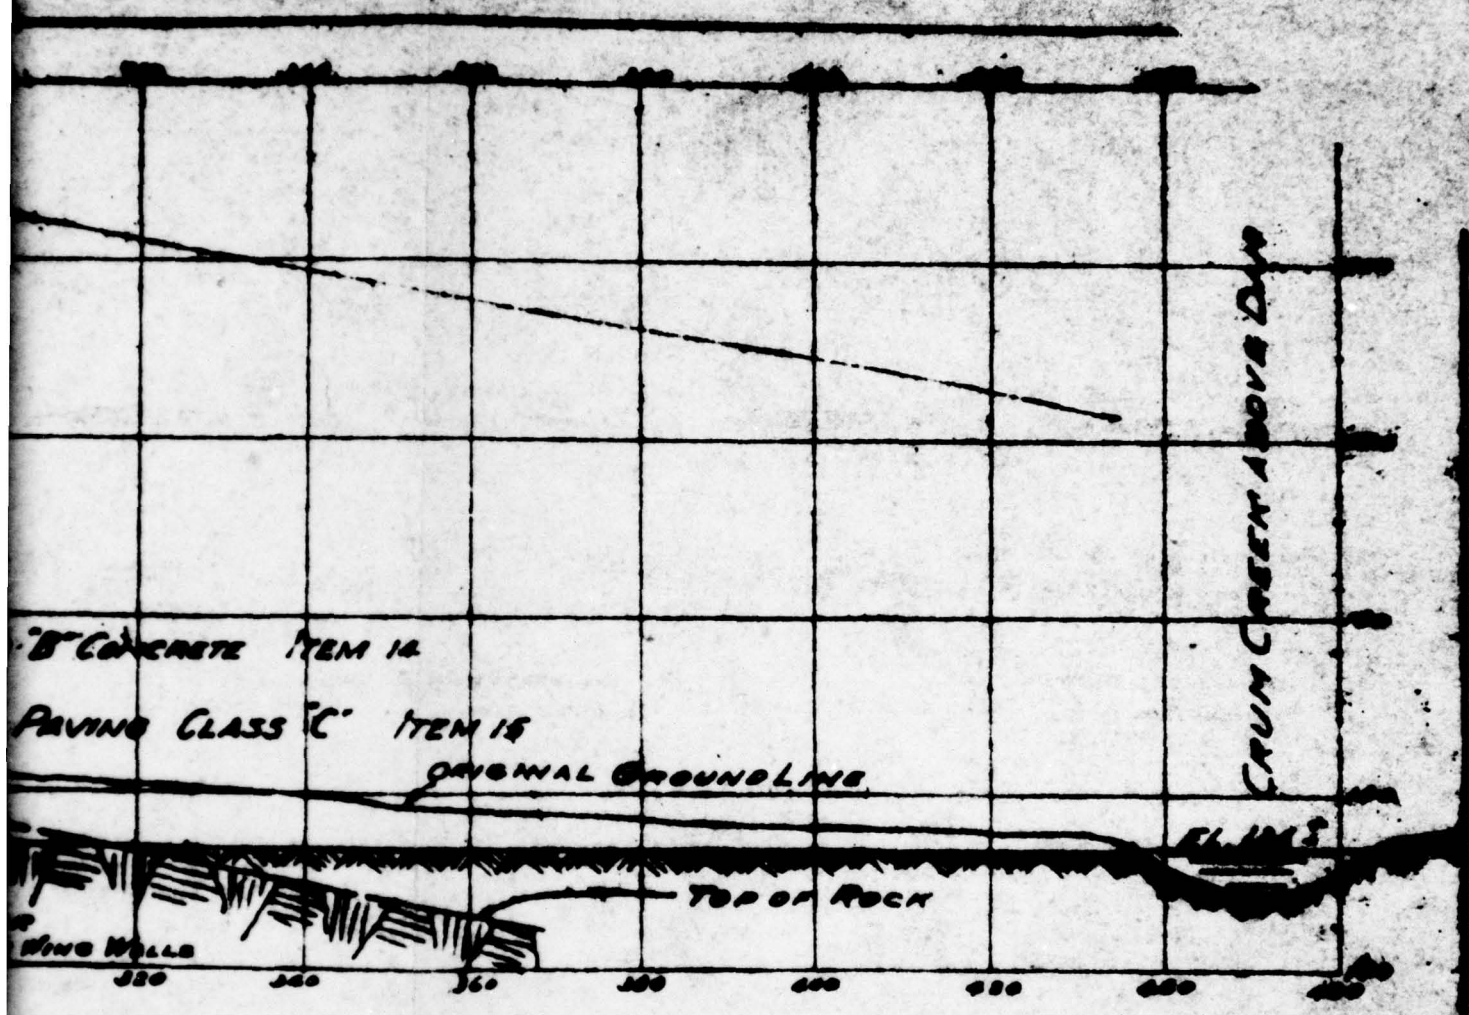
TYPICAL PROFILE ALONG CENTERLINE OF CONDUIT AND INTAKE TOWER GEIST STORAGE DAM		
DELAWARE COUNTY		PENNSYLVANIA
DATA OBTAINED FROM PHILADELPHIA SUBURBAN WATER WATER COMPANY DOCUMENTS		
		PLATE 4

Geist Dam consists of a rolled essentially homogeneous earth fill structure containing a concrete core wall founded within bedrock. A typical cross-section, enclosed as Plate 4, shows the crest width to be 44 feet and the height of the dam to be about 75 feet above the valley floor. The upstream slope of the earth fill is inclined at 3 horizontal to 1 vertical and the downstream slope at 2 horizontal to 1 vertical.

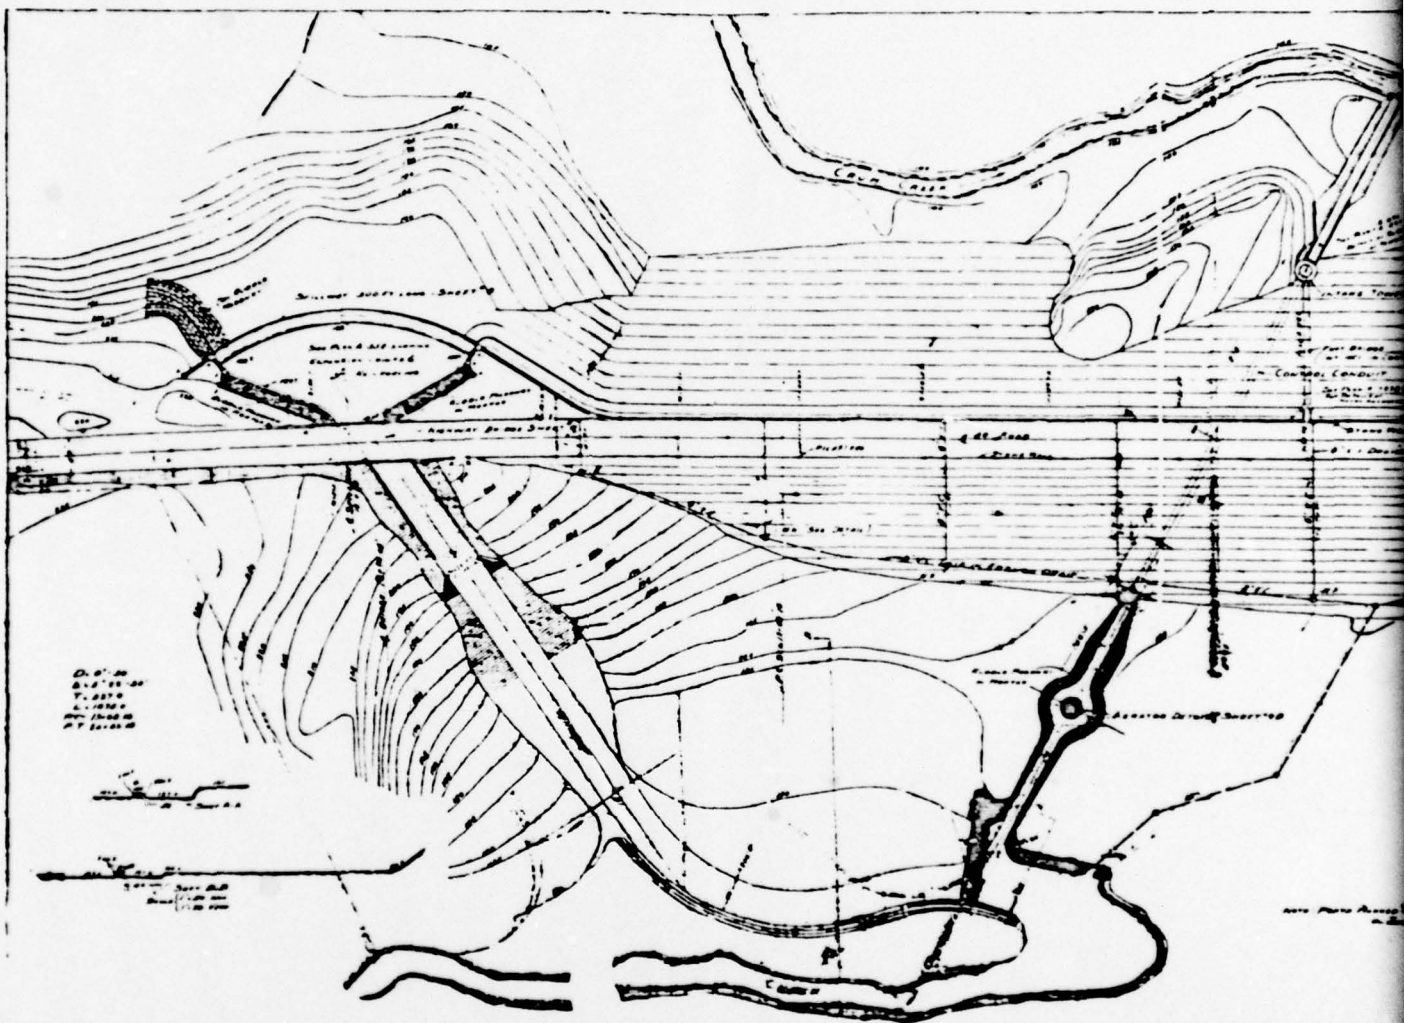
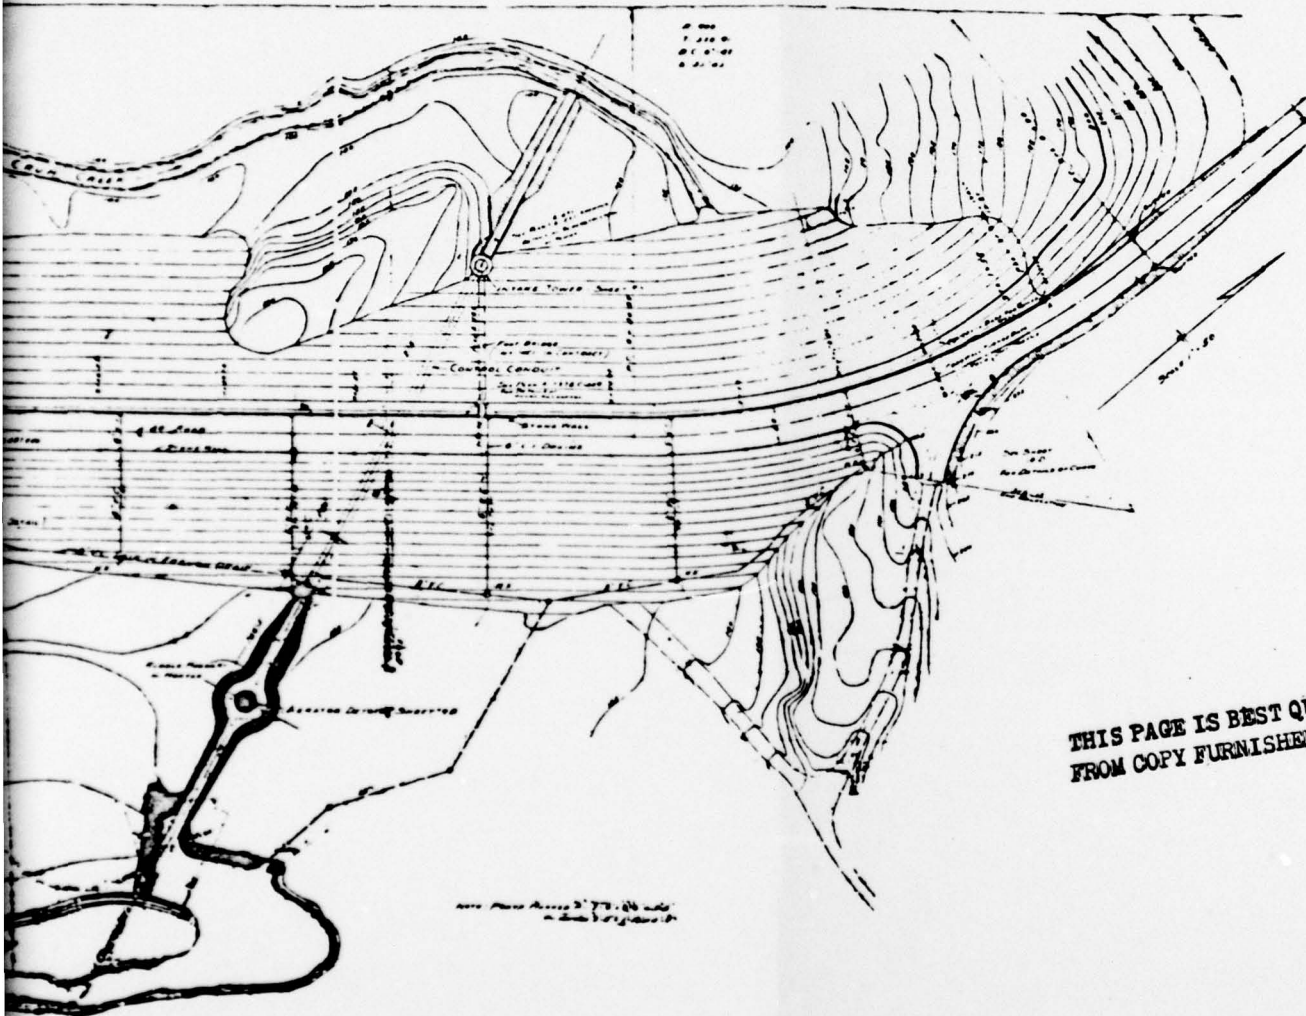
<p align="center">PLAN OF DAM AND APPURTENANCES GEIST STORAGE DAM</p>		
<p>DELAWARE COUNTY</p>		<p>PENNSYLVANIA</p>
<p>DATA OBTAINED FROM PHILADELPHIA SUBURBAN WATER WATER COMPANY DOCUMENTS</p>		
		<p>PLATE 2</p>

As shown on Plate 2, the spillway is located at the west abutment of the dam and, as documented by construction records, is excavated and keyed into-rock. The length of the ogee crest is approximately 300 feet and has the form of a circular arc. The paved spillway channel discharges into an unpaved channel, joining Crum Creek below the dam. An auxiliary spillway has not been provided.
