PHASE I REPORT
National Dam Inspection Program

Keystone Station Dam

Inspection Team - GAI Consultants, Inc.

PHASE I INSPECTION REPORT
NATIONAL DAM INSPECTION PROGRAM
KEYSTONE STATION DAM
ID# NDI PA-275; PENNDR# 3-28

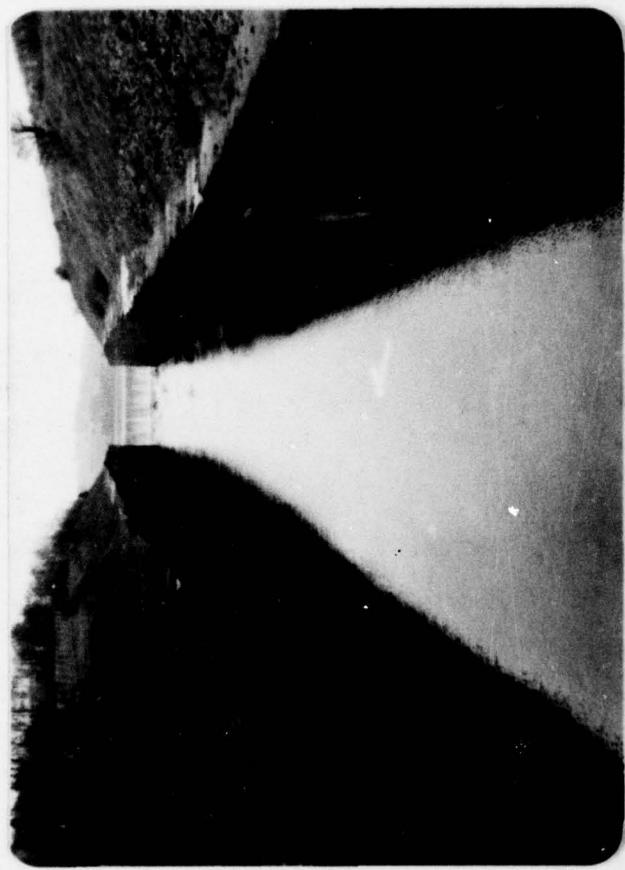
- PHOTOGRAPH 7 View of the toe drain of the embankment and the relief wells mentioned in the previous photograph. The weir in the center of the photograph gauges flow from the area of the right abutment and any flow which might be discharging through the relief wells.
- PHOTOGRAPH 8 This is a view of the spillway at the Keystone Station Reservoir located approximately one mile upstream of the Keystone Reservoir embankment.
- PHOTOGRAPH 9 This is a view of the interior of the gate house at the Keystone Reservoir. The gate controls in the center of the photograph are used to raise sluice gates on the discharge system for the reservoir.
- PHOTOGRAPH 10 View taken from the road located approximately 1/2 mile downstream showing the Keystone Dam embankment in the background.
