SPEERS RUN DAM  
NDI Pa - 505 .

PHASE I INSPECTION REPORT,  
NATIONAL DAM INSPECTION PROGRAM. ✓

PHASE I REPORT

Speers Run Dam

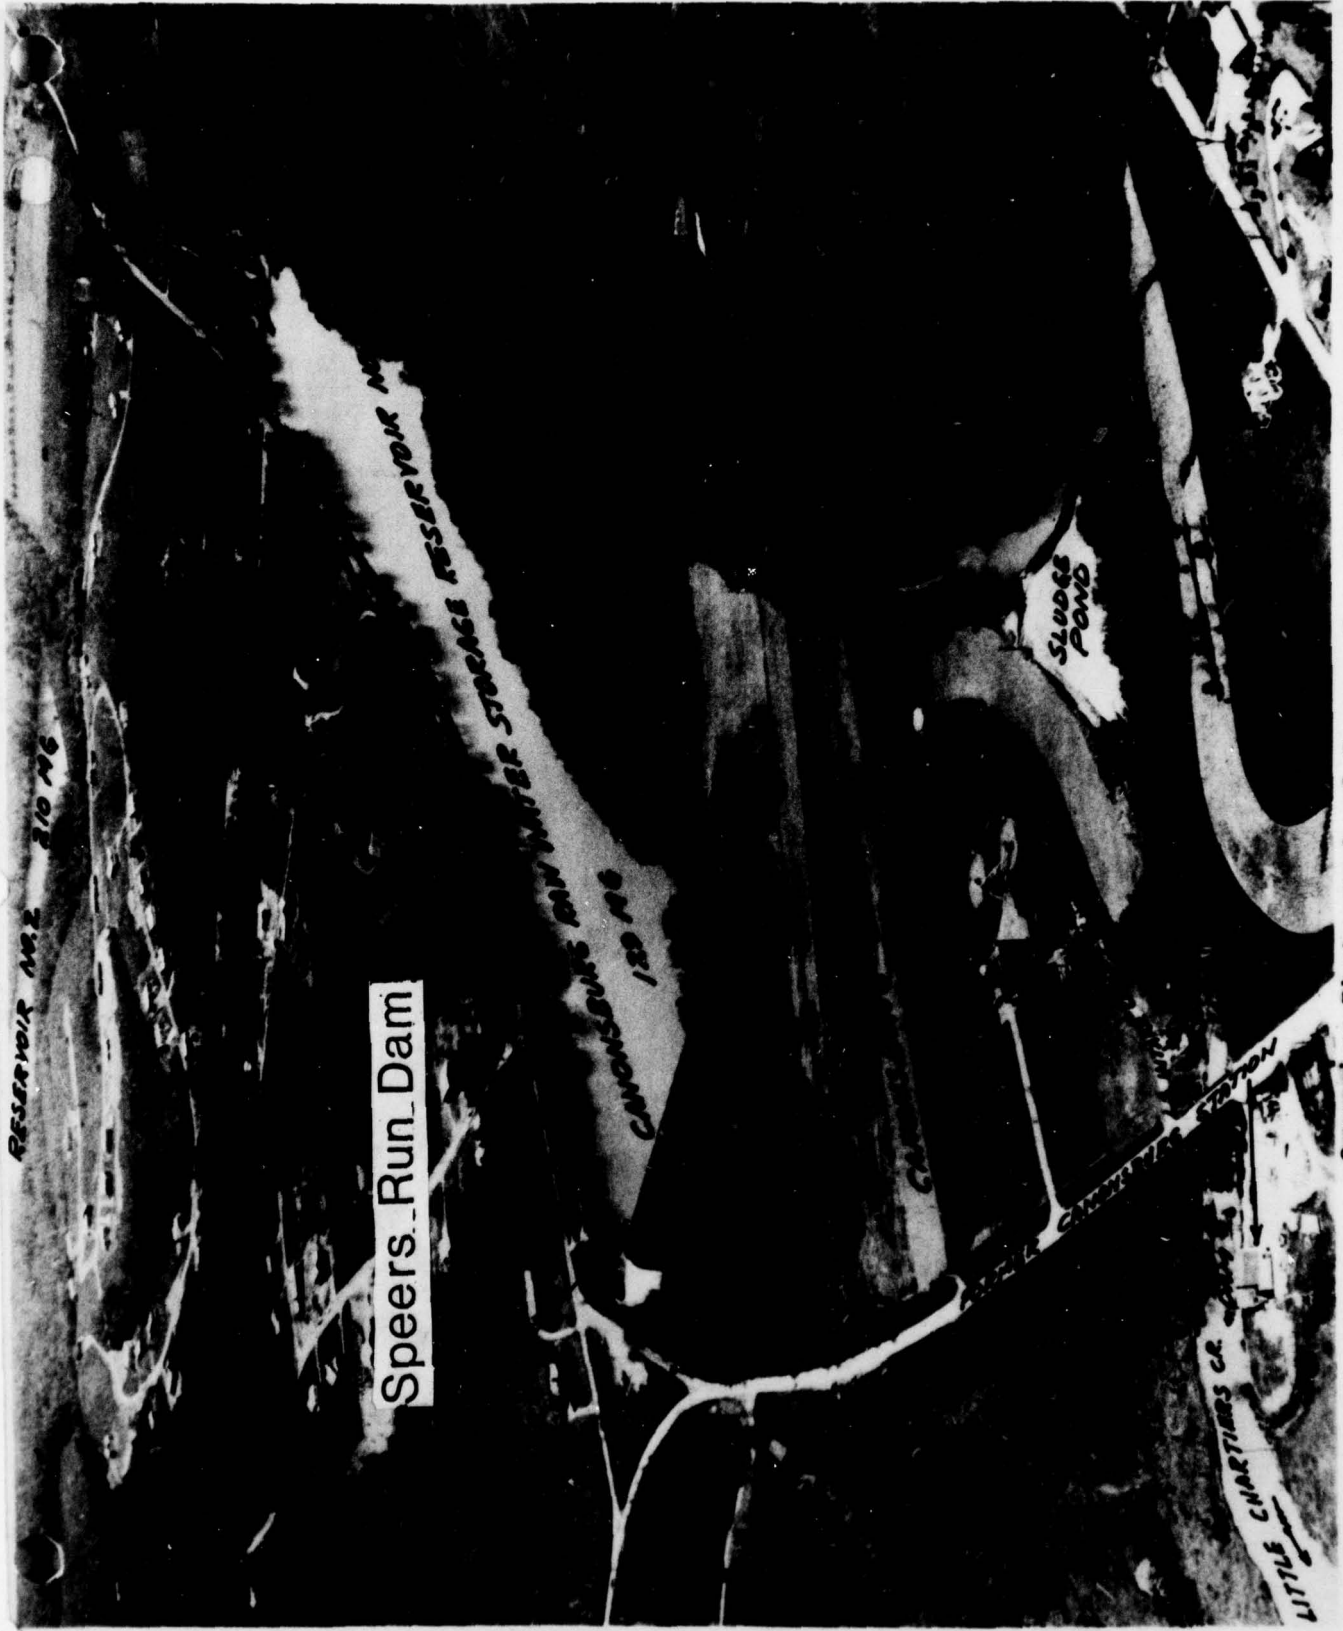
Overview Photograph of Speers Run Dam iii

Based on visual inspection and available data, the dam and spillway works appear to be in good condition. The outlet appurtenances (intake tower, supply line, and blow-off line) present a potentially hazardous condition in that they are inaccessible at normal pool level, and probably inoperable and (in case of the blow-off line) of unknown location. Thus, an assessment of their condition and remedial measures to restore these appurtenances to operability are recommended.

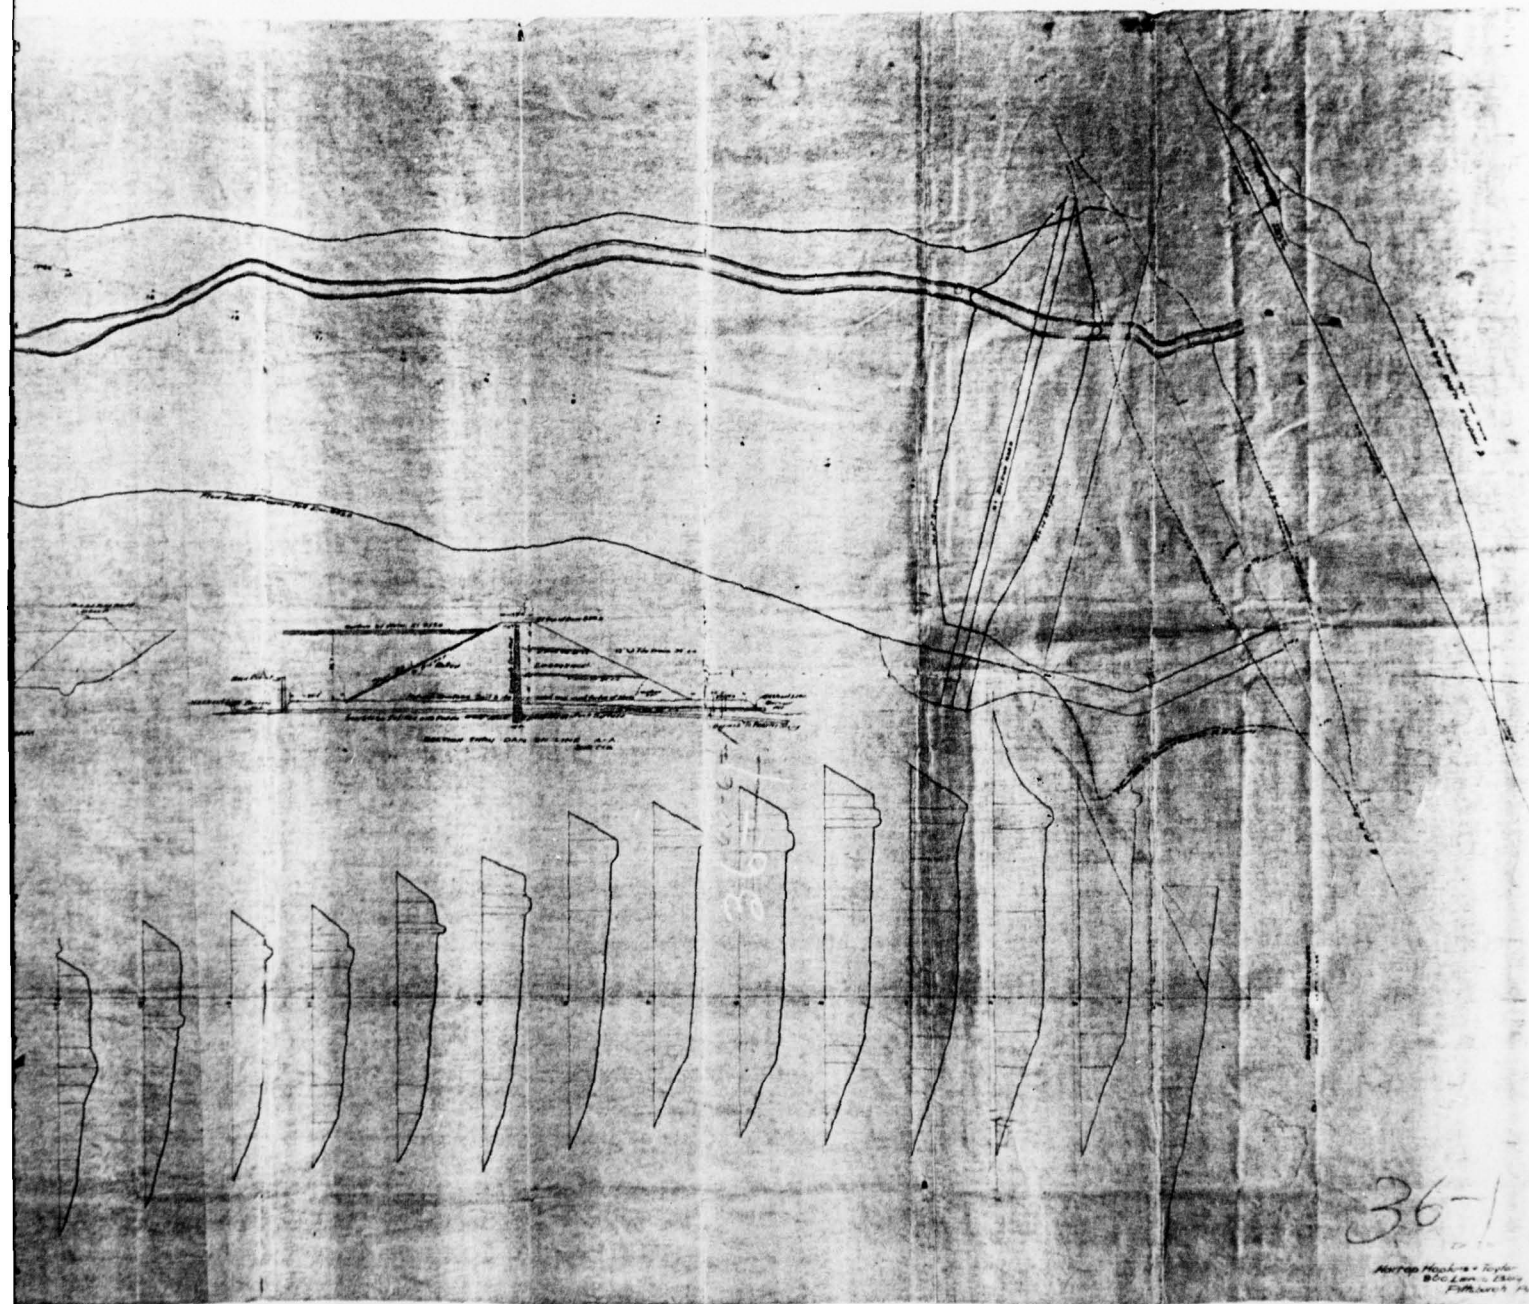
FIGURE 1

Data provided on proposed drawing (mentioned above) indicates that design proposals for Speers Run Dam were presented circa 1911. At that time, consideration was given to constructing the dam in conjunction with a railroad embankment. However, it appears that both were eventually built independently, with Speers Run Dam being constructed first. As no documents relative to as-built conditions are available, it is not known whether the cross-section (Section A-A) indicated on Figure 1 is in fact representative of the initial embankment. The location of the spillway, however, appears consistent with subsequent drawings from a 1927 renovation of the facility.

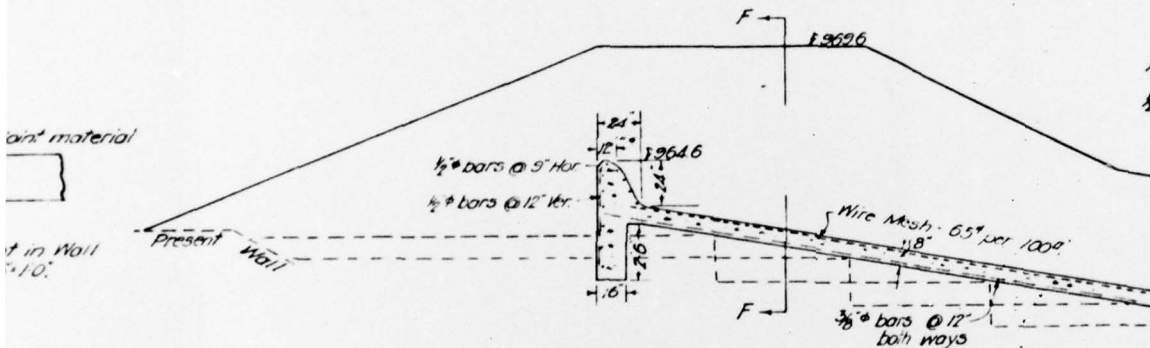
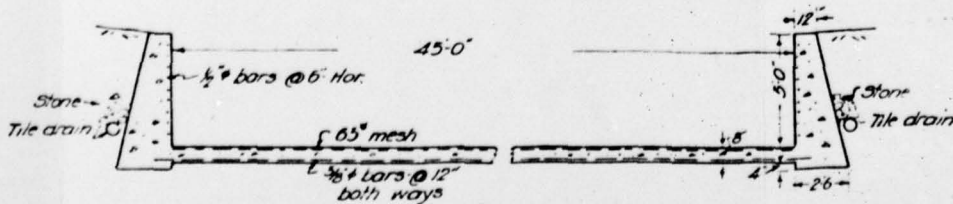
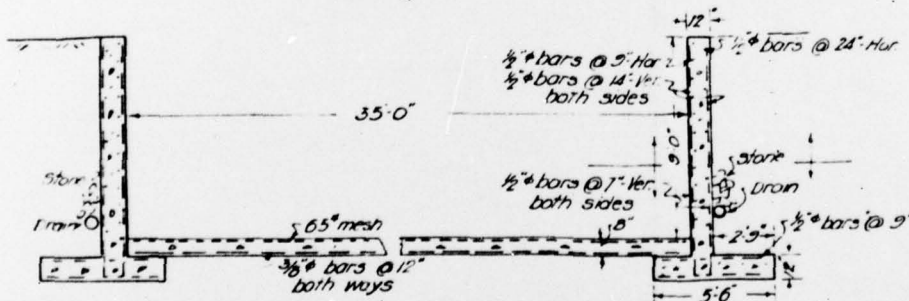
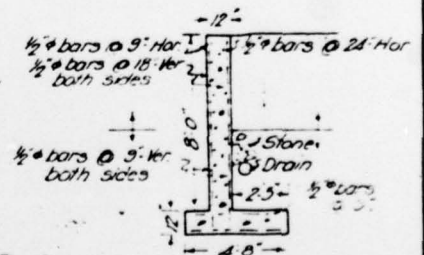
FIGURE 4

a) Spillway. The spillway is a concrete structure with an ogee-shaped crest at the entrance located along the right abutment (see Figures 2 and 4, Photographs 1, 4, and 5).
