SCHUYLKILL RIVER BASIN
FURNACE CREEK, BERKS COUNTY

FURNACE CREEK DAM

PHASE I INSPECTION REPORT
NATIONAL DAM INSPECTION PROGRAM

FURNACE CREEK DAM
BERKS COUNTY, PENNSYLVANIA
NATIONAL I.D. NO. PA 00706

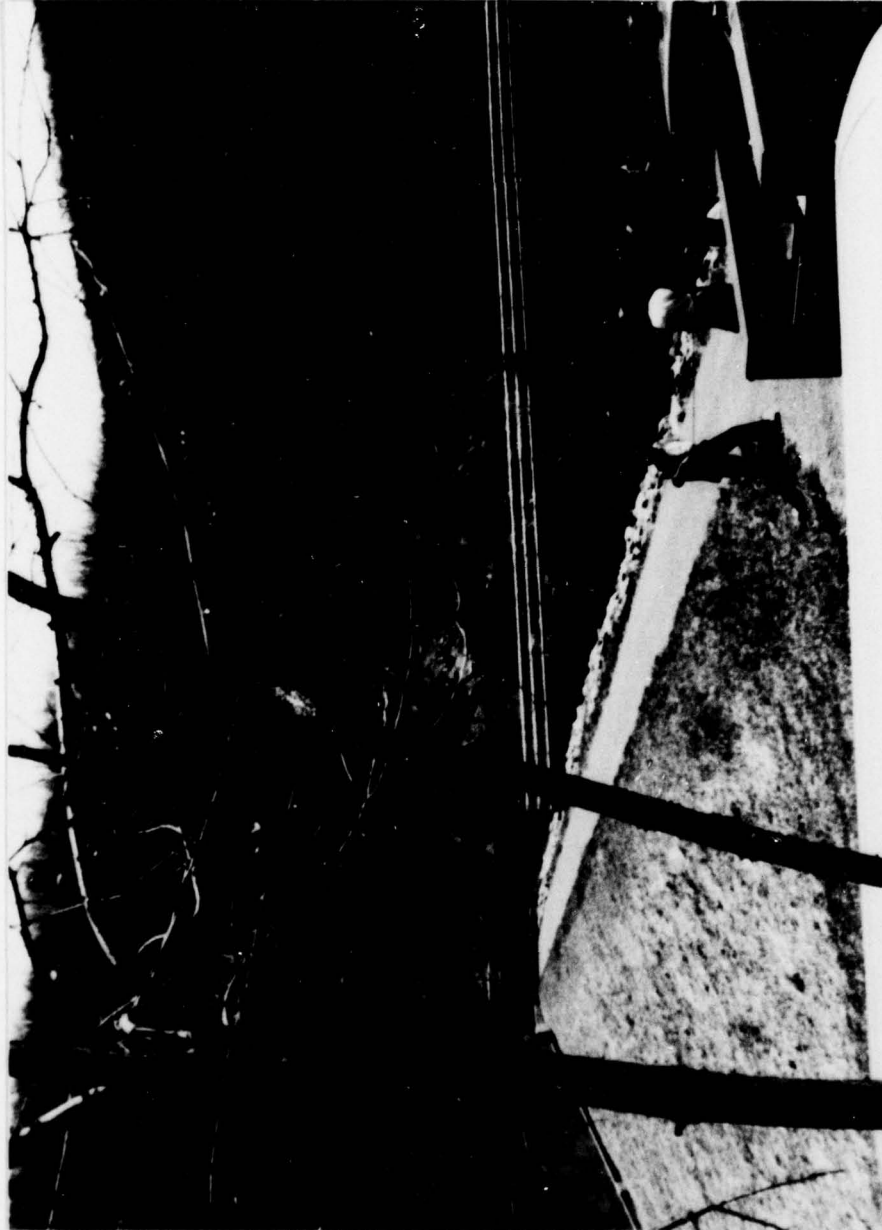
OVERVIEW
FURNACE CREEK DAM

Examination of Furnace Creek Dam resulted in the assessment that the facility is in good operating condition. No suspect conditions were noted that would give rise to immediate concern for the overall integrity of the dam.

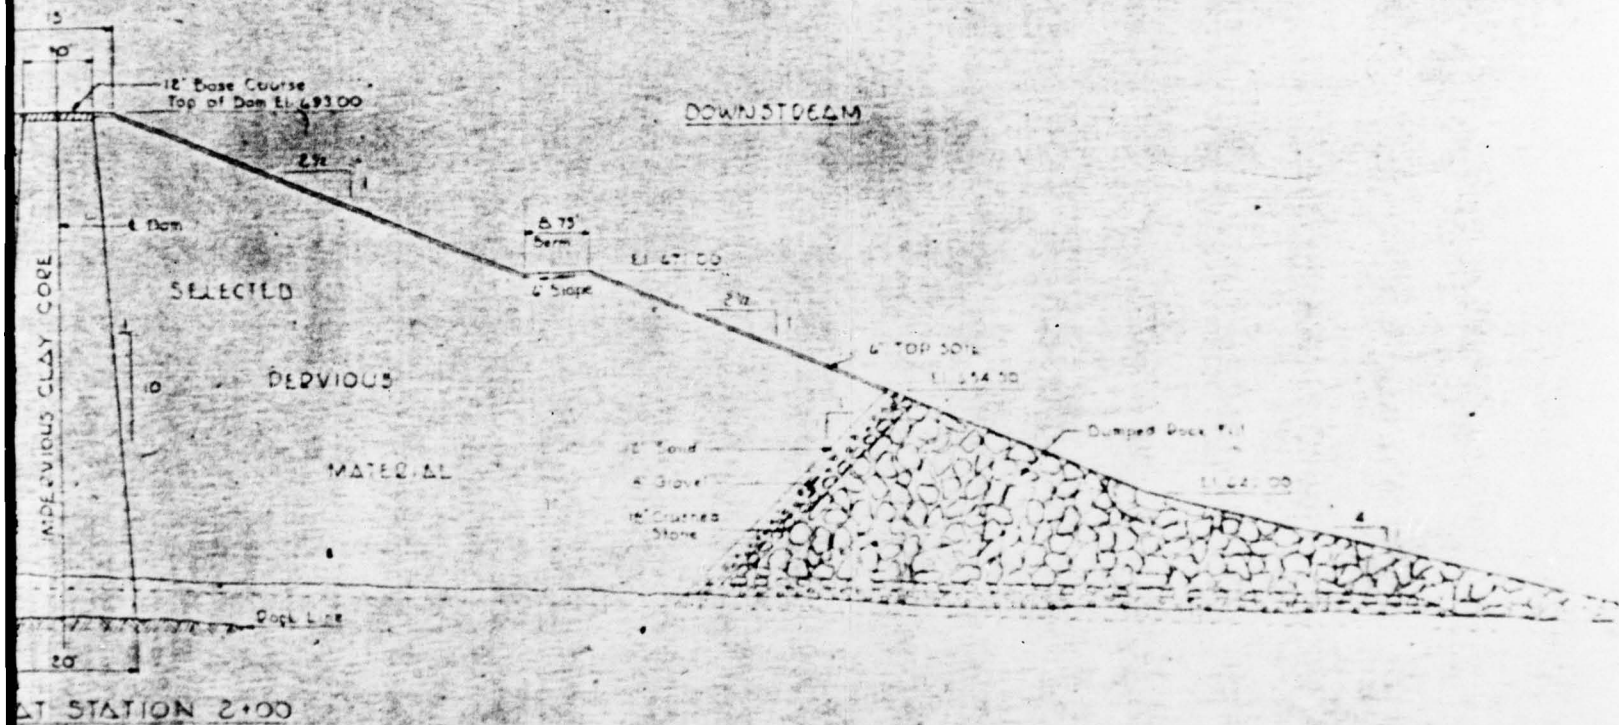
TYPICAL EMBANKMENT SECTION
FURNACE CREEK DAM

It was observed that the crest of the dam was about one foot below the top of the spillway wall. The design drawings indicated the dam crest to be 0.5 feet below the spillway wall so that this observation would indicate about 0.5 feet of settlement adjacent to the spillway. However, the Owner's representative reported that the dam crest was constructed level with the top of the spillway wall so that this observation would indicate about one foot of settlement at this location. Additional observations on the downstream face disclosed a maximum of about one foot of embankment settlement adjacent to the spillway wall.

It is recommended that the crest of Furnace Creek Dam, including the right abutment backfill, be raised to the top of the spillway walls. In this way the spillway is estimated to be capable of passing about 90% of the PMF.

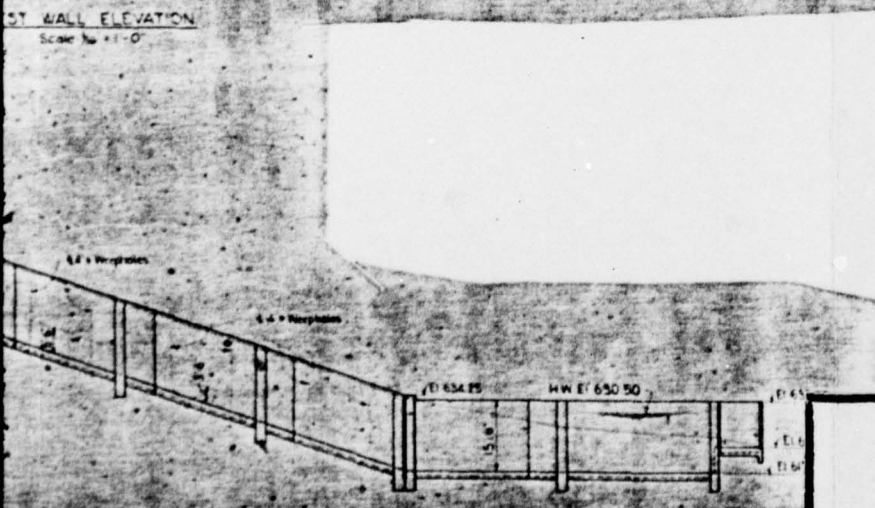
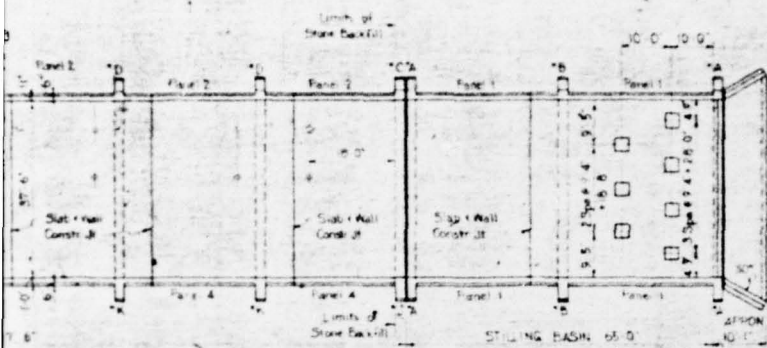
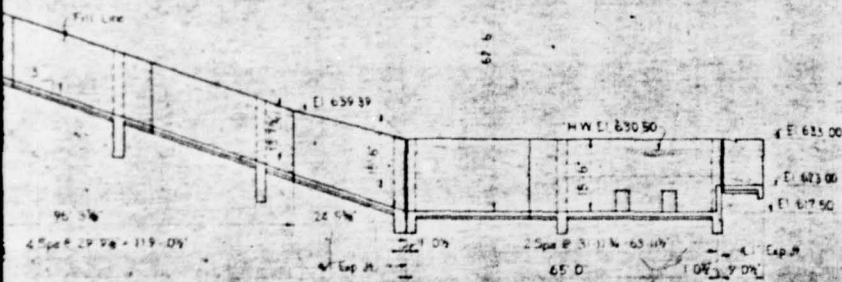
SPILLWAY PLAN AND PROFILE
FURNACE CREEK DAM

The main area of concern identified during this study is the condition of the spillway walls. The right wall serves as an earth/rock retaining structure at the foot of the steeply sided natural abutment and the left wall retains the embankment fill. It appears that translation and/or rotation of more than one inch has occurred along the top of this wall since construction and exces-

sive stresses have caused structural cracking and separation between the wall and supporting buttresses. It is recommended that the stability of this wall be further evaluated.

top of the spillway walls. Concrete cracks up to 1/4 inch wide were observed at two of the buttresses on the spillway walls. These cracks appeared to propagate from the re-entrant corners of the buttress and are approximately parallel to the face of the spillway wall.
