2 QUEMAHONING DAM

(NDI I.D.NO: 740)

PHASE I INSPECTION REPORT  
NATIONAL DAM INSPECTION PROGRAM

1275p D'APPOLONIA CONSULTING ENGINEERS  
10 DUFF ROAD  
PITTSBURGH, PA. 15235

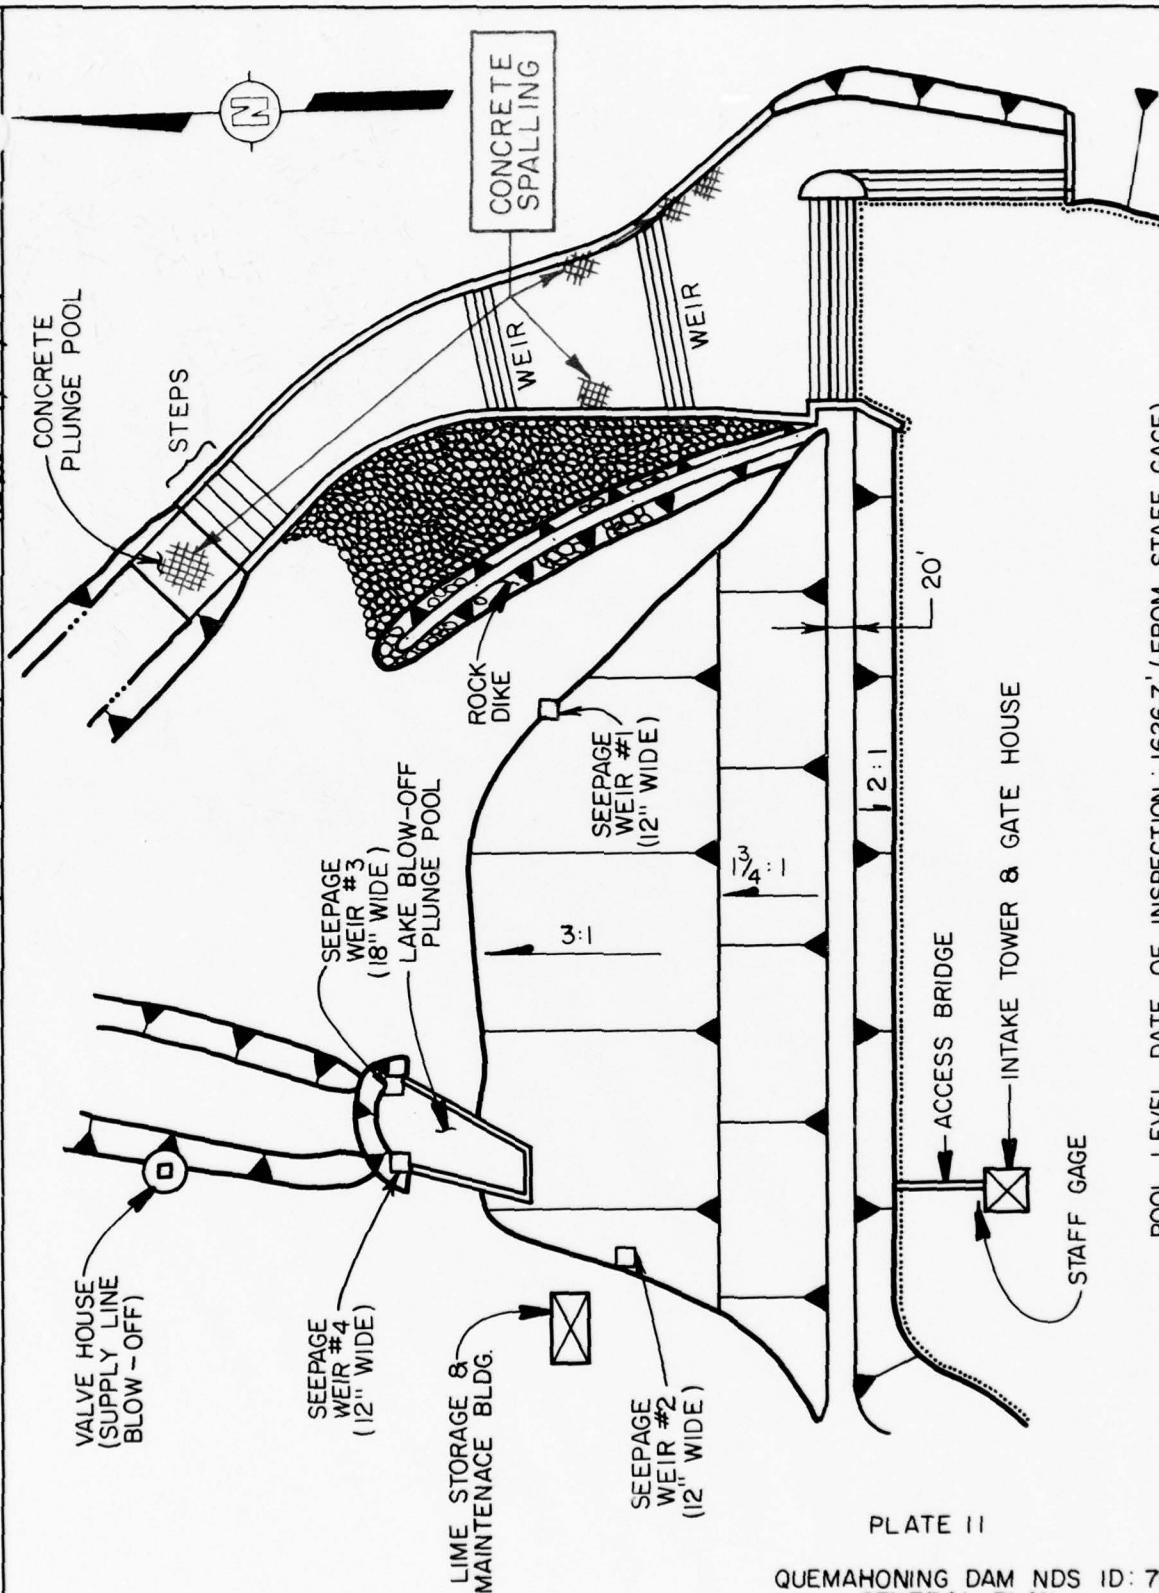
POOL LEVEL DATE OF INSPECTION : 1626.7' (FROM STAFF GAGE)

PLATE II  
 QUEMAHONING DAM NDS ID: 740  
 GENERAL PLAN  
 FIELD INSPECTION NOTES  
 FIELD INSPECTION DATE : JUNE 9 , 1978  
**D'APPOLONIA**

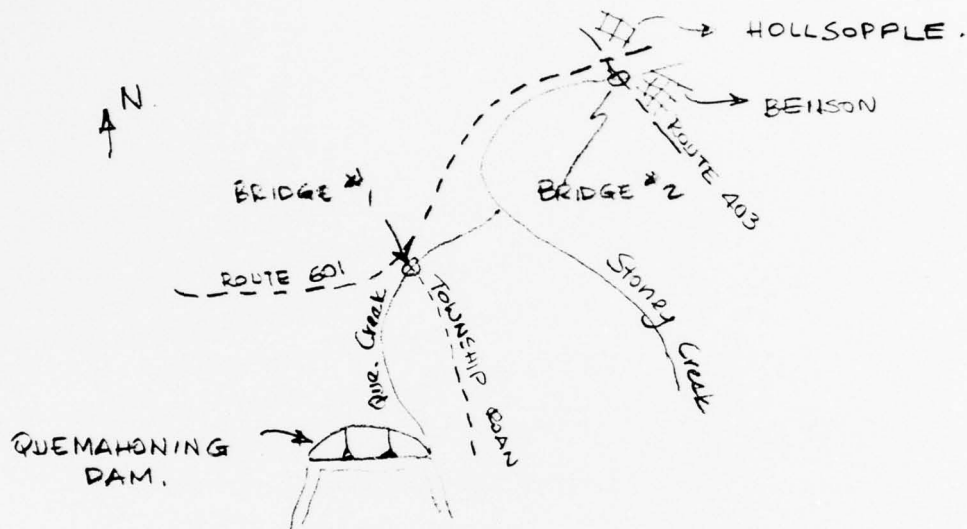
## STREAM CROSS-SECTION & BRIDGE LOCATIONS
