# STILLWATER RESERVOIR DAM

## PHASE I INSPECTION REPORT NATIONAL DAM SAFETY PROGRAM

NY 00316

Date of Inspection: June 13, 1978

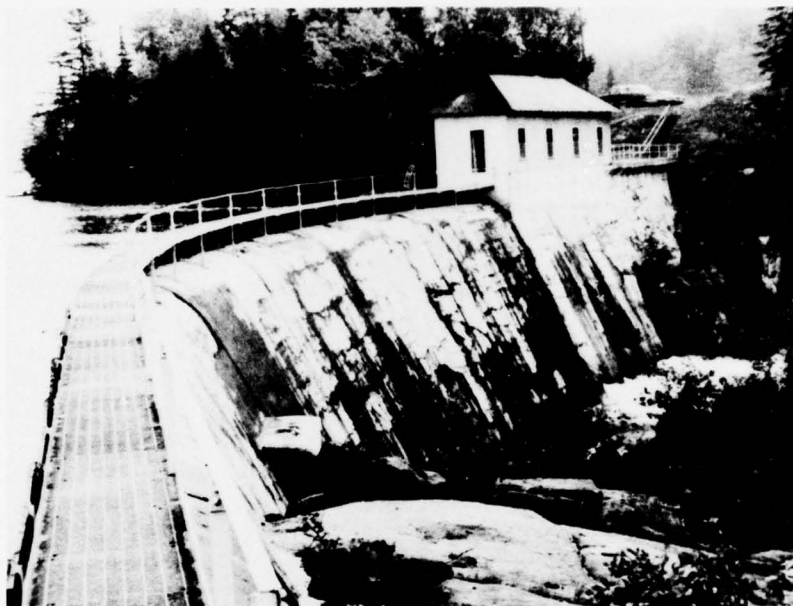
CONCRETE SPILLWAY AND GATE HOUSE

The downstream face of the non-overflow section shows signs of deterioration. A protective surface treatment (gunite) which was applied to the structure has weathered and cracked. Some spalling of the gunite was noted in the downstream slope of the non-overflow section.

The downstream face of the spillway has also been surfaced with a protective material. A much more significant deterioration of the material than observed on the non-overflow section was evident. In areas where the material had dislodged from the structure, spalled concrete was again noted. No seepage was observed in the toe area of the gravity section.

3. Remove and replace the deteriorated concrete surface protection material as required.
