National Dam Safety Program. Tipton Dam (NDI I.D.-525), Susquehanna River Basin, Tipton Run, Blair County, Pennsylvania. Phase I Inspection Report.

## TIPTON DAM

### PHASE I INSPECTION REPORT NATIONAL DAM INSPECTION PROGRAM

TIPTON DAM  
NDI I.D. NO. 525  
JULY 11, 1978

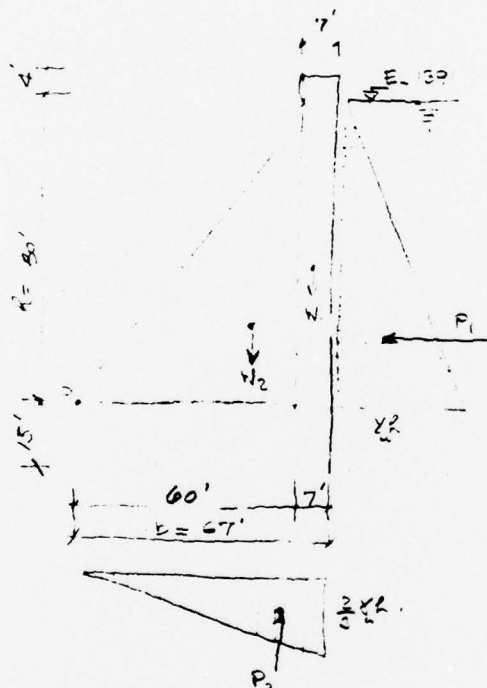
## STABILITY OF DAM @ NORMAL P.O.O. LEVEL.

OVERTURNING MOMENTS ABOUT P.T. 2

$$\begin{aligned} &= \frac{1}{2} \times 80' \times \frac{1}{3} \times 80'^2 - \frac{1}{2} \times \frac{2}{3} \times 80'^2 \times \left(\frac{2}{3} \times 80'\right) \\ &= \frac{1}{6} \times 80'^3 + \frac{2}{9} \times 80' \times 80'^2 \\ &= \frac{1}{6} \times 64 \times 10^3 - \frac{2}{9} \times 64 \times 10^3 \times \frac{2}{3} \\ &= 53 \times 10^3 + 5.0 \times 10^3 \end{aligned}$$

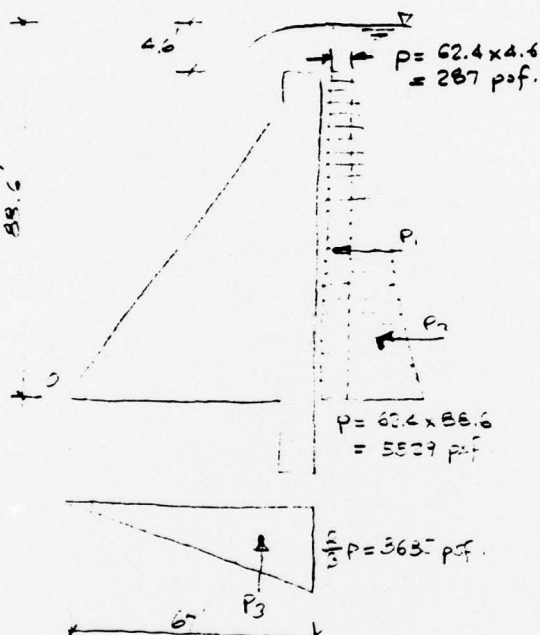
### STABILITY OF DAM @ POOL 4.6 ABOVE CREST

HYDROSTATIC PRESSURE

$$P_1 = 62.4 \times 4.6 \times 84 = 24 \times 10^3 \text{ lb.}$$
