Name Of Dam: BIG CHERRY DAM

Inventory Number: VA 19502

# PHASE I INSPECTION REPORT NATIONAL DAM SAFETY PROGRAM

GILBERT ASSOCIATES, INC.

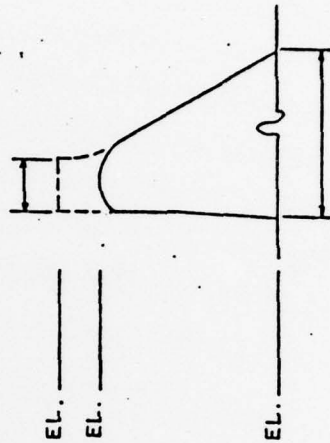
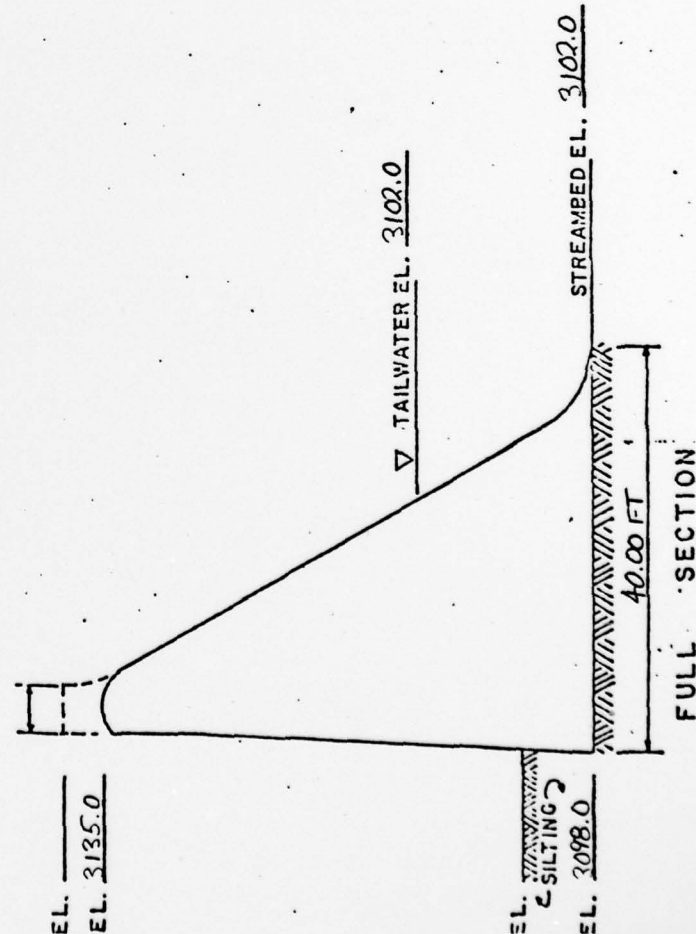
ANALYSIS DONE ON X FULL SECTION PARTIAL SECTION  
 LOCATION OF SECTION BIG CREEK DAM  
 ANALYSIS PREPARED BY DR. BEECHWOOD

LOADING CASE	ELEV. HEAD WATER	ELEV. TAIL WATER	$\Sigma V$	$\Sigma H$	$\frac{\Sigma H}{\Sigma V}$	LOCATION RESULTANT FROM TOE	% BASE IN COMPRESSION	FACTOR SAFETY SLIDING	FOUNDATION PRESSURE	
									TOE	HEEL
PMF	3145.1	3102.0	63.0 K/FT	66.1 K/FT	1.05	11.49 FT	86%	0.54	3.66 KSF	0.0 KSF
$\frac{1}{2}$ PMF	3142.1	3102.0	66.8	59.1	0.88	14.27	100%	0.67	3.11	0.23
NORMAL WATER LEVEL + ICE	3135.0	3102.0	75.6	47.7	0.63	17.31	100%	1.04	2.65	1.13

NOTES: ANALYSIS PERFORMED ON 1 FT. THICK SECTION WITH FULL UPLIFT  
 FOR SLIDING ALONG POTENTIAL FAILURE PLANE,  
 $\phi = 32^\circ$   
 $\delta = 0$
