⑥ National Dam Inspection Program. Dehart Dam (Inventory Number NDS-PA-561), Susquehanna River Basin, Clarks Creek, Dauphin County, Pennsylvania. Phase I, Inspection Report.

DEHART DAM

PHASE I INSPECTION REPORT

Name of Dam: DEHART DAM
State & State No. PENNSYLVANIA - 22-9
County: DAUPHIN
Stream: CLARKS CREEK
Date of Inspection: July 7, 1978

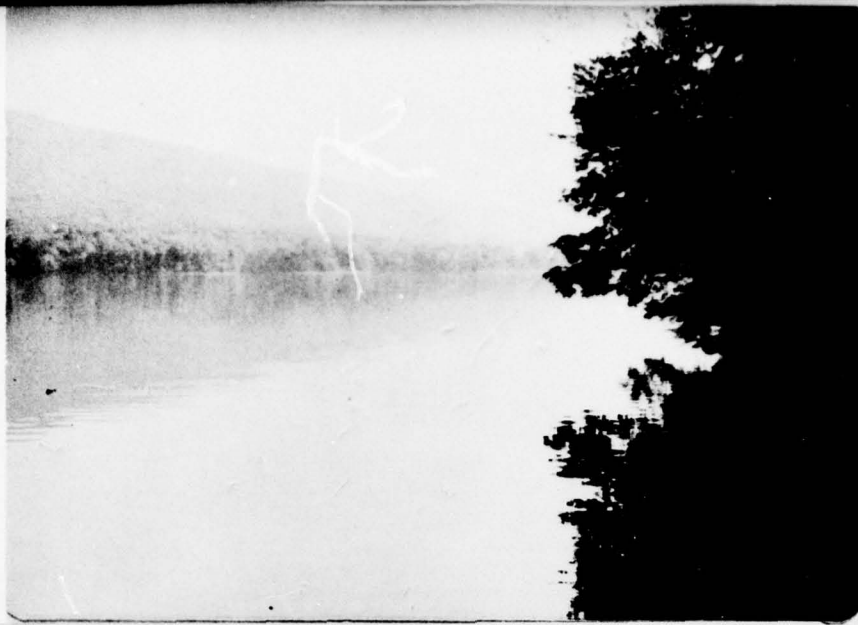
Reservoir

Sedimentation has not been reported as a problem. The reservoir slopes are forested and are not subject to heavy erosion. The general reservoir area is in good condition.

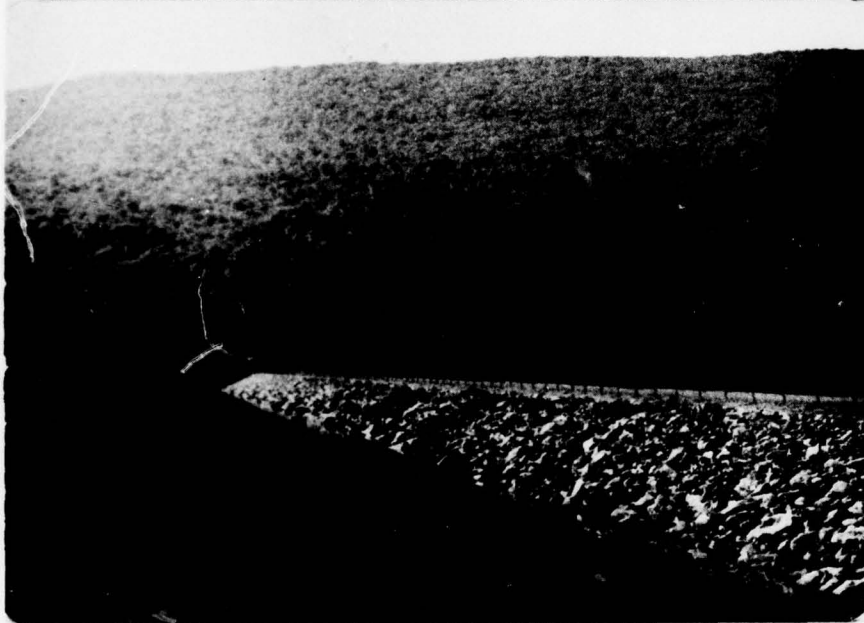
Upstream
Embankment

The embankment shows no signs of distress. The rock slopes, both upstream and downstream are relatively uniform considering the size of rock (18 to 48 inches) which cover these surfaces. Heavy fern growth is found between the nested rocks on the downstream slope. Some light fern growth is located near the top of the slope on the upstream slope. The presence of this vegetation does not have any influence on the stability of the embankment; however, some trees on the downstream slope should be removed.
