AFWL-TR-77-274

# FRACTURE ANALYSIS OF REENTRY VEHICLE STRUCTURAL MATERIALS

September 1978

Final Report

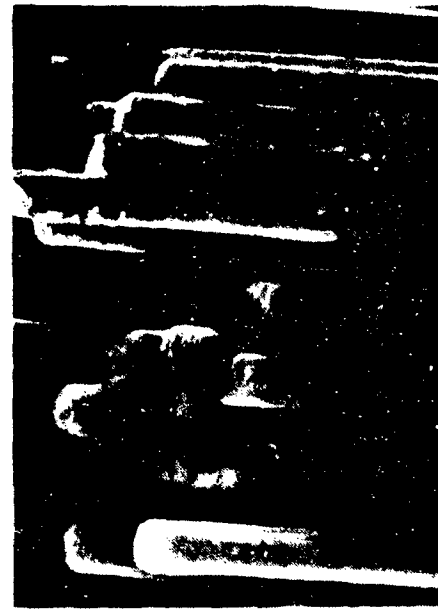
The scanning electron microscope (SEM) was used to look at the fracture surfaces at high magnification. For the G/E composites, both virgin and degraded material were examined after either static or dynamic tests. These four material/test condition combinations are shown in figures 24, 25, 26, and 27. A typical low magnification SEM photomicrograph of the fracture surface is shown in figure 28. By comparing similar areas from different test conditions, it can be seen that there is no significant difference from one test condition to another or from virgin material to degraded material. In comparing figure 24a, 25a, 26a, and 27a with each other, one can see that failure parallel to the fibers always occurred at or near the fiber-matrix interface (rather than entirely within the matrix) and that there was always a rather fine structure or "river" pattern in the fracture of the matrix. From figures 24b, 25b, 26b, and 27b, it can be seen that there is no significant difference in the fracture of the fibers themselves. Finally, from figures 24c and d, 25c and d, and 27c, it can be seen that fiber pullout was approximately the same in each test condition. Thus, it was concluded that there was no significant microscopic differences between the test conditions and degree of degradation of the

Figure 24. SEM Photomicrographs of Fracture Surfaces of G/E After Test; Virgin Material, Static Test. (a) View of Declamination Surface 2000X. (b) Single Fiber End in 45° Ply 1000X. (c) Fiber Ends in Longitudinal Ply 500X.
