MISCELLANEOUS PAPER GL-79-4

EVALUATION OF THE EFFECTIVENESS OF MEMBRANES FOR PREVENTION OF CRACK REFLECTION IN THIN OVERLAYS

Geotechnical Laboratory
U. S. Army Engineer Waterways Experiment Station
P. O. Box 631, Vicksburg, Miss. 39180

March 1979

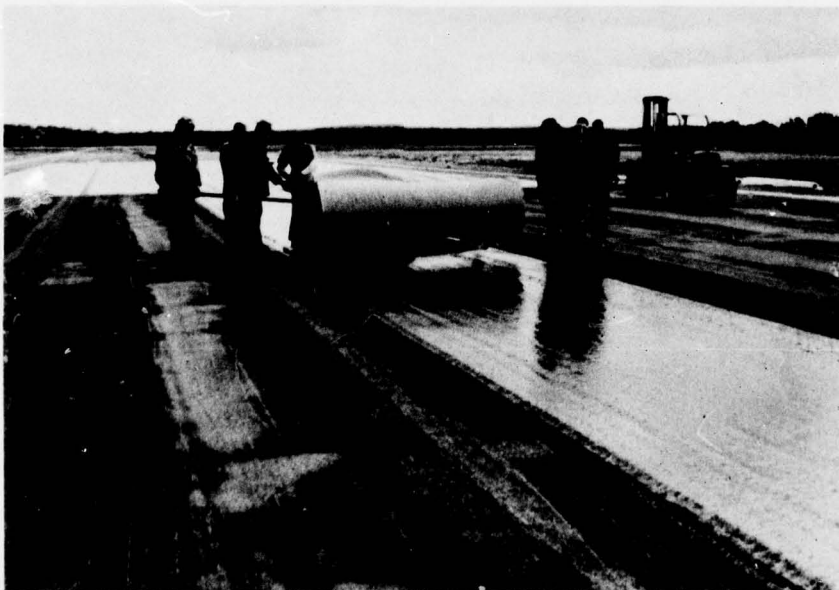
Photo 4. Fort Devens--placement of Bidim C-22 fabric on NW-SE runway; very difficult to place wrinkle free

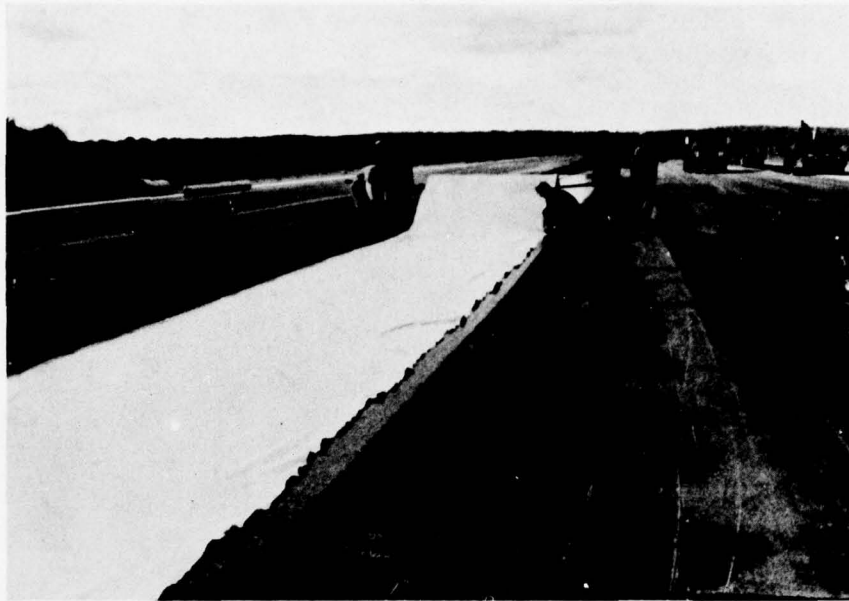
Photo 5. Fort Devens--sawed edge of Bidim C-22 gave a ragged appearance; material smoothed out under roller

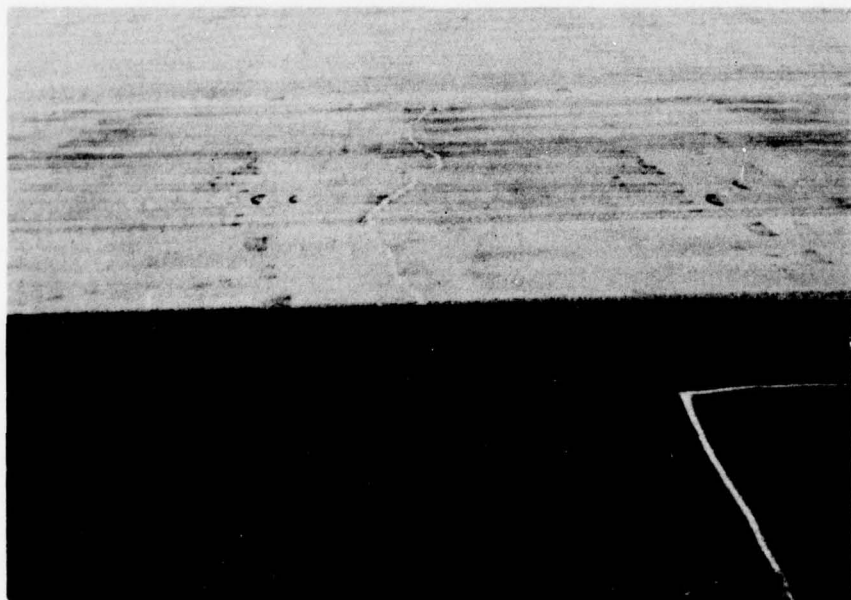
Photo 12. Fort Devens--unsealed crack under Bidim C-22 fabric in apron test area

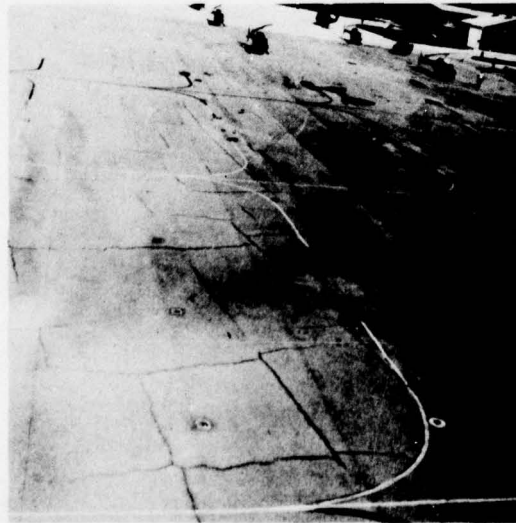
Photo 20. Fort Stewart--crack pattern
from soil-cement base

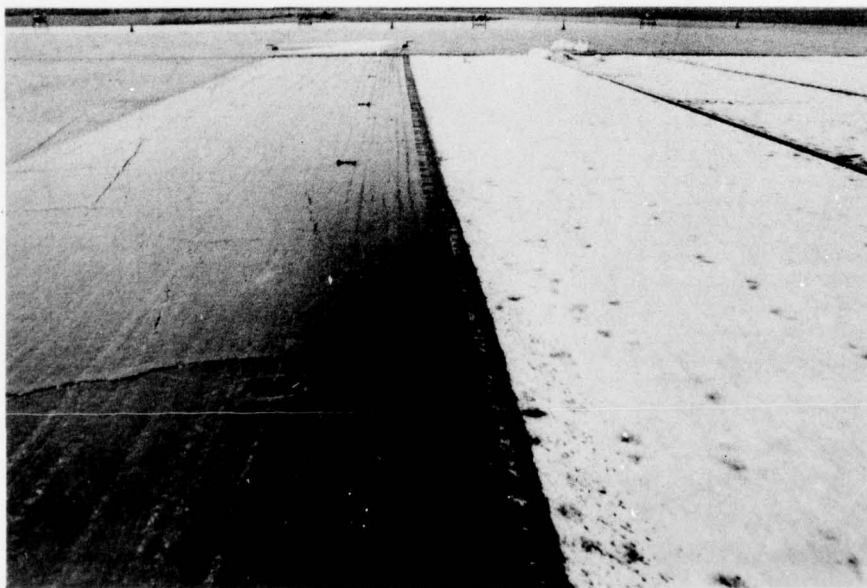
Photo 22. Fort Stewart--overlap of about 6 in.;
note wrinkling of Mirafi 140 fabric

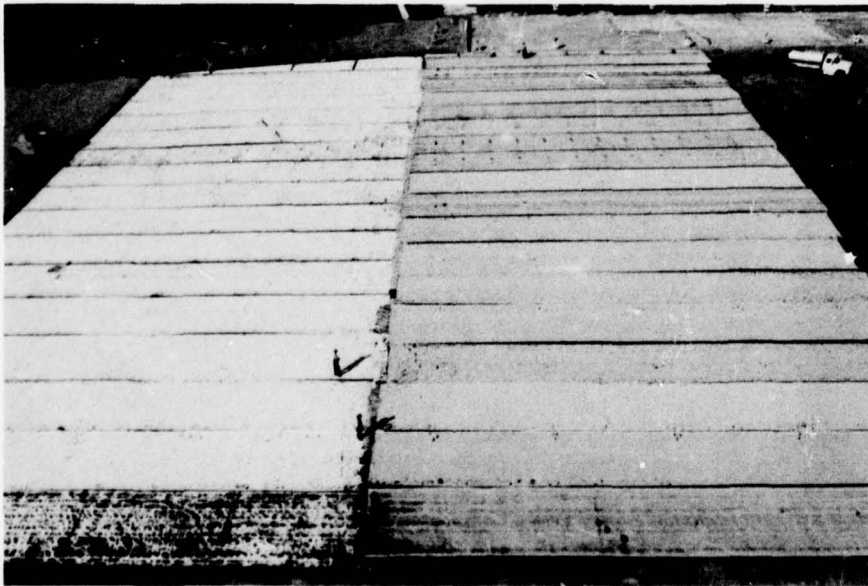
Photo 24. Fabric sections installed; joint between sections sanded to prevent roller pickup; lane in foreground where fabric was placed before emulsion allowed to cure; Mirafi 140 fabric on left and Bidim C-22 fabric on right

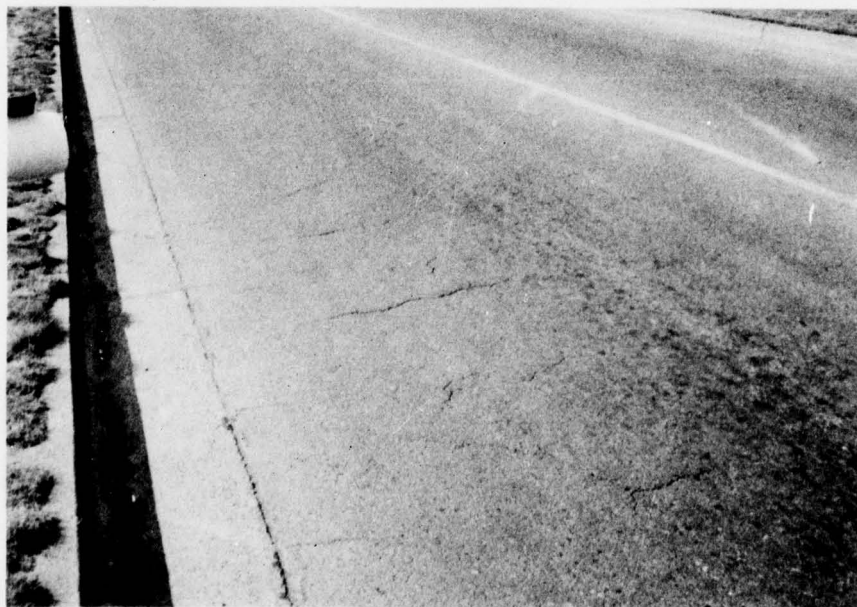
Photo 30. Fort Lewis--type cracking in pavement
surface on Second Division Drive

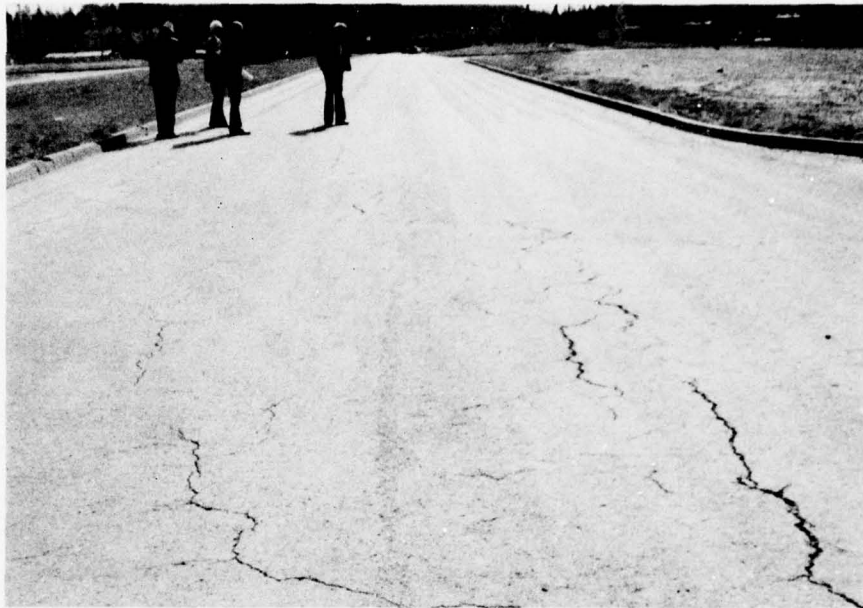
Photo 31. Fort Lewis--cracking in pavements on Faith Avenue; most of cracks in localized areas

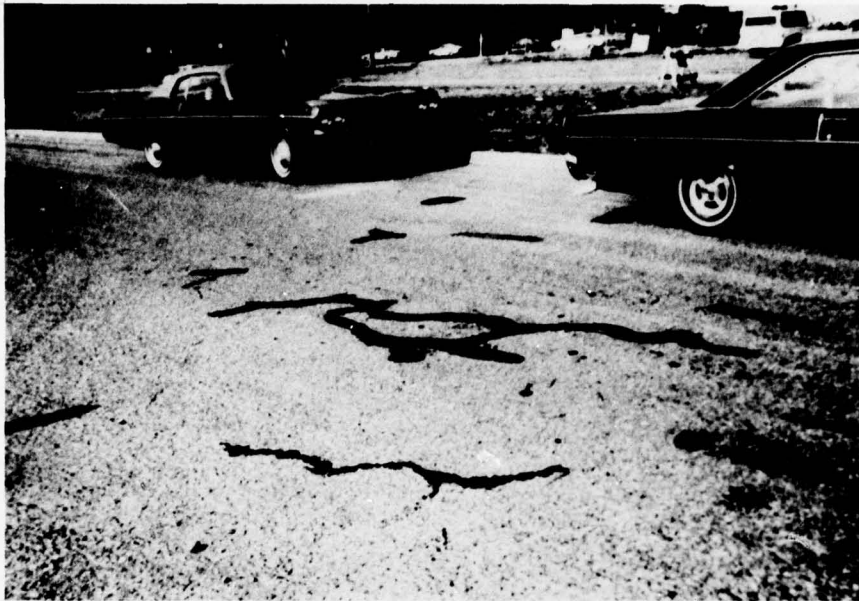
Photo 33. Fort Lewis--cracks on Faith Avenue sealed with AR-4000 asphalt

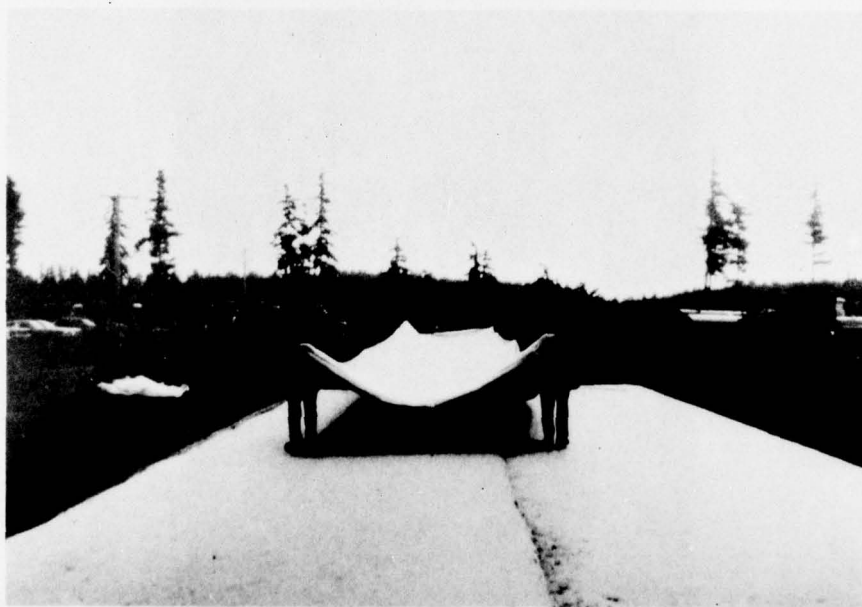
Photo 37. Fort Lewis--asphalt-rubber membrane
peeled up due to wet pavement surface

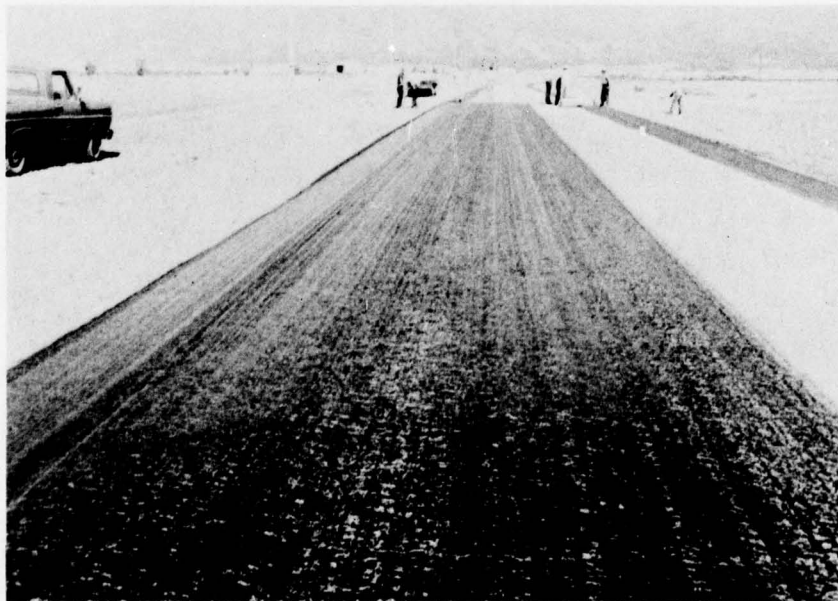
fabric (Photo 43). No problems were reported in the placement of the overlay over the fabric.

Photo 43. Fort Polk--Petromat fabric placed with considerable amount of wrinkles

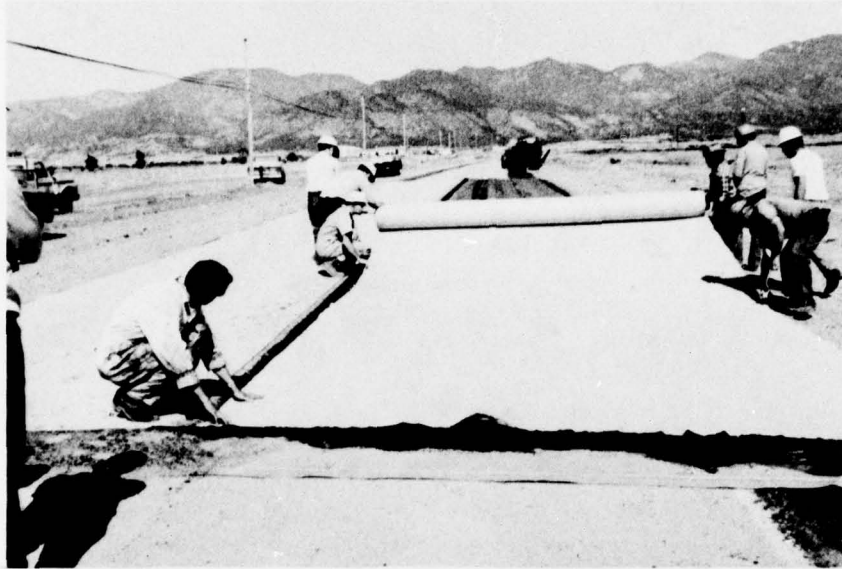
41. Arizona Refining Company used their distributor truck to spray the AC-10 tack material for the fabric test sections. The AC-10 was obtained from Continental Oil Company in Denver. Initial spray of tack for the first lane of the Bidim C-22 fabric resulted in only about 0.15 gal/sq yd of material placed when about 0.22 gal/sq yd was required (Photo 44). This was because the AC-10 was not hot enough to spray properly. The material was heated to about 310°F and reapplied. Total amount of tack material for the first lane of Bidim C-22 was about 0.30 gal/sq yd. The rate of application was controlled much better after the material was heated to the higher temperature. The Bidim C-22 fabric was received in rolls 200 ft long and 13 ft 10 in. wide and was placed by two men holding a 1-in. pipe suspended through the core of the roll and unrolling the fabric in the fresh tack material (Photo 45). A longitudinal lap joint of about 6 in. was used at the center of the roadway, and the excess fabric was cut along each edge of the roadway. The Mirafi 140 fabric was placed next. The fabric, which was in a roll 328 ft long and 14 ft 9 in. wide, was first sawed to a width so that two lanes would have 24 ft 6 in (Photo 46). The test area was sprayed with asphalt tack at the rate of 0.18 gal/sq yd. Fabric laydown was accomplished by attaching a 1-in.-diam support pipe and hand-held brake devices to the fabric roll and adjusting each brake to provide uniform drag. The fabric was then placed by unrolling about 20 ft of fabric, stretching it taut and

Photo 44. Fort Carson--application of tack very light, about 0.15 gal/sq yd

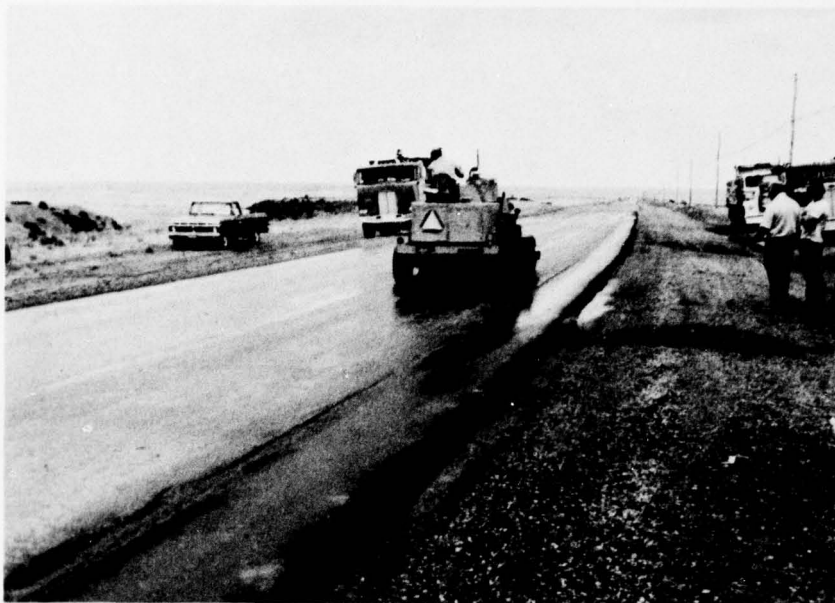
wrinkle free, and lowering it into the asphalt (Photo 47). All spray applications were begun and ended on building paper (Photo 48). The Petromat (Paving-Grade fabric weighing 4.2 oz/sq yd) was placed next. Phillip's Fibers Corporation also manufactures a 6- and 8-oz Paving-Grade Petromat fabric. The fabric was in a roll 300 ft long and 12 ft 6 in. wide and was placed with a small tractor designed and equipped to lay fabric (Photo 49). The test area was sprayed with asphalt tack at the same rate as had been applied for the Bidim C-22 fabric (between 0.2 and 0.25 gal/sq yd). The tractor is positioned with the roll of fabric on the front and proceeds to lay the fabric in the fresh tack material fairly rapidly (Photo 50). The fabric can be laid fairly wrinkle free with an experienced operator on the tractor (Photo 51). Placement of all fabric sections was completed by early afternoon. There was some excess Petromat fabric, and this was placed in the area indicated in Figure 5 between telephone poles Nos. 1 and 2. All fabric areas were rolled with a pneumatic-tired roller after completion; and with the high air temperatures, the asphalt tack was evident on the surface of the fabric (Photo 52).

Photo 52. Fort Carson--tack material evident on surface of fabric

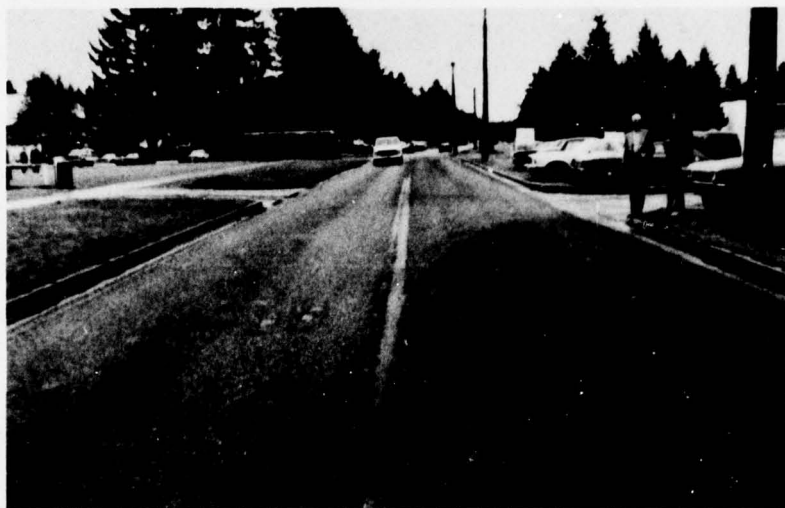
44. In February 1978, approximately 5 months after construction, it was reported by personnel of the Facilities Engineering that distress in the form of ravelling was occurring in the asphalt-rubber chip seal on Second Division Drive, and fine hairline cracks were observed in one of the fabric sections on Faith Avenue. A visit was made to Fort Lewis at that time, and it was found that the asphalt-rubber chip seal placed by Sahuaro on Second Division Drive was ravelling with loss of chips in the traffic wheel paths and turnoffs to parking areas (Photo 58).

Ravelling was occurring in areas where the precoated chips and uncoated chips were used and was worst in the wheel path of vehicles travelling south. A considerable buildup of loose chips was evident at the curb line. The U. S. Rubber chip seal was observed to have an area about 100 ft long along the center line of the roadway where during construction the distributor truck failed to overlap the first spray application and a blank area about 6 in. wide existed (Photo 59). On the south side of Faith Avenue at the transition area between the Mirafi 140 fabric section and the U. S. Rubber section, a crack had developed and fabric was protruding up through the overlay (Photo 60). A core taken in this area indicated that loose cover aggregate from the U. S. Rubber section was not cleaned off the pavement prior to placement of the fabric and the aggregate kept the fabric from bonding to the pavement. A fine hairline crack was found about midway in the Mirafi 140 fabric section on the south side of Faith Avenue and also one on the north side (Photo 61). Cores taken indicated the fine hairline crack was a result of a wrinkle in the fabric and not reflection from a crack in the base pavement.

Photo 58. Fort Lewis--asphalt-rubber chip seal placed
by Sahuaro ravelling in traffic wheel paths;
note buildup of loose chips at curb line

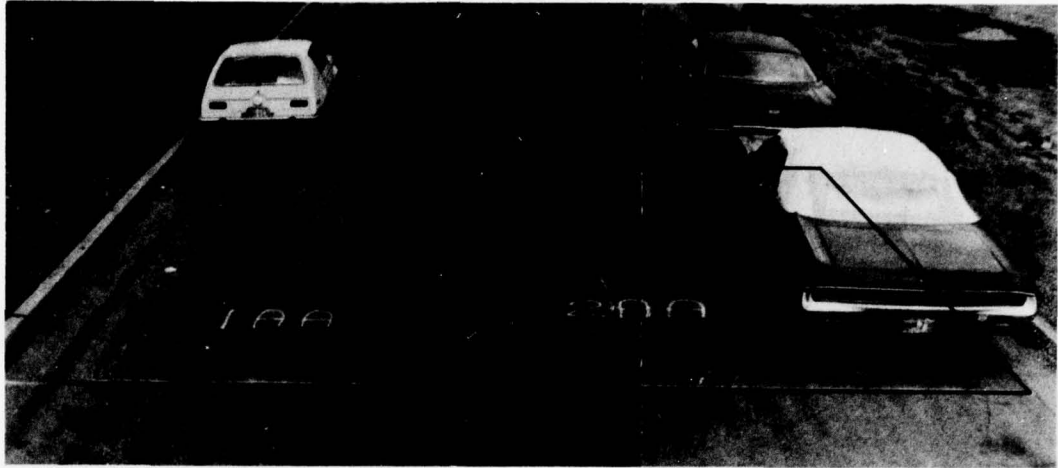
Photo 63. Fort Lewis--reflection crack in control
section on north side of Faith Avenue

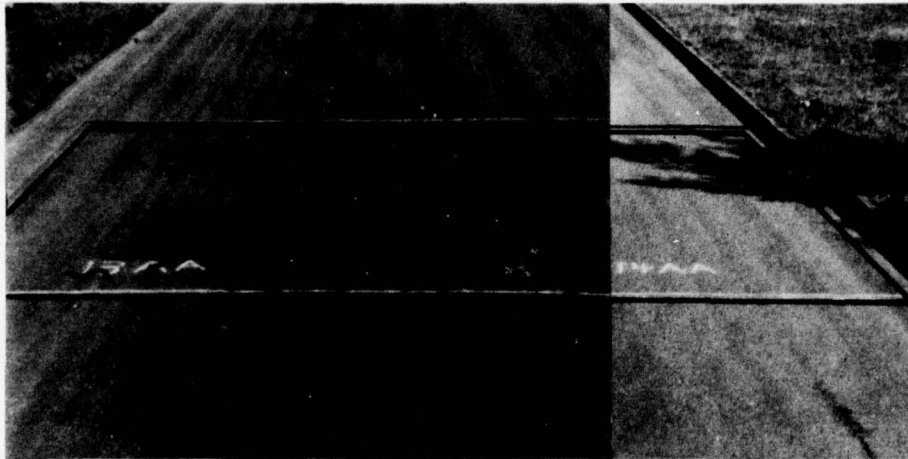
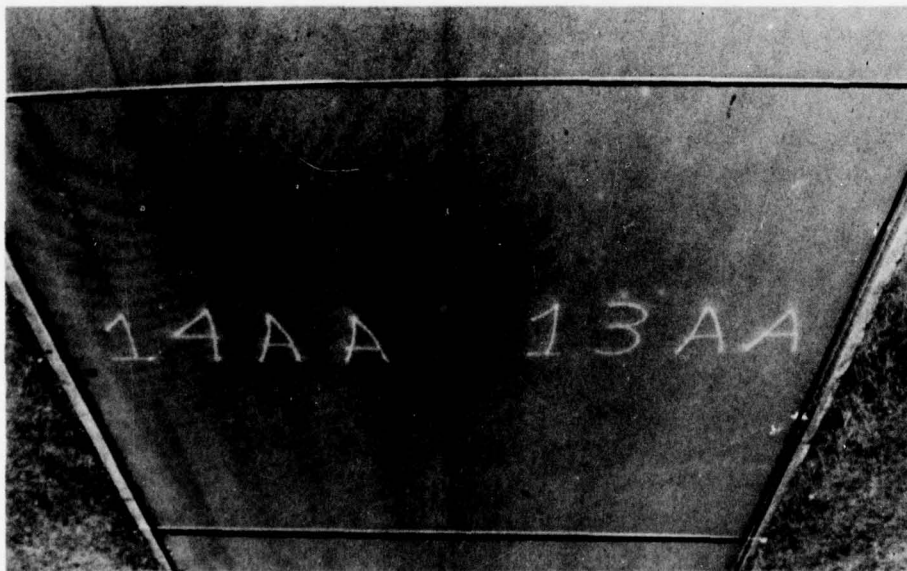
a. Condition of surface prior to overlay

b. Condition of surface 6 months after overlay

Photo 70. Fort Lewis--Mirafi 140 fabric section;
north side of Faith Avenue

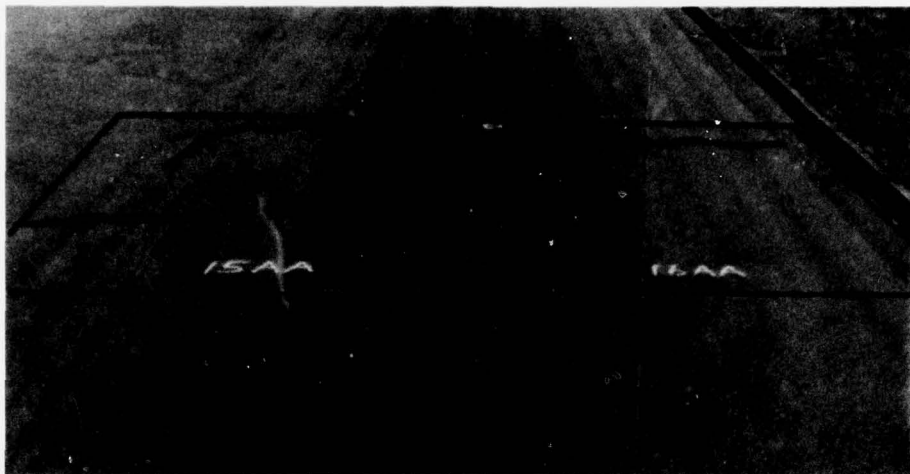
a. Condition of surface prior to overlay

b. Condition of surface 6 months after overlay

Photo 71. Fort Lewis--control section,
north side of Faith Avenue

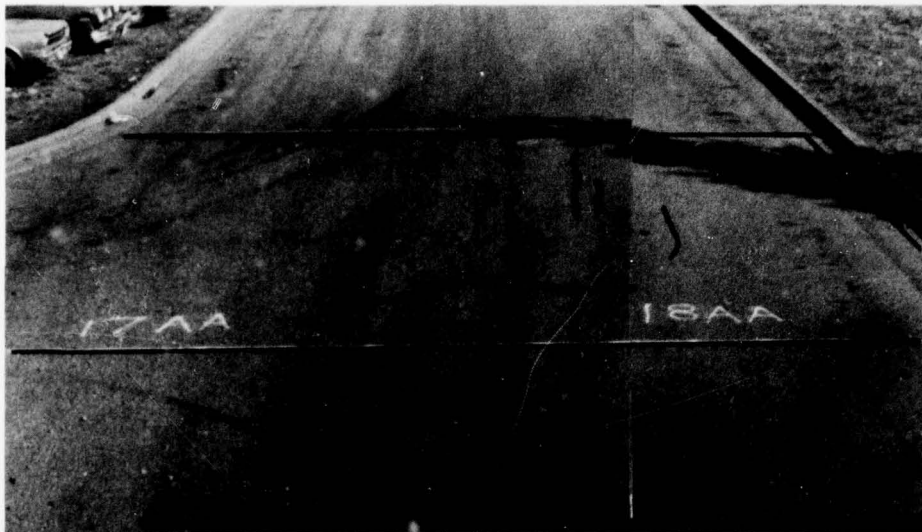
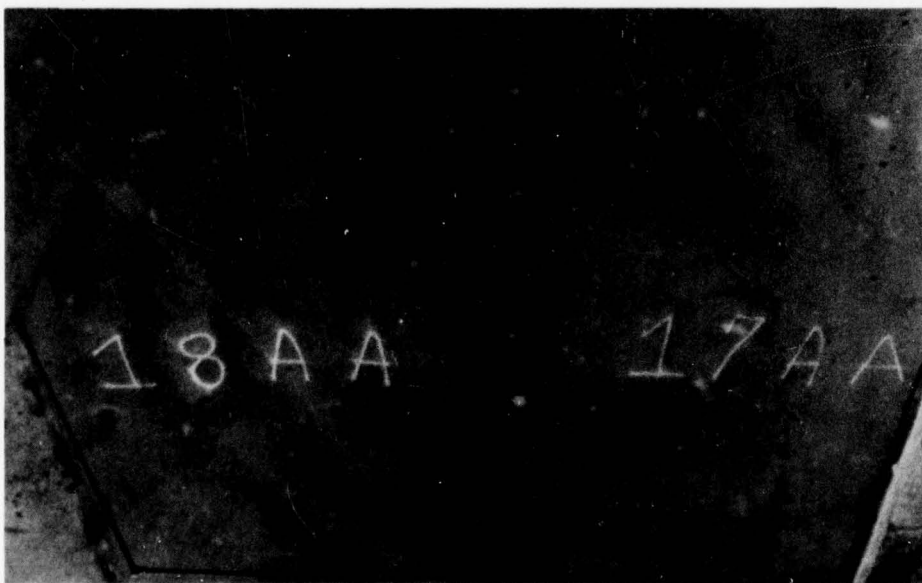
a. Condition of surface prior to overlay

b. Condition of surface 6 months after overlay

Photo 72. Fort Lewis--Bidim C-22 fabric section;
north side of Faith Avenue

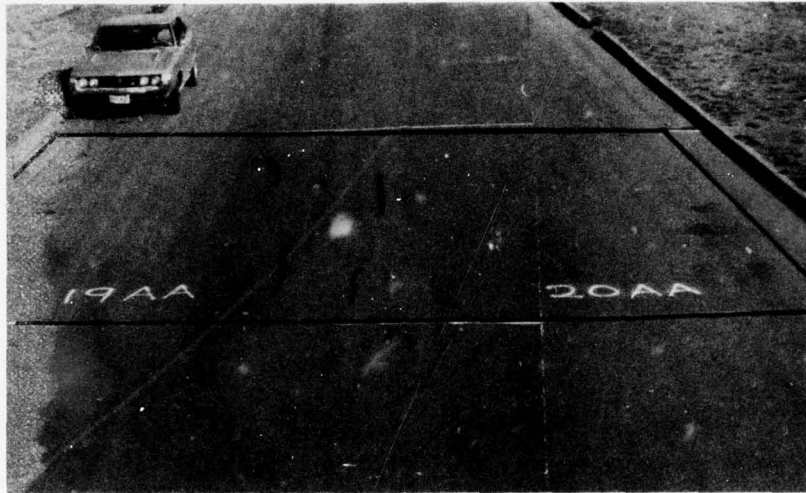
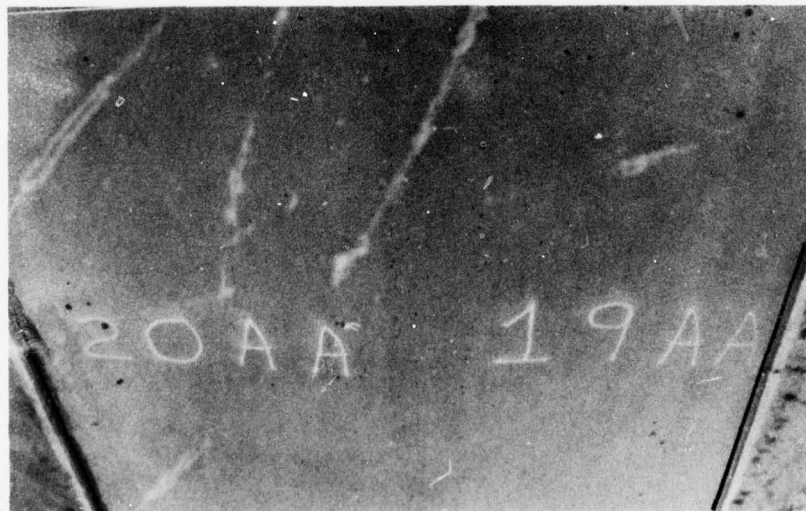
a. Condition of surface prior to overlay

b. Condition of surface 6 months after overlay

Photo 73. Fort Lewis--U. S. Rubber section,
north side of Faith Avenue

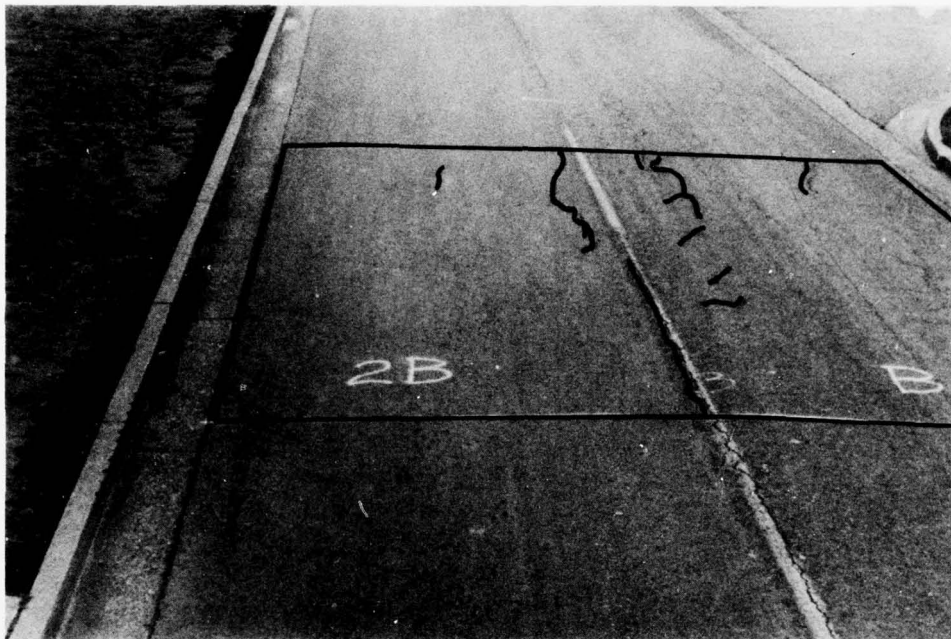
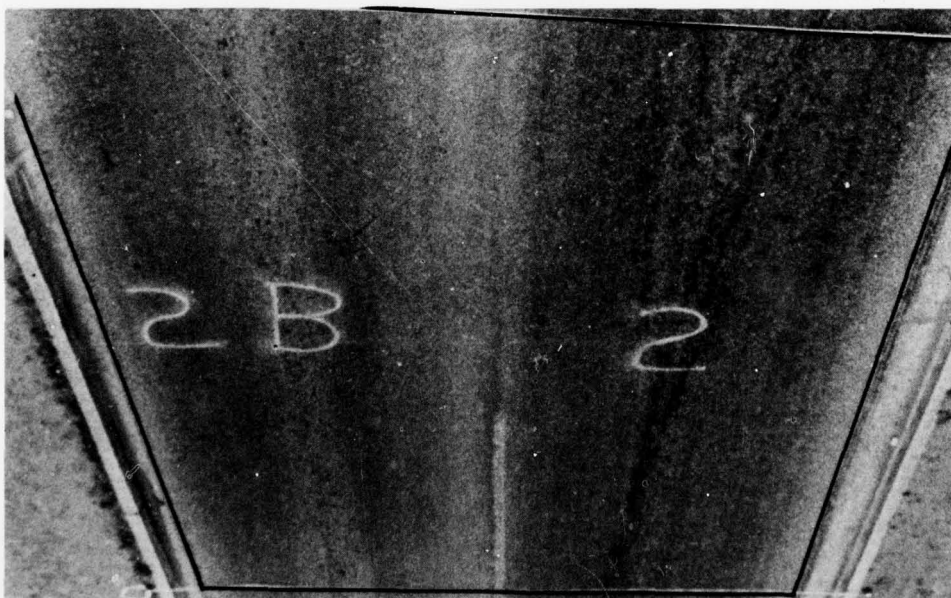
a. Condition of surface prior to overlay

b. Condition of surface 6 months after overlay

Photo 74. Fort Lewis--U. S. Rubber section,
Second Division Drive

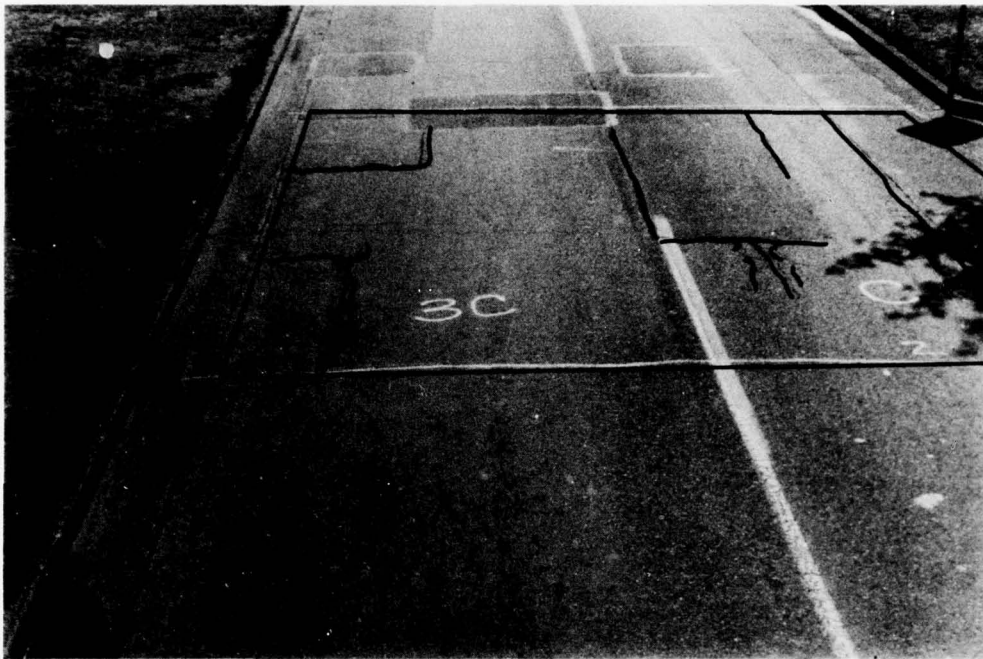
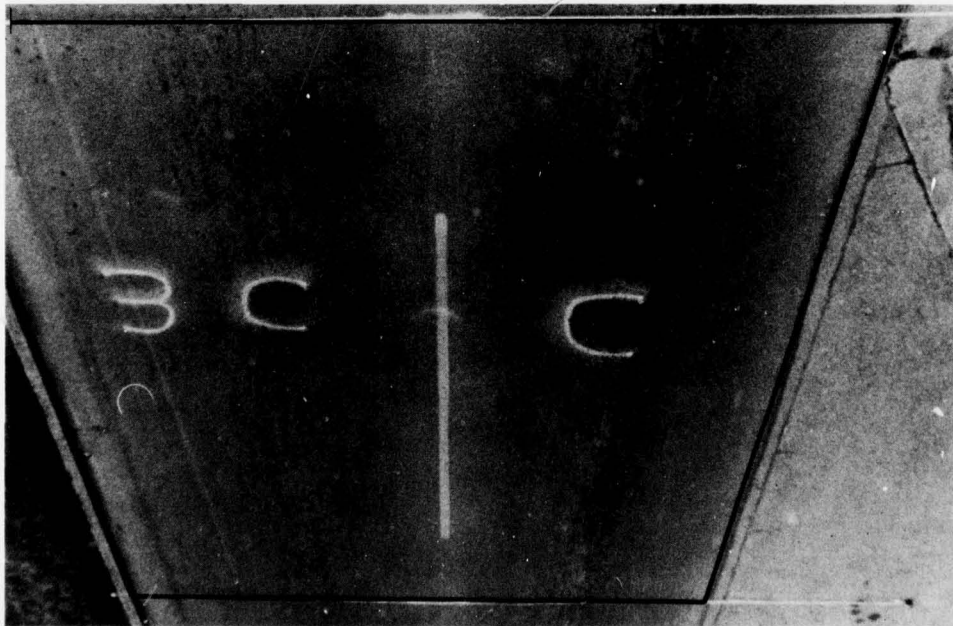
a. Condition of surface prior to overlay

b. Condition of surface 6 months after overlay

Photo 75. Fort Lewis--control section,
Second Division Drive.

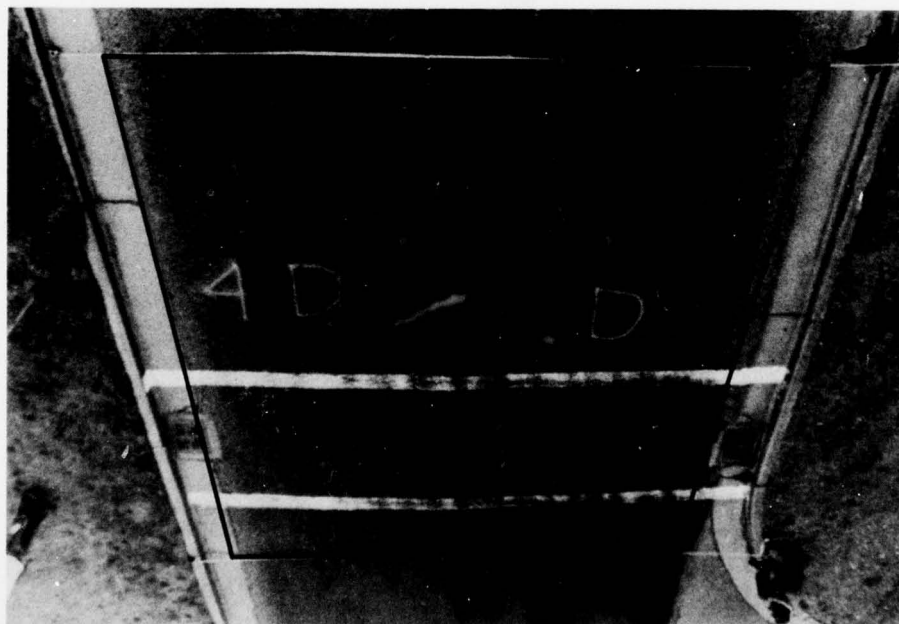
b. Condition of surface 6 months after overlay

Photo 76. Fort Lewis--Sahuaro rubber section,
Second Division Drive

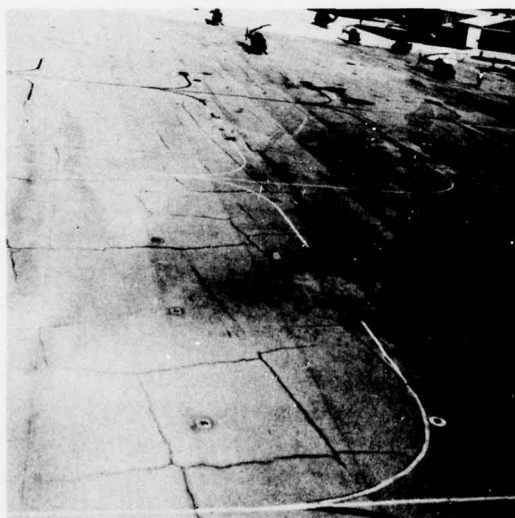
Photo 78. Fort Stewart--general view of condition of apron pavement prior to overlay

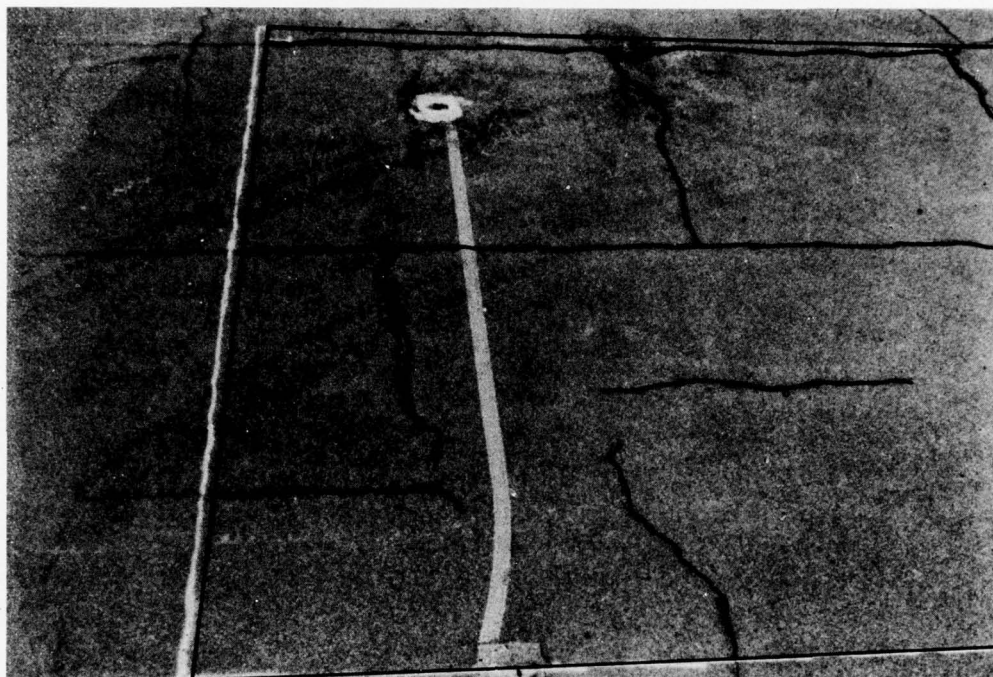
a. Condition of surface prior to overlay

b. Condition of surface 6 months after overlay

Photo 79. Fort Stewart--test square in south end
of Sahuaro rubber section

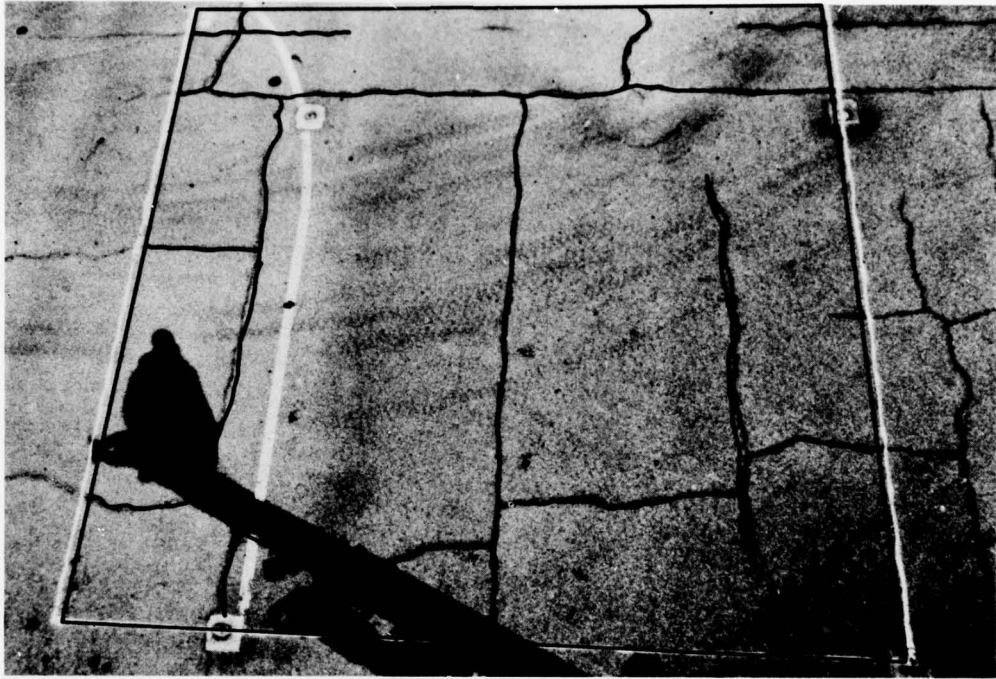
a. Condition of surface prior to overlay

b. Condition of surface 6 months after overlay

Photo 81. Fort Stewart--test square in south end
of U. S. Rubber section

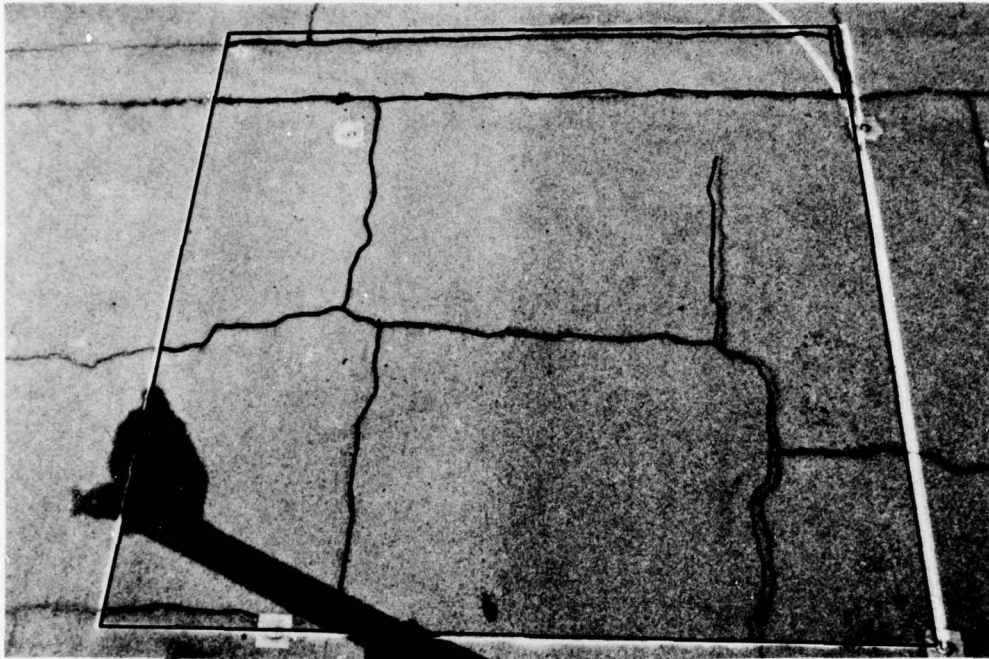
a. Condition of surface prior to overlay

b. Condition of surface 6 months after overlay

Photo 82. Fort Stewart--test square in north end
of U. S. Rubber section

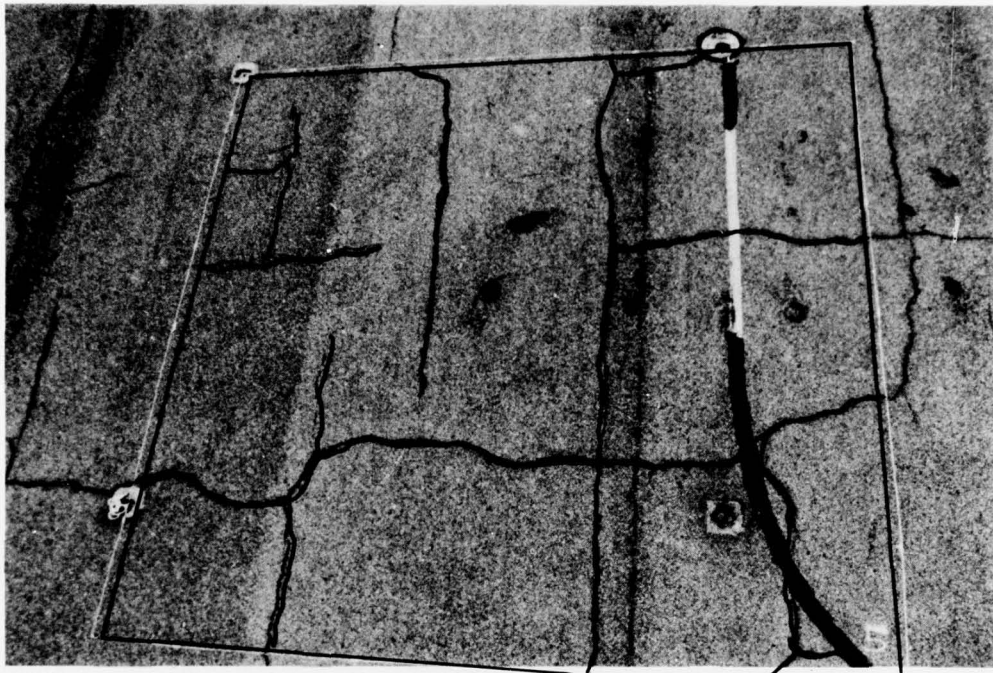
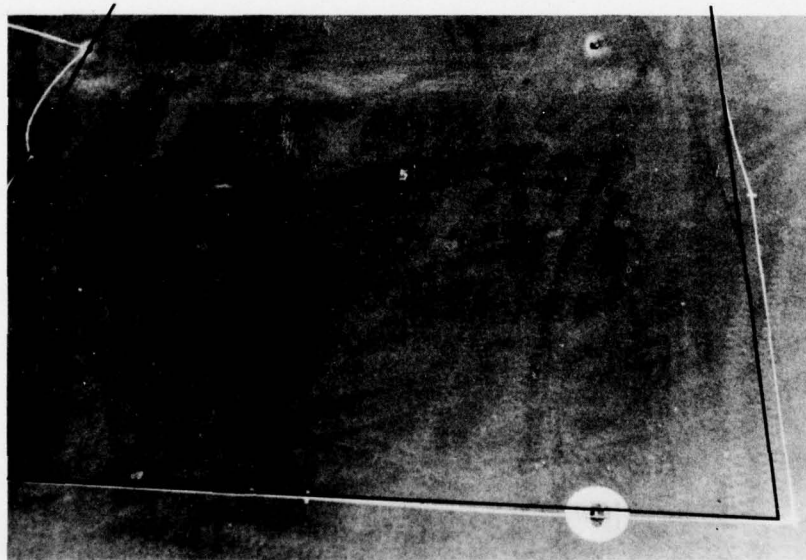
a. Condition of surface prior to overlay

b. Condition of surface 6 months after overlay

Photo 83. Fort Stewart--test square in north end
of Bidim C-22 fabric section

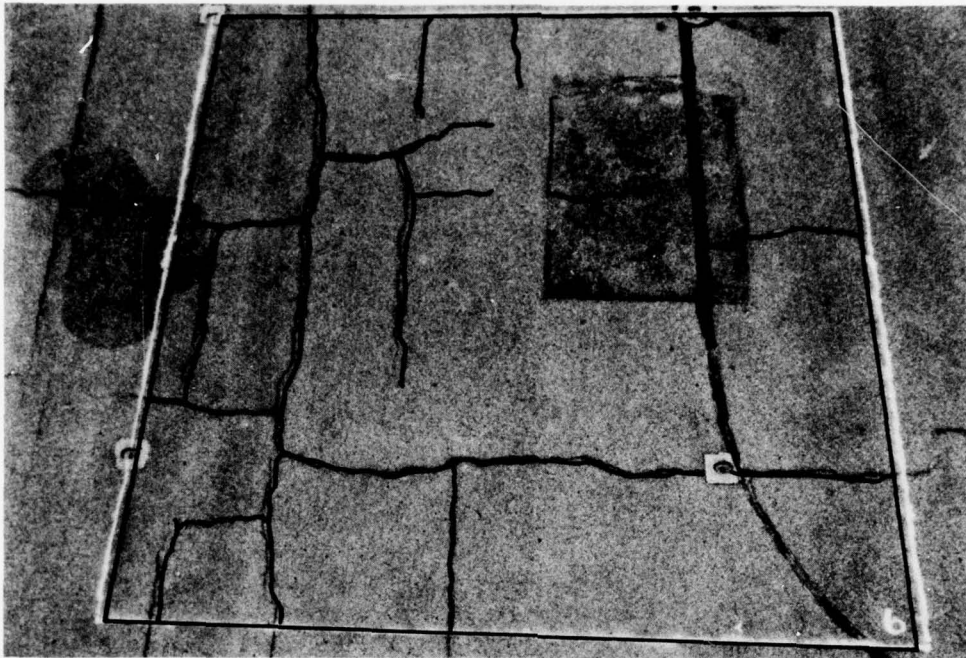
a. Condition of surface prior to overlay

b. Condition of surface 6 months after overlay

Photo 84. Fort Stewart--test square in south end
of Bidim C-22 fabric section

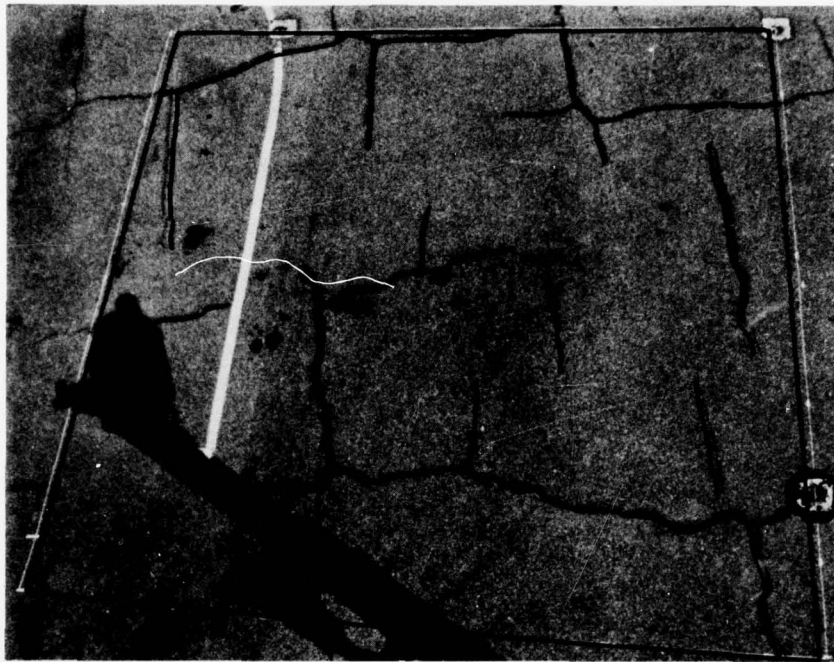
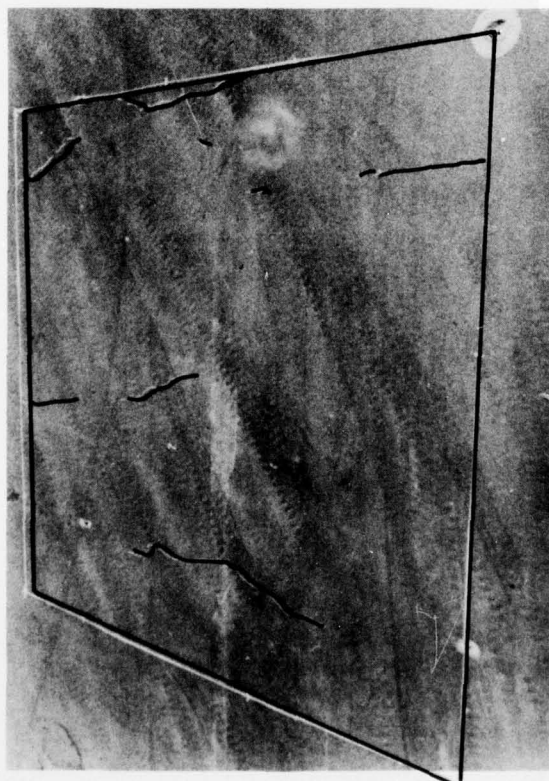
47. A visit to observe the performance of the various test sections was made on 11 May 1978. During the interval of the visit in November and May, a tar emulsion slurry seal (an item in the contract that had not been completed by November) had been placed over the apron surface. There were two selected 25- by 25-ft photographic areas in each test section (Figure 3). Photo 78 shows a general view of apron area prior to overlay. Photos 79-88 show the crack condition of the pavement prior to the overlay and 6 months after placement of the overlay. As noted in Photos 85 and 86, cracks in the selected photographic area in the Mirafi 140 section have reflected through the surface.

a. Condition of surface prior to overlay

b. Condition of surface 6 months after overlay

Photo 85. Fort Stewart--test square in south end
of Mirafi 140 fabric section

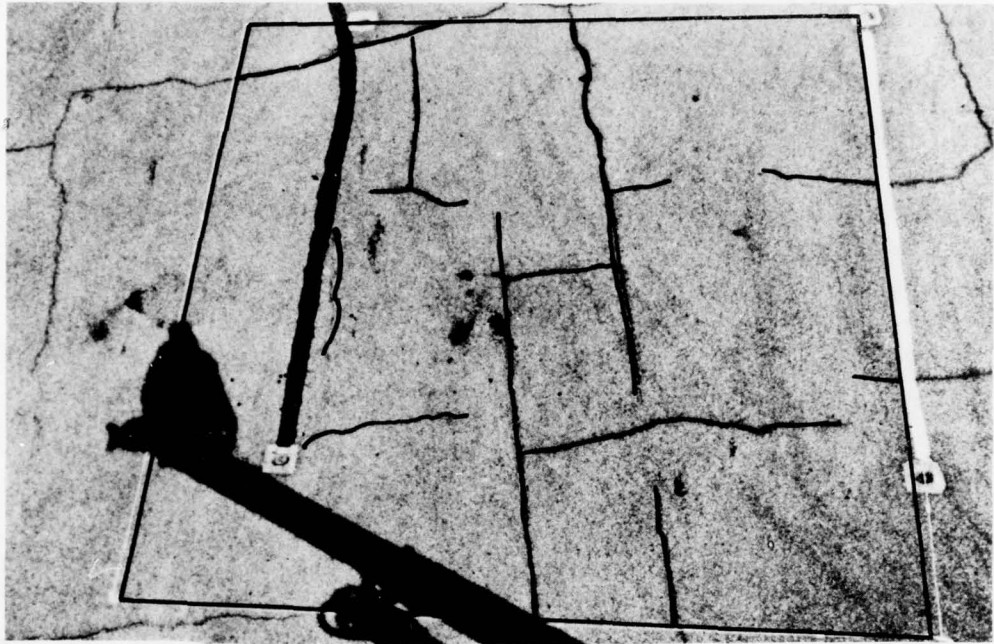
a. Condition of surface prior to overlay

b. Condition of surface 6 months after overlay

Photo 86. Fort Stewart--test square in north end
of Mirafi 140 fabric section

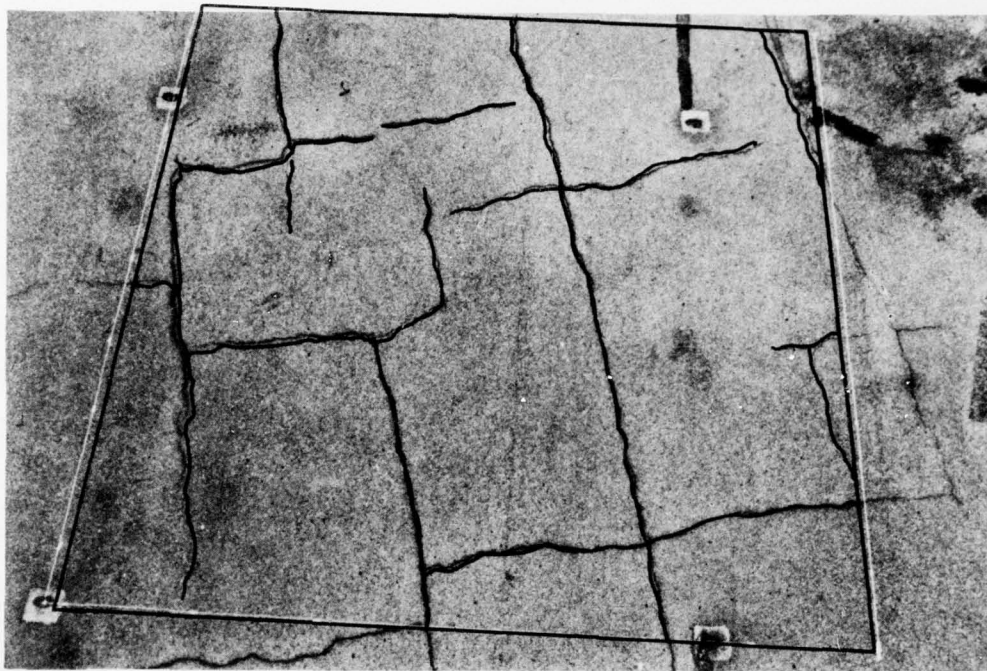
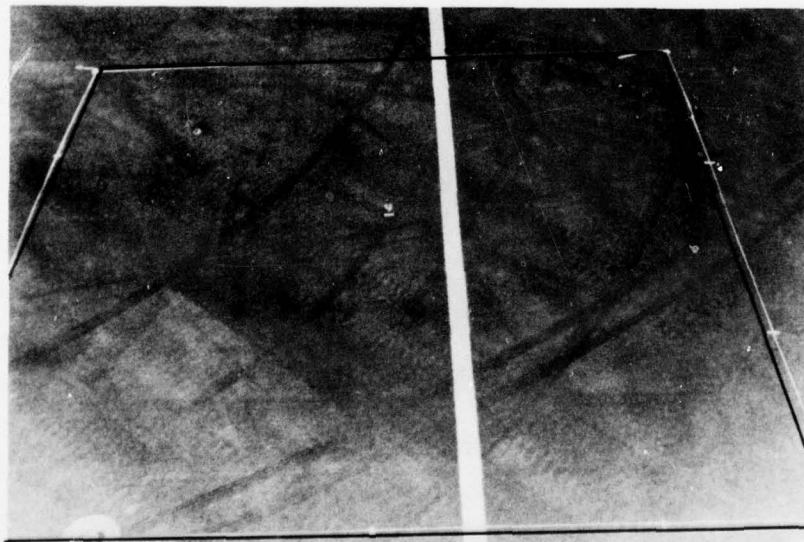
a. Condition of surface prior to overlay

b. Condition of surface 6 months after overlay

Photo 87. Fort Stewart--test square in south end
of control section
