MISCELLANEOUS PAPER GL-79-4

EVALUATION OF THE EFFECTIVENESS OF MEMBRANES FOR PREVENTION OF CRACK REFLECTION IN THIN OVERLAYS

Geotechnical Laboratory
U. S. Army Engineer Waterways Experiment Station
P. O. Box 631, Vicksburg, Miss. 39180

March 1979

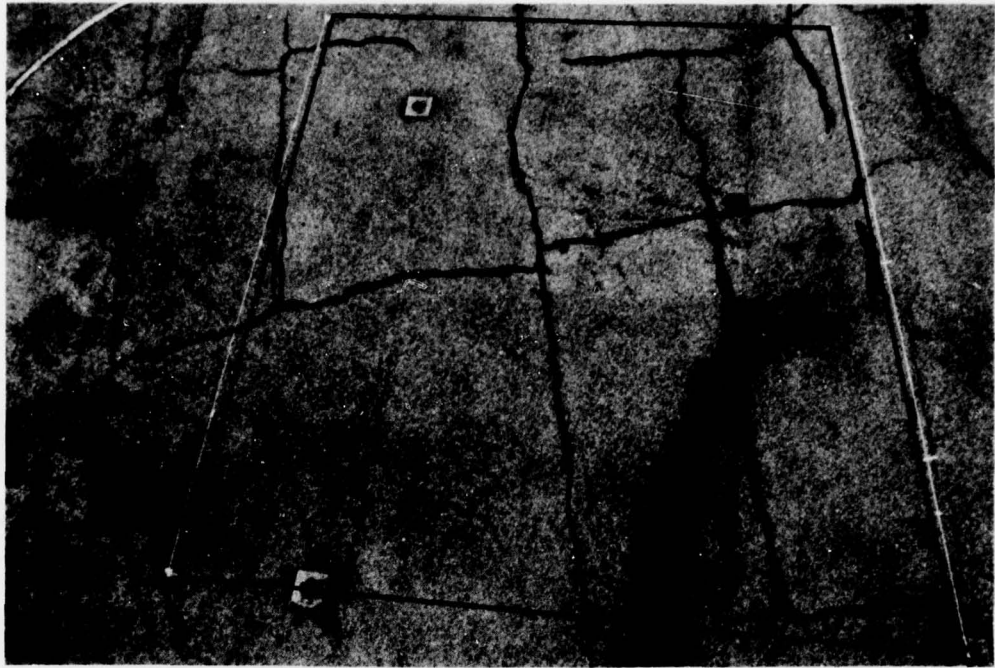
a. Condition of surface prior to overlay

b. Condition of surface 6 months after overlay

Photo 88. Fort Stewart--test section in north end
of control section

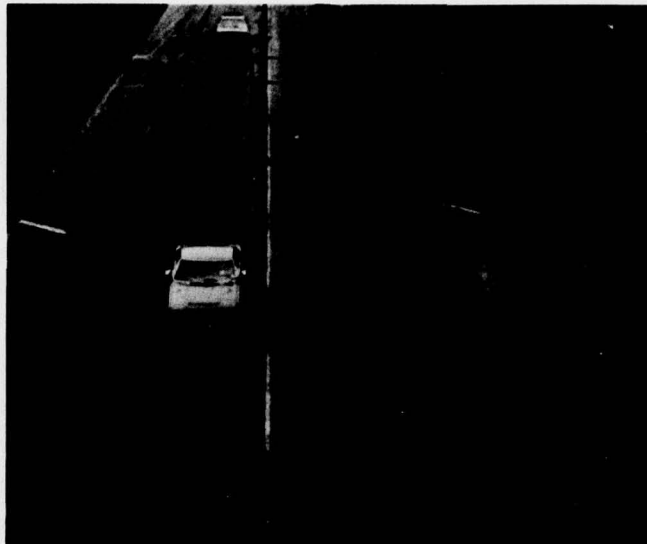
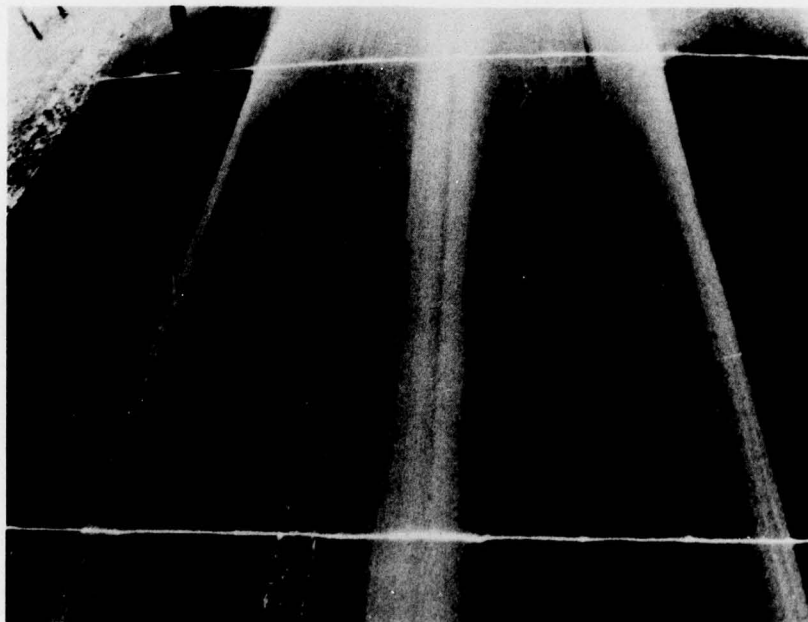
48. The survey to monitor the performance of the Petromat fabric on Louisiana Avenue at Fort Polk was made on 1 June 1978. Photos 89 and 90 indicate the crack pattern that existed in the selected photographic areas before placement of the overlay and 6 months after placement of the overlay. As noted in the photographs, two cracks in each 25- by 25-ft area existed from the underlying JC pavement, and these cracks have reflected through the fabric and overlay after the 6-month period. An inspection of the entire roadway indicated about 50 percent of the joint cracking has reflected through the overlay where the Petromat fabric was

a. Condition of surface prior to overlay

b. Condition of surface 6 months after overlay

Photo 89. Fort Polk--test section No. 1,
Louisiana Avenue

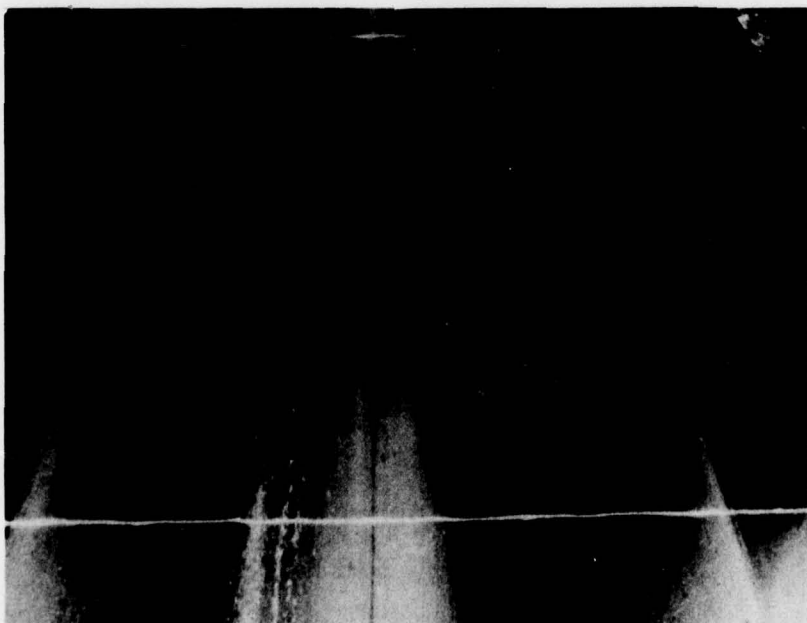
b. Condition of surface 6 months after overlay

Photo 90. Fort Polk--test section No. 2,
Louisiana Avenue

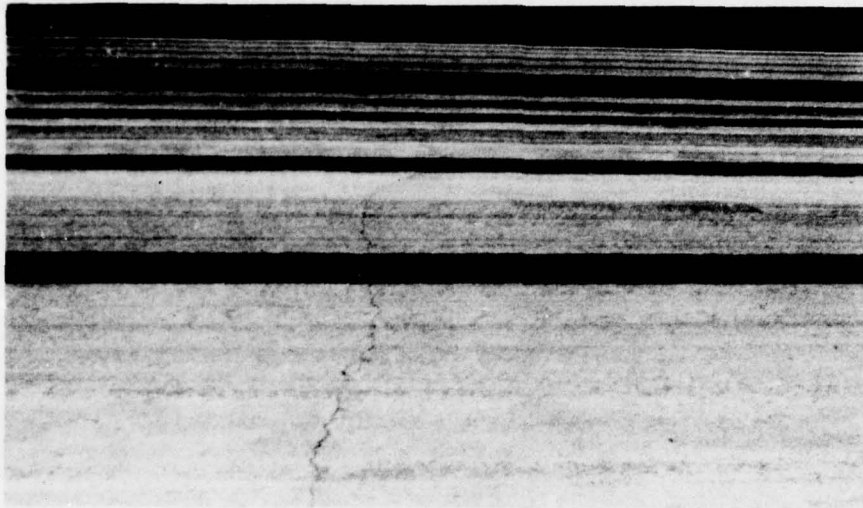
Photo 108. Fort Devens--reflected crack in NW-SE runway near NW end; interlayer of U. S. Rubber membrane

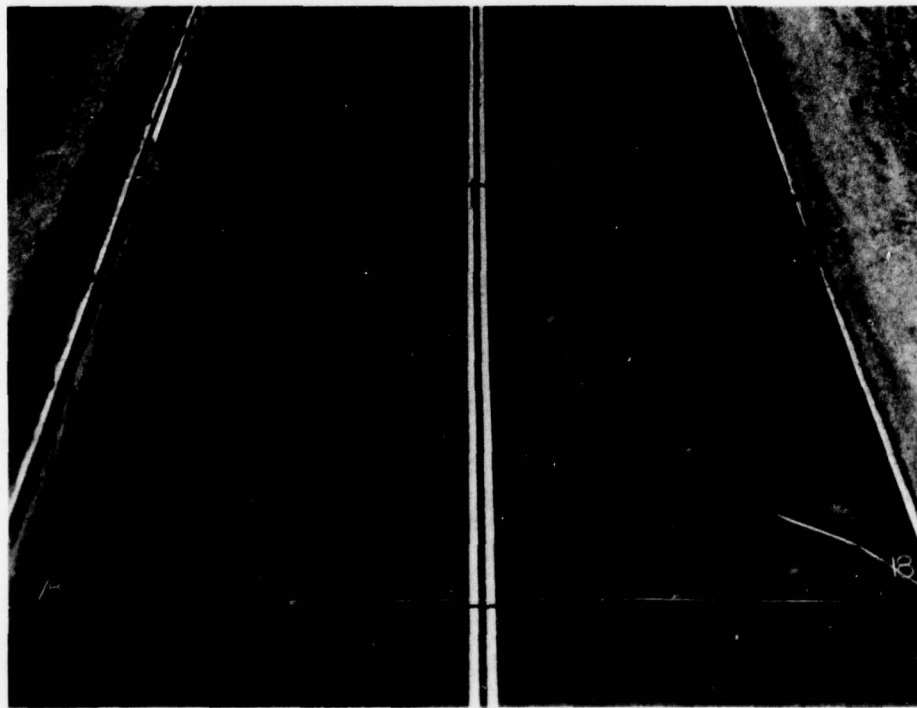
b. Condition of surface 6 months after overlay

Photo 111. Fort Devens--Sahuaro rubber section,
Barnum Road

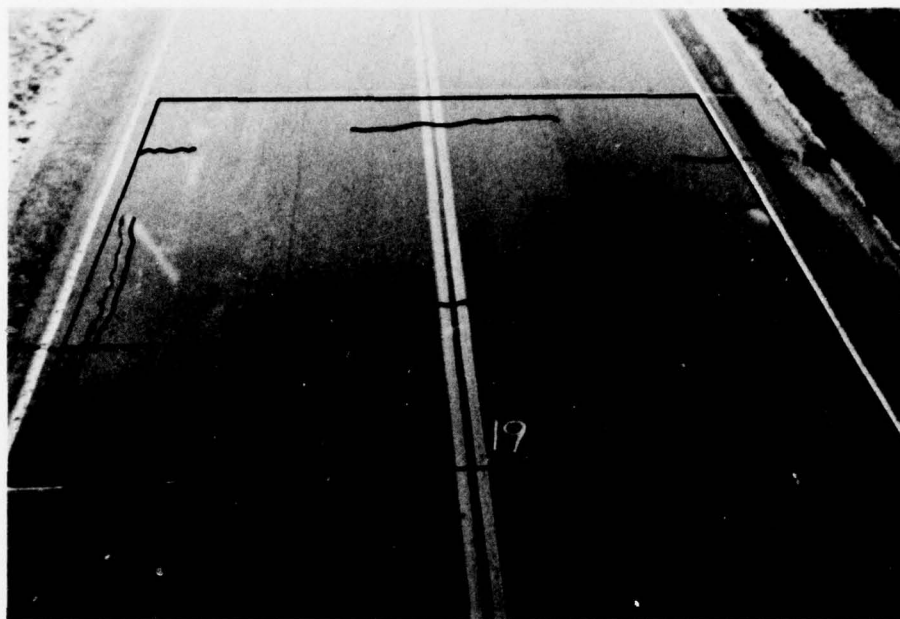
a. Condition of surface prior to overlay

b. Condition of surface 6 months after overlay

Photo 112. Fort Devens--U. S. Rubber section,
Barnum Road

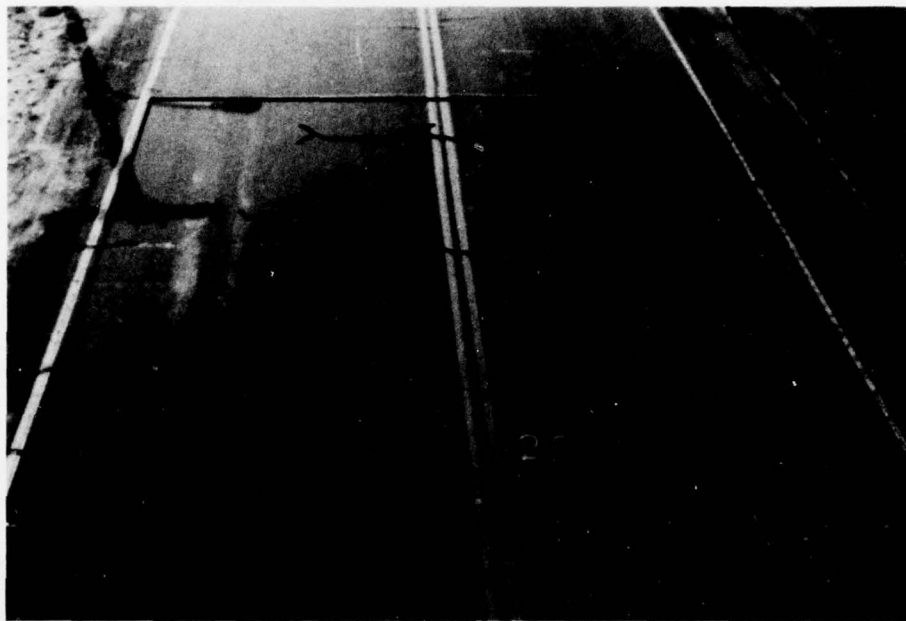
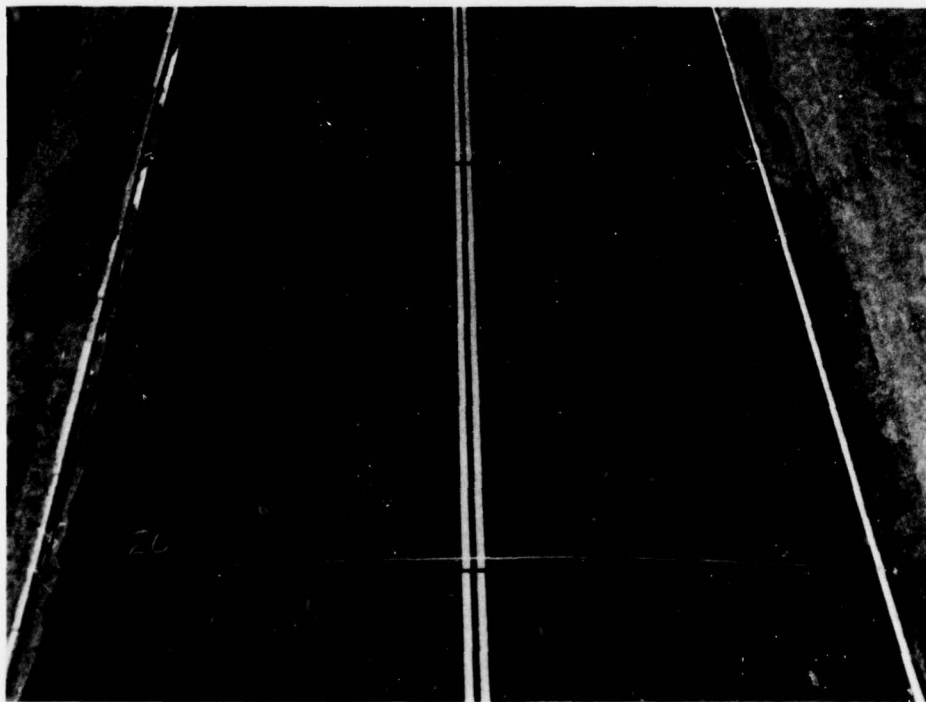
a. Condition of surface prior to overlay

b. Condition of surface 6 months after overlay

Photo 113. Fort Devens--Mirafi 140 fabric section,
Barnum Road

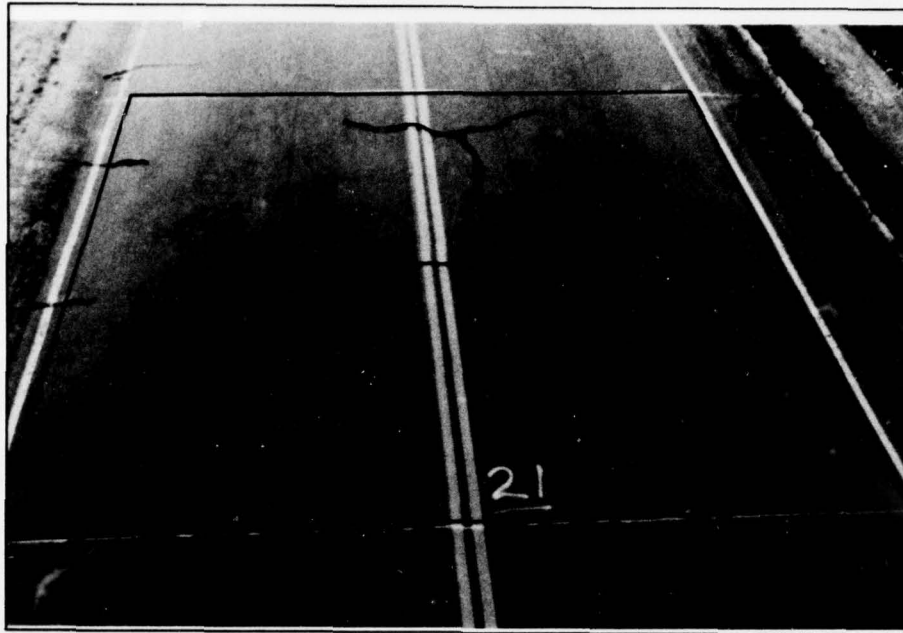
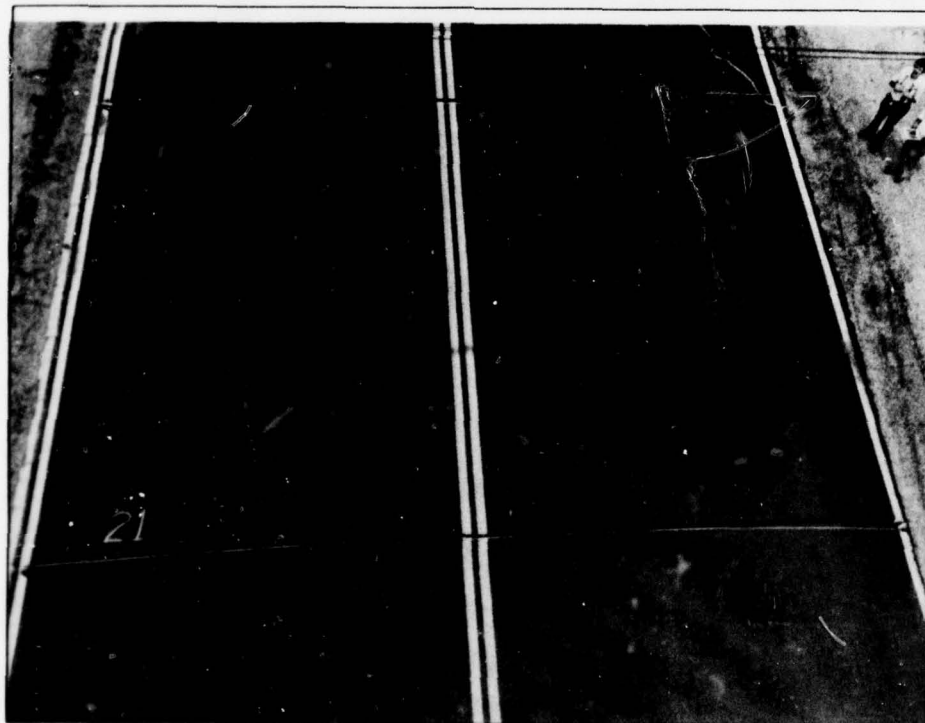
a. Condition of surface prior to overlay

b. Condition of surface 6 months after overlay

Photo 114. Fort Devens--Bidim C-22 fabric section,
Barnum Road

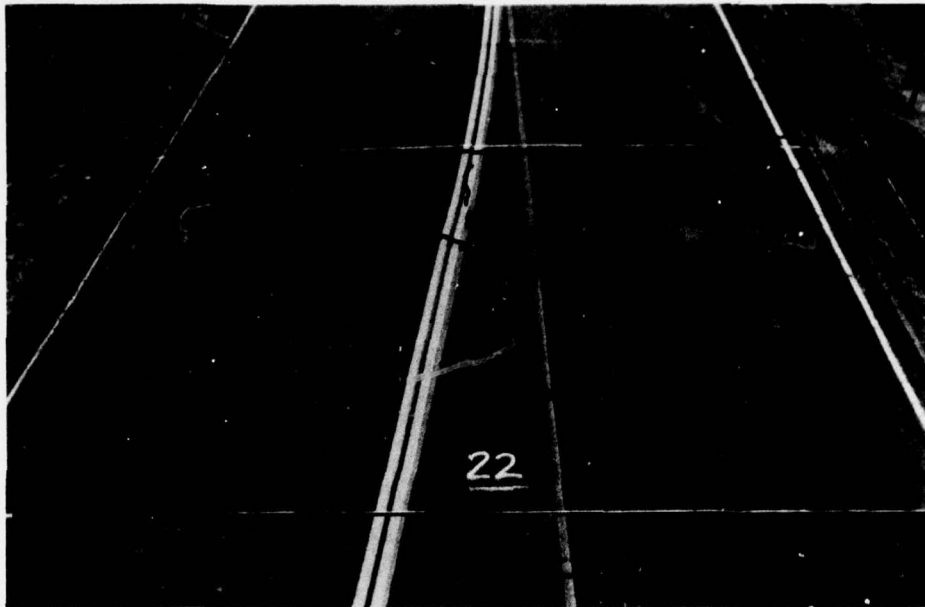
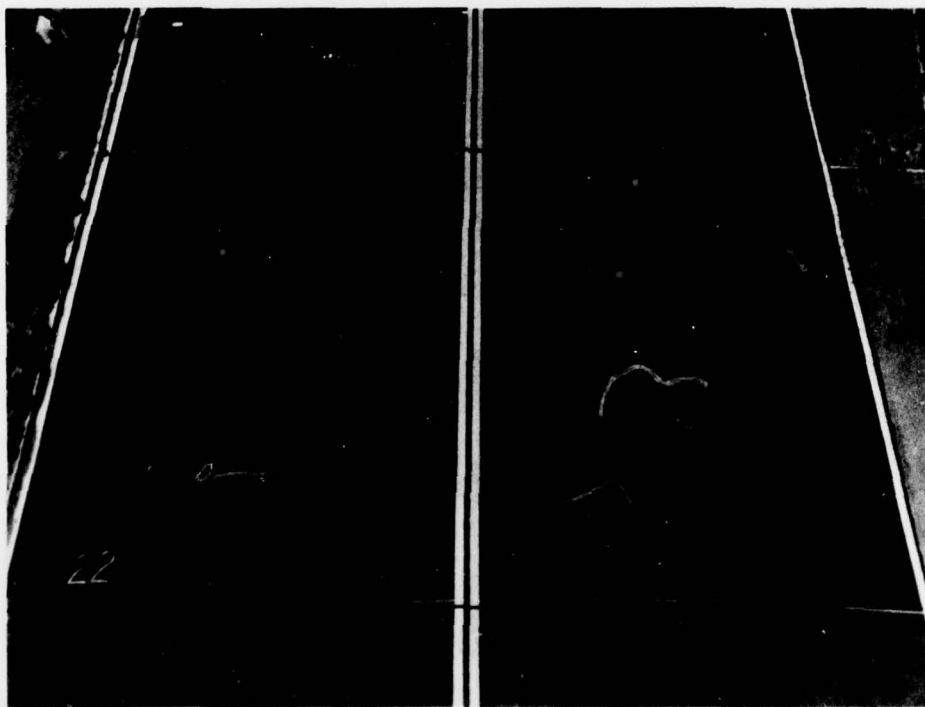
a. Condition of surface prior to overlay

b. Condition of surface 6 months after overlay

Photo 115. Fort Devens--control section, Barnum Road

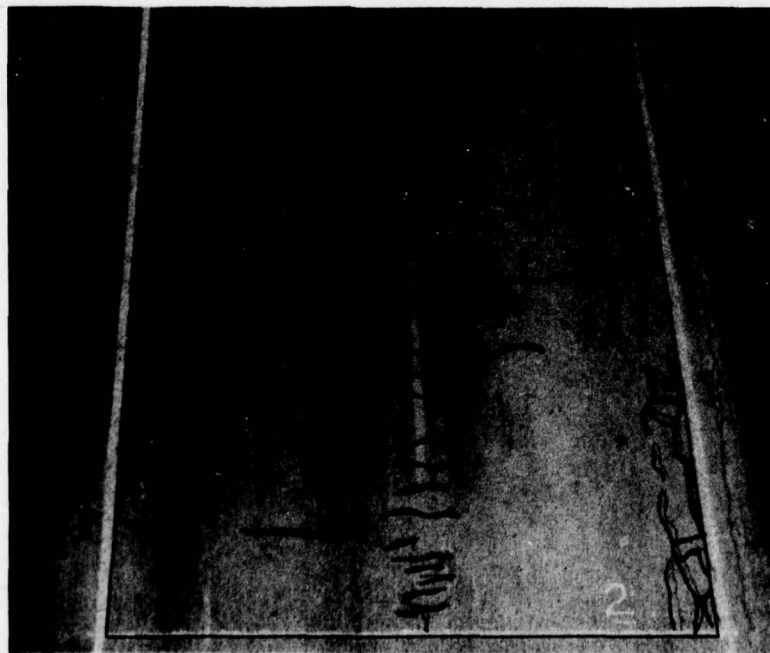
Photo 118. Fort Carson--condition of test area No. 2
prior to overlay

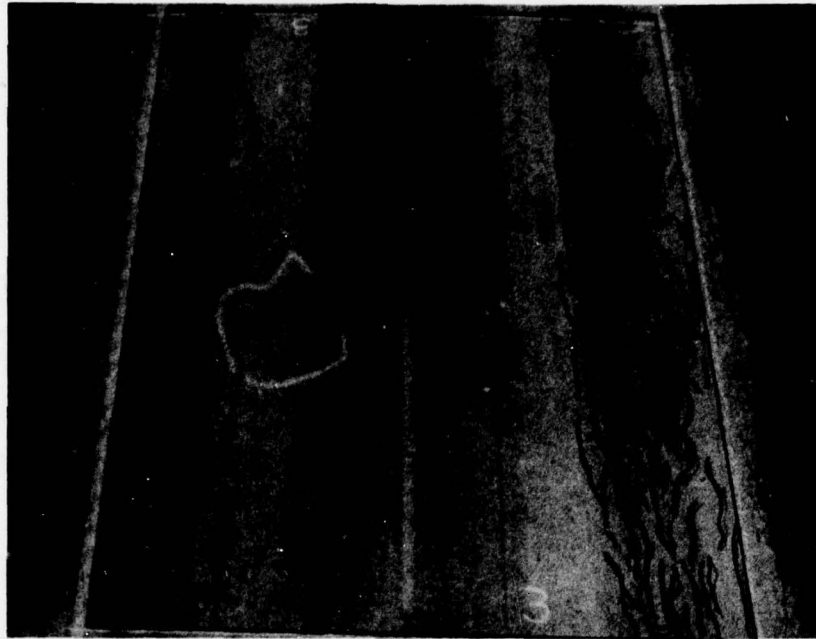
Photo 119. Fort Carson--condition of test area No. 3
prior to overlay

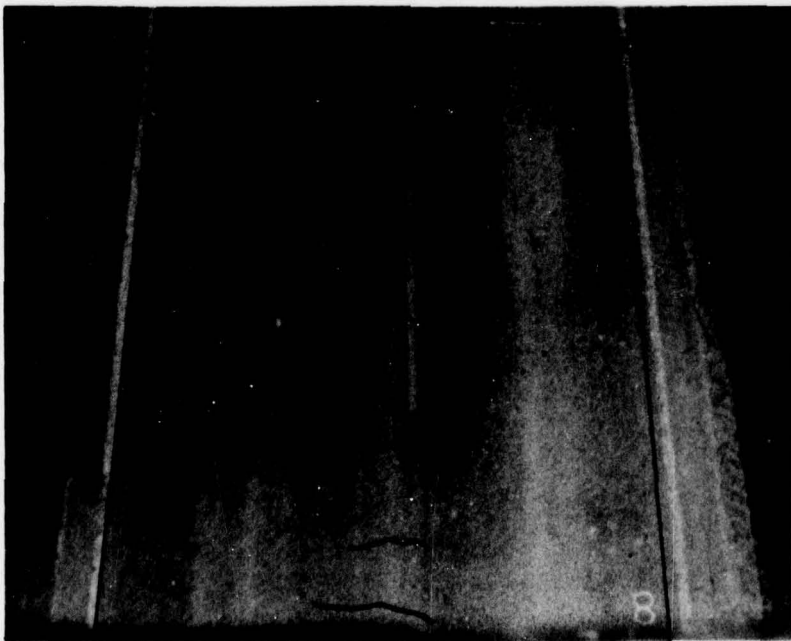
Photo 124. Fort Carson--condition of test area No. 8
prior to overlay

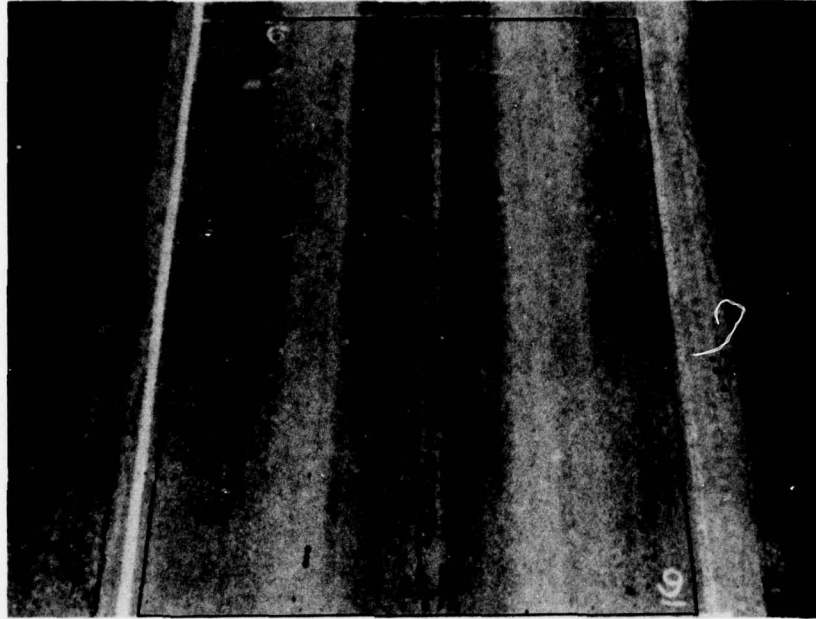
Photo 125. Fort Carson--condition of test area No. 9
prior to overlay

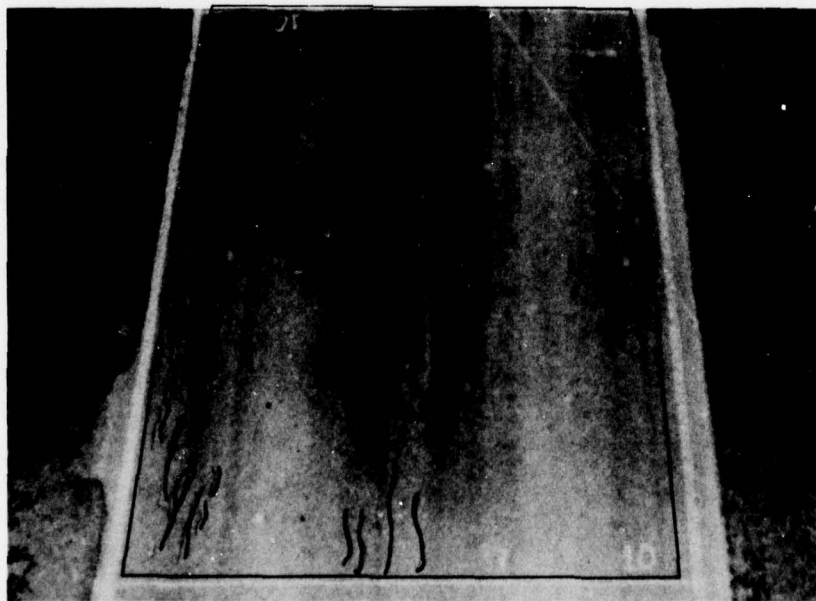
Photo 126. Fort Carson--condition of test area No. 10
prior to overlay
