REPORT DOCUMENTATION PAGE		
REPORT NUMBER 2. GOVT ACCESSION NO		BEFORE COMPLETING FORM D. 3. RECIPIENT'S CATALOG NUMBER	
100057			
TITLE (and Subtitie)		5. TYPE OF REPORT & PERIOD COVERED	
Phase I Inspection Report National Dam Safety Program Manahawkin Lake Dam Ocean County, N.J. AUTHOR(a) Richard J. McDermott, P.E.		FTNAL

MANAHAWKIN LAKE DAM (NJ00057)

PHASE I REPORT NATIONAL DAM SAFETY PROGRAM

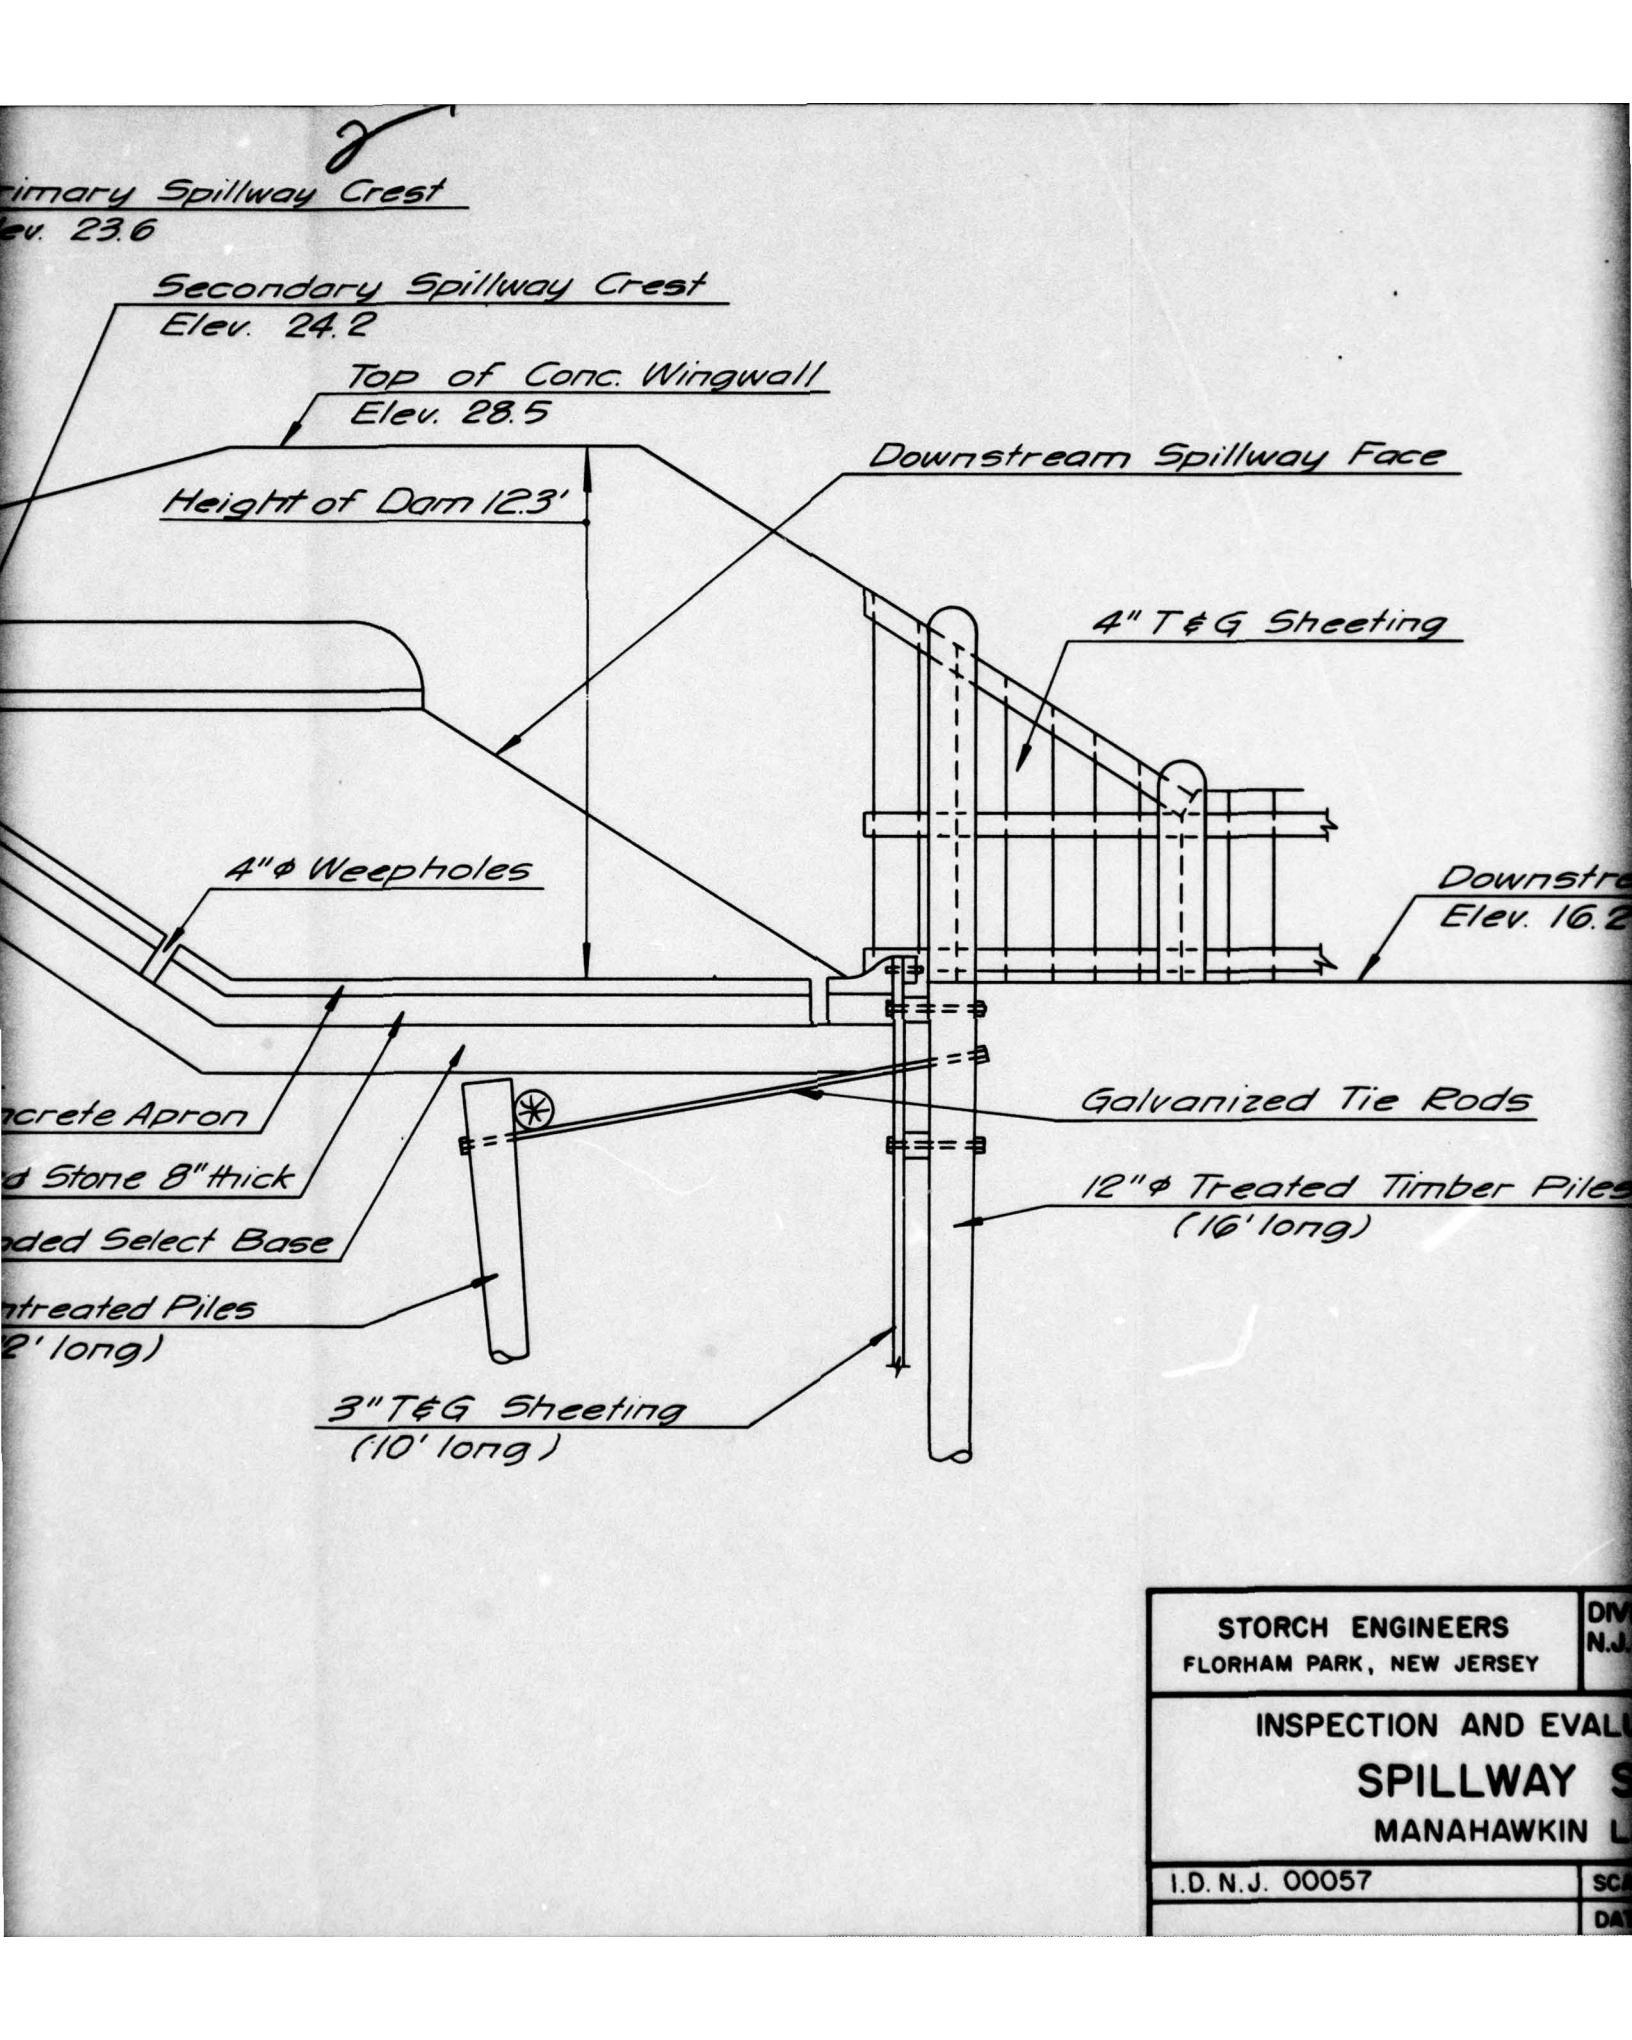
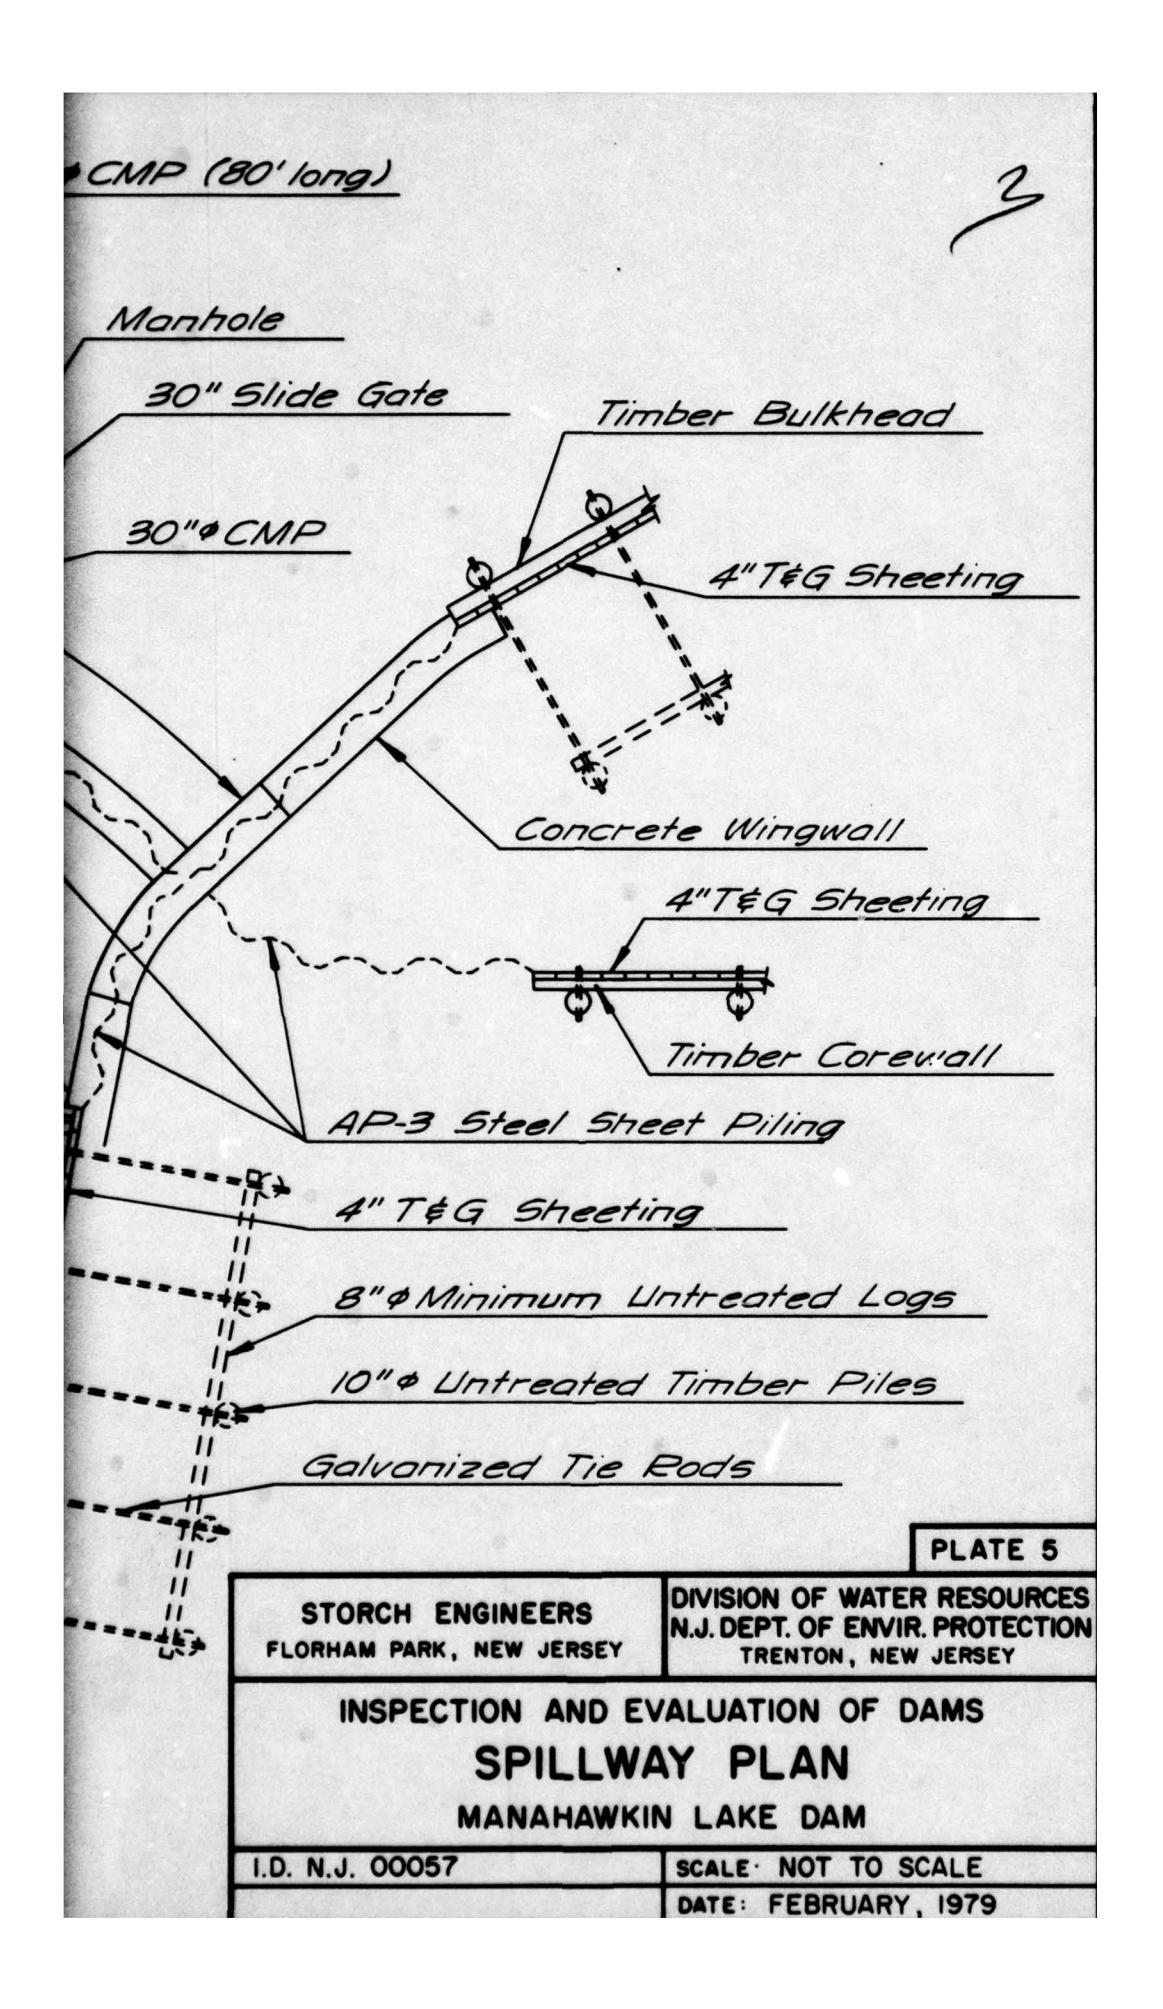
Primary Spillway Crest Elev. 23.6 Secondary Spi Elev. 24.2 TOP O Elev. Normal Pool Elev. 23.7 Height of Dam Fill Clay Gravel A" & Weepho MILAUXUXUXUXUXUXUXUX AP-3 Steel Sheet Piling (16' long) 4" Concrete Apron Grouted Stone 8" thick 12" Graded Select Base 10" # Untreated Piles (12' long) 3"TEG (10'10 NOTE: Information taken from plan by Richard E. Lane, P.E., June, 1964 and field inspection December 20, 1978.
