CRANDON LAKE DAM
NJ 00267

PHASE 1 INSPECTION REPORT
NATIONAL DAM SAFETY PROGRAM

May, 1979

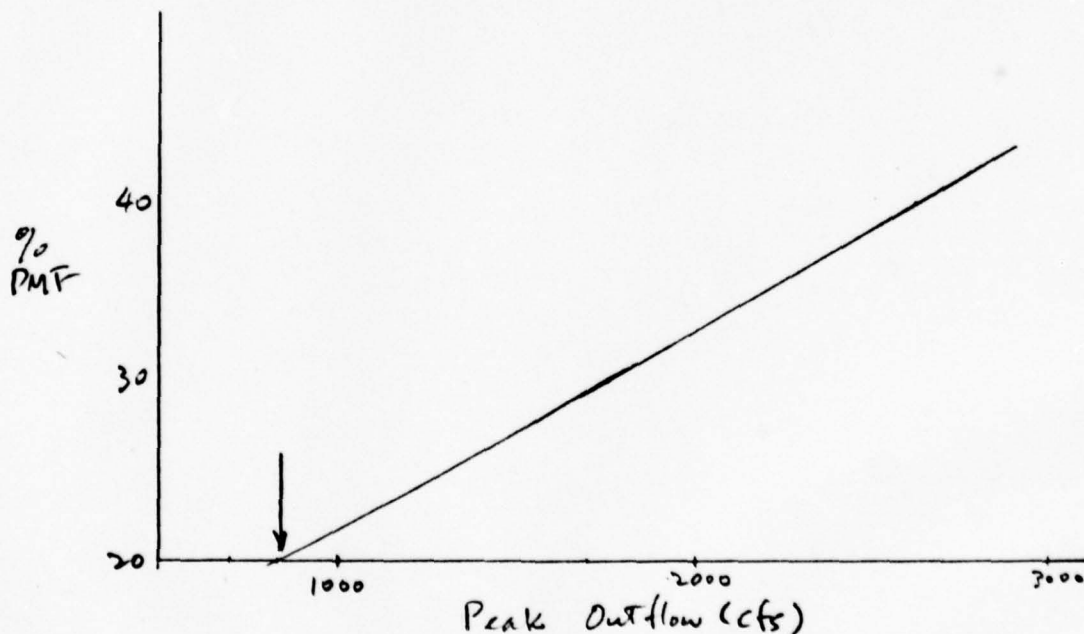
OVERTOPPING POTENTIAL

3. Dam overtops at approx. El. 859 with $Q = 840$ cfs
 \therefore dam can pass approx. 20 % of PMF.
