NSWC/DL-TR-3904

4. TITLE (and Subtitle) FABRICATION AND ASSEMBLY OF A SHIPBOARD MULTI-FUNCTIONAL WASTE INCINERATOR (MFI). PHASE II	5. TYPE OF REPORT & PERIOD COVERED Final rept.	6. PERFORMING ORG. REPORT NUMBER

11. CONTROLLING OFFICE NAME AND ADDRESS Naval Sea Systems Command Washington, DC 20362	12. REPORT DATE April 1979	13. NUMBER OF PAGES 53
14. MONITORING AGENCY NAME & ADDRESS (if different from Controlling Office) 1252p.	15. SECURITY CLASS. (of this report) UNCLASSIFIED	15a. DECLASSIFICATION/DOWNGRADING SCHEDULE

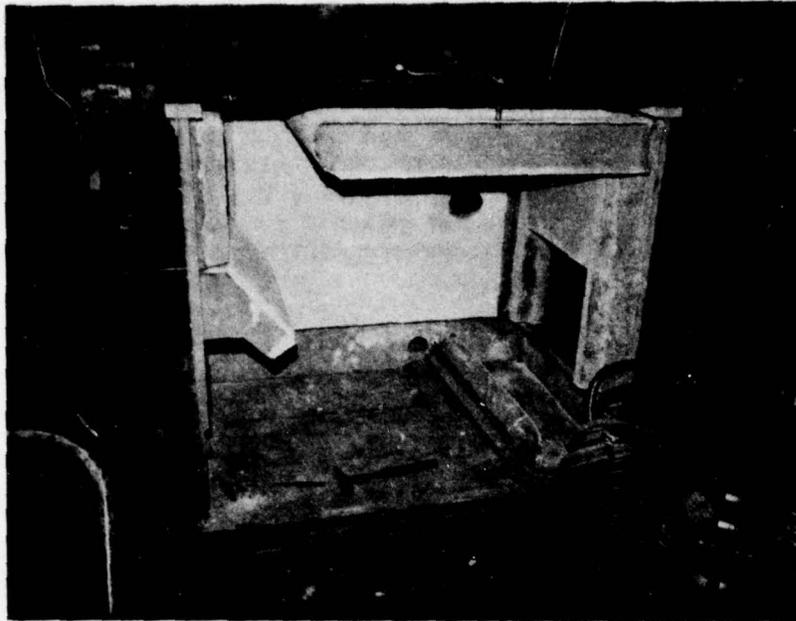
Figure 8. Partial Assembly of Firebox

Figure 7 shows the sewage chamber walls: one wall partially cast, and the other wall completely cast. The oval-shaped exhaust port can be observed on the fully cast wall. The cast firebox module was assembled as shown in Figure 8 to check for alignment. The forward wall, the right (burner) side wall, and the rear wall are shown in position. The left side panel cracked diagonally when alignment pins were used to align bolt holes. The panel was recast within 2 hr and after curing, was refit to the module. A small crack about 6 in. in length occurred again upon assembly across the upper right corner. This crack was small enough to be patched with Greencast 97 fines.

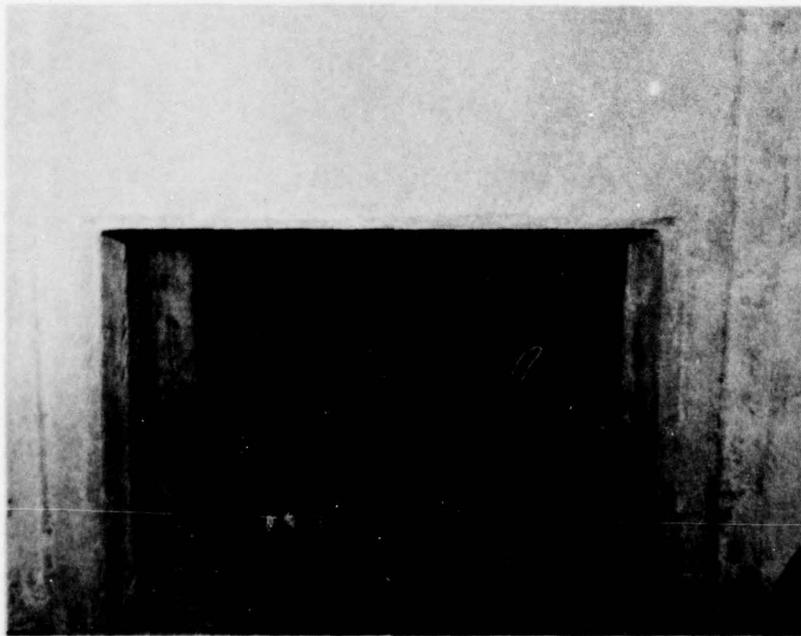
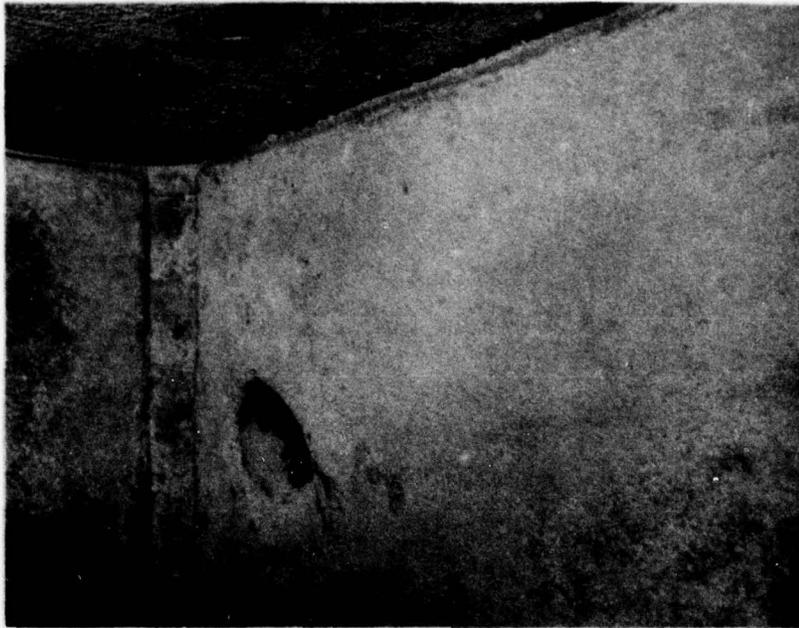
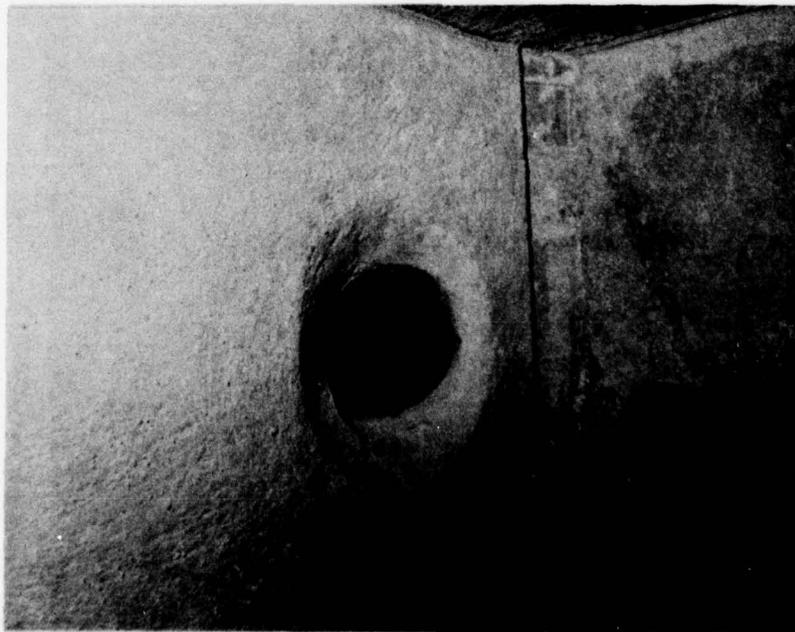
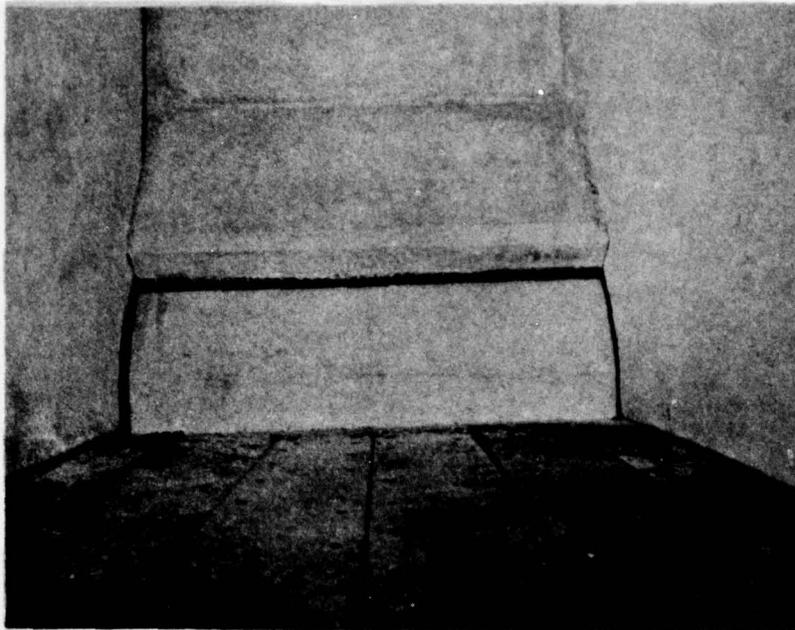
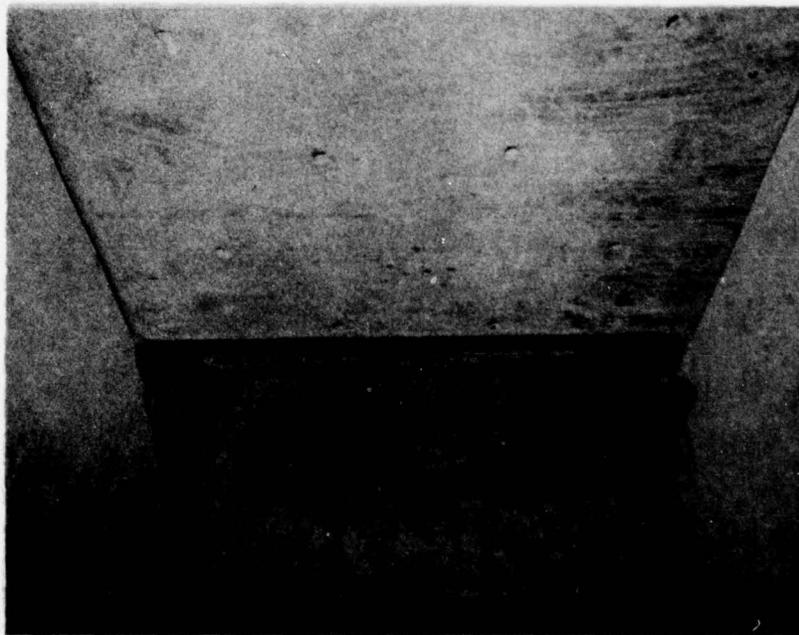
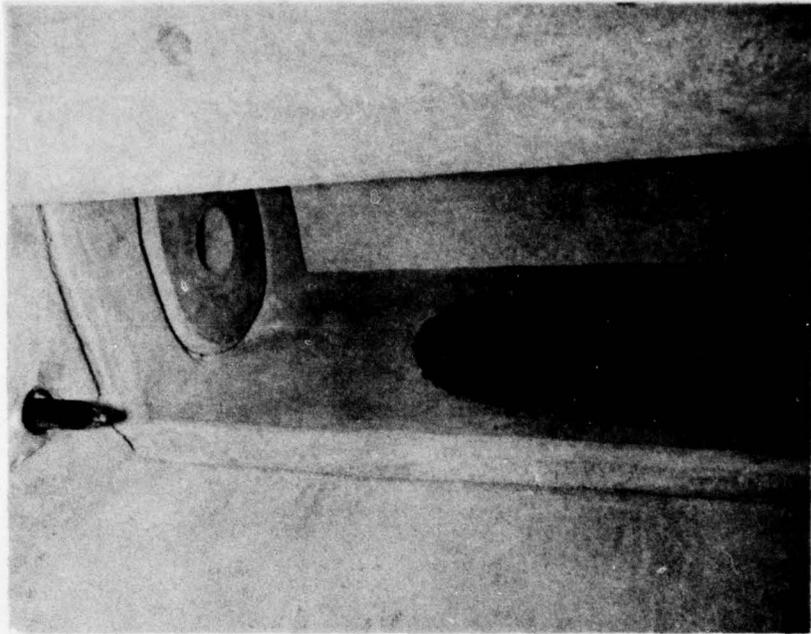
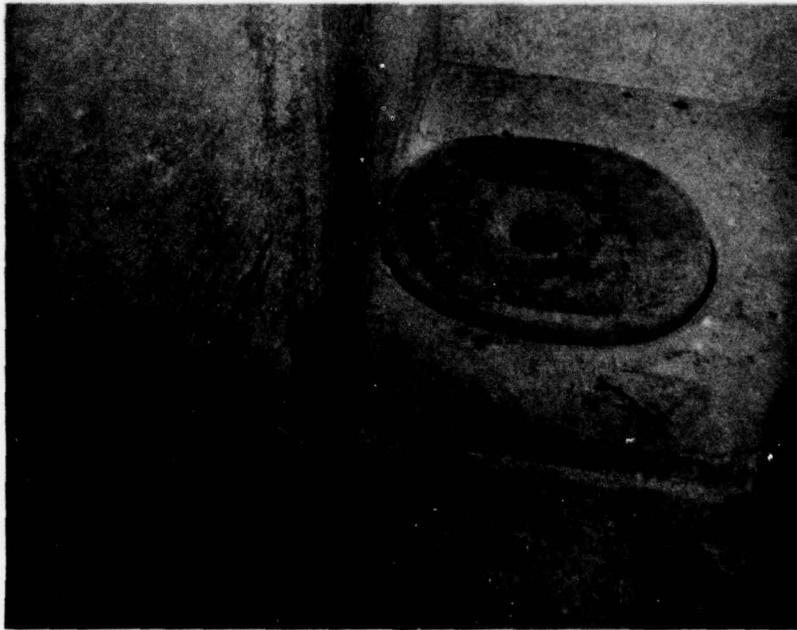
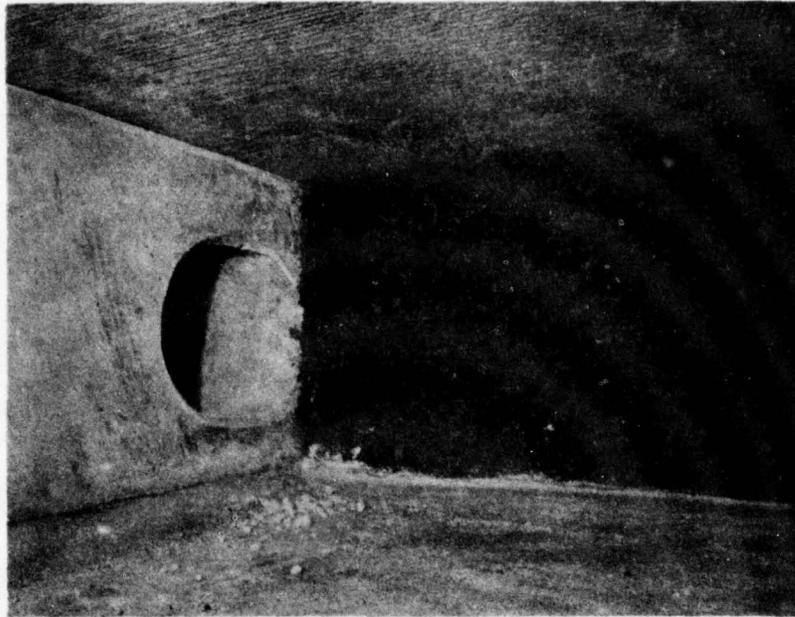
The fully assembled unit is shown in Figure 16, an isolated picture of the flyash collector is presented in Figure 17, and the sewage nozzle assembly installation is shown in Figure 18. Complete photodocumentation made of the interior of the incinerator prior to curing (Figures 19 through 26) shows that all casting appears to be in excellent condition.

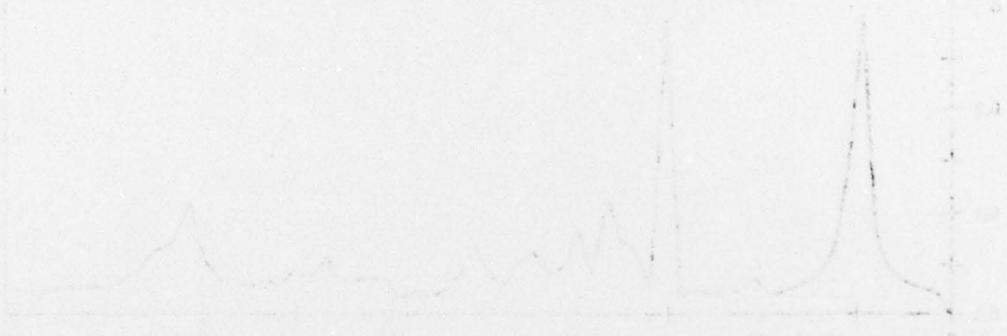
The acceleration data indicated that there was a peak in the acceleration level at approximately 50 Hz. Because the blower fan had four blades, there was also a peak in the acceleration level at approximately 200 Hz. Additional peaks in the acceleration level occurred at harmonics of the 50- and 200-Hz frequencies. These results indicate unbalance in the shaft/impeller assembly, which was possibly due to shaft set on exposure to the excessively high temperatures encountered during initial burn tests.

NOTE: THE OVERALL g LEVEL WAS 2.55 g PEAK (1.8 g rms)
