6  
National Dam Inspection Program. Twin  
Lakes Number 1 Dam (NDS PA-00487,  
Pennder 65-42), Ohio River Basin, Little  
Crabtree Creek, Westmoreland County,  
Pennsylvania. Phase I Inspection  
Report.

TWIN LAKES NO. 1 DAM

PHASE I INSPECTION REPORT  
NATIONAL DAM INSPECTION PROGRAM

11 APR 1979

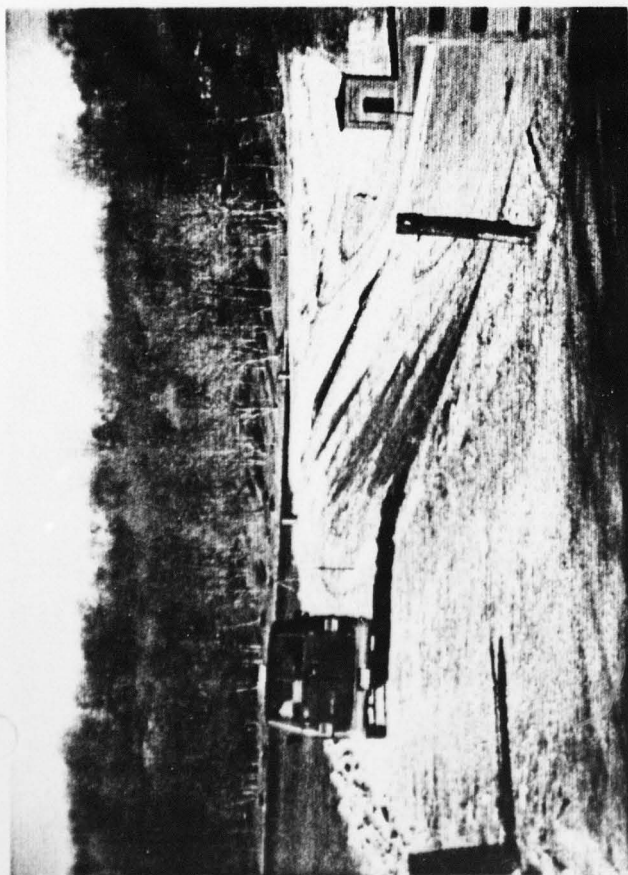
PHOTOGRAPH 1 View looking west along the crest and downstream slope of the embankment.

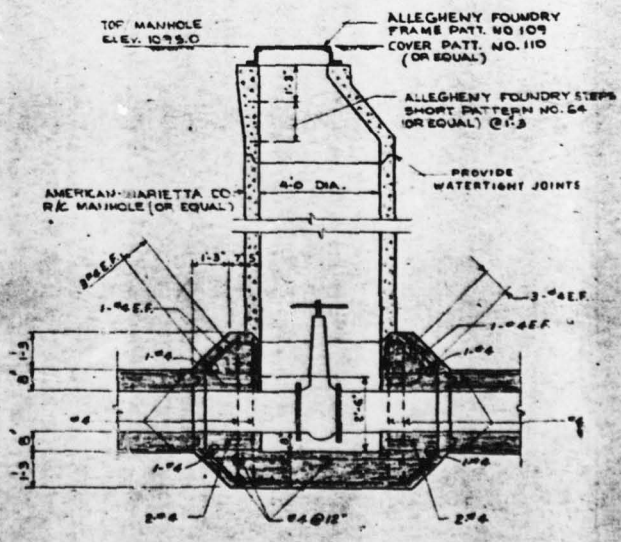
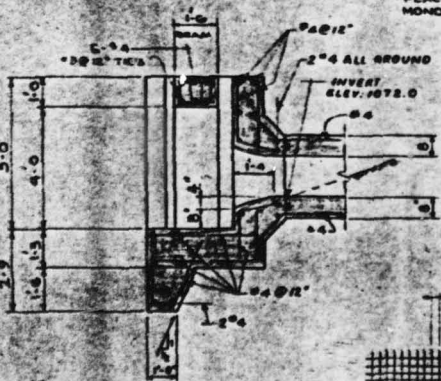
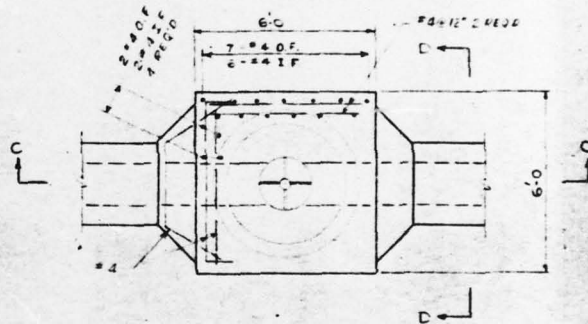
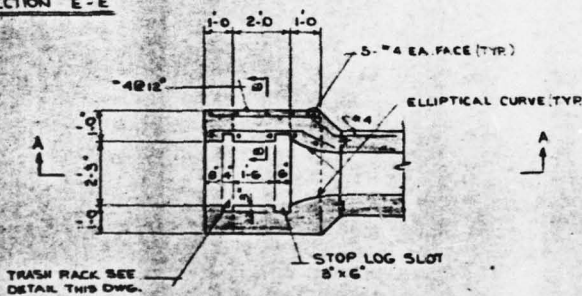
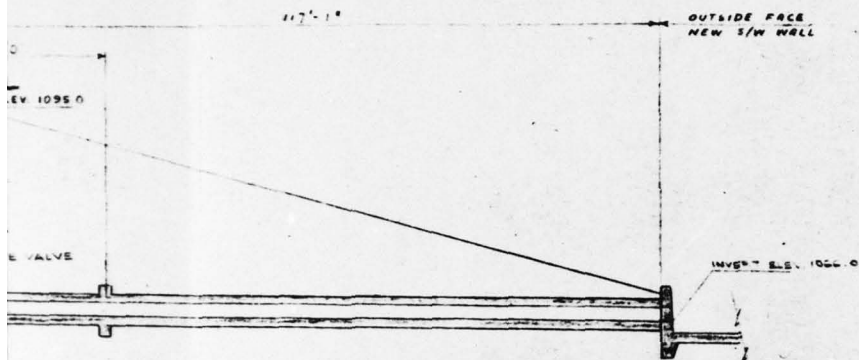
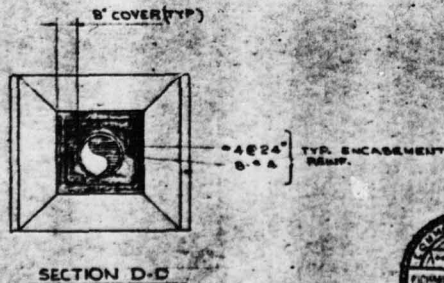
**FIGURE 7**

The gate valve access  
manhole is located  
on the crest of the  
embankment, just to  
the left of the spillway.  
The 48-inch diameter  
reinforced concrete  
pipe manhole contains  
one 16-inch diameter  
gate valve control at  
the base. The gate  
valve control is provided  
with an extension to  
permit operation from  
the crest of the dam  
without descending the  
manhole (see Figure 7).

b) Outlet Works. The rehabilitated outlet works (blowoff) consists of one 16-inch diameter ductile iron pipe encased in 8 inches of reinforced concrete carried through the dam. The 16-inch diameter outlet conduit is approximately 197 feet in length and passes through the embankment just left of the spillway. Flow through the conduit is controlled by a 16-inch diameter gate valve situated at the base of the access manhole located along the crest of the embankment. The submerged inlet is also equipped with a trash rack and stop log slot (see Figure 7).
