SUSQUEHANNA RIVER BASIN
BEAR RUN, CLEARFIELD COUNTY

PIKE TOWNSHIP
MUNICIPAL AUTHORITY
DAM

NDS I. D. No. PA-00916
PENNDER I. D. No.17-111

PHASE I INSPECTION REPORT
NATIONAL DAM INSPECTION PROGRAM

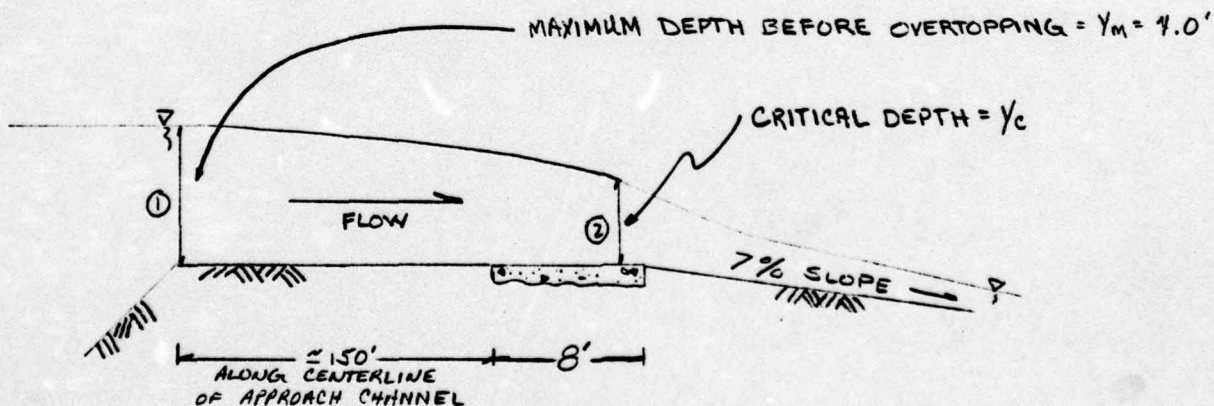
SPILLWAY PROFILE (NOT TO SCALE)

NOTE 4: THE ABOVE DRAWINGS WERE SKETCHED BASED ON MEASUREMENTS TAKEN DURING THE FIELD INSPECTION

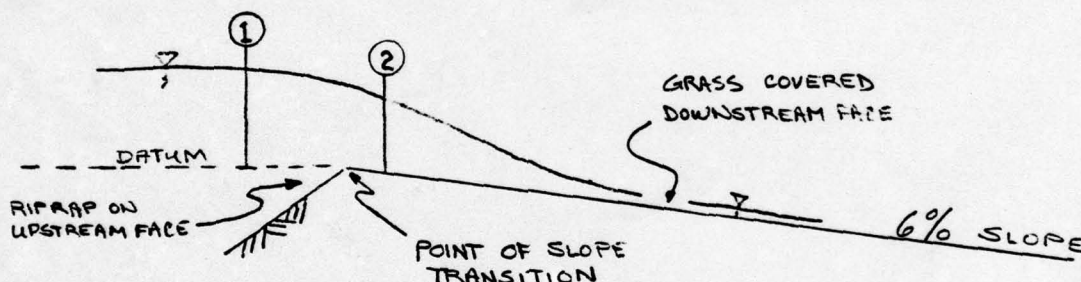
ACCORDING TO AVAILABLE DATA, THE TOP OF DAM IS AT ELEVATION 1646. THIS IS THE POINT WHERE OVERTOPPING OF THE DAM STARTS. FIELD MEASUREMENTS INDICATE THE LENGTH OF THE DAM, EXCLUDING THE SPILLWAY, IS APPROXIMATELY 310 FEET. THE EMBANKMENT WAS CONSTRUCTED WITHOUT A FLAT CREST SECTION AND IS TRIANGULAR IN CROSS-SECTION AS SHOWN BELOW.

DUE TO THE EMBANKMENT CONFIGURATION, CRITICAL DEPTH IS EXPECTED TO CONTROL THE EMBANKMENT FLOWS. THE CONTROL SECTION WILL LIKELY BE LOCATED NEAR THE POINT OF SLOPE TRANSITION
