LITTLE SHENANGO DAM

(PA 490)

# PHASE I INSPECTION REPORT

NATIONAL DAM INSPECTION PROGRAM

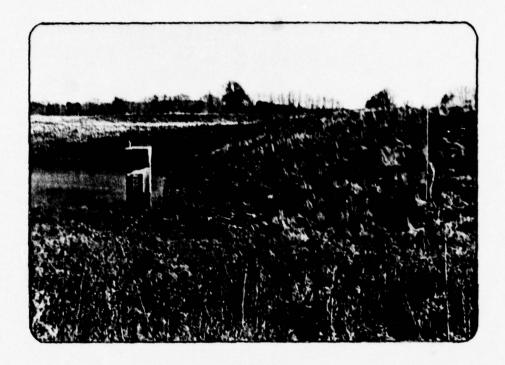
- Photo 1 View East across Upstream Slope of Dam from Right (West) Abutment (Pond and intake structure at left side of photo; spillway inlet above intake structure.)

PHOTO 1. View East across Upstream Slope

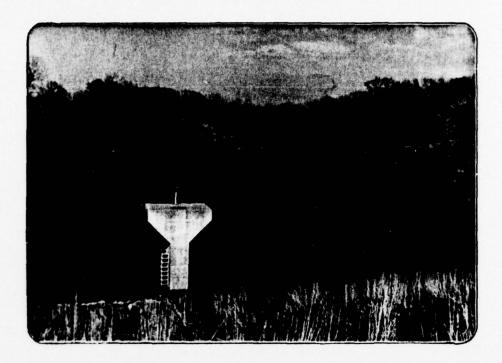
- Photo 5 View Upstream over Intake Structure and Pond from Center of Dam Crest
- Photo 6 View Downstream over Outlet Channel from Right (West)
  Side of Dam Crest
  (Outlet structure in bottom left corner of photo;
  sandstone boulder with dam name plaque in left-center
  of photo; unpaved road in top right corner of photo.)

PHOTO 5. View Upstream from Dam Crest
