6 National Dam Inspection Program, Colyer  
Lake Dam (NDS ID Number PA-00448,  
PennDer ID Number 14-112), Susquehanna  
River Basin, Sinking Creek, Centre  
County, Pennsylvania.

Phase I Inspection Report.

GAI CONSULTANTS, INC.  
570 BEATTY ROAD  
MONROEVILLE, PENNSYLVANIA 15146

APRIL 1979

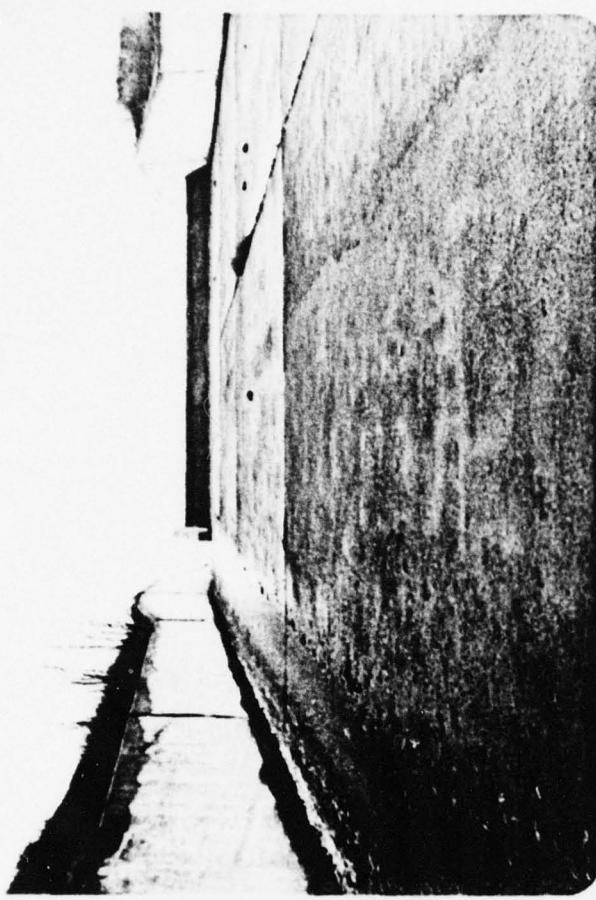
6

1. Spillway. The visual inspection of the spillway revealed that it is in need of minor repair. Cracking and spalling of the trapezoidal weir section was evident as shown in Photograph 7. Cracking and efflorescence were particularly associated with the weep holes in the spillway sidewalls. There was also minor cracking in the wall separating the flume section from the trapezoidal weir section of the spillway.

The overall appearance of the facility indicates that it is in good condition. The spillway requires repair on the trapezoidal weir section where significant spalling and cracking has occurred (see Photograph 7). Cracking and efflorescence within the spillway and outlet conduit should be observed in subsequent inspections to insure that the condition does not deteriorate.

The spillway, spillway sidewalls, and stilling basin are generally in good condition, one notable exception being the cracking and spalling on the trapezoidal weir section (see Photograph 7). Minor cracking and efflorescence were also noted at numerous locations on the spillway side walls particularly at the sidewall weep holes.

**PHOTOGRAPH 7** Close-up view of cracking and spalling on the trapezoidal-shaped weir portion of the spillway.

- a. Repair the spalled areas of the spillway weir and seal all cracks in the weir and spillway sidewalls.
- b. Evaluate the cracking within the outlet conduit during subsequent periodic inspections and take remedial action if deteriorating conditions are observed.
