The purpose of this program is to develop high frequency ultrasonic evaluation techniques capable of detecting defects in the 10 to 100 μ m (0.0004 to 0.004 inch) size range in gas turbine quality ceramics, such as silicon nitride and silicon carbide. The present contract is the third one-year contract in this program. In the first year's contract (Ref. 1), a high frequency (25-45 MHz), longitudinal wave mode, pulse-reflection technique was developed and applied to a range of candidate gas turbine ceramics. This technique was shown to be capable of detecting voids at least as small as 25 μ m (0.001 inches) and also high density inclusions, although of a somewhat larger size. It was also shown to be capable of detecting the porosity in a material that is not fully dense, such as reaction bonded silicon nitride. In the second year's contract (Ref. 2), a 45 MHz shear wave technique was developed which provides improved sensitivity, reduces the back surface deadband to 40 μ m (0.0016 inches) and provides correlation between inspection results and four-point-bend test data.

Effort under this contract was directed towards developing a high frequency (45 MHz) surface wave inspection tech

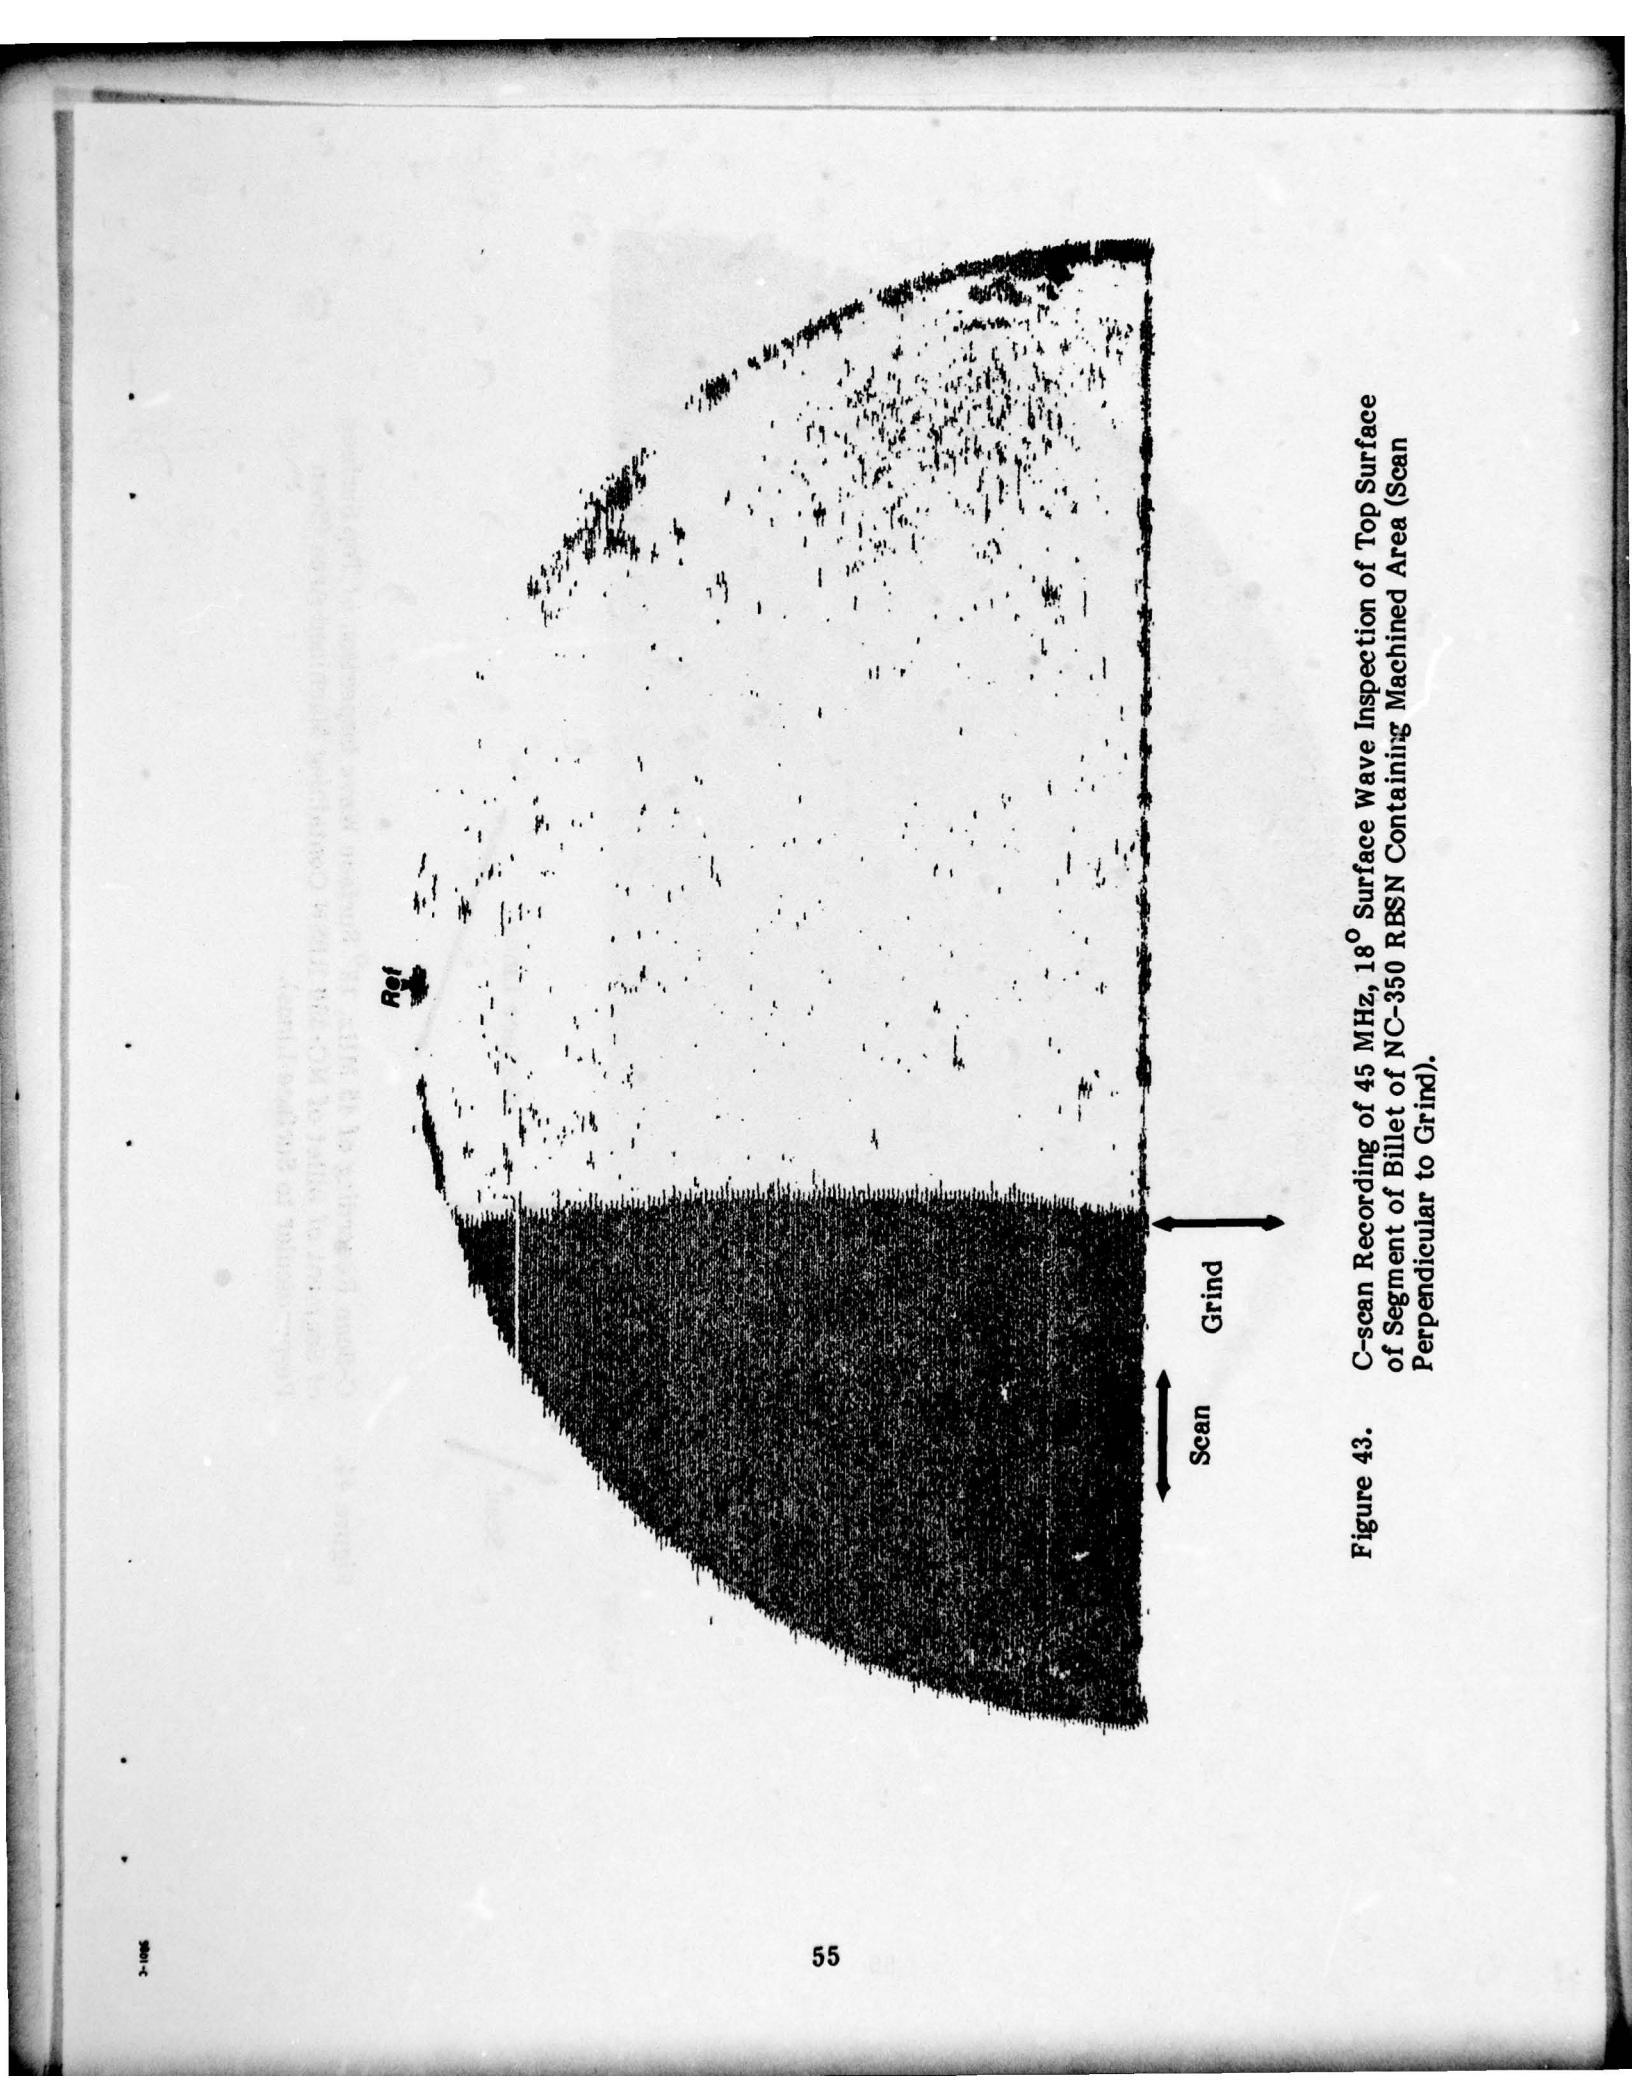
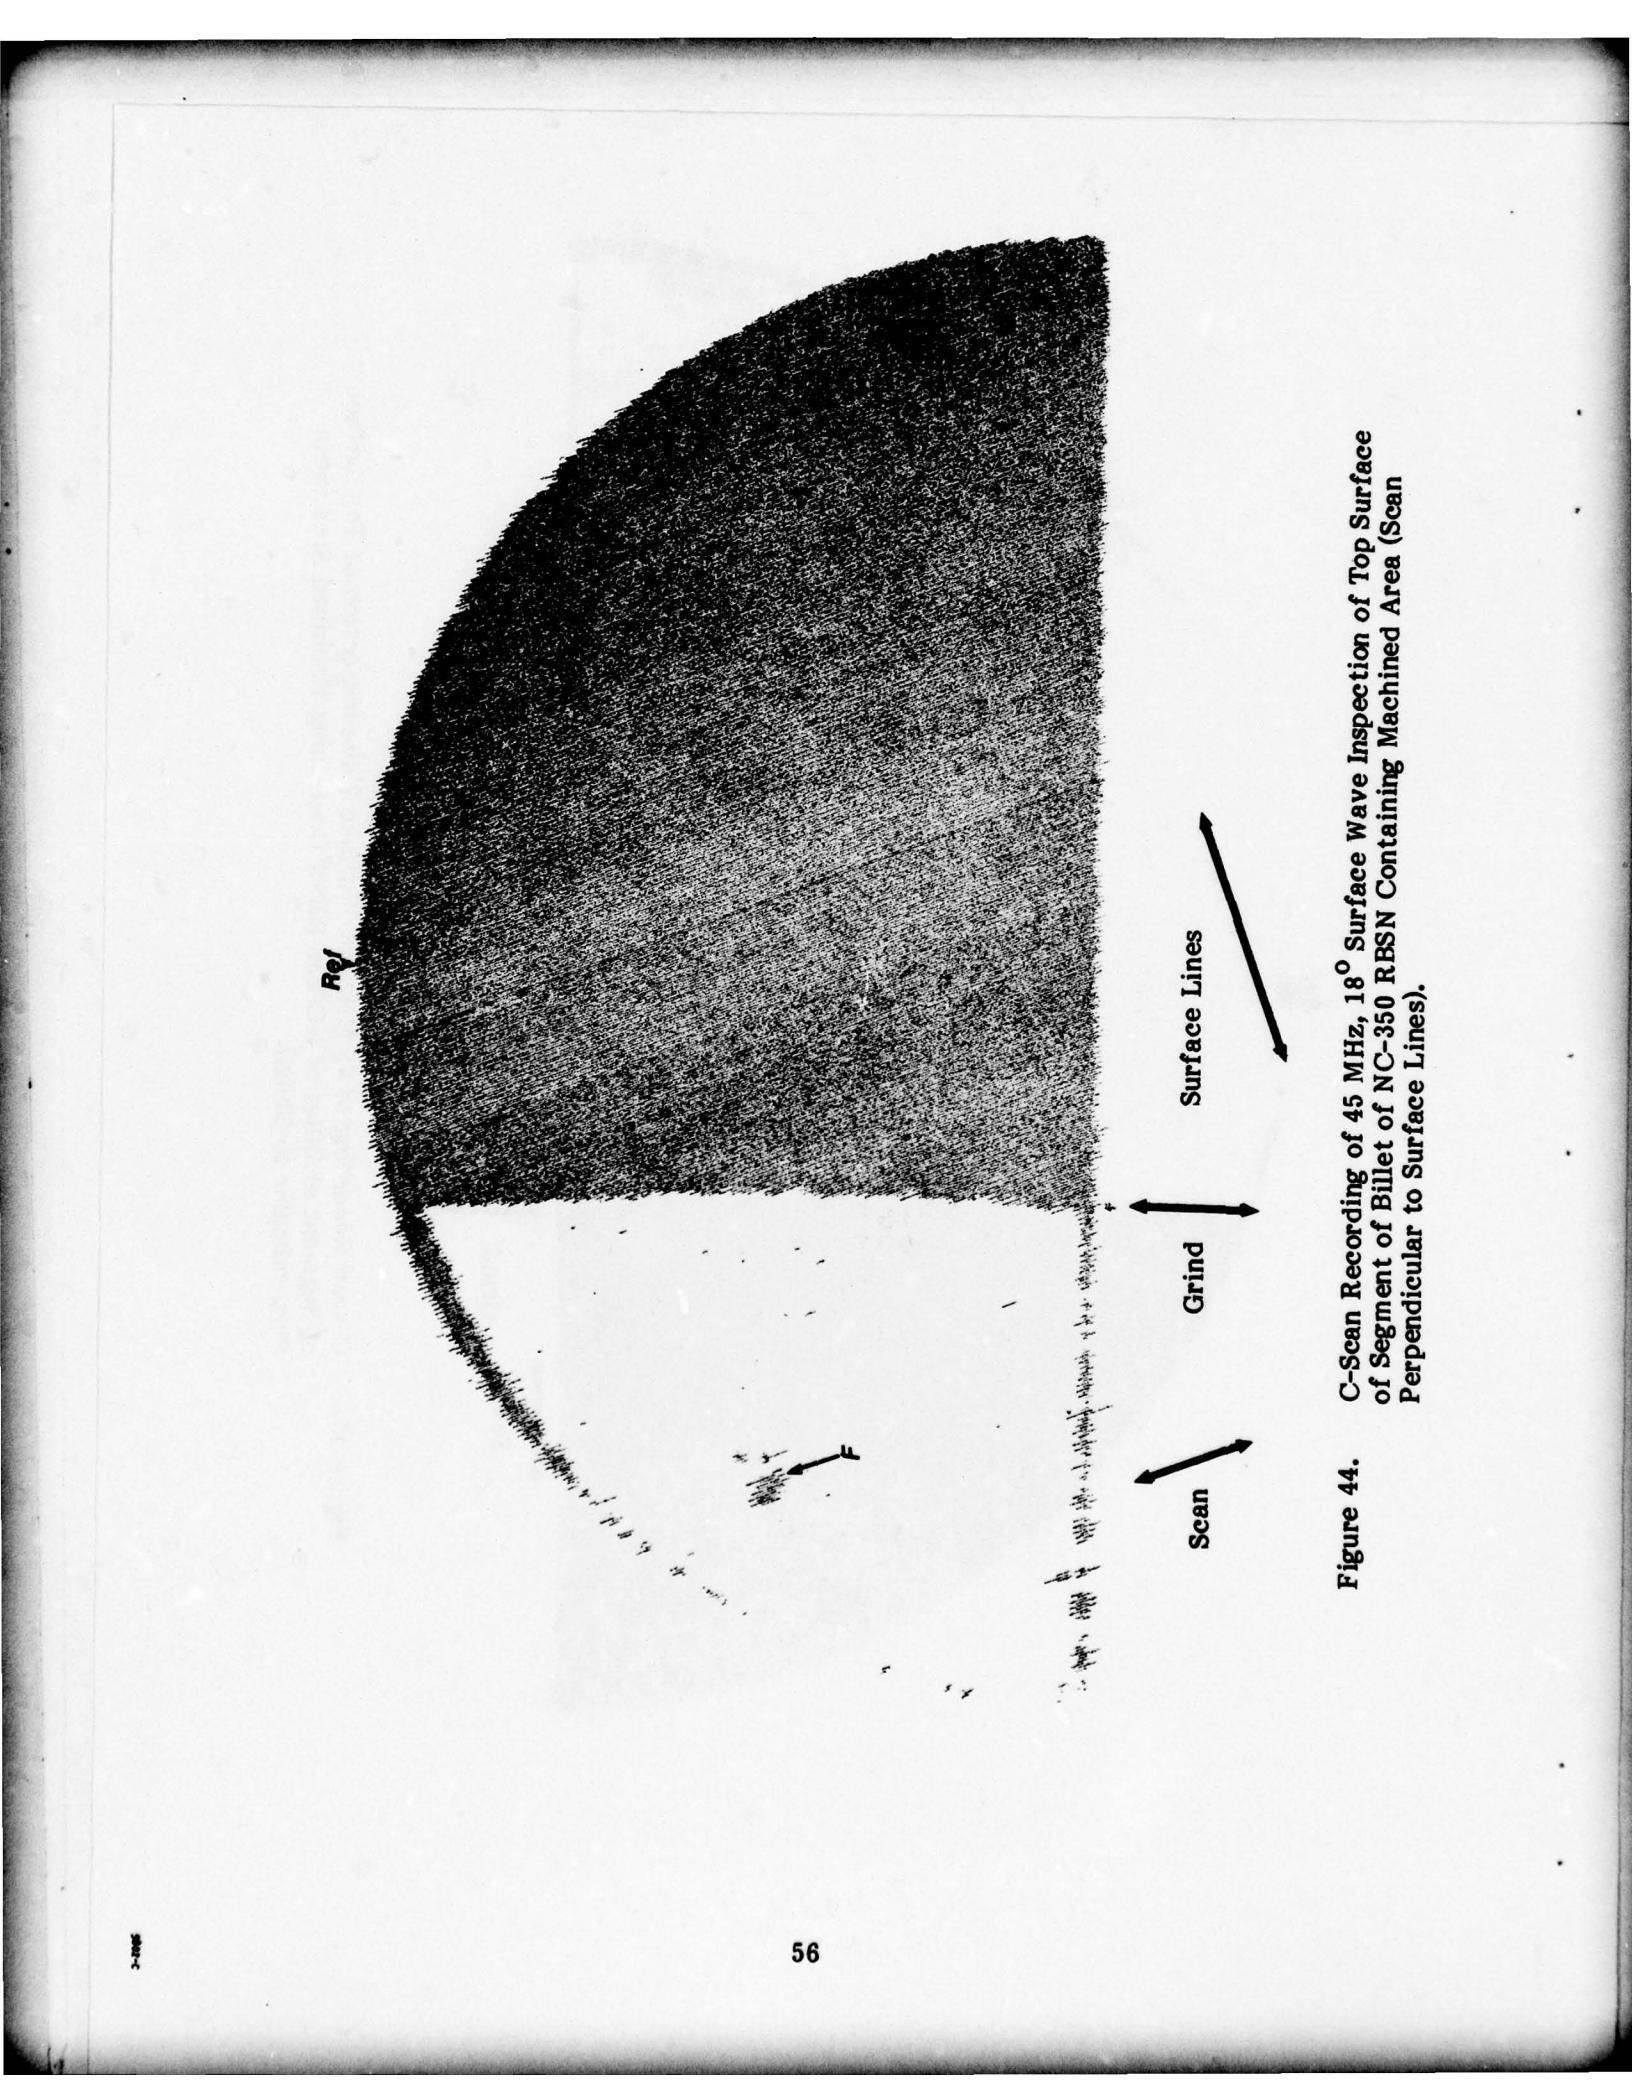
grinding direction and the surface lines in the unmachined portion of the billet. In Figure 42, ultrasonic scanning was performed parallel to the grinding direction. Indication F still appears in the machined area and the crack-like indication still appears in the unmachined area. Apparently the defect associated with this indication is less than 15 μ m (0.0006 inches) deep.

In Figure 43, the scanning direction is perpendicular to the grinding direction. In this orientation the entire machined area shows up as defective. Apparently the damage caused by grinding is as severe as the defects detected from other orientations. It should also be noted that the crack-like indication cannot be detected from this orientation. In Figure 44, the scanning direction is perpendicular to the surface lines in the unmachined portion of the specimen. This is a rotation of about 20 from Figure 43. In this case the entire unmachined area appears defective and indication F is again evident against a clean background in the machined area.

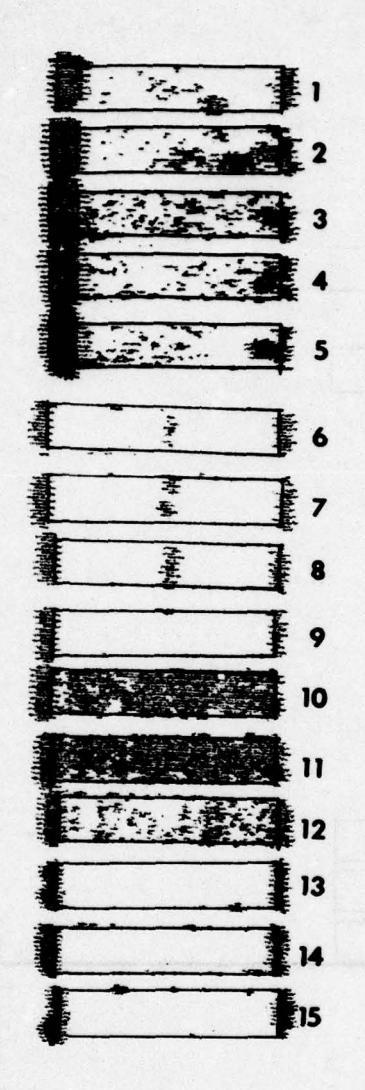
Figure 47. C-scan Recording of 45 MHz, 18⁰ Surface Wave Inspection of Tensile Surfaces of NC-350 RBSN Four-Point-Bend Specimens.

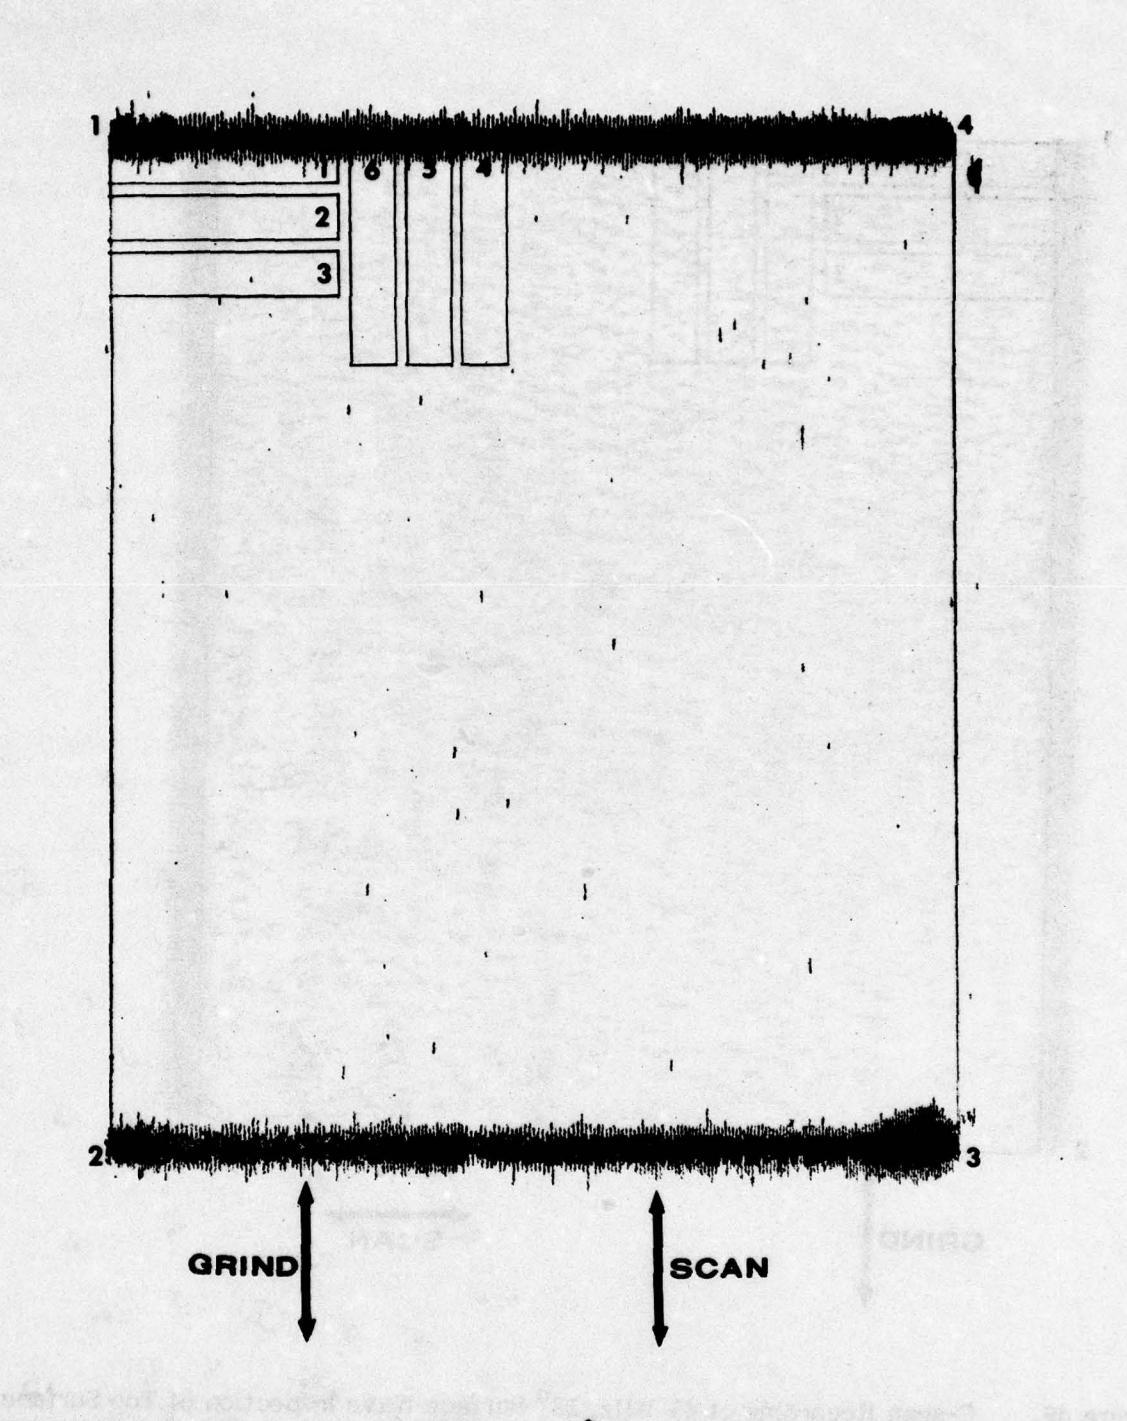
Figure 48. C-scan Recording of 45 MHz, 18⁰ Surface Wave Inspection of Top Surface of Billet of Ceralloy 146 HPSiC (Scan Parallel to Grinding Direction).

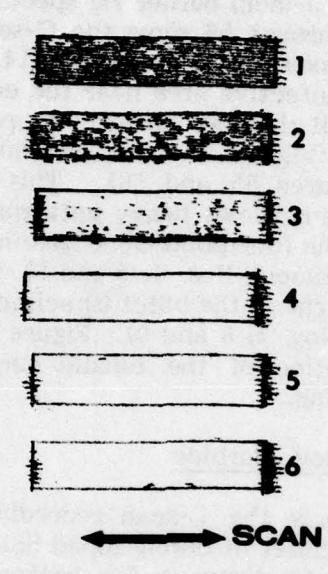
Figure 52. C-scan Recording of 45 MHz, 18⁰ Surface Wave Inspection of Tensile Surfaces of Ceralloy 146 HPSiC Four-Point-Bend Specimens.

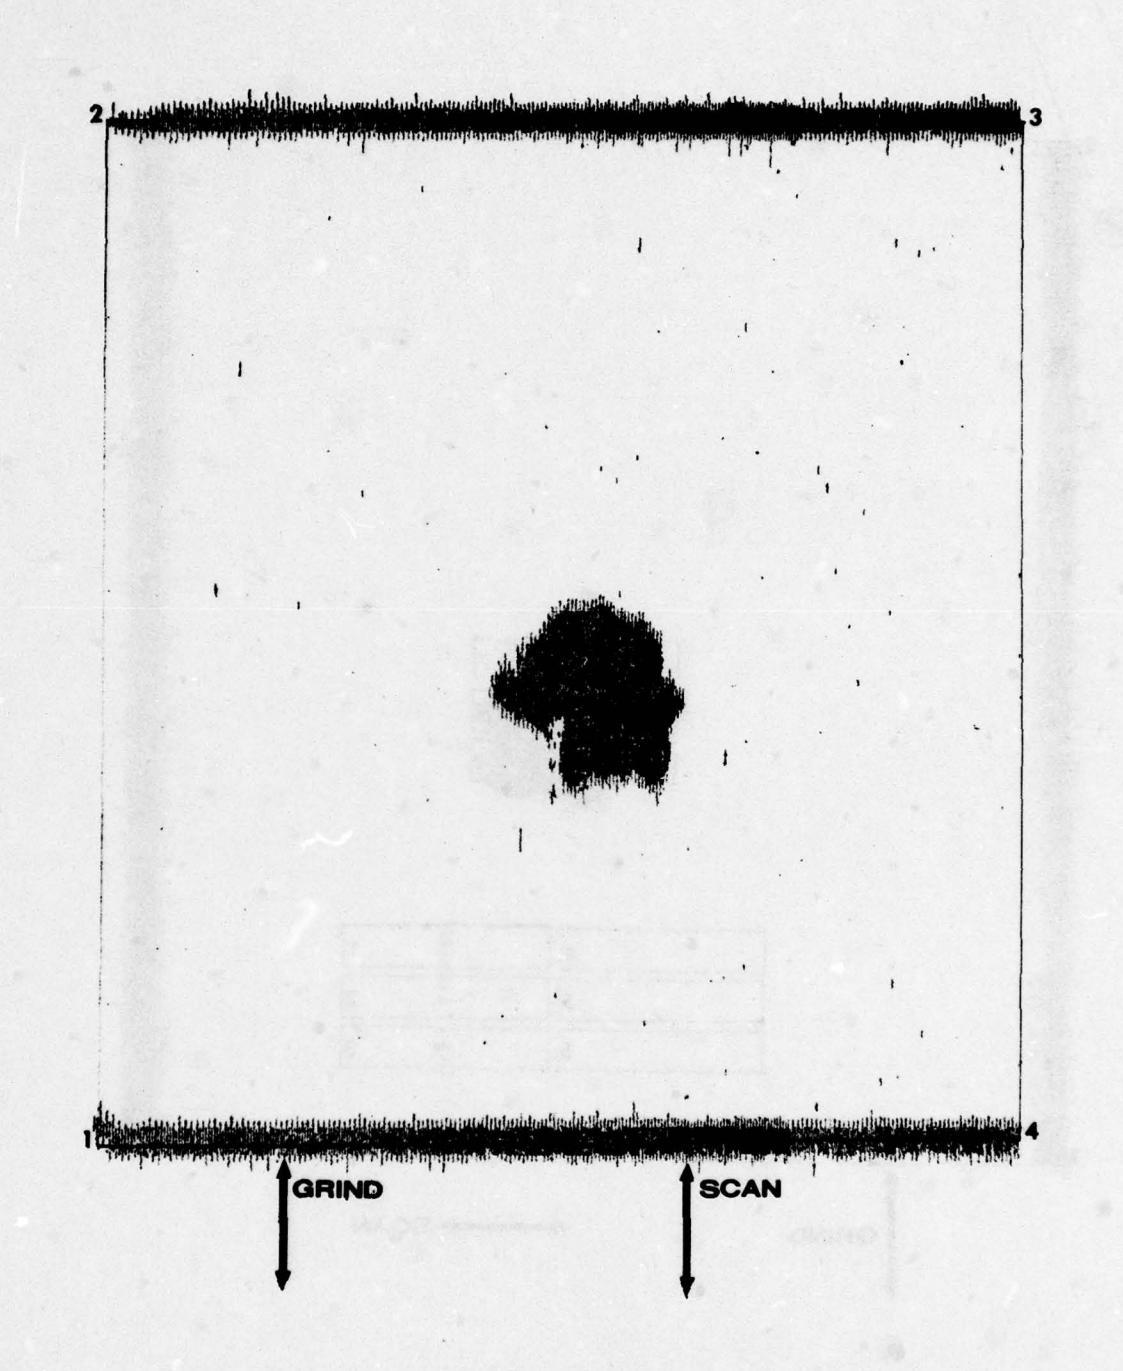
Figure 53. C-scan Recording of 45 MHz, 18⁰ Surface Wave Inspection of Top Surface of Billet of NC-203A HPSiC (Scan Parallel to Grinding Direction).

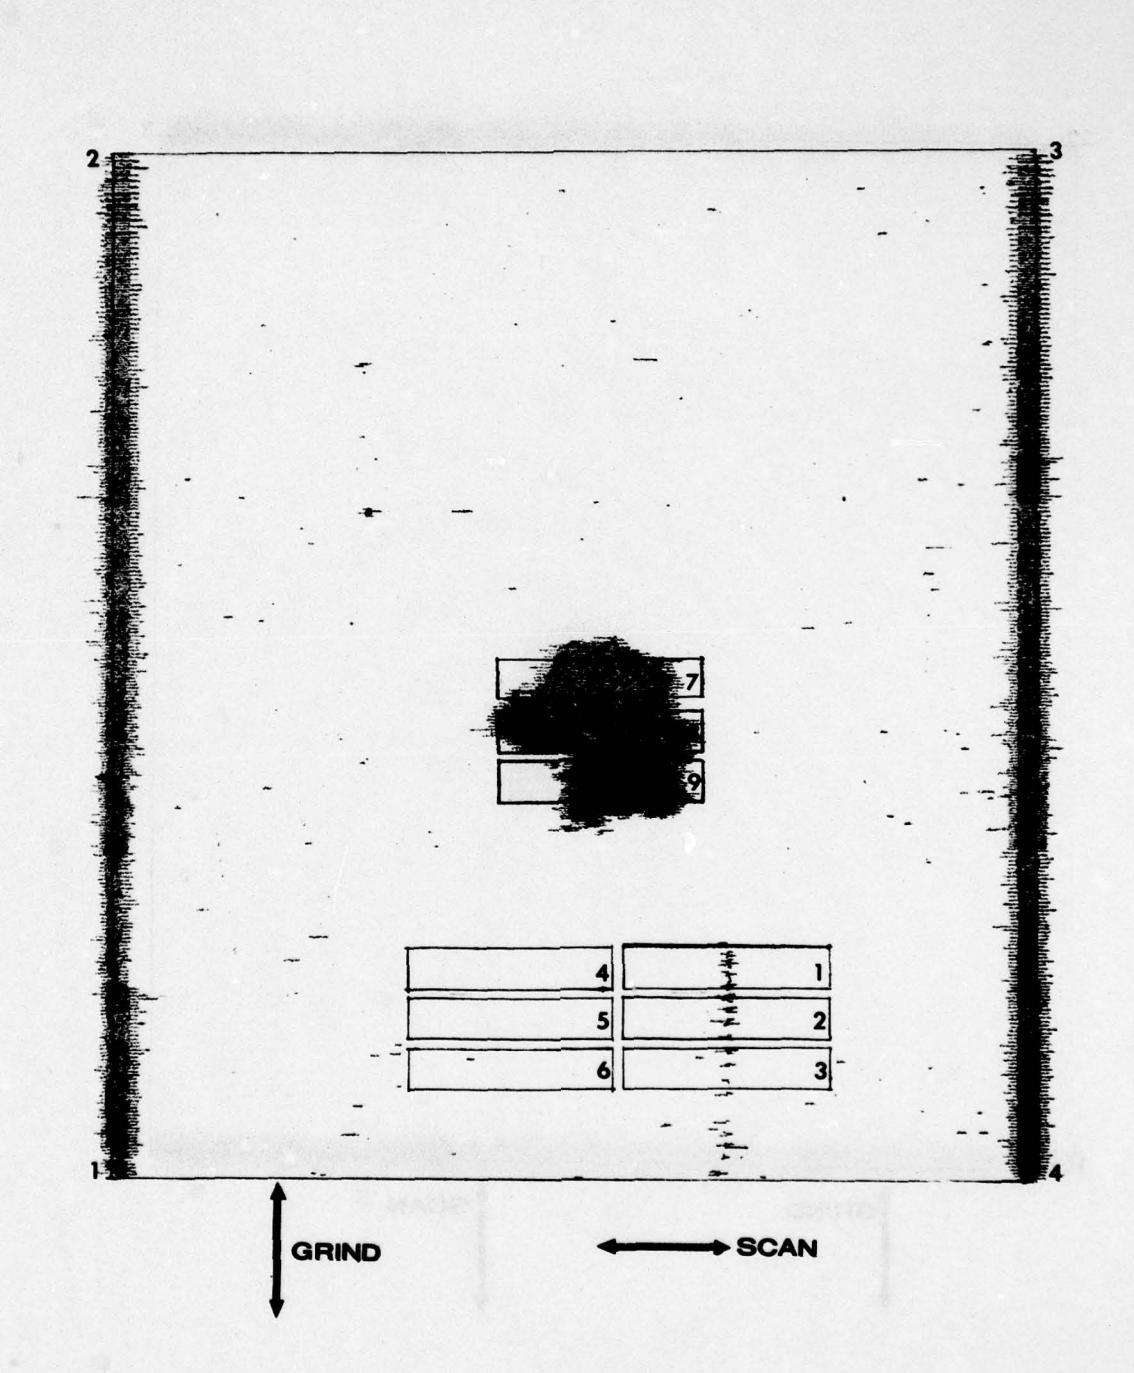
Figure 54. C-scan Recording of 45 MHz, 18⁰ Surface Wave Inspection of Top Surface of Billet of NC-203A HPSiC (Scan Perpendicular to Grinding Direction).

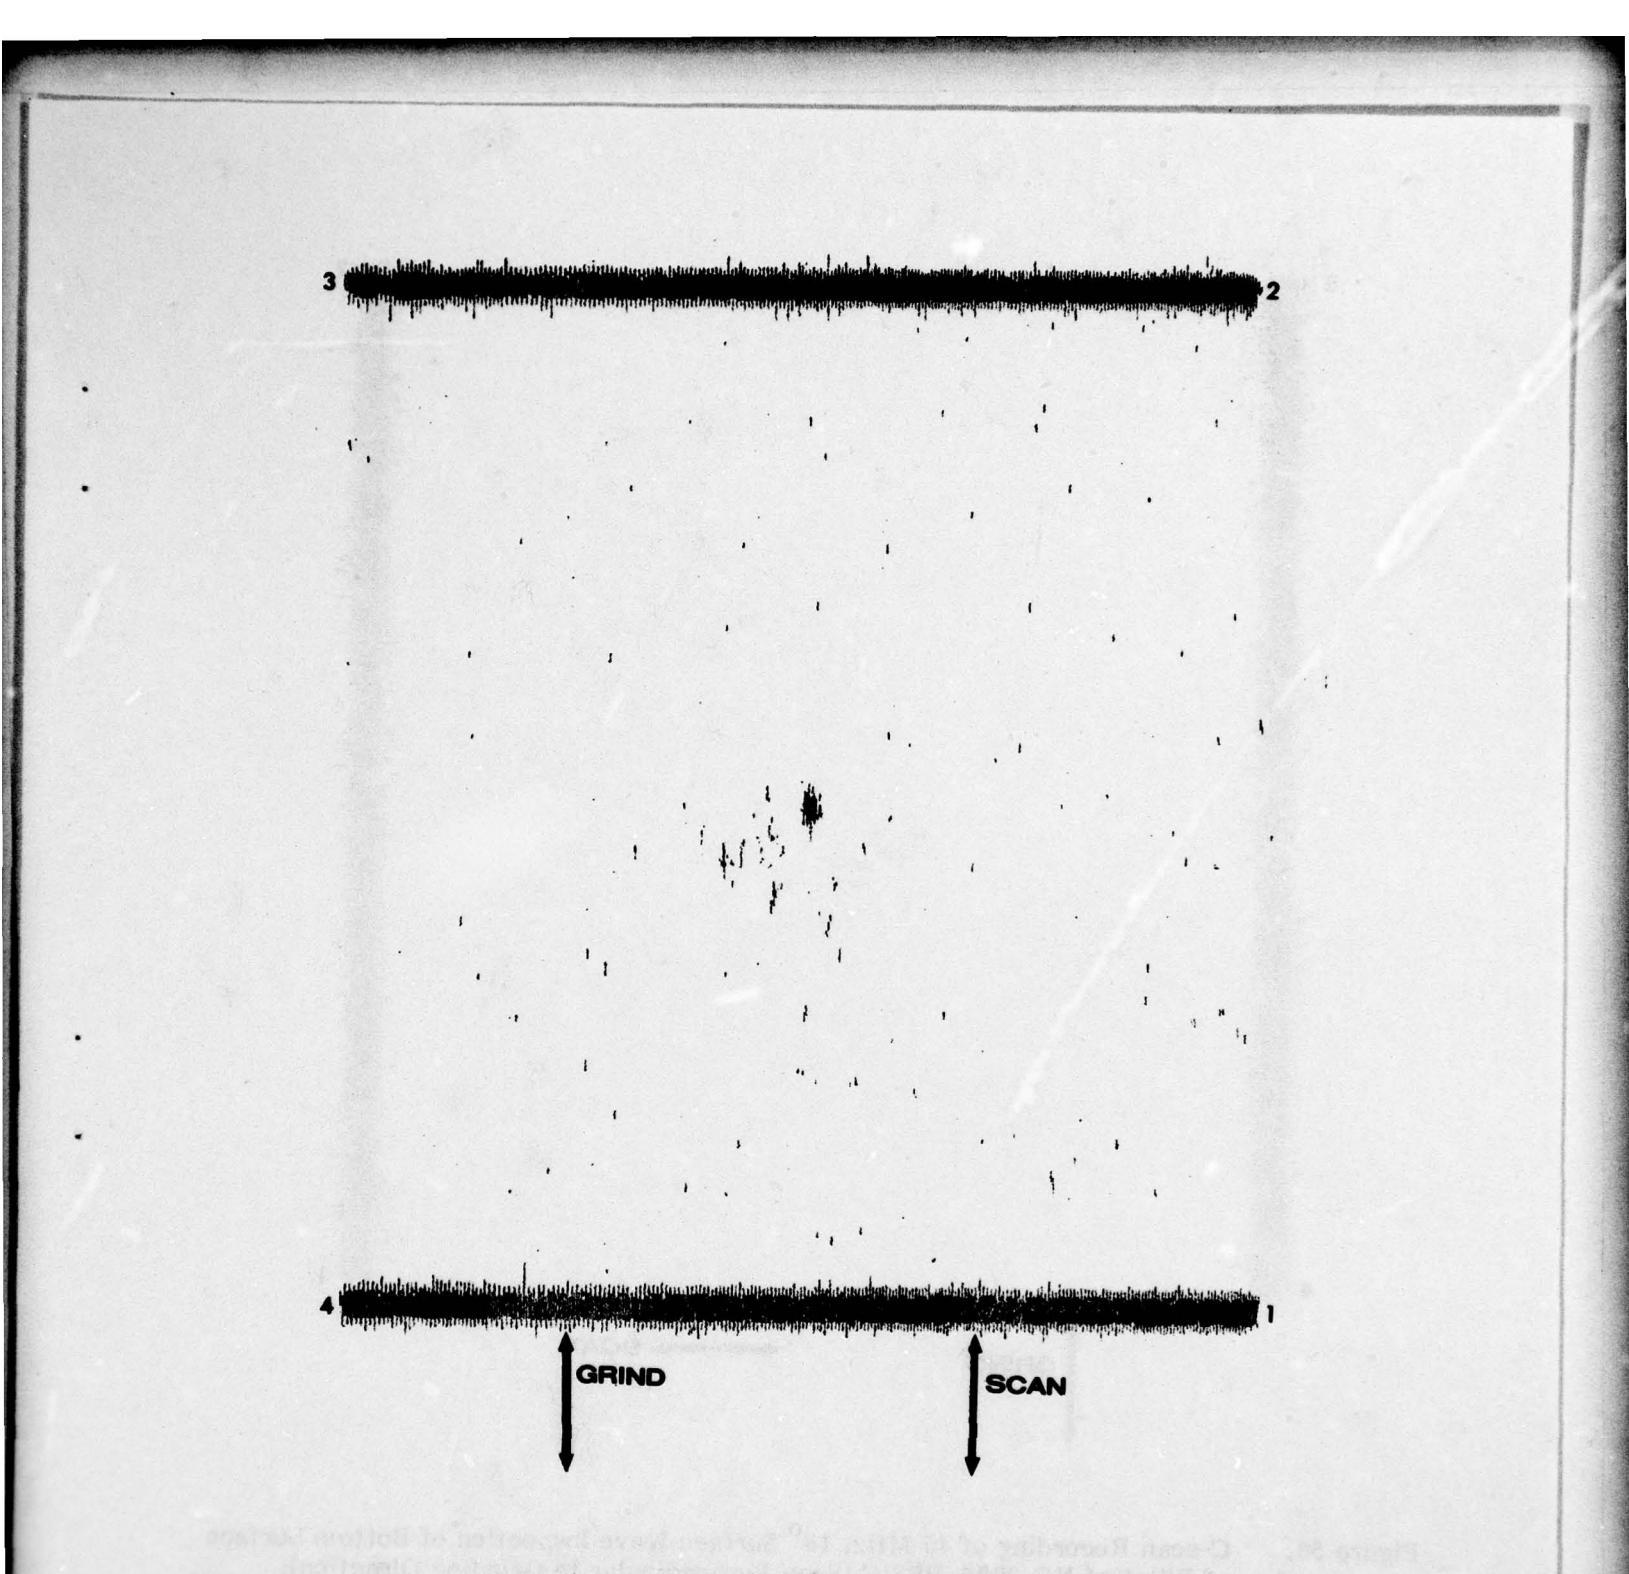
Figure 55. C-scan Recording of 45 MHz, 18⁰ Surface Wave Inspection of Bottom Surface of Billet of NC-203A HPSiC (Scan Parallel to Grinding Direction).

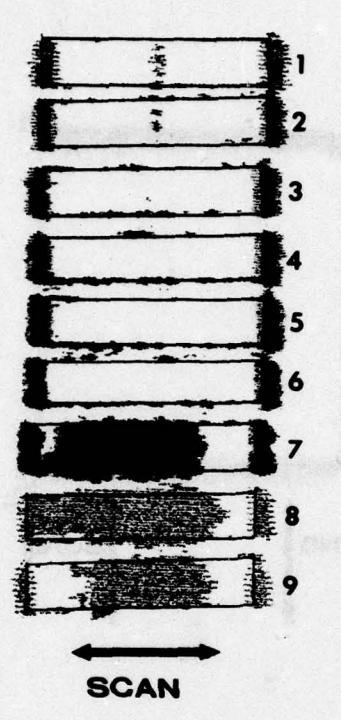
Figure 57. C-scan Recording of 45 MHz, 18⁰ Surface Wave Inspection of Tensile Surfaces of NC-203A HPSiC Four-Point-Bend Specimens.

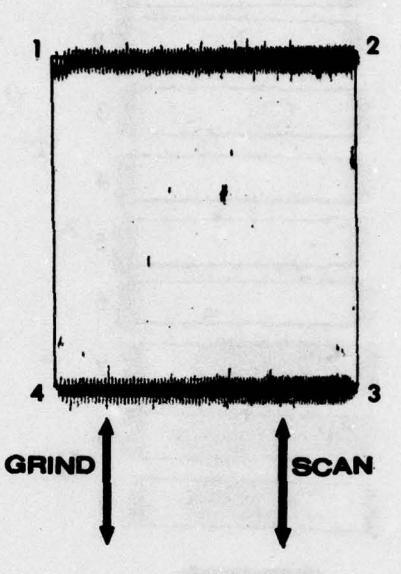
Figure 58. C-scan Recording of 45 MHz, 18⁰ Surface Wave Inspection of Top Surface of Billet of Boron Doped SSiC (Scan Parallel to Grinding Direction).

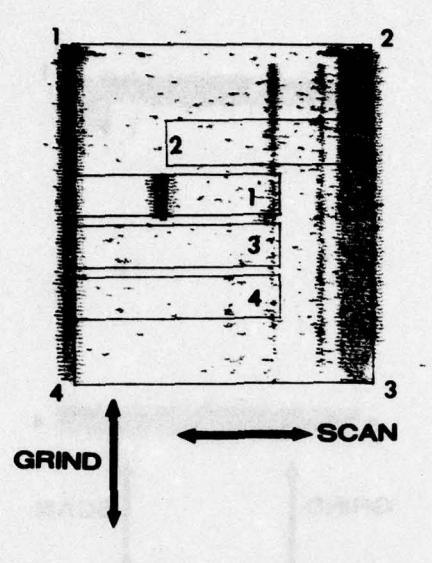
Figure 59. C-scan Recording of 45 MHz, 18⁰ Surface Wave Inspection of Top Surface of Billet of Boron Doped SSiC (Scan Perpendicular to Grinding Direction).

The results of the four-point-bend tests on boron-doped SSiC are listed in Table IV. All the specimens were machined perpendicular to the grinding damage. As can be seen in Figure 59, specimen No. 1 contained a severe individual linear defect indication. It failed at the defect location at a strength of only 192 MN/m² (27.9 ksi). Specimen No. 2 contained machining damage less severe than the defect in specimen 1. It failed at the defect location at a strength of 358 MN/m² (51.9 ksi). Specimens 3 and 4 showed no machining damage at the sensitivity of inspection. Their average strength was 423 - 27 MN/m² (61.4 - 3.9 ksi). Figure 80 shows the fracture surfaces of specimen No. 1. While there is a well defined fracture origin at the surface near one corner, the failure appears to have propagated along a line of pre-existing surface damage over most of the width of the specimen. Figure 81 shows 100X views of this damage away from the fracture origin. The depth of the defective area is estimated to have been about 50 μ m (0.0020 inches). Specimen No. 2 shows similar results, except that the defect depth is only about 15 μ m (0.0006 inches). Specimens 3 and 4 shattered so badly that a fracture origin could not be identified.

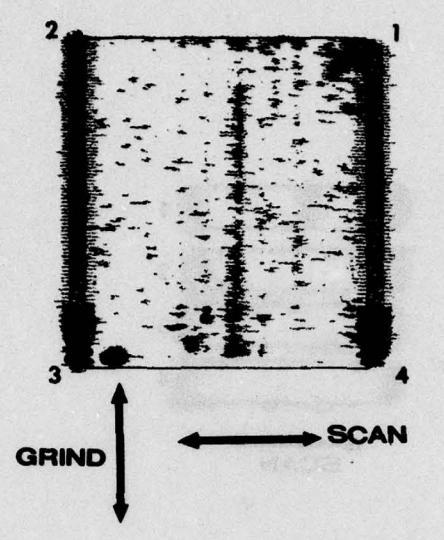
Figure 61. C-scan Recording of 45 MHz, 18⁰ Surface Wave Inspection of Bottom Surface of Billet of Boron Doped SSiC (Scan Perpendicular to Grinding Direction).

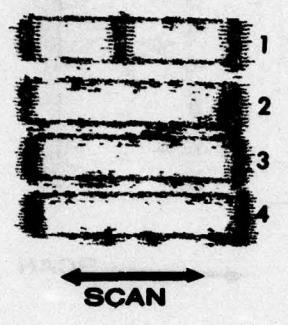
Figure 62. C-scan Recording of 45 MHz, 18⁰ Surface Wave Inspection of Tensile Surfaces of Boron Doped SSiC Four-Point-Bend Specimens.

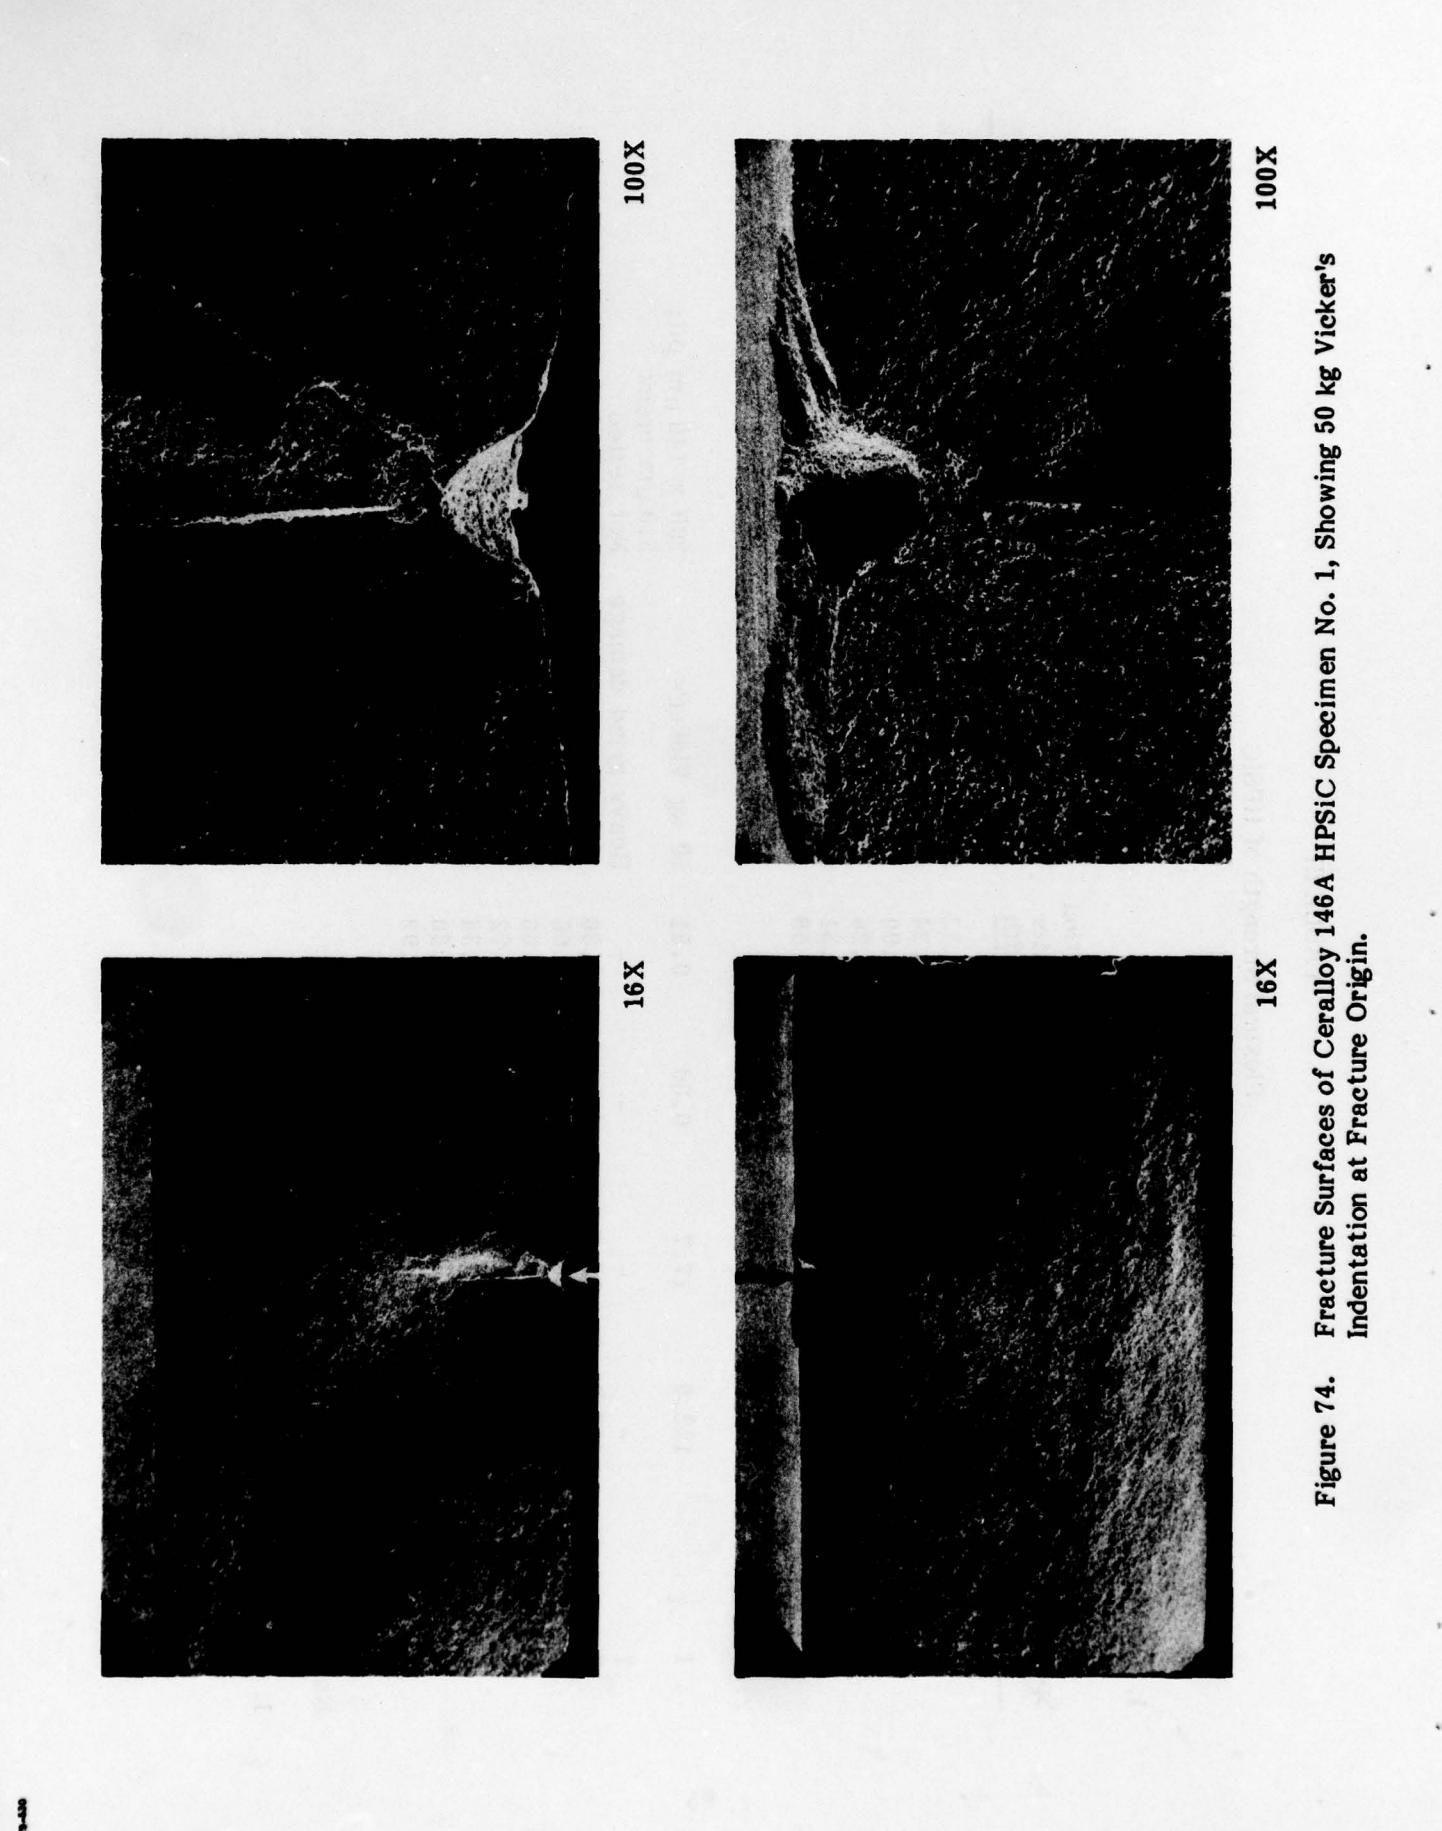
The results of the four-point-bend tests on HPSiC are listed in Table III. Specimens 1 and 4 of Ceralloy 146 contained the 50 kg and 1 kg Vicker's, respectively. The fracture surfaces of these specimens are shown in Figures 74 and 75. In Figure 74 it can be seen that the 50 kg Vicker's indentation consisted of a pit 200 μ m (0.008 inches) wide by 160 μ m (0.0064 inches) deep with a crack extending 605 μ m (0.0242 inches) deep. The 1 kg Vicker's indentation shown in Figure 75 consists of a pit 20 μ m (0.0008 inches) wide by $2 \mu m$ (0.00008 inches) deep with a crack extending about 25 μm (0.0010 inches) deep. Specimens 2 and 3 of Ceralloy 146, which, were machined perpendicular to the grinding damage, had an average strength of 429 - 16 MN/m² (62.3 -2.3 ksi) compared to 509 -61 MN/m² (73.8 -8.8 ksi) for specimens 5 and 6 which were machined parallel to the grinding direction. While this difference is large, there is too much scatter in the data and too few specimens to conclude that it is significant with a high degree of confidence. The specimen containing the 1 kg Vicker's was significantly weaker, 299 MN/m⁴ (43.3 ksi) than those machined perpendicular to the grinding damage. Specimens 2, 3, 5 and 6 all failed through identifiable fracture origins in which no specific defect could be identified.

1000X 100X Fracture Surfaces of Ceralloy 146A HPSiC Specimen No. 4, Showing 1 kg Vicker's Indentation at Fracture Origin. 16 X 16X à Figure 75.

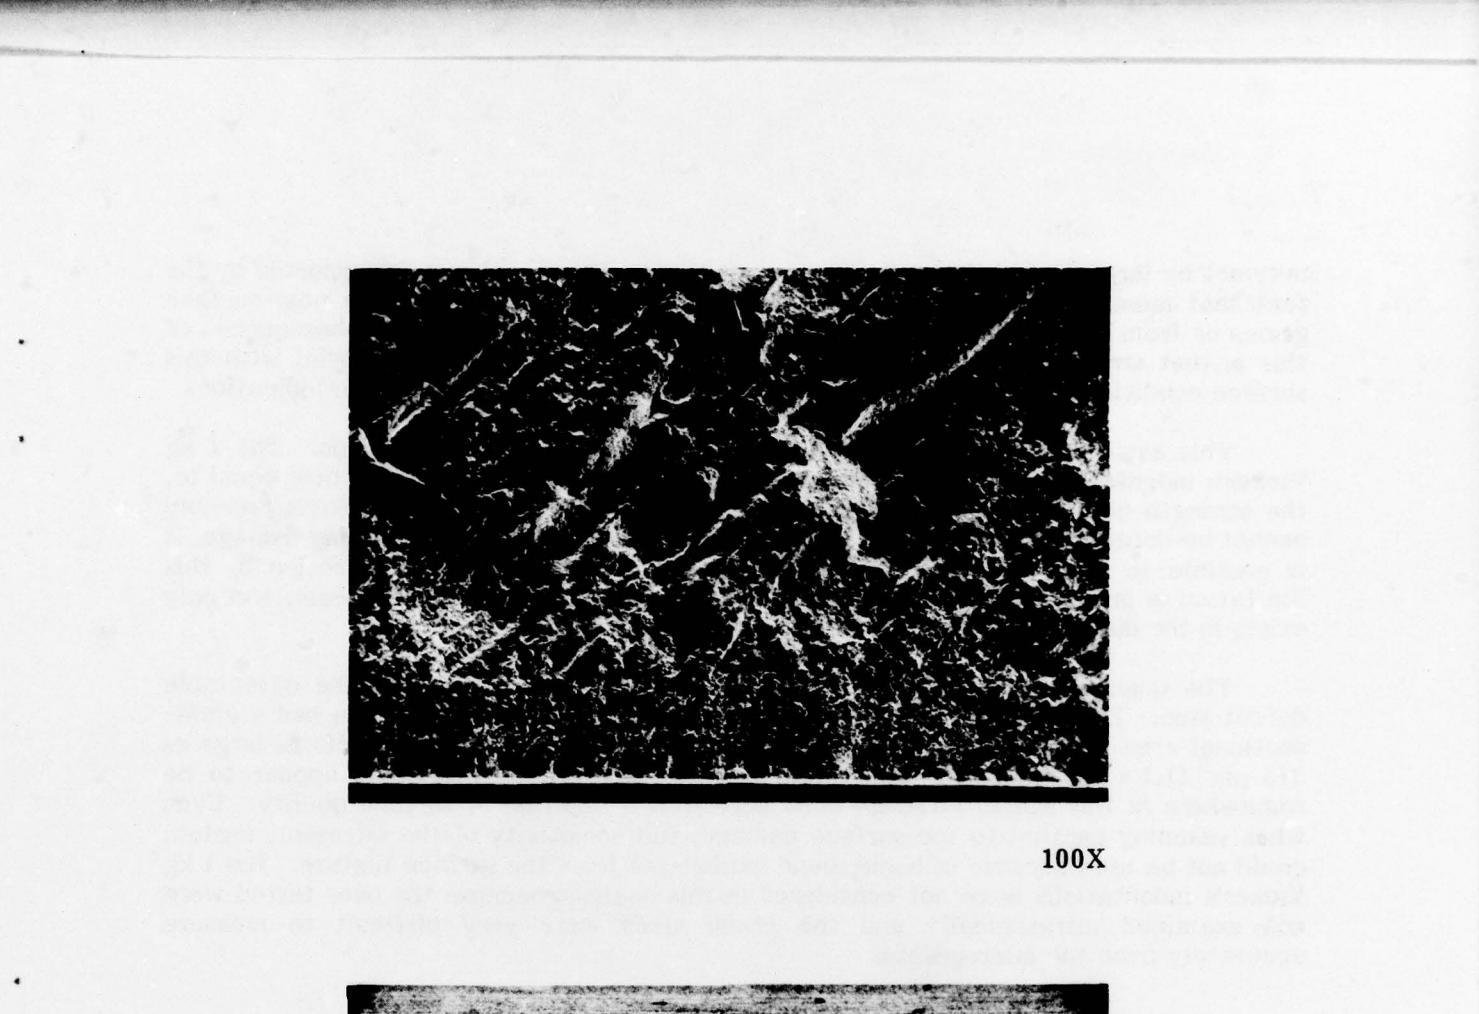
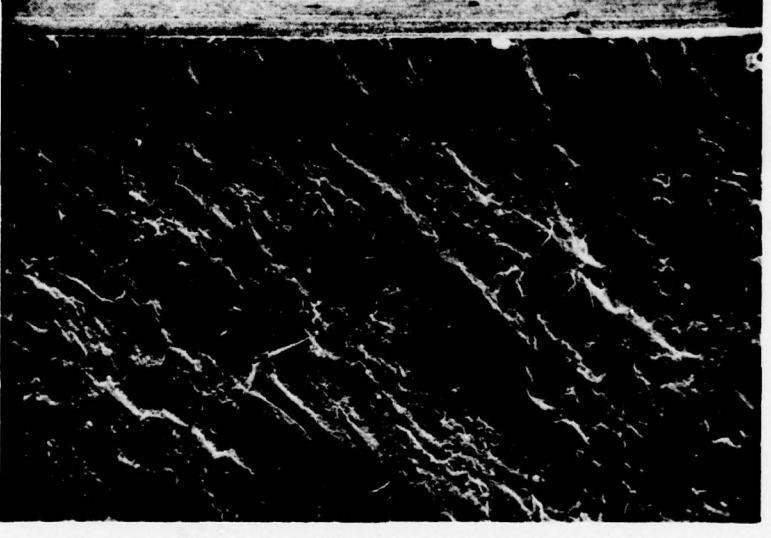
Figure 81. Fracture Surfaces of Boron Doped SSiC Specimen No. 1, Showing Ultrasonically Detected Linear Defect in Area Away From Fracture Origin.
