USARTL-TN-35

HLH ROTOR BOX BEAM FATIGUE TEST

M. Hanson

September 1979

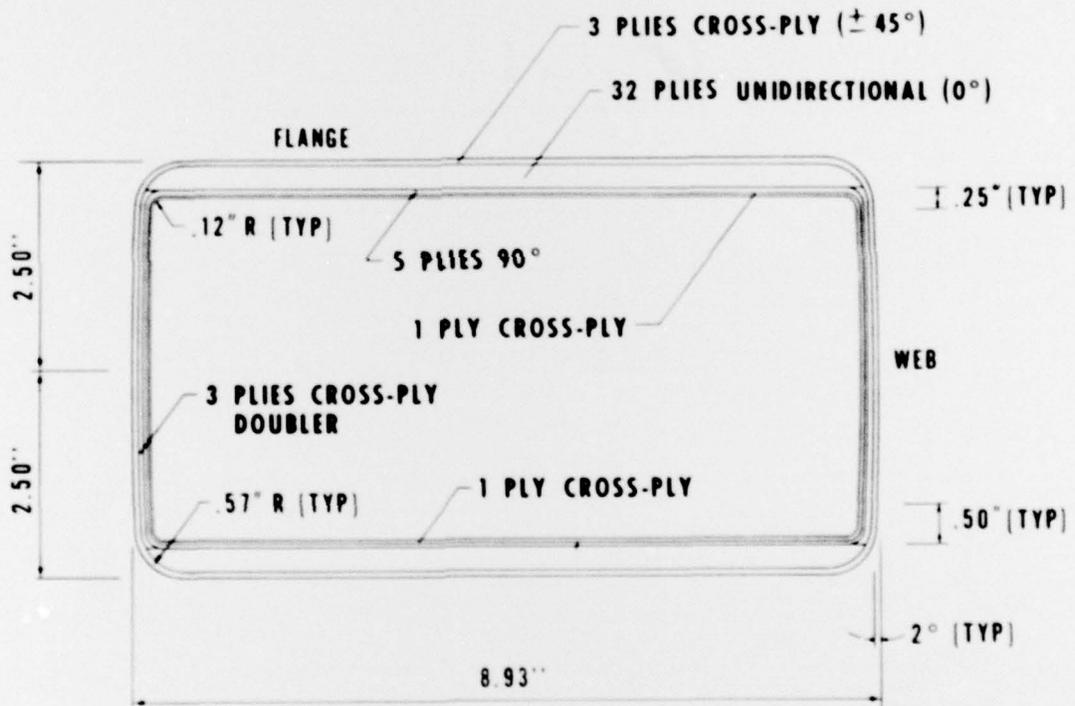
Figure 1. Cross section of box beam.

The Boeing Company, Vertol Division furnished a 180-inch-long fiberglass box beam to the Structures laboratory of the Applied Technology Laboratory. The beam was uniform in cross section over its entire length with the exception of 17 inches on each end where the cross section was gradually built up with unidirectional material to provide additional end grip support (see Figure 1). The layup on the flanges of the beam was $\pm 45^\circ_3/0^\circ_{12}/90^\circ_5/\pm 45^\circ_1$ and on the vertical web was $\pm 45^\circ_3/0^\circ_3/90^\circ_5/\pm 45^\circ_1$, with 0° parallel to the longitudinal axis of the beam. This layup was similar to that used in the HLH/ATC blade spar design. Manufacturing flaws consisted primarily of dimples and wrinkles (Figures 2 and 3) and were in evidence the entire length of the beam.

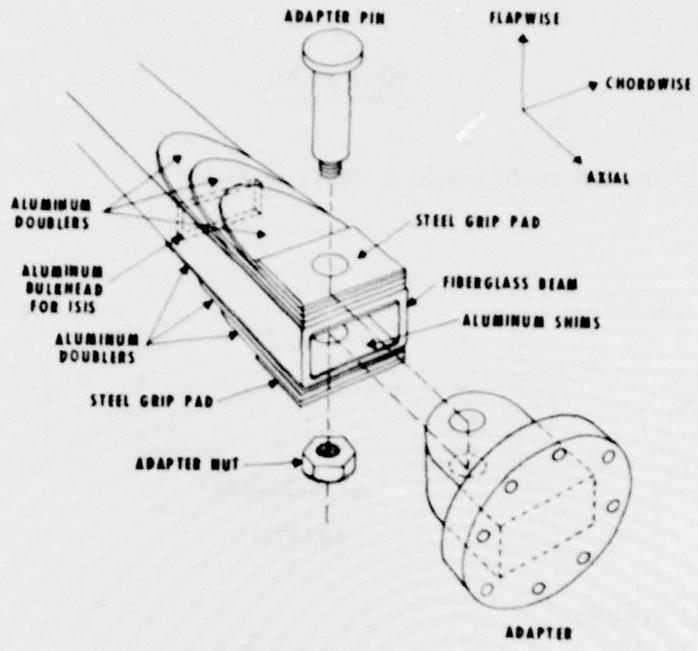
Figure 4. Beam end attachment grip buildup.

The fatigue test was conducted at a frequency of 18.6 Hertz after the resonance point had been determined. After a total of 3600 cycles, of which approximately 600 were at the strain equivalent of high-speed flight loads (2200 microinches per inch at midspan), one set of the grip doublers at the actuator end of the test machine debonded from approximately 40 percent of its beam contact area.

The doublers were rebonded to the beam, and an aluminum bearing plate was bonded inside the beam. Bolt holes were drilled through the doublers, beam, and bearing plate, and bolts were installed. The ISIS bulkhead had to be removed for this repair, and the ISIS was inoperative after the bulkhead was replaced due to its inability to effectively seal the bolt holes or due to early blade damage caused by the fatigue failure described below.

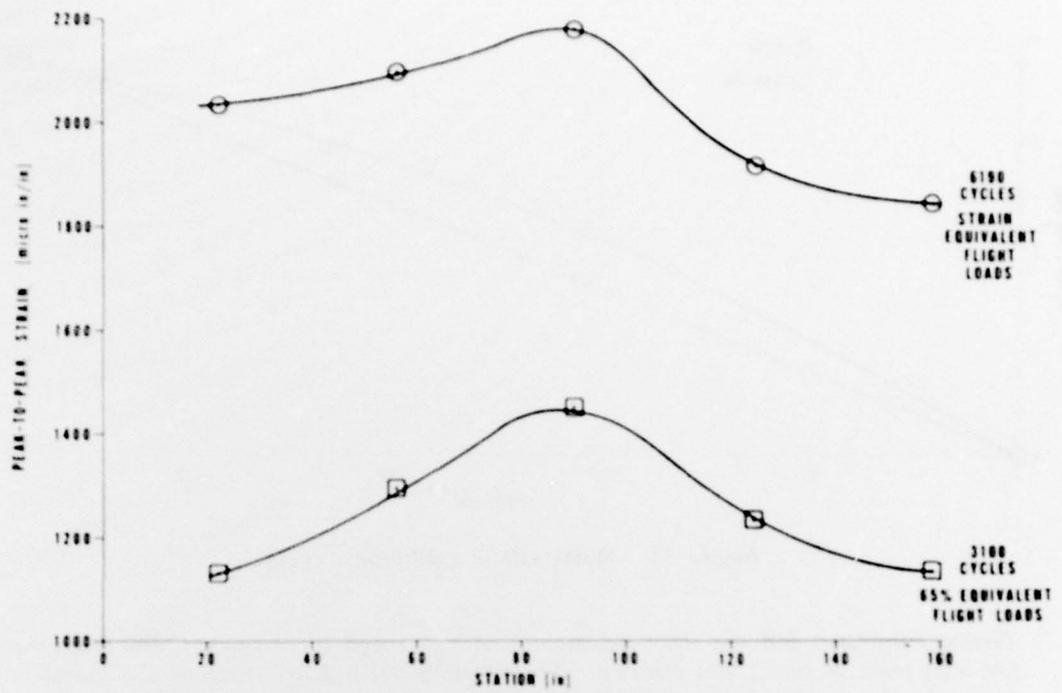
Figure 9. Bending strain distribution.

The test resumed at the strain equivalent of high-speed flight loads, and after 6000 cycles the machine was shut down by an axial deflection limit detector. Inspection revealed a transverse fatigue crack 26 inches from the reaction end of the beam on the bottom flange in the chordwise direction. The crack area was too hot to touch. The crack originated at a manufacturing flaw (wrinkle) and extended approximately 3 inches past the end of the surface wrinkle (see Figure 8). The bending strain distributions after 3100 cycles at a low loading condition and after 6000 cycles at an equivalent flight loading condition are shown in Figure 9.

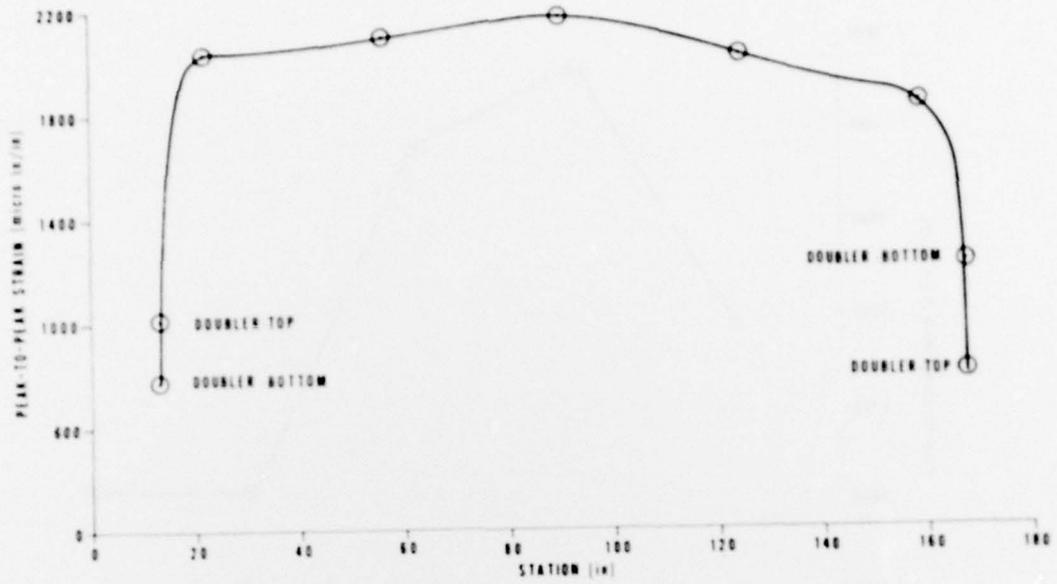
Figure 12. Bending strain distribution (9,000 cycles).

Testing continued and the strain equivalent of high-speed flight loads (2200 microinches per inch peak to peak) was reached. The bending strain distribution at this point is shown in Figure 12. At approximately 16,000 cycles the bending amplitude was increased and a strain of 3400 microinches per inch peak to peak was recorded (see Figure 13). At this point a bolt in the test fixture failed, causing the test to be stopped. The crack previously discovered had become charred and had propagated to the corner of the beam and 2 inches up the side (web) of the beam. Smoke was also observed in the grip area at the reaction end of the beam. The doublers at both ends were hot to the touch, and debonding between the doublers and the beam had obviously started. Two additional fatigue cracks were also discovered, one approximately 40 inches from the reaction end of the beam (near the first crack) on the bottom flange and one near midspan on the top flange.

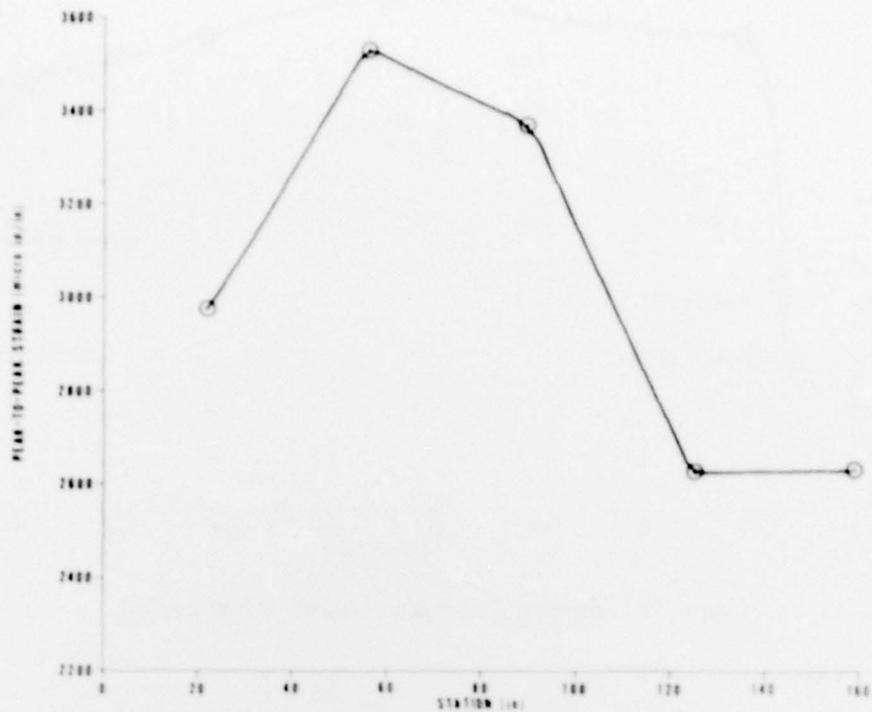
Figure 14. Bending strain distribution (18,000 cycles).

After replacement of the failed bolt, testing resumed. A strain of 3500 microinches per inch peak to peak was achieved in the test section when an axial deflection limit detector again shut down the machine. The maximum strain had shifted away from midspan (see Figure 14). After several more shutdowns and inspections, the limit detector was removed and testing resumed. The frequency was increased gradually to find the peak of the resonance curve. The amplitude of the strains increased as frequency increased. At 20 Hertz and 22,000 cycles the beam failed catastrophically in the grip area at the reaction end where smoke had been previously observed. The fiberglass beam failed in shear at the adapter pin connections of each flange (see Figure 15). The doublers on one flange debonded and, in turn, sheared the bolts that were used to secure the doublers to the beam (see Figure 16). The doubler assembly on the other flange failed in tension (see Figure 15).

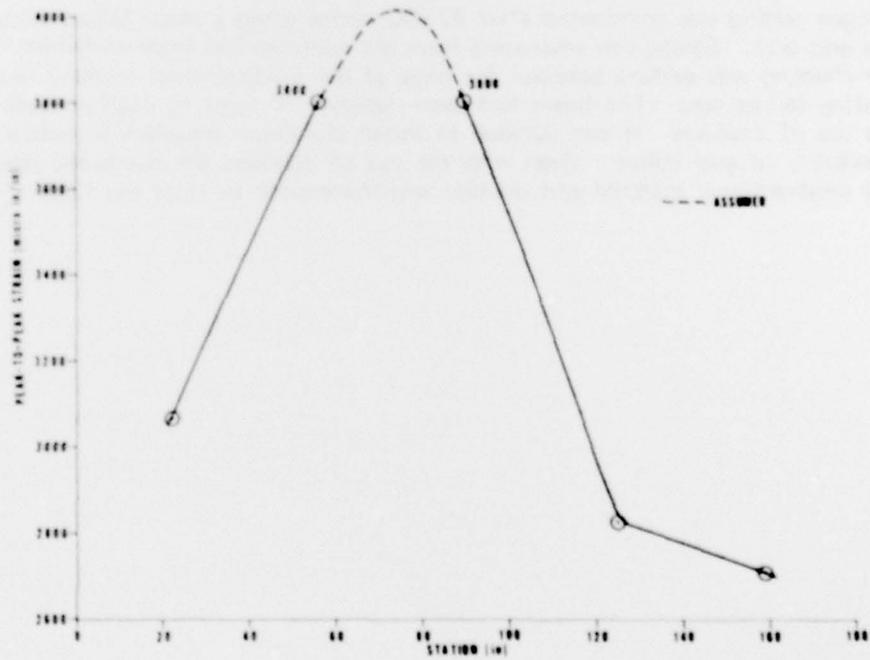
Figure 17. Bending strain distribution (22,000 cycles).

The maximum strain recorded was 3800 microinches per inch peak to peak, as shown in Figure 17. This strain was recorded at two adjacent stations, so actual maximum strain may have reached 4000 microinches per inch peak to peak between those stations.
