| SECURITY CLASSIFICATION OF THIS PAGE (When Data Entered) | | |
|--|--|--|
| 4. TITLE (and Subtitle) Phase I Inspection Report Lake Moraine Dam Chenago River Basin, Madison County, New York Inventory No. 354 | 5. TYPE OF REPORT & PERIOD COVERED Phase I Inspection Report National Dam Safety Program | 6. PERFORMING ORG. REPORT NUMBER |
| 7. AUTHOR(s) John B. Stetson, P.E. | 8. CONTRACT OR GRANT NUMBER(s) DACP-51-79-C-0001 | 9. PROGRAM ELEMENT, PROJECT, TASK AREA & WORK UNIT NUMBERS |
| 10. CONTROLLING OFFICE NAME AND ADDRESS New York State Department of Environmental Conservation/ 50 Wolf Road Albany, New York 12233 | 11. REPORT DATE 28 September 1979 | 12. NUMBER OF PAGES |

PHASE I INSPECTION REPORT
NATIONAL DAM SAFETY PROGRAM
NAME OF DAM - LAKE MORaine DAM ID# - NY 354

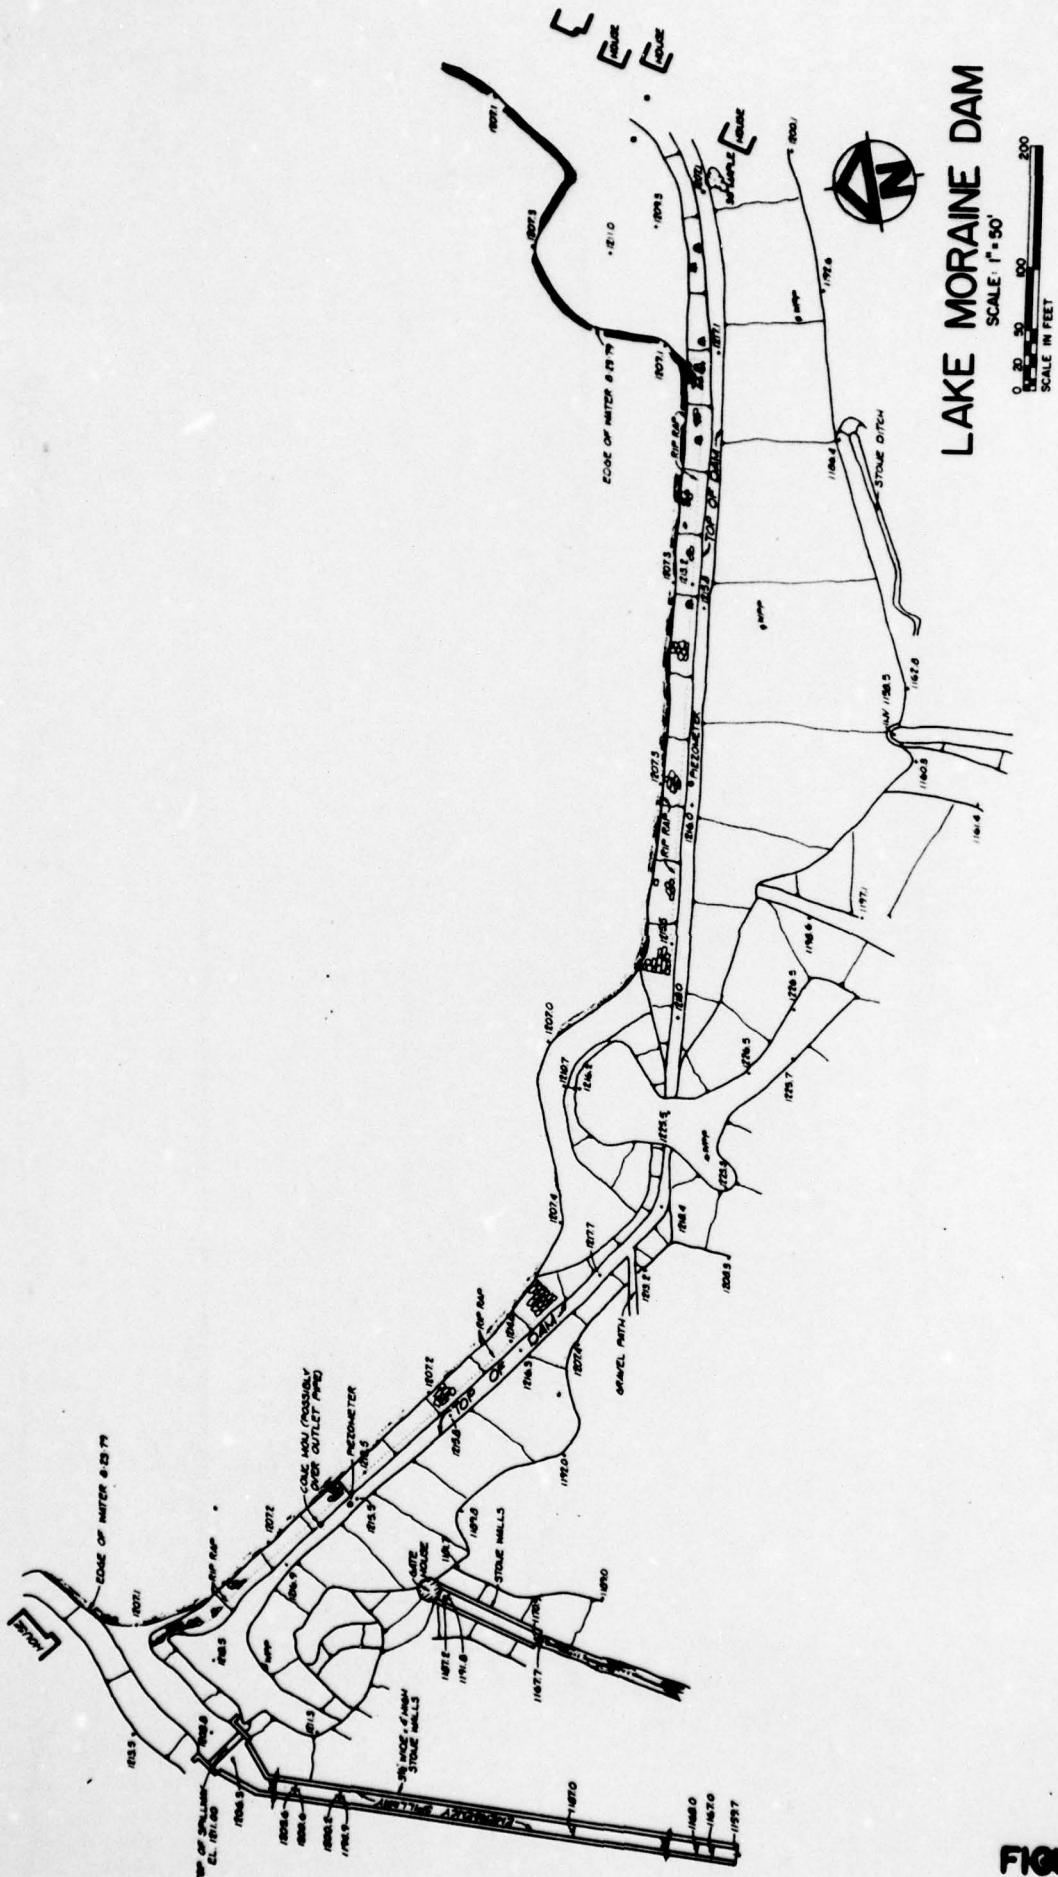
FIGURE 2

The emergency spillway, located at the west abutment of the westerly embankment, is in generally good condition. The structure is constructed of masonry and shows no signs of severe deterioration. A short approach channel extends from the spillway crest to the impoundment. At the time of this inspection, water was standing in the approached channel. Observation wells have recently been installed in the center of both the easterly and westerly embankments. These piezometers are shown on the survey map (See Figure No. 2.).
