NRL Memorandum Report 4123

Mechanical Properties of Wrought Iron from Hull Plate of USS MONITOR

November 20, 1979

NAVAL RESEARCH LABORATORY Washington, D.C.

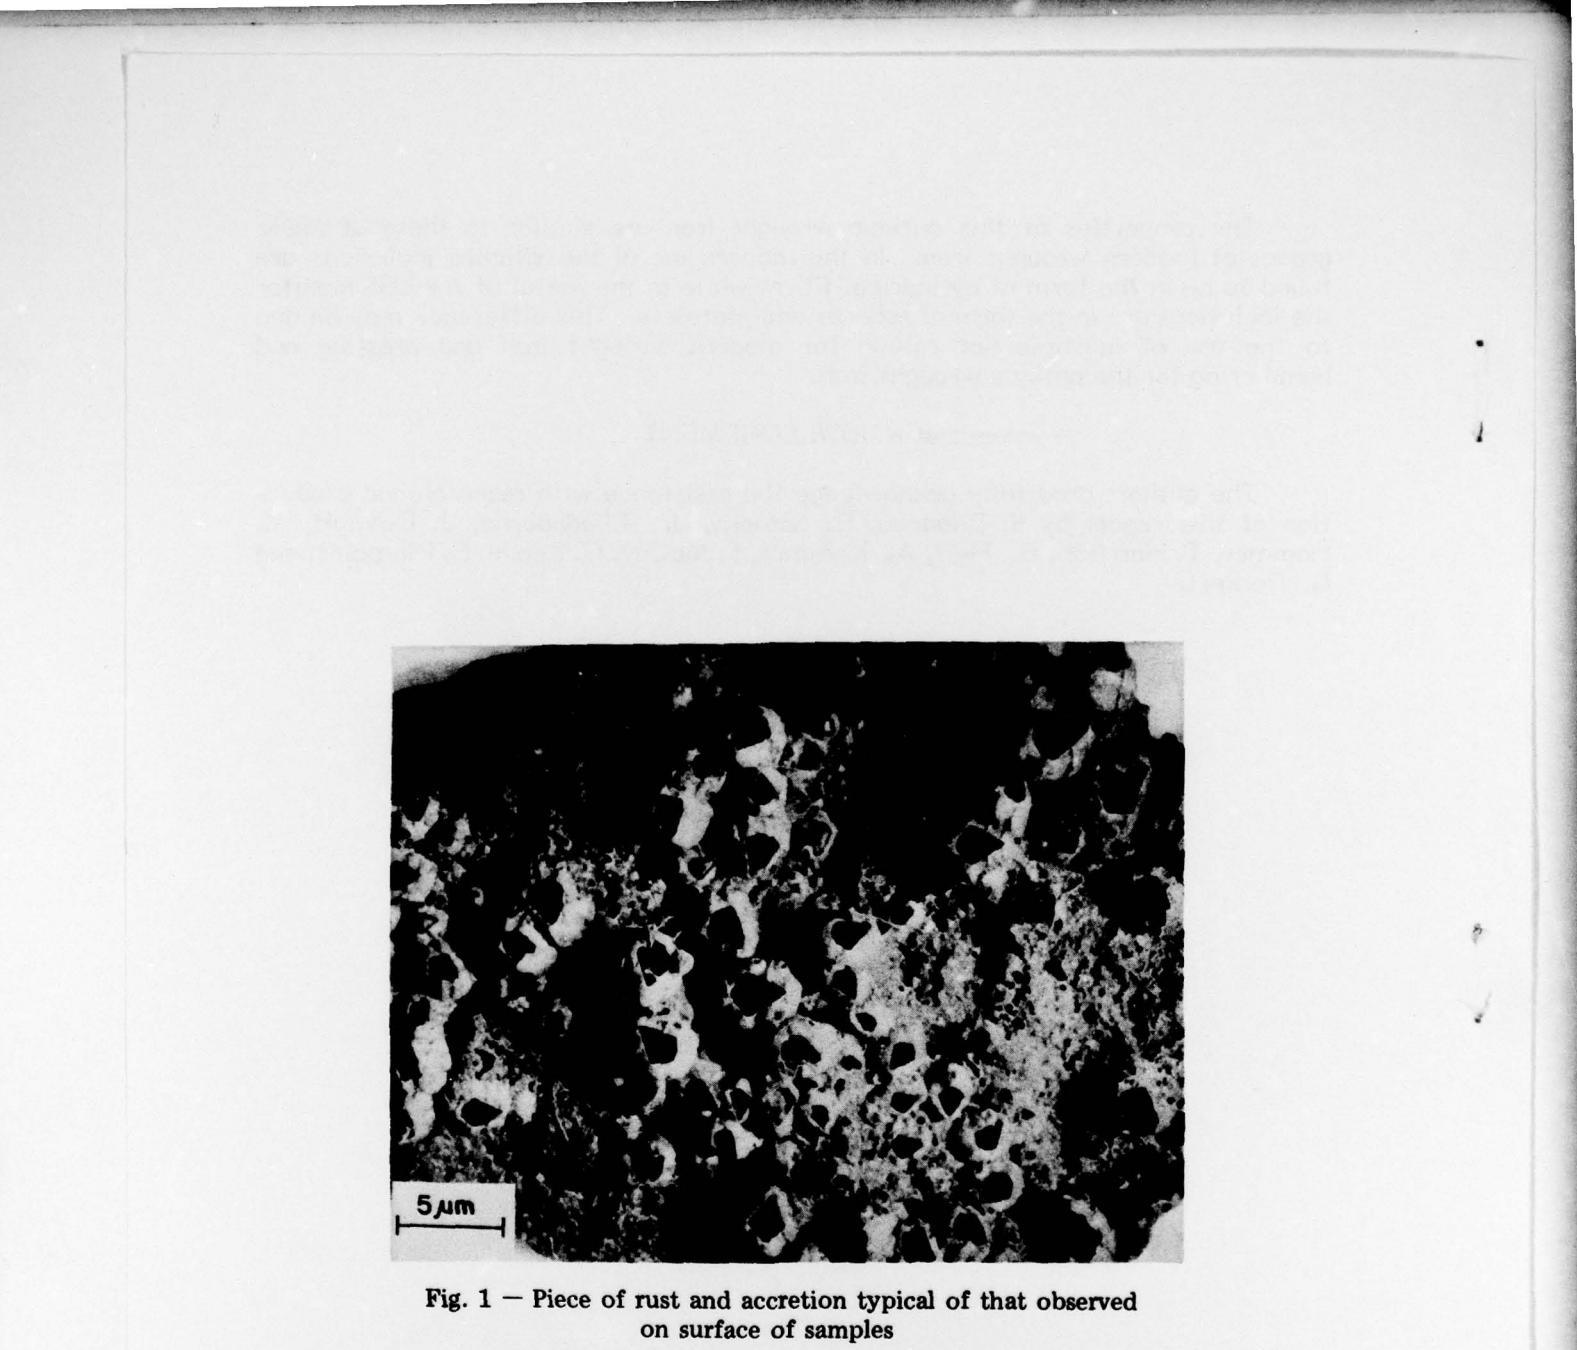
Prior to studying the metal which comprises much of the samples, a piece of the rust and accretion which covered the metal was examined. The primary constituents of the piece were rust, barnacle-like encrustations, a black, waxy material, and silicate particles. The latter are usual constituents of wrought iron. Figure 1 shows the rust piece which is typical of the coating of the plate. Figure 2 shows the layers of rust, wax, and barnacles. Figure 3 shows a two phase silicate particle embedded in the rust.
