PENNSYLVANIA
VALLEY-HI EAGLE LAKE DAM

NDS I.D. No. PA - 00186
PENNADER I.D. No. 29 - 33

PHASE I INSPECTION REPORT
NATIONAL DAM INSPECTION PROGRAM

PREPARED BY
GAI CONSULTANTS, INC.
570 BEATTY ROAD
MONROEVILLE, PENNSYLVANIA 15146
SEPTEMBER 1979

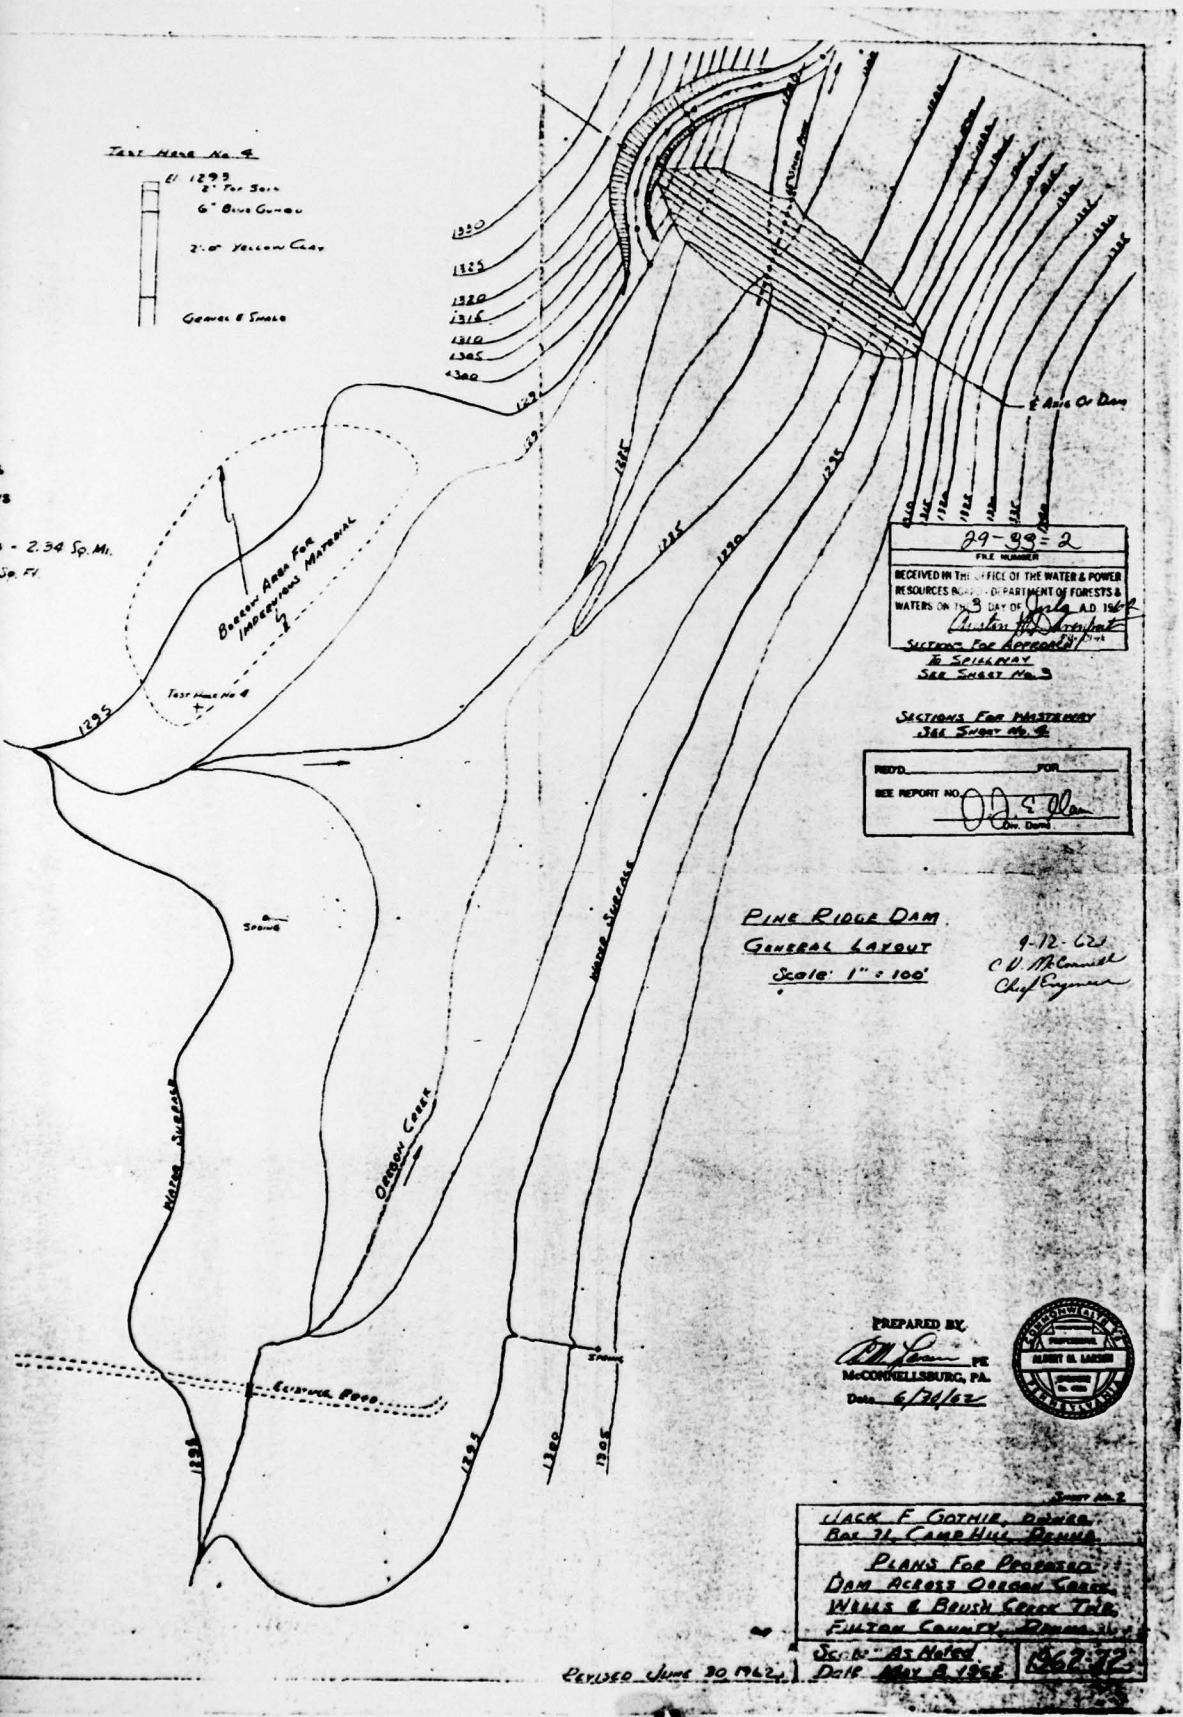
FIGURE 2

Available design drawings indicate that a 10-foot wide cutoff is provided along the embankment centerline (see Figure 2). Contract specifications state that all fill was to be placed in 8-inch loose layers and compacted with a sheep's foot roller to a density of 95 percent of maximum dry weight.
