MEADOW GROUNDS DAM,

(NDS I.D. PA - 00185,
PENNDER I.D. 29 - 32)

PHASE I INSPECTION REPORT
NATIONAL DAM INSPECTION PROGRAM

PHASE I INSPECTION REPORT
NATIONAL DAM INSPECTION PROGRAM
MEADOW GROUNDS DAM
NDI# PA-185, PENNDER# 29-32

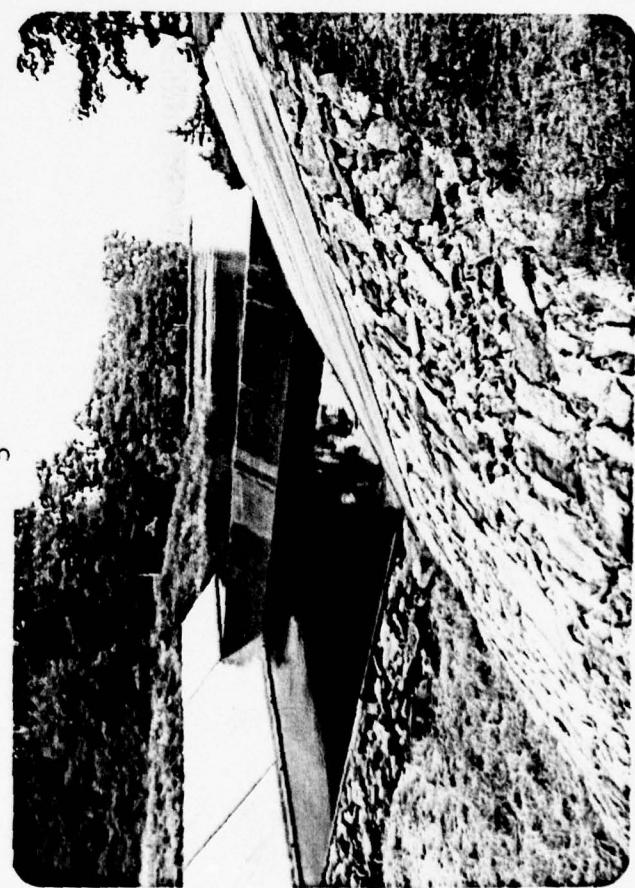
b) Outlet Works. The outlet works consist of a reinforced concrete riser and a 4-foot square (inside dimension) box culvert which discharges at the downstream embankment toe (see Figure 7). Flow through the outlet is controlled via removable stoplogs set in grooves within the riser (see Photograph 10).

PHOTOGRAPH 10 View of interior of control riser.
