MISCELLANEOUS PAPER SL-80-8

# CONCRETE AND ROCK TESTS MAJOR REHABILITATION, DRESDEN ISLAND LOCK AND DAM, ILLINOIS WATERWAY CHICAGO DISTRICT, PHASE I REHABILITATION

September 1980

Final Report

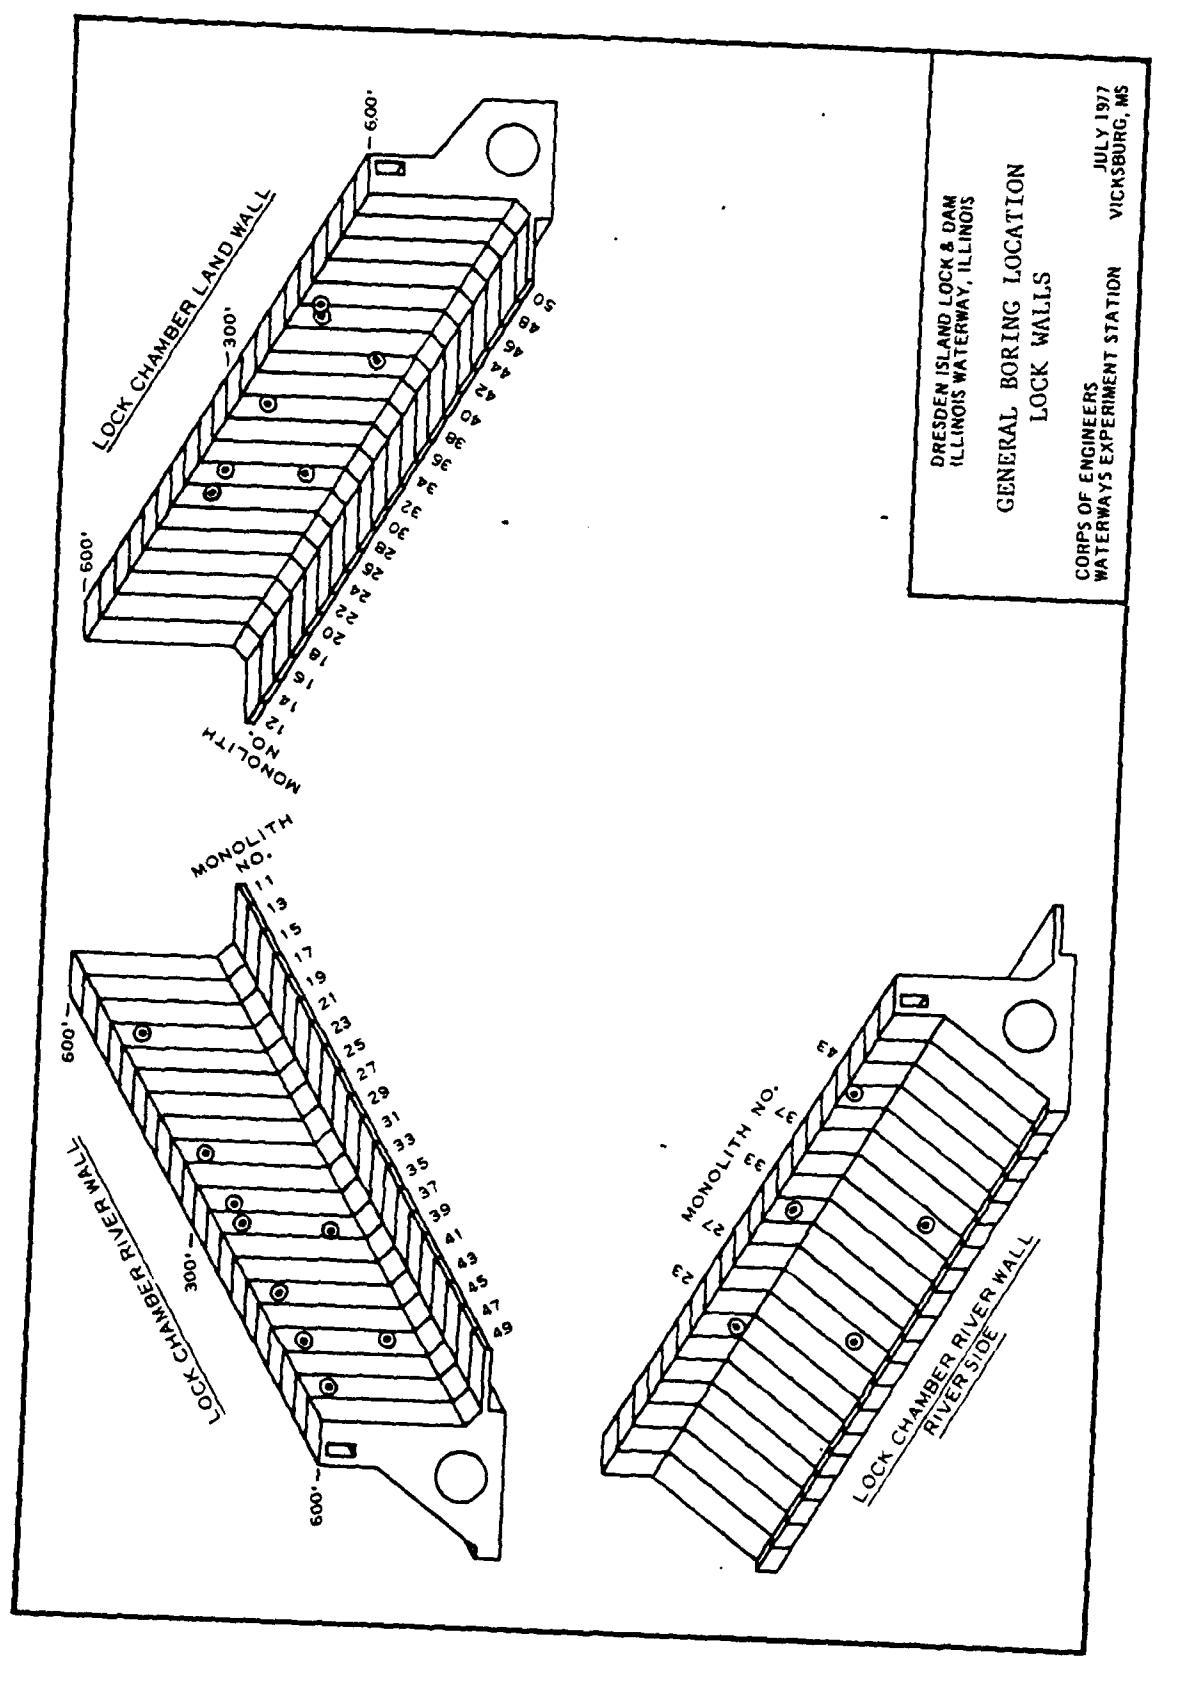
9. The core drilling by WES in 1976 is the only sampling of concrete from which the samples are currently available that are pertinent to this study. Sixteen horizontal borings were drilled into the lock chamber walls from inside the chamber. The approximate boring locations within monoliths are shown in Plate 1. The monolith numbering system is the same as used in Plate 9, Reference 3.

64. Depth of deterioration. The average depth of concrete deterioration through the eroded portion of the wall is 0.7 ft; the maximum depth is 1.2 ft (see Figure 8 for depth of deteriorated concrete for each hole). Figure 8 is a duplicate of Plate 1 which shows both boring locations and depth of deterioration; it is presented here for continuity. The total depth of deterioration as measured from the original face of the lock wall is the sum of the eroded depth and of the present frost damaged concrete. The deepest damaged concrete is near the top of the wall.

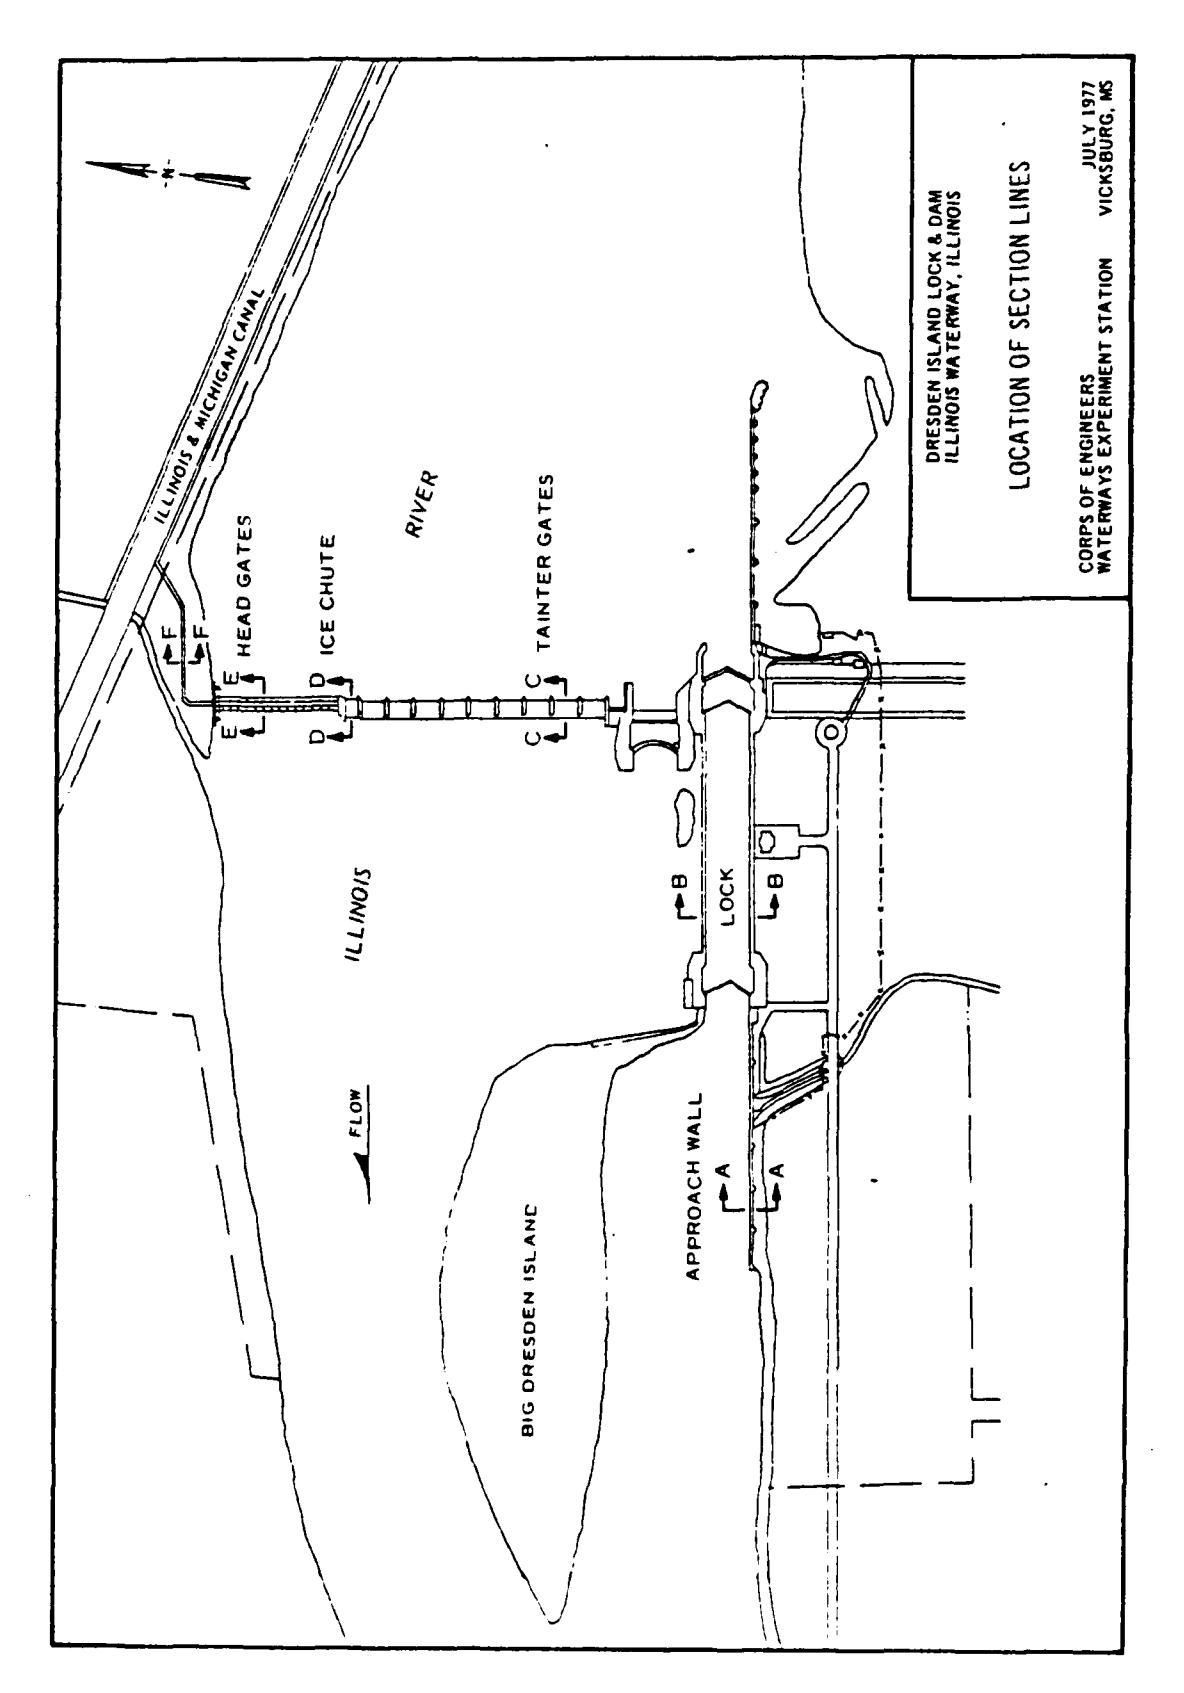
Plate 2a

12. The general boring location plan is presented in Figure 1a and lb; the specific locations on structure sections are given in Plates 1, 2a, and 2b. A summary of boring locations, direction, number and depth is given below:

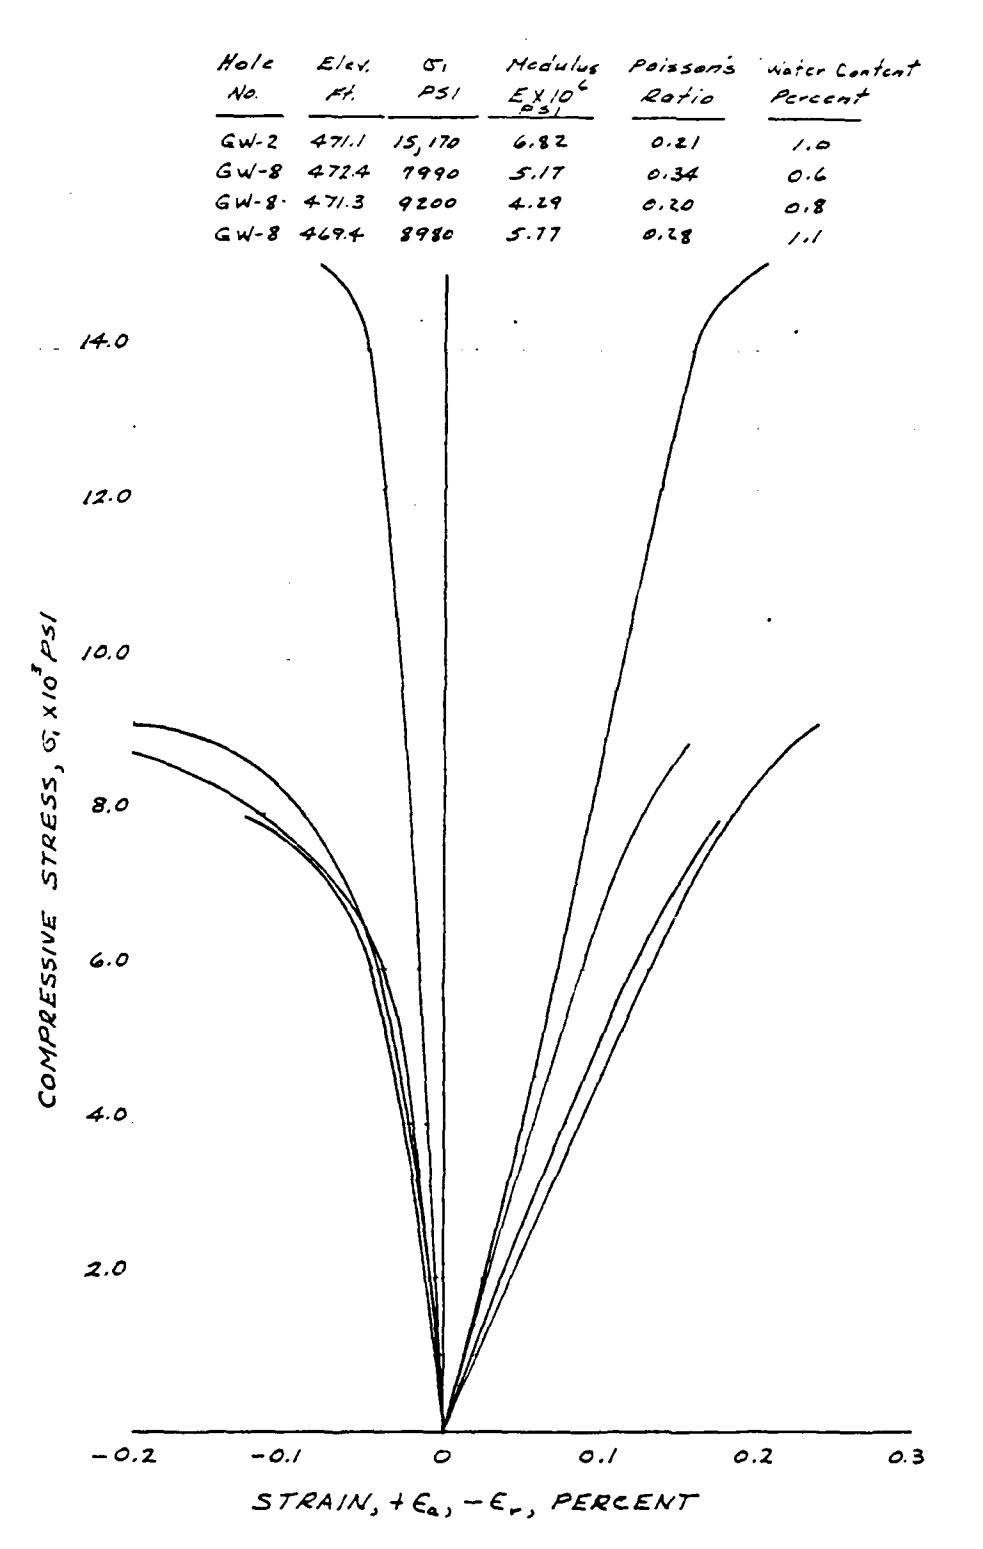
Plate 7

48. Results of the modulus of elasticity and Poisson's ratio tests are presented in Tables 2 and 3. The stress-strain relation for the limestone and shale are presented in Plates 7 and 8, respectively. The E was calculated as an incremental value between 0 to 500 psi, in most cases the 0 to 500 psi increment corresponded to the initial linear portion of the stress-strain curve for both rocks.

STRESS-STRAIN RELATION FOR LIMESTONE, DI LOCK & DAM

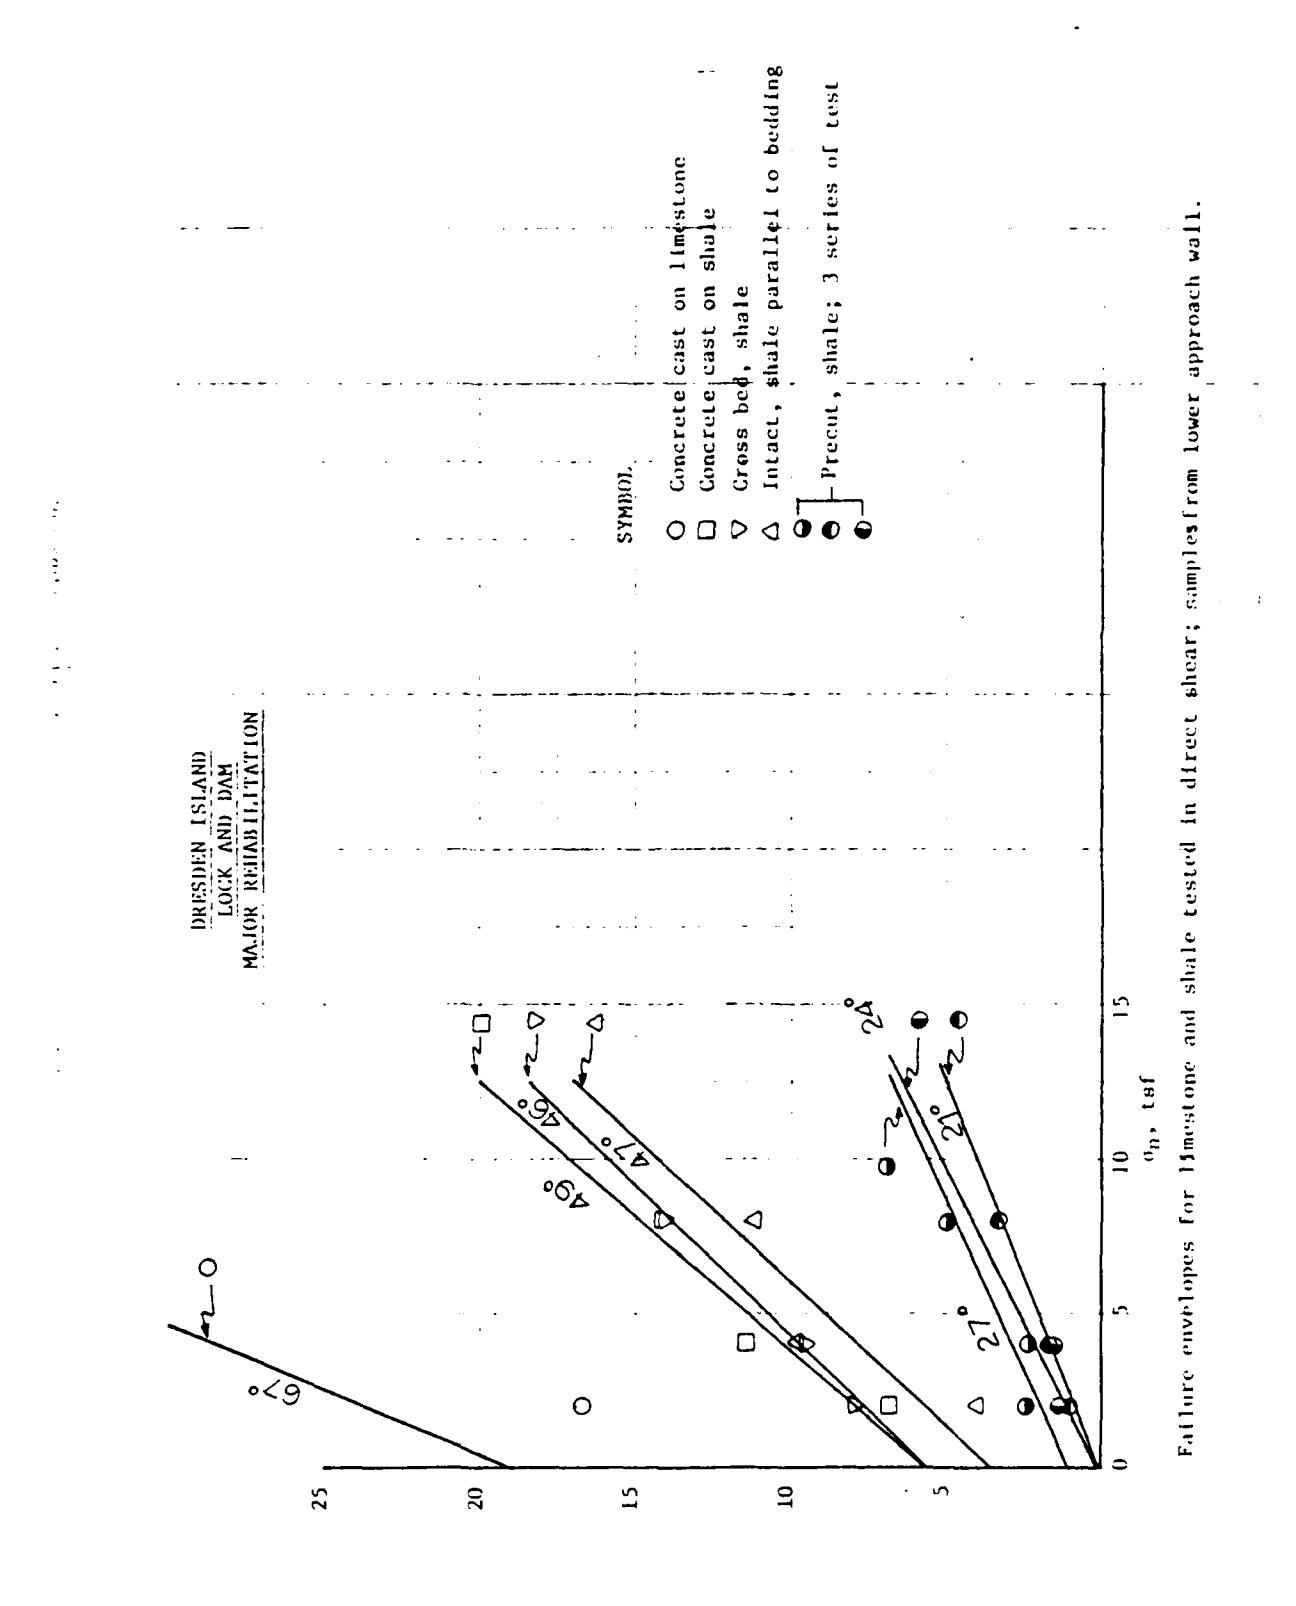
Plate 9

51. The stress value for the direct shear tests are presented in Table 4; the direct shear envelopes are plotted on Plate 9.
