ESL-TR-80-45

## FLUSH AM-2 MAT PATCH FOR RAPID RUNWAY REPAIR

JAMES L. GREENE

SEPTEMBER 1980

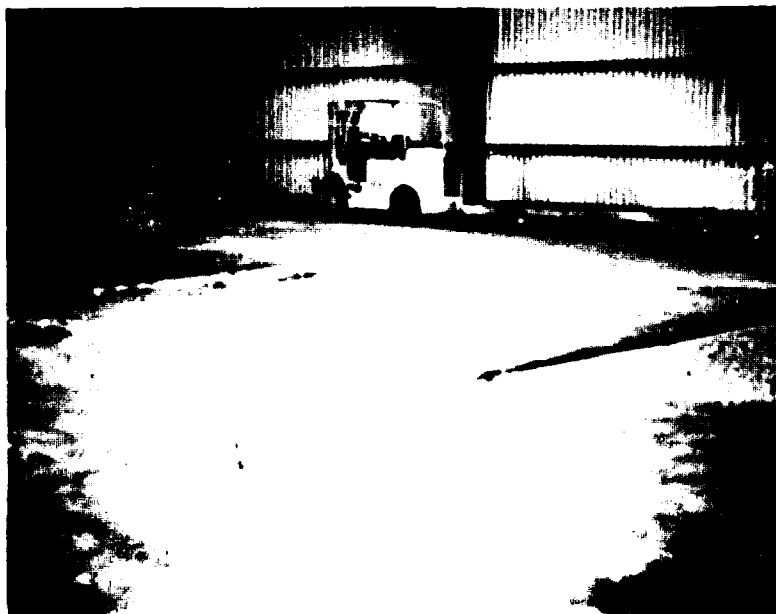
Figure 56. Test 2 (Perimeter Rail)-Base Course After Testing
