DELAWARE RIVER BASIN  
GREEN VALLEY FARMS DAM  
MRS. ELEANOR M. REYNOLDS

NDI NO. PA-01101  
DER NO. 15-307

PHASE I INSPECTION REPORT  
NATIONAL DAM INSPECTION PROGRAM

PHASE I REPORT  
NATIONAL DAM INSPECTION PROGRAM  
BRIEF ASSESSMENT OF GENERAL CONDITIONS  
AND RECOMMENDATIONS

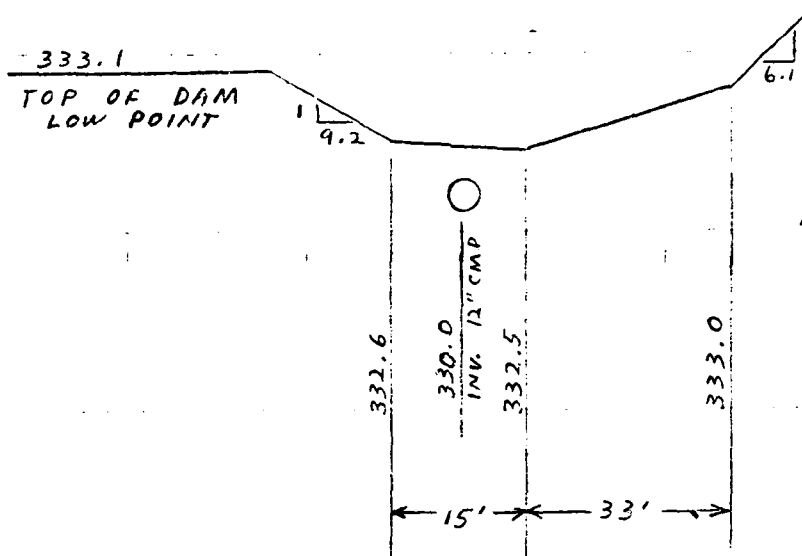
SPILLWAY RATING

SOD-LINED  
BROAD CRESTED  
WEIR

$C = 2.7$  (KINGS HDBK)
