| REPORT DOCUMENTATION PAGE | | READ INSTRUCTIONS<br>BEFORE COMPLETING FORM |
|---|---|---|
| 4. TITLE (and Subtitle)<br>Phase I Dam Inspection Report<br>National Dam Safety Program<br>Spring Lake Dam (MO 31180)<br>Cape Girardeau County, Missouri | | 5. TYPE OF REPORT & PERIOD COVERED<br>Final Report |

PHASE I INSPECTION REPORT  
NATIONAL DAM SAFETY PROGRAM  
SPRING LAKE DAM  
MISSOURI INVENTORY NO. 31180

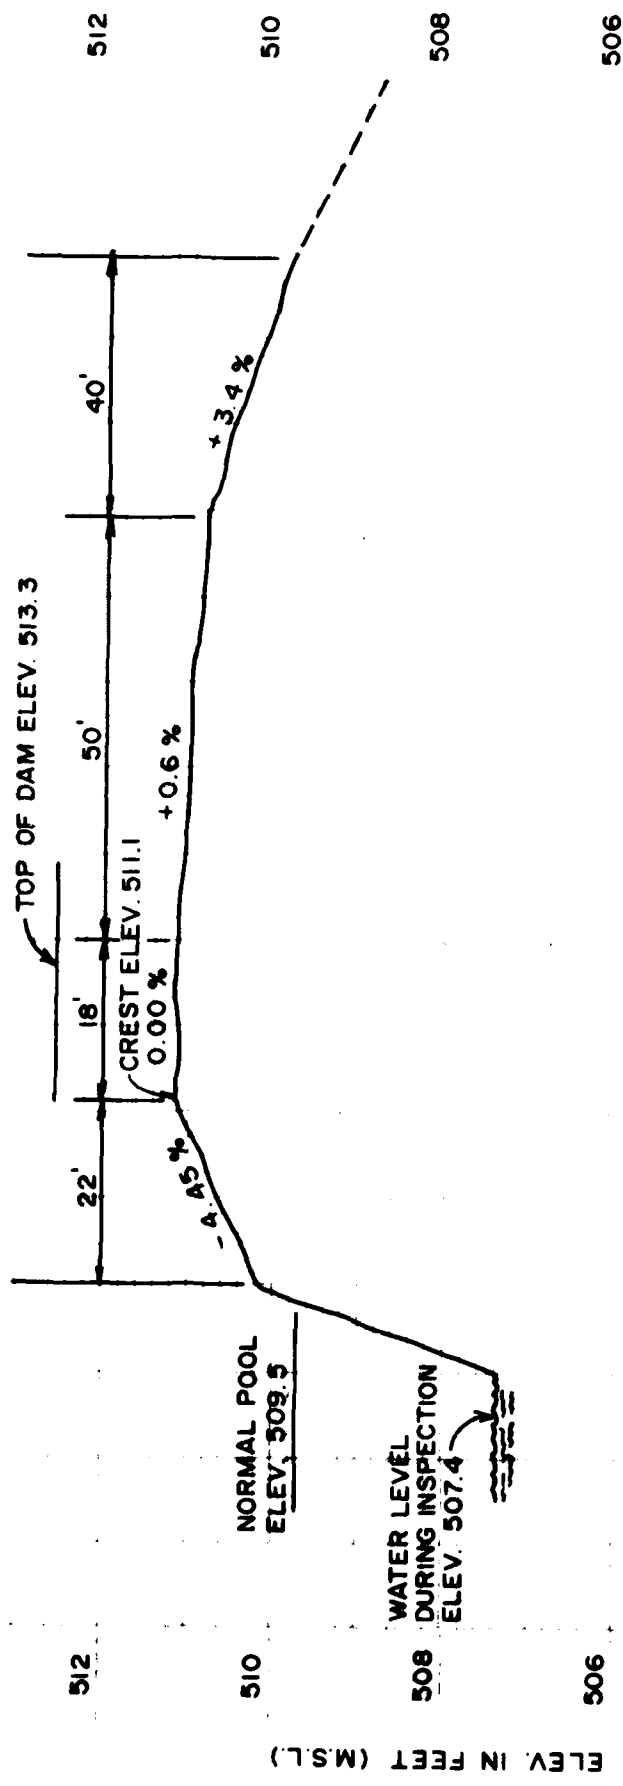
The emergency spillway consists of a trapezoidal grass lined channel located to the left of the left abutment. A cross-section and profile of the emergency spillway are shown on Exhibits 3 and 4. Photo 8 is a view of the emergency spillway crest and the downstream part of the channel. Photo 9 shows the emergency spillway approach channel. The channel is obstructed by several steel drums and a wire fence. The emergency spillway is lined with a good vegetal (grass) cover.
