| REPORT DOCUMENTATION PAGE | | READ INSTRUCTIONS<br>BEFORE COMPLETING FORM |
|---|---|---|
| 4. TITLE (and Subtitle)<br>Phase I Dam Inspection Report<br>National Dam Safety Program<br>Sunnen Dam (MO 30111)<br>Washington County, Missouri | | 5. TYPE OF REPORT & PERIOD COVERED<br>Final Report |

SUNNEN LAKE DAM  
WASHINGTON COUNTY, MISSOURI  
MISSOURI INVENTORY NO. 30111

PHASE I INSPECTION REPORT  
NATIONAL DAM SAFETY PROGRAM

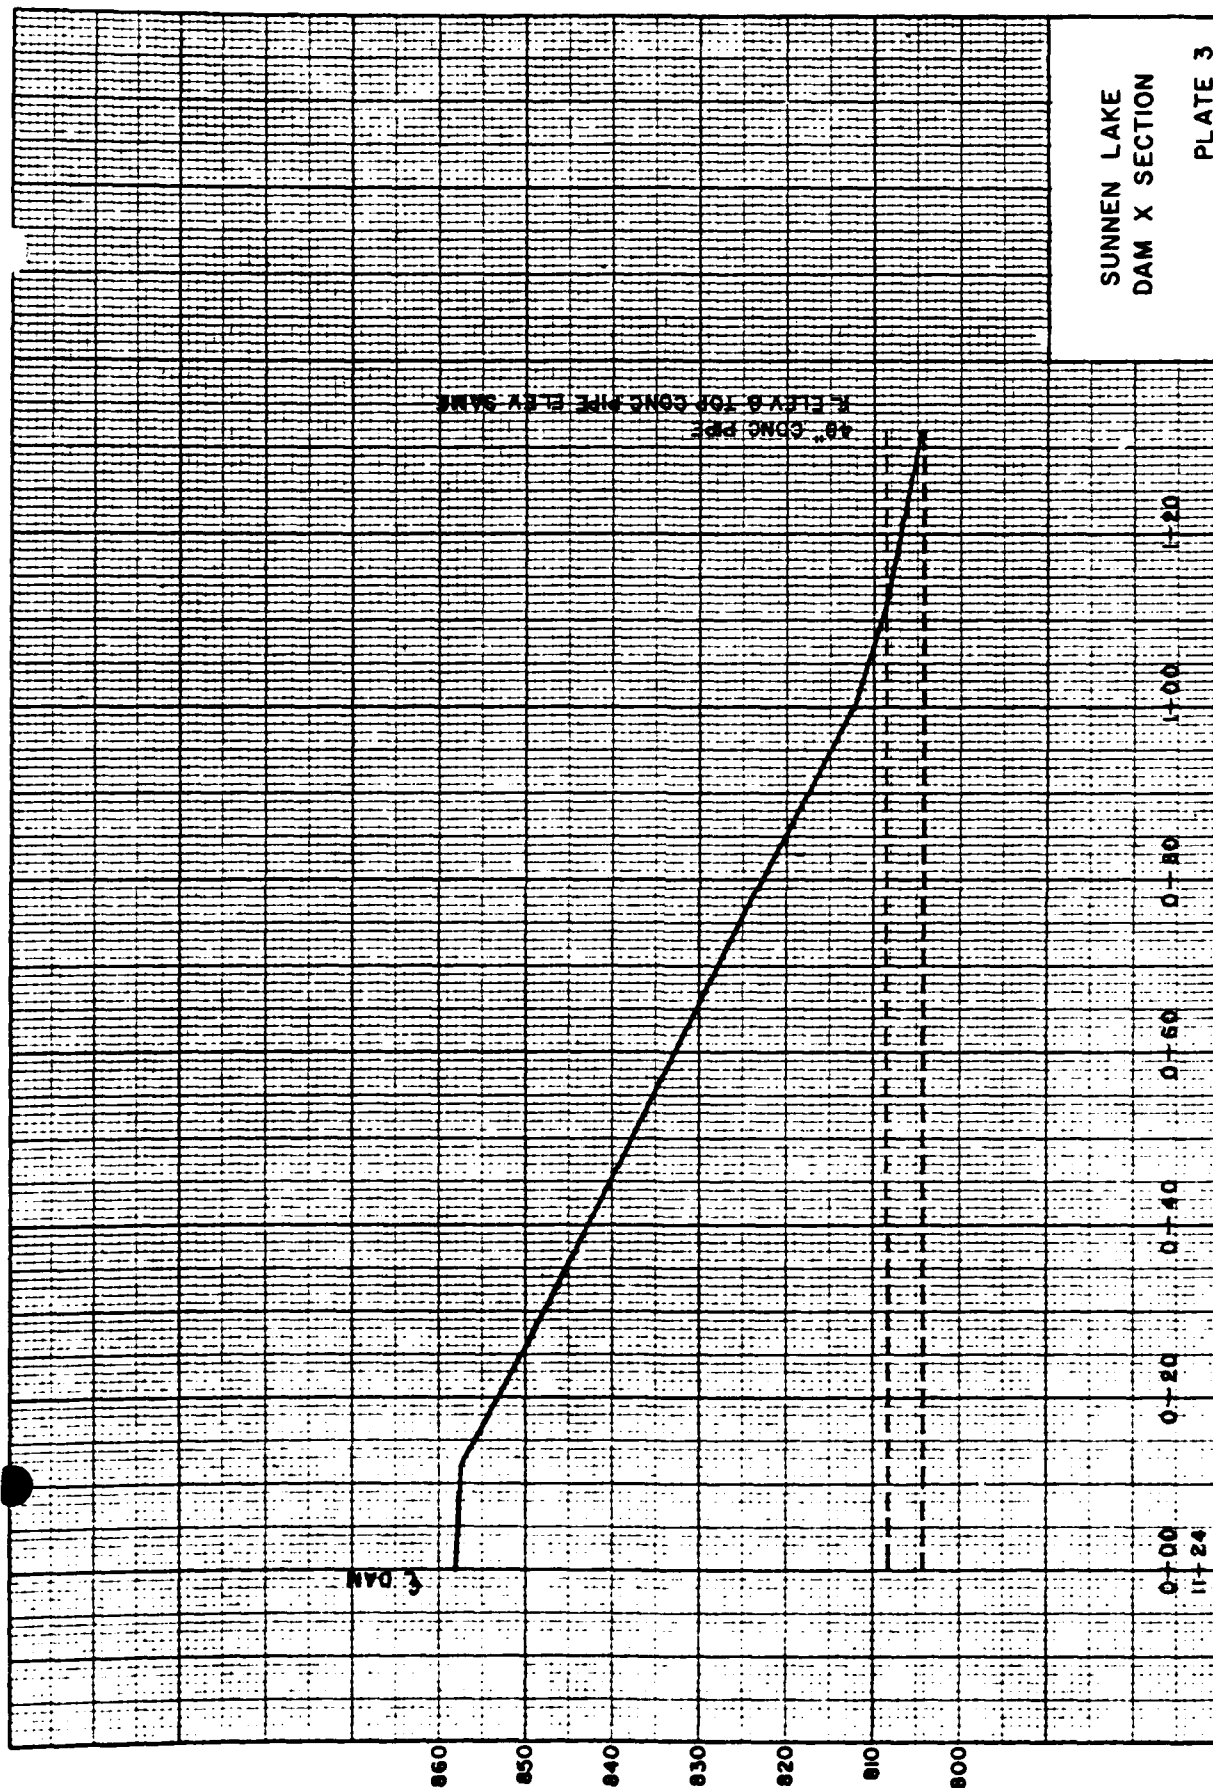
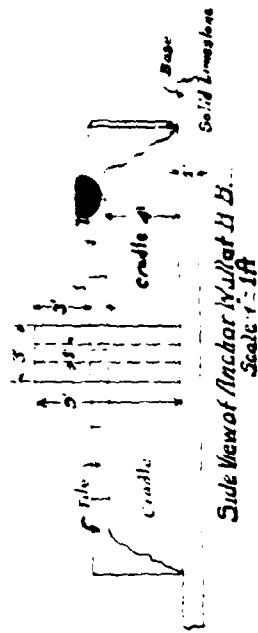
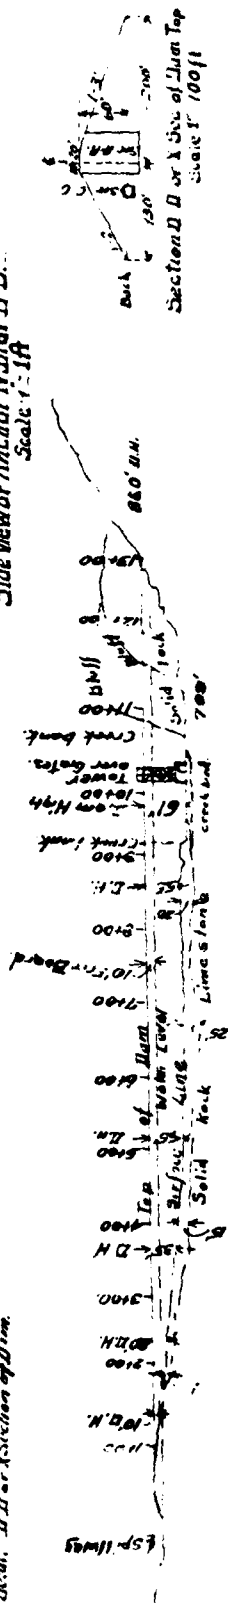
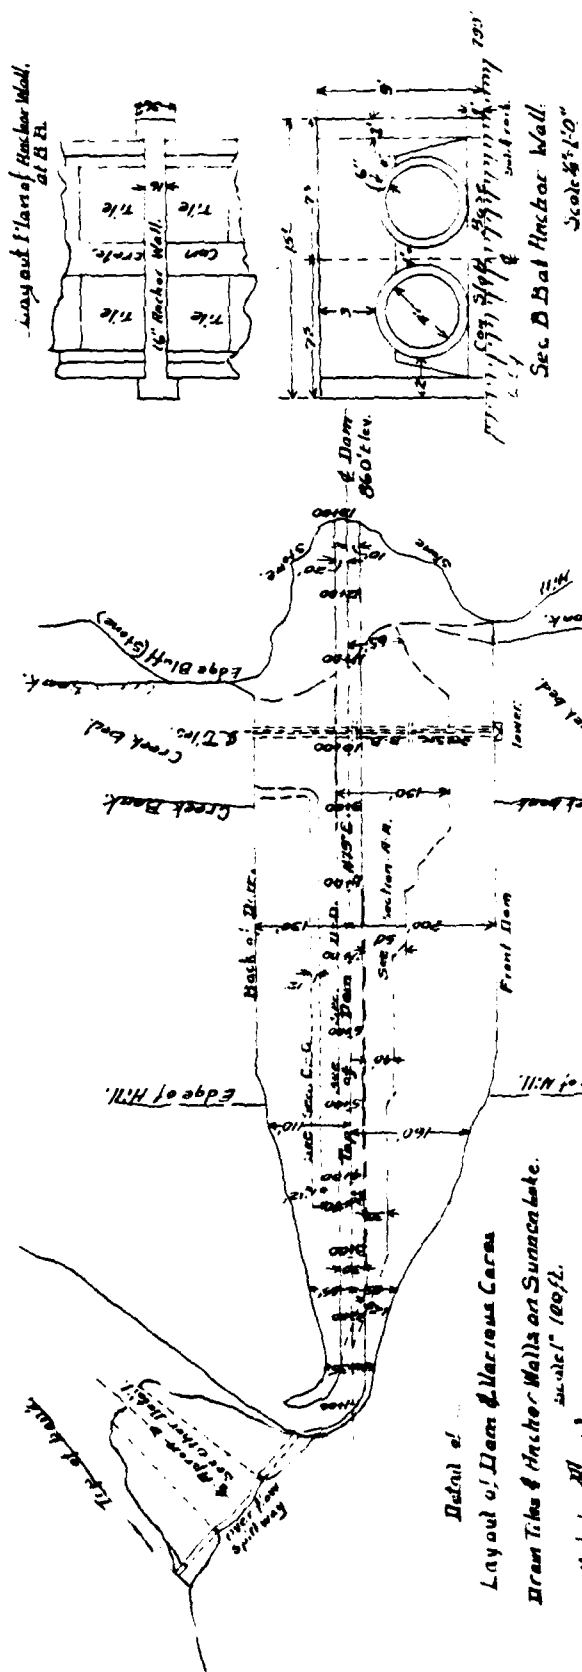
AS BUILT DRAWING  
PLATE 5

- (1) Type - Earth.
- (2) Length - 1318 feet.
- (3) Height - 54 feet.
- (4) Top width - 24 feet.
- (5) Side Slopes -
  - (a) Downstream - 1V on 2.0 H.
  - (b) Upstream - unknown, as built drawings indicate 1V on 3H.
- (6) Zoning - unknown, except for some details indicated on attached as built drawing (Plate 5).
- (7) Impervious Core - unknown, (see 6 above).
- (8) Cutoff - attached as built drawing (Plate 5) implies a cutoff was constructed. Further details unknown.
- (9) Grout curtain - unknown.

Material Used Sec C.C. was Gravel for Drains;  
Plaster Used in Sec D.D. was A No. 3  
Good Compression Clay with Poaster  
Gravel on back side with Medium or Better  
on front side of Dam  
See Detail of Wall Section of Dam.
