LAKE CHARLES DAM

CHARLES COUNTY, VIRGINIA

VA. NO. 01124

PHASE I INSPECTION REPORT

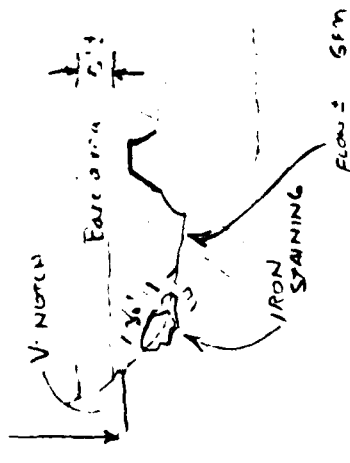
BACKUP FROM
BEAVER POND

7.3.6 For monitoring purposes, it is recommended that the downstream beaver dam(s) be removed, so as to prevent submergence of drain outlets.
