**INDIAN CREEK MINE DAMS
WASHINGTON COUNTY, MISSOURI
MO 30717 & 31036**

**PHASE 1 INSPECTION REPORT
NATIONAL DAM SAFETY PROGRAM**

FEBRUARY 1980

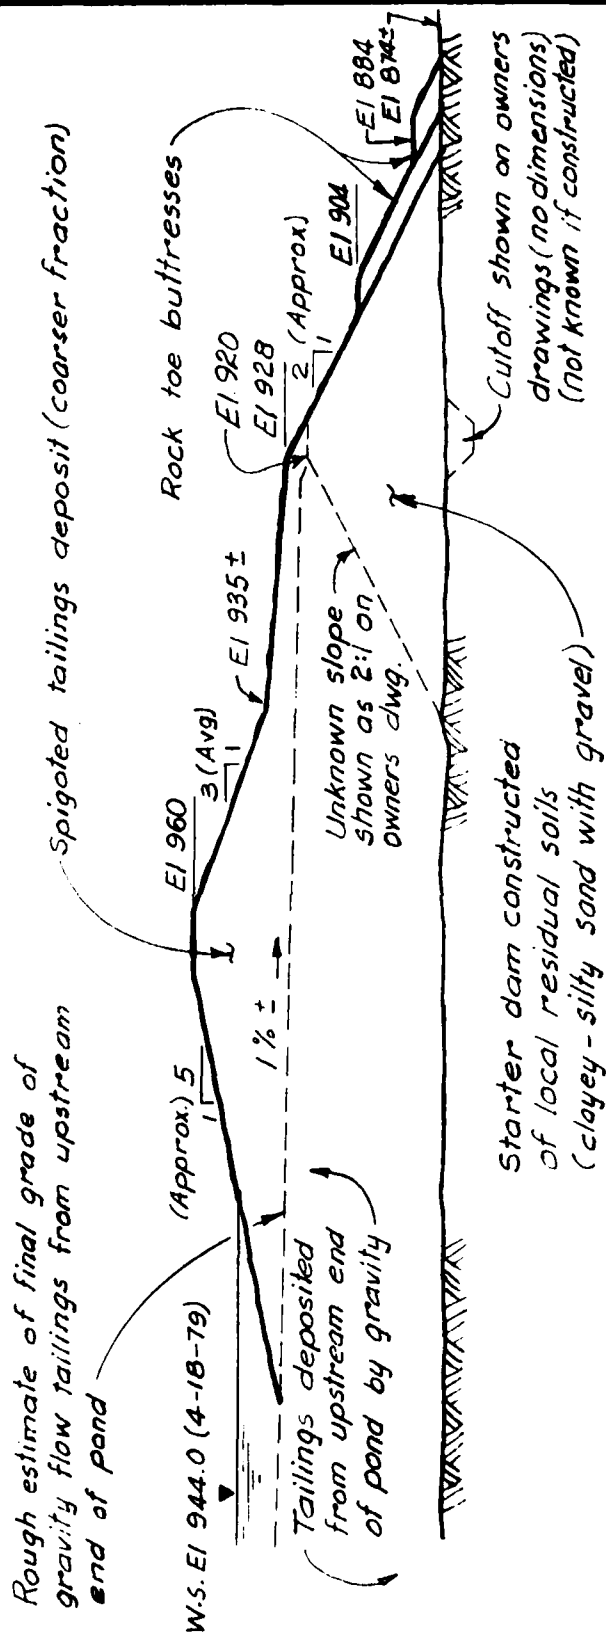
DATE _____
DRAWING NO. _____
PLATE 10

The dam consists of an earthfill starter dike and an enlargement that was built of coarse tailings placed on top of old tailings directly upstream of the original starter dike. This indicates the use of an upstream construction method. An interpretive section through the dam is shown on Plate 10. Wind erosion is causing some shifting of the fine sands composing the tailings embankment from the upstream to the downstream direction. No evidence of sliding, cracking, settlement, or animal burrows was noted.
