LAKE GREELEY DAM

NDI ID. NO. PA-00752
PENNDER ID. NO. 52-20

PHASE I INSPECTION REPORT
NATIONAL DAM INSPECTION PROGRAM

SEPTEMBER 1981

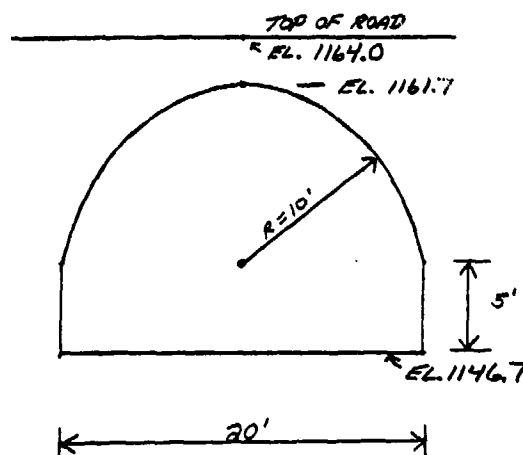
THE ROADWAY CULVERT CONSISTS OF A CONCRETE SEMI-CIRCULAR ARCH TYPE CULVERT, AS SKETCHED ABOVE. DISCHARGE THROUGH THE CULVERT CAN BE ESTIMATED BY THE EQUATIONS OF FLOW FOR BOX CULVERTS UNDER INLET CONTROL, USING ADJUSTED FLOW AREAS (SEE NOTE 3):
