### LOW COST SHORE PROTECTION

A Report on the Shoreline Erosion Control Demonstration Program (Section 54 Program)

Office, Chief of Engineers U.S. Army Corps of Engineers Washington, D.C. 20314

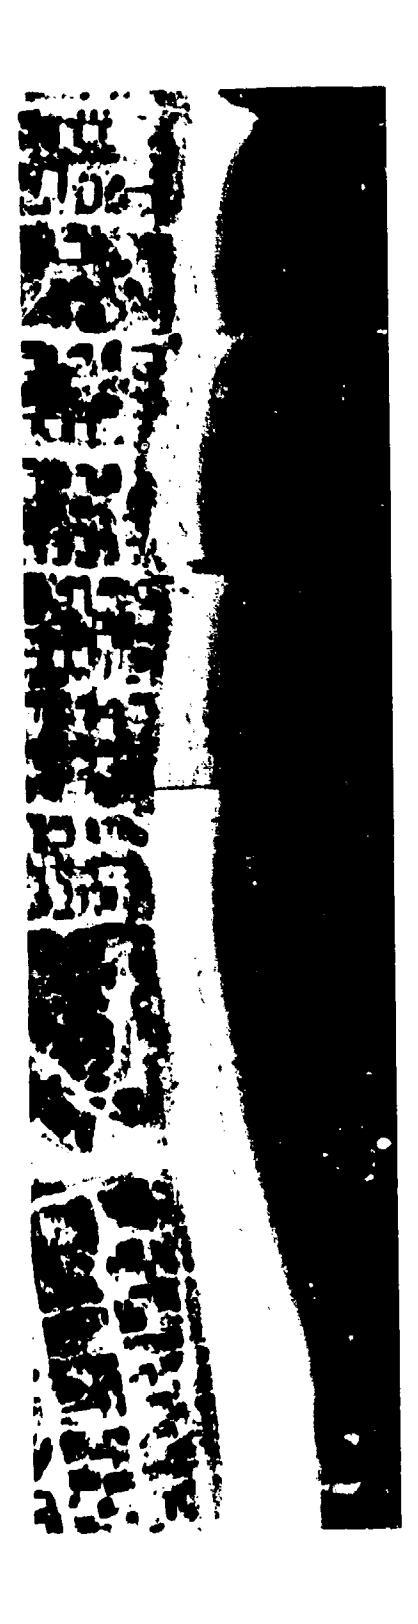
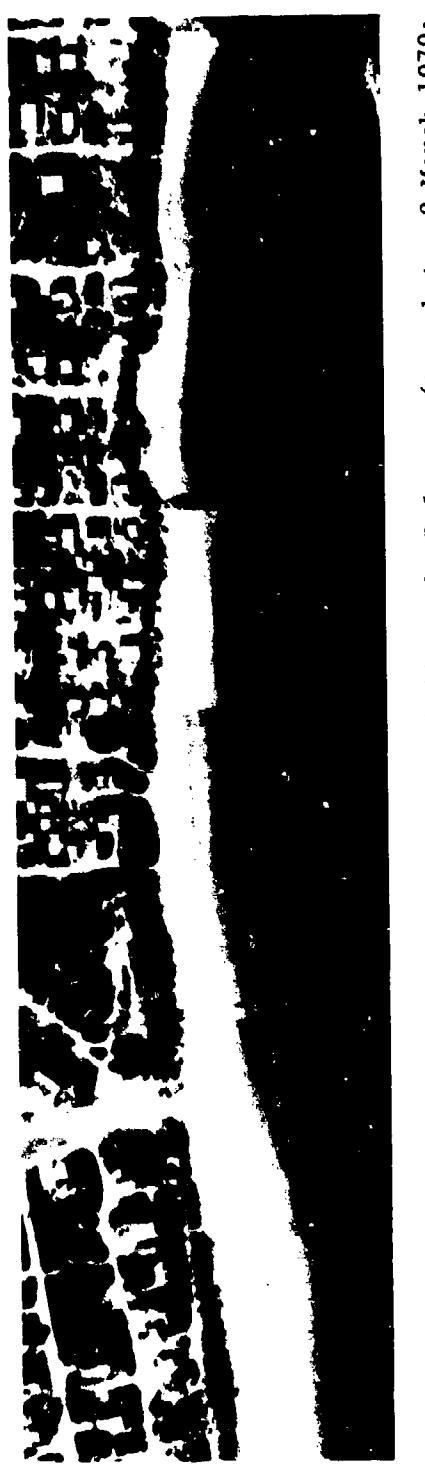
(3) <u>Performance</u>. The groin field has retained the beach fill placed in 1976 and no renourishment projects have since been required. The contour changes were too small to show on the General Plan, but Figure 2-41 illustrates the functional performance of the groin-retained beach fill.

Groin-retained beach fill at Broadkill Beach, Delaware (top photo, 9 March 1979; bottom photo, 18 October 1979). Figure 2-41.

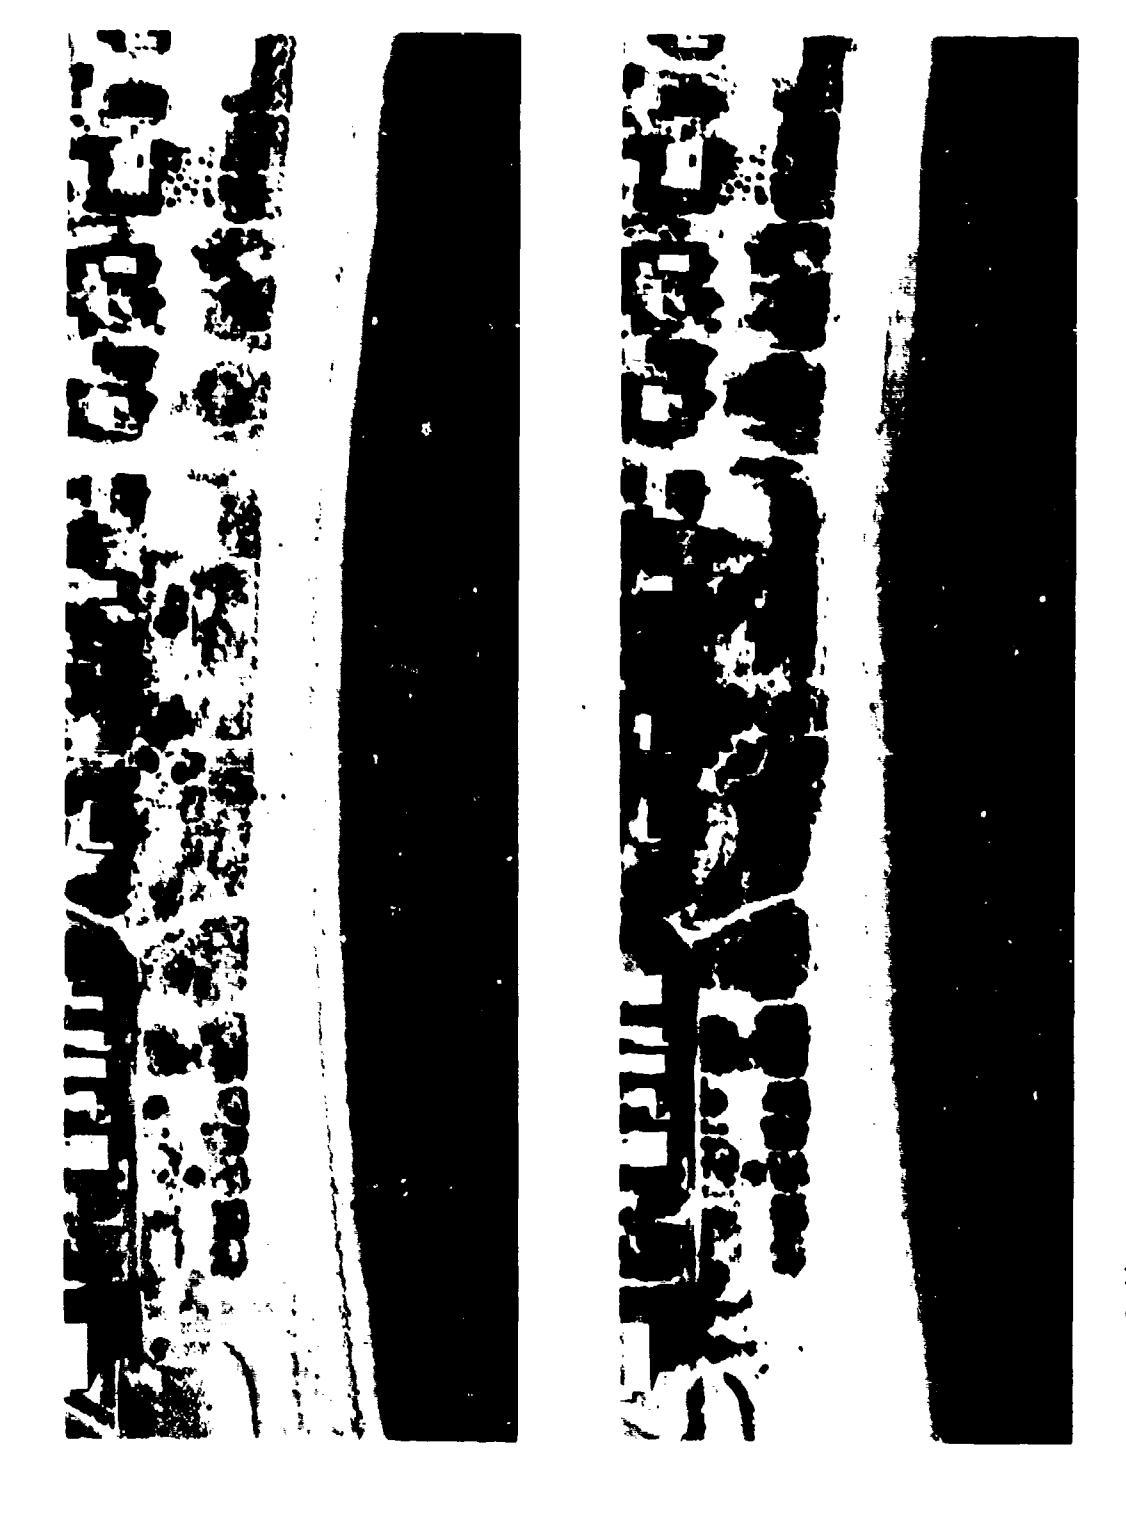
(3) <u>Performance</u>. Shoreline erosion along the beach at Lewes has been controlled only by the placement of a protective beach fill. Aerial photos reveal no dramatic changes during the relatively short timespan from March to October 1979 (Fig. 2-44), and the scale of the General Plan is too small to plot contour changes. However, profiles taken from surveys made between April 1979 and April 1980 (Fig. 2-45) show a retreat of the beach berm of about 50 feet near the west and tapering to only a few feet near the east end of Lewes beach. This is indicative of a strong eastward transport of littoral drift along this reach.

Figure 2-44. Aerial photos of the beach nourishment at Lewes, Delaware (top photo, 9 March 1979; bottom photo, 18 October 1979).

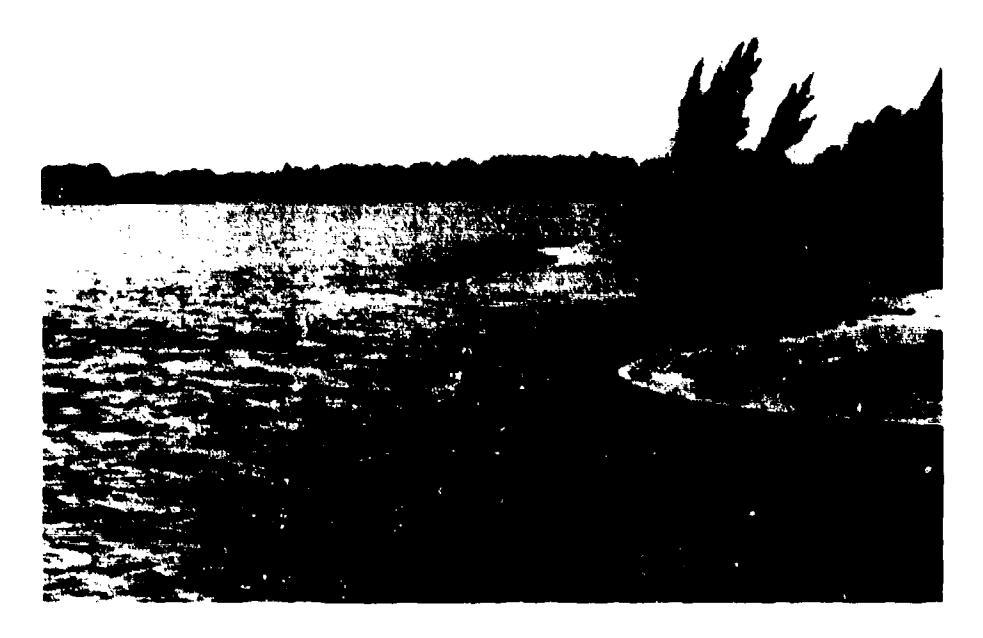
(e) Site 35 (Vegetation and Temporary Tire Breakwater). Assembly of the floating tire breakwater was completed by the Florida Institute of Technology in June 1979. It was assembled in sections onshore, then the sections were combined and anchored 300 feet offshore. The alinement of the structure shifted after being anchored and began orienting itself perpendicular to the approaching wave fronts (Figs. 2-58 and 2-59). Polypropylene rope with a nylon protective cover (0.5 inch) was used to bind the tire clusters together. Once installed, the rope wore through the rubber coating covering the steel band around the inside rim of the tires as a result of wave agitation. The exposed steel band then frayed the rope, eventually causing it to fail. Inspection of the breakwater indicated that a heavy growth of marine organisms (oysters and barnacles), as well as some accumulation of silt, was observed in the submerged parts of the tires. Nevertheless, the structure was effectively attenuating the normal wave activity at the site.

Figure 2-58. Floating tire breakwater at Stuart Causeway, Florida, 4 May 1979.

In September 1979, Hurricane David broke the breakwater loose and washed it ashore. Several tire bundles (30 tires per bundle) separated from the structure, scattering tires along adjacent beaches. The breakwater was reassembled in spring 1980, using steel cable instead of synthetic fiber rope and screw anchors instead of Danforth anchors.

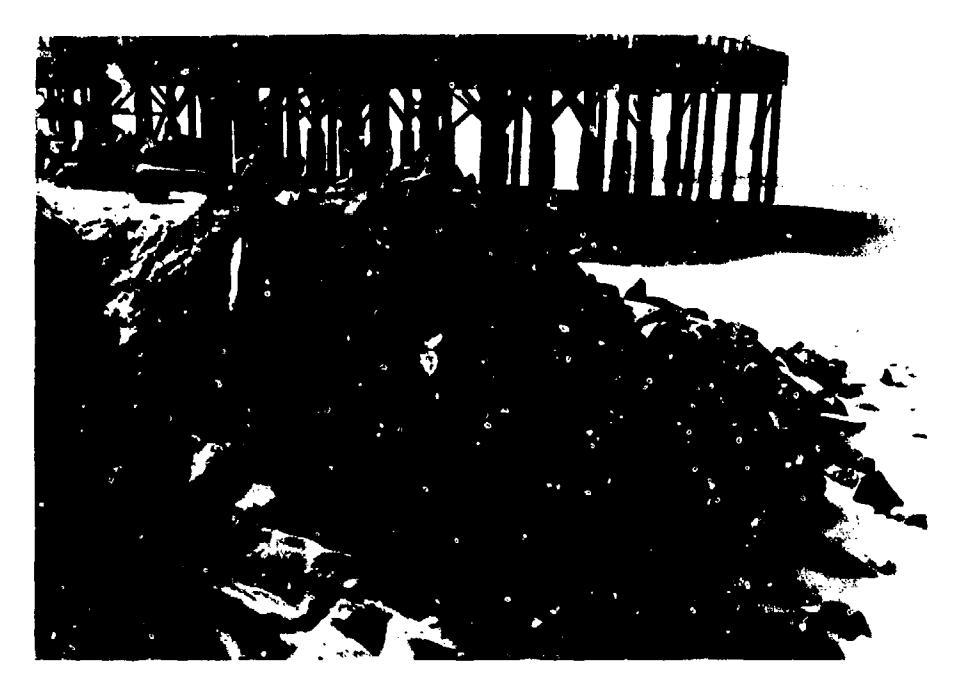
<u>2</u> Performance. No change in structural alinement or cross section occurred from March to July 1979. In July 1979, wave action during high tide displaced many rocks along the revetment, exposing the filter material (Fig. 2-94) at three locations. This deterioration continued through August, but was not as severe. In early September 1979, Hurricane David destroyed the entire beach at device 2, leveling the revetment and dispersing rocks across Arctic Avenue (Fig. 2-95); the timber groin remained intact.

Figure 2-94. Displaced rock exposing filter material, device 2, Folly Beach, South Carolina, 16 July 1979.

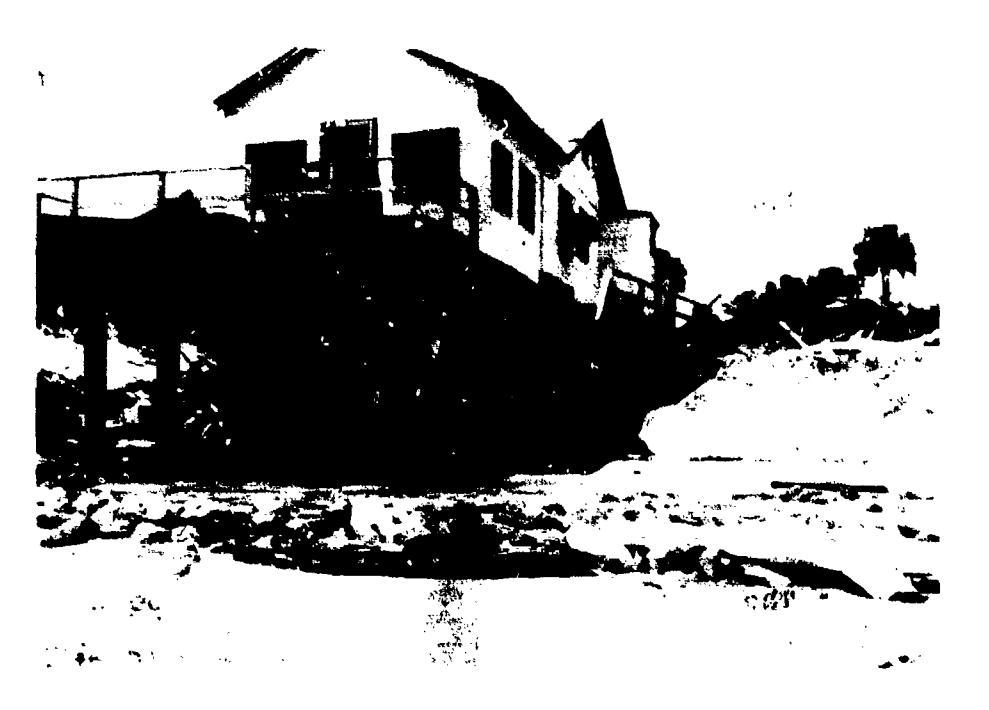
In December 1979 the rock revetments (devices 3 and 5) were rebuilt to higher levels in front of houses 306 and 308. In January 1980 sandfill was added on top of and behind device 3 (Fig. 2-113), and the rocks on device 5 were displaced by waves, exposing the filter cloth (Fig. 2-114). By March 1980 major structural damage had occurred to house 306 behind device 3. It is not known whether wave action damaged the house; however, adjacent houses were not damaged. By May 1980, device 3 was completely destroyed (Fig. 2-115) and more riprap was placed on device 5. As of May 1980

Figure 2-115. Device 3 revetment was completely destroyed, Folly Beach, South Carolina, 29 May 1980.

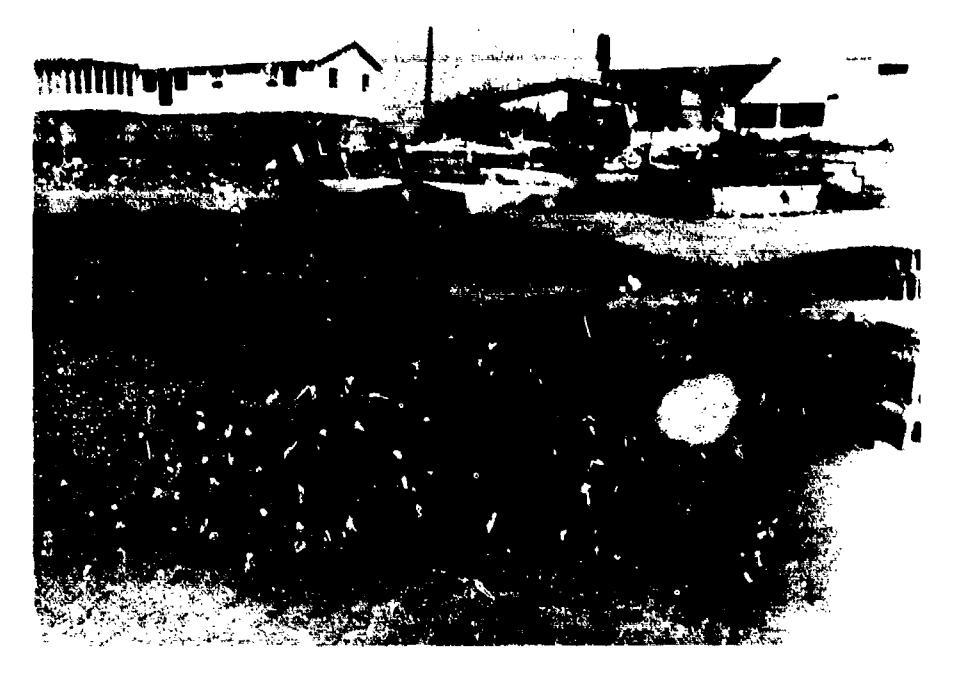
<u>2</u> <u>Performance.</u> When the monitoring began in February 1979 the devices were in good condition. By July 1979 the Sandgrabbers were deteriorating rapidly. Many of the blocks on the top row of the seaward Sandgrabber were broken. The center of the landward unit was slumping, but few of its blocks were broken (Fig. 2-117). Sections of the concrete-block seawall between the timber piles were leaning in various

Figure 2-117. Broken blocks and settlement of Sandgrabbers, Folly Beach, South Carolina, 27 June 1979.

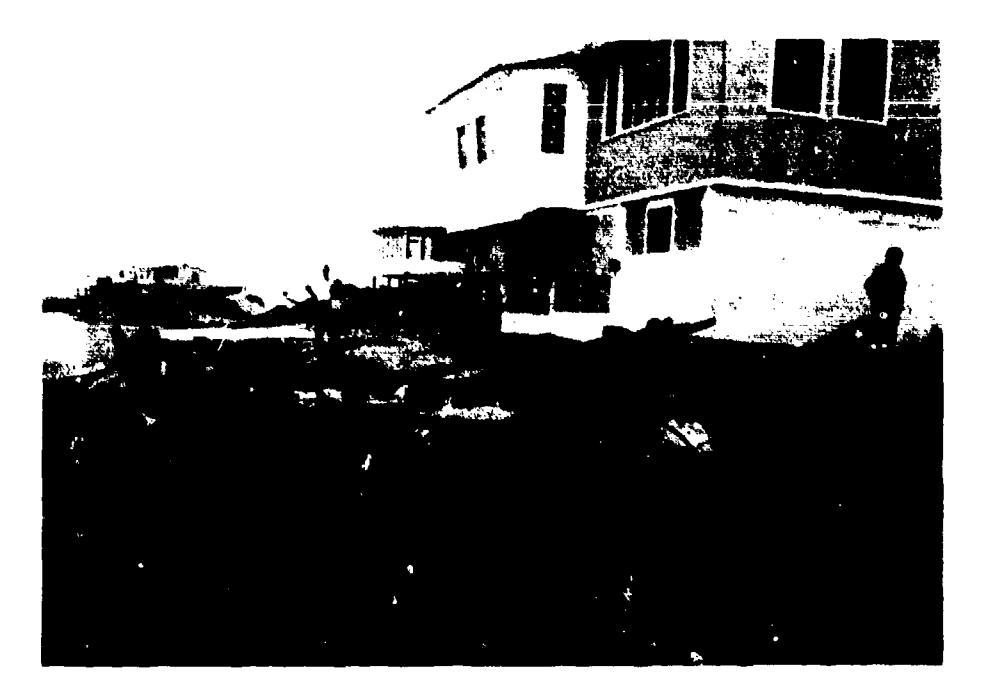
Figure 2-121. Fallen concrete-block buikhead sections, Folly Beach, South Carolina, 5 September 1979.

Repairs began in December 1979. Most of the riprap was restacked and the concrete-block bulkhead was resurrected and backfilled. The Sandgrabbers and the concrete bulkhead were not repaired. As in the other monitoring areas, the devices in area 3 performed well under moderate wave conditions. The riprap and bulkheads protected the berm and landward structures from the surging waves and tides, while the Sandgrabbers slowly accreted sand. Figures 2-122 and 2-123 show the sand accumulation from September to December. The seaward Sandgrabber protected the other unit from initial wave contact, as evidenced by the number of broken blocks in the top row of each structure. The tandem positioning of the Sandgrabbers also hastened sand accumulation between them.

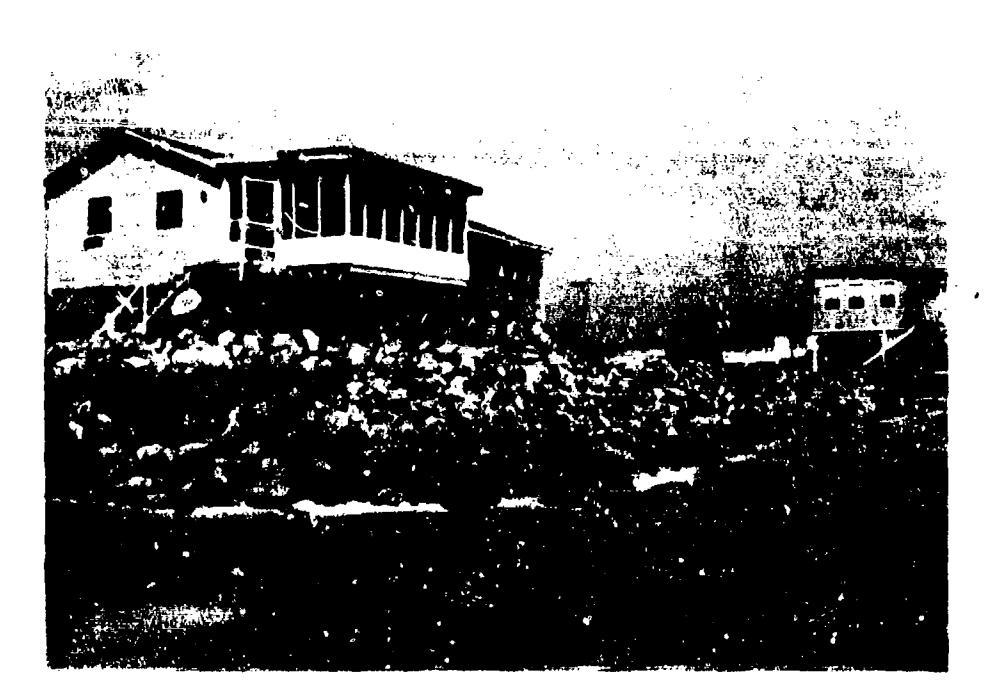
Figure 2-126. New riprap placed in front of building 1308 in device 10, Folly Beach, South Carolina, 5 March 1980.

Before the hurricane, some sand was accumulating behind the north end of the concrete bulkhead. Local erosion occurred where the revetments and bulkheads had failed (Figs. 2-124 and 2-125). In March 1980, new fill and riprap were placed where device 10 had been in front of building 1308 (Fig. 2-126). No additional changes were made as of May 1980. The two groins, devices 8 and 14, sustained little damage.

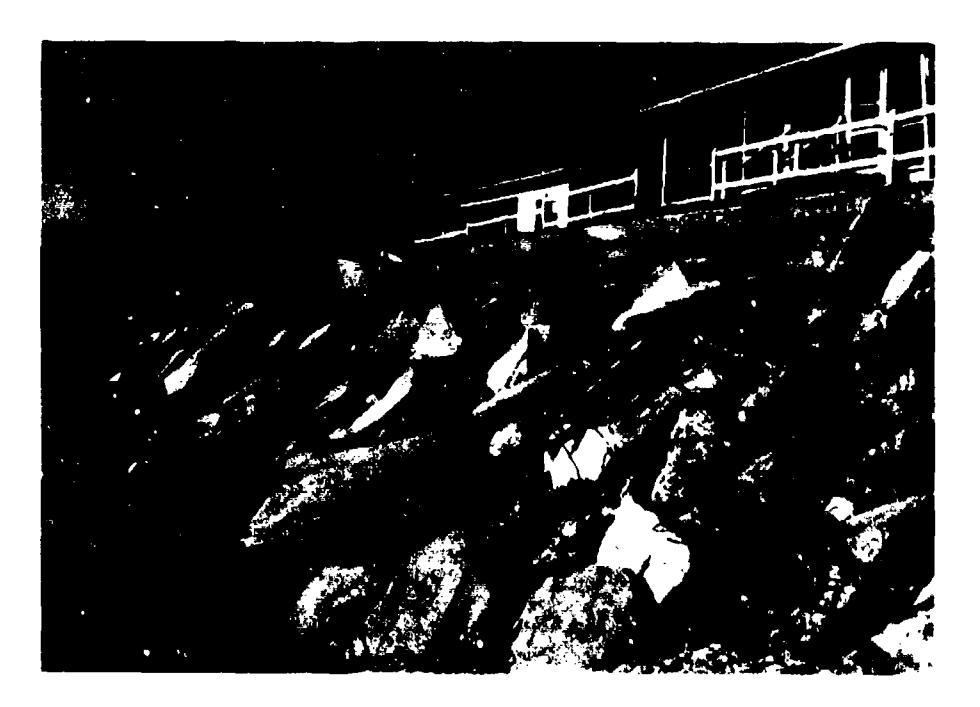
Figure 2-131. Broken concrete placed in front of device 15 bulkhead after storm, Folly Beach, South Carolina, 30 October 1979.

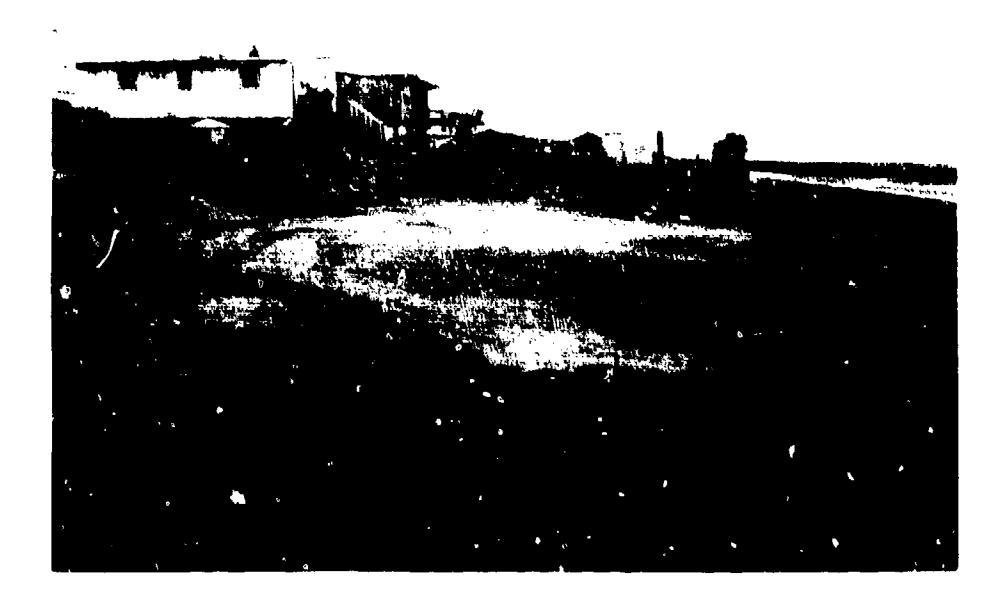
The shoreline in area 4 did not deteriorate severely from the wave forces of Hurricane David. There was no erosion of the bank behind the riprapped concrete bulkhead. Erosion did occur along the revetment where the fallen riprap exposed the berm (Fig. 2-132). The adjacent beach just north of groin 12 was severely eroded after a small section of bulkhead there failed (Fig. 2-133). As of May 1980, devices 15 and 16 remained intact.

Figure 2-133. Erosion of adjacent beach north of groin 12, Folly Beach, South Carolina, 5 September 1979.

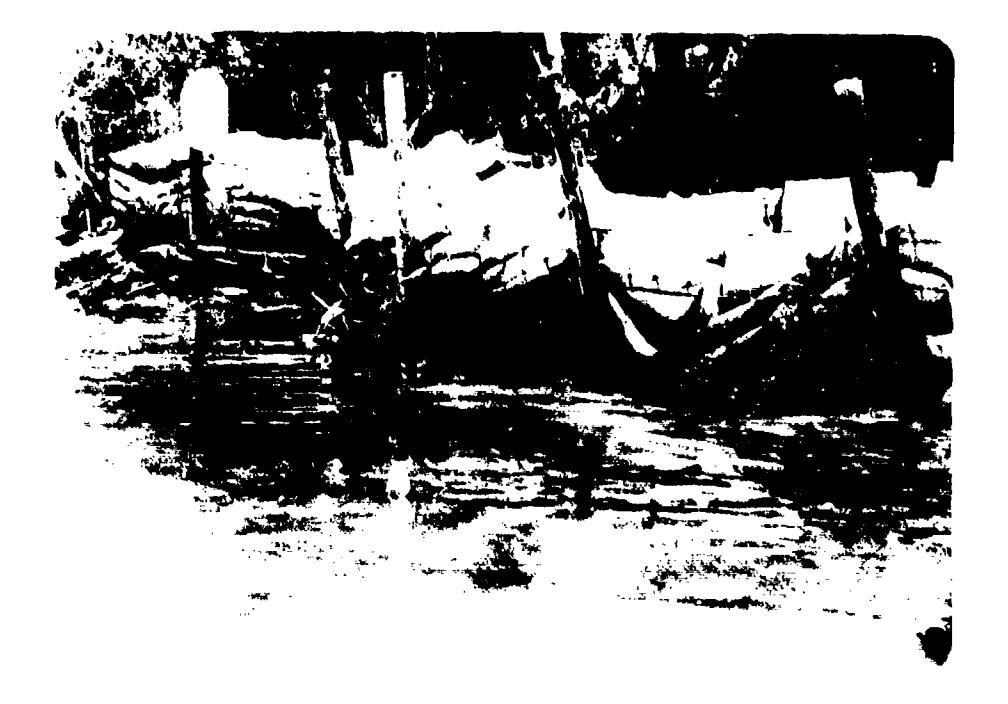
Figure 2-153. Dislodged Monsanto Sand Pillows, Basin Bayou, Florida, 22 June 1979.

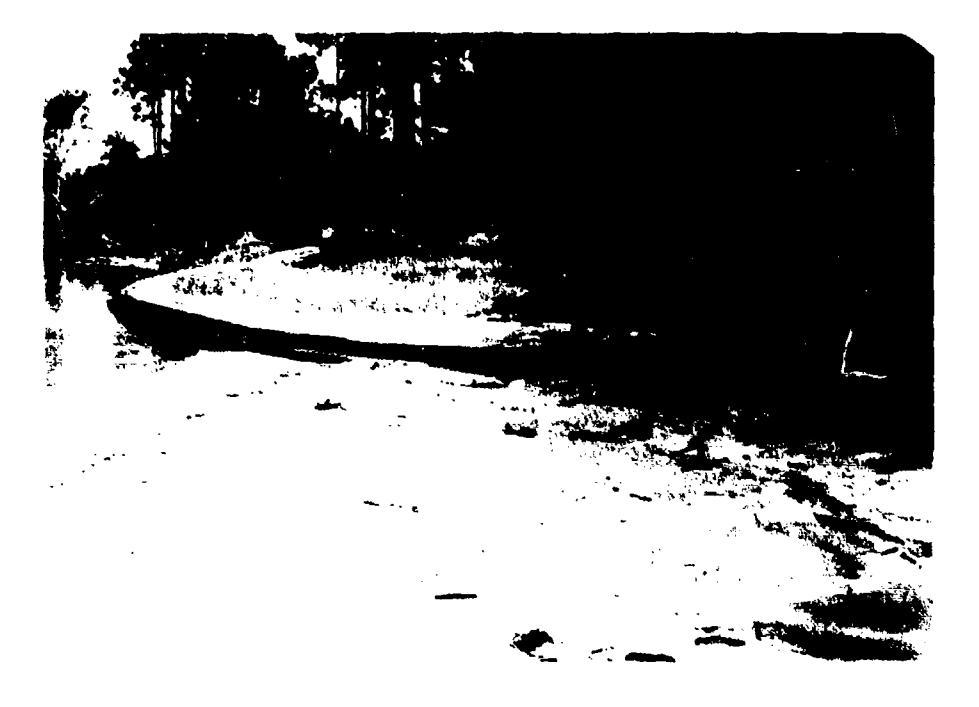
(e) Sandgrabber. Accretion of sand in front of and behind the middle third of the structure was noticeable the first month after installation. Erosion of sand from under the seaward side of the structure about 50 feet from the east end was also evident. A few of the steel rods connecting the blocks were beginning to rust. Two months after installation, the middle of the structure appeared to be rotating downward from the quarter points. On the east end, this was attributable to sand erosion from under the toe. A number of cracked and broken blocks were found about 50 feet from the east end, as a result of sand erosion from under the structure. Where earlier accretion had occurred, the beach had started to erode. Structural damage continued; after 4 months there were about 35 broken concrete blocks around the east quarter point and 15 broken blocks around the west quarter point, displacing some of the steel rods. Sand had built up to within 6 inches of the top of the structure about 50 feet from the west end. After about 6 months, the settlement of the central segment ceased and the structure stabilized, with little additional damage. Figures 2--159 and 2--160 show the condition of the Sandgrabber in late August 1979. In March 1980, the eastern end of the structure rotated seaward slightly, yet did not substantially damage the structure. As of May 1980, there was some slight erosion in front of the structure but it remained structurally sound.

Figure 2-159. View of Sandgrabber about 50 feet east of structure, Basin Bayou, Florida, 20 August 1979.

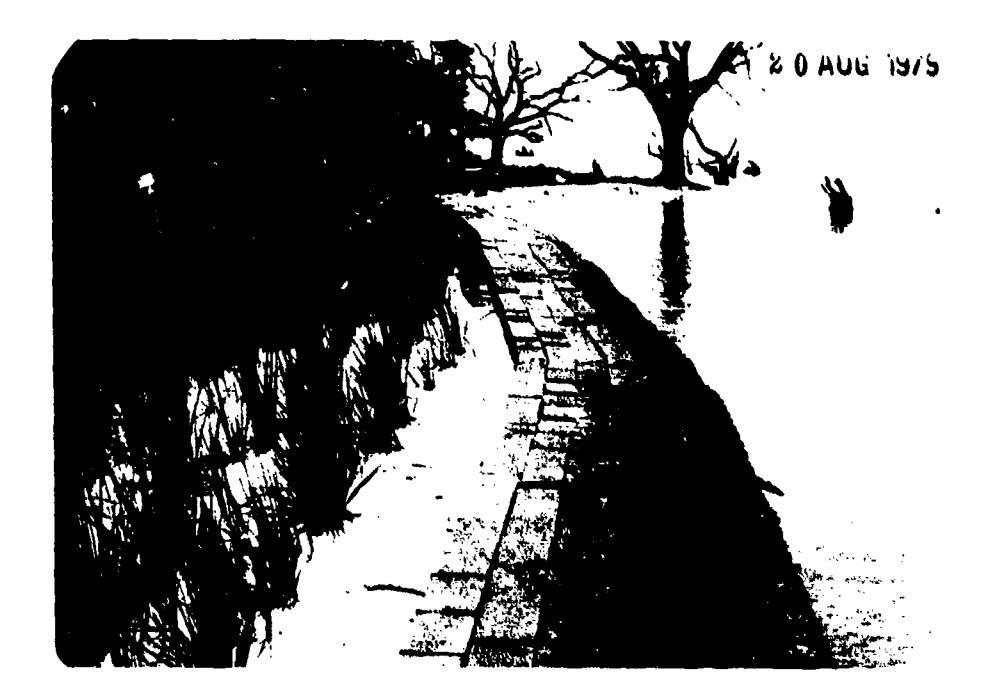
Figure 2-160. View while standing on Sandgrabber, looking east, Basin Bayou, Florida, 20 August 1979.

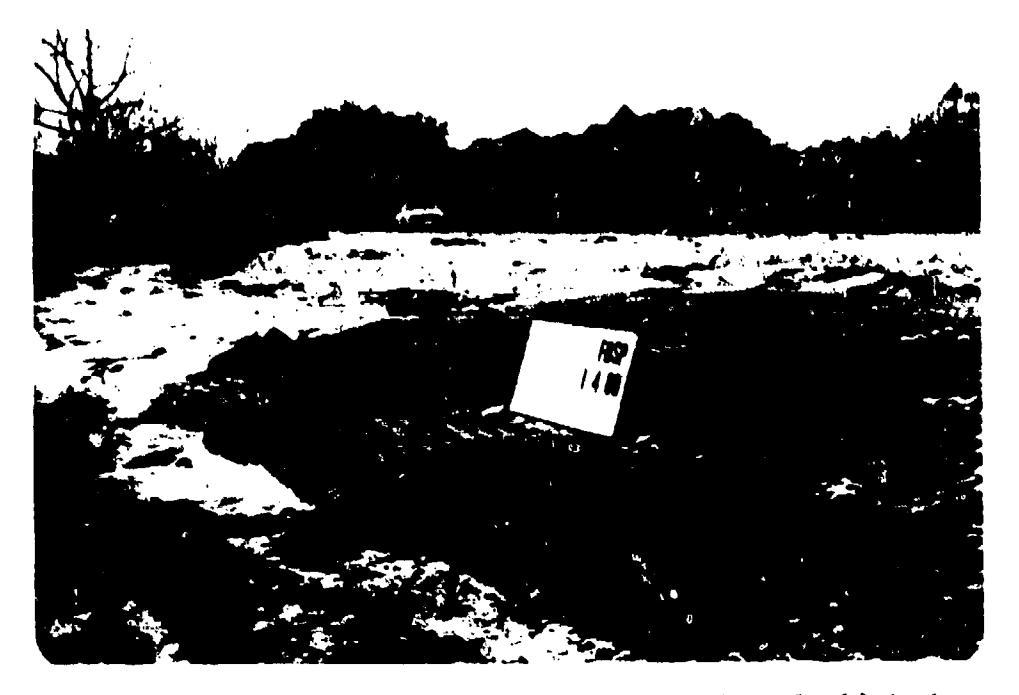
<u>2</u> <u>Performance</u>. Some settlement occurred during the first .nter of the monitoring period but no major changes in cross section were  $\varepsilon$  parent. Soon after construction, the mat settled irregularly as shown in Figure 2-170. On 13 April 1980, a storm hit the area. The structure suffered no damage, although the lakeward edge of the mat was settling as a result of toe scour. The unprotected north end had subsided slightly before the storm, but the storm waves apparently did not aggravate this settlement (Fig. 2-171). The sand that had accumulated on the crown of the device was removed and washed over the access road by the storm. This structure was still intact by June 1980.

Figure 2-170. Photo shows a drop of approximately 10 inches (near sign) of the Erco-mat of device 1 and the protruding filter-cloth carrier strip used for placing the double mats, Fontainebleau State Park, Louisiana, 4 January 1980.

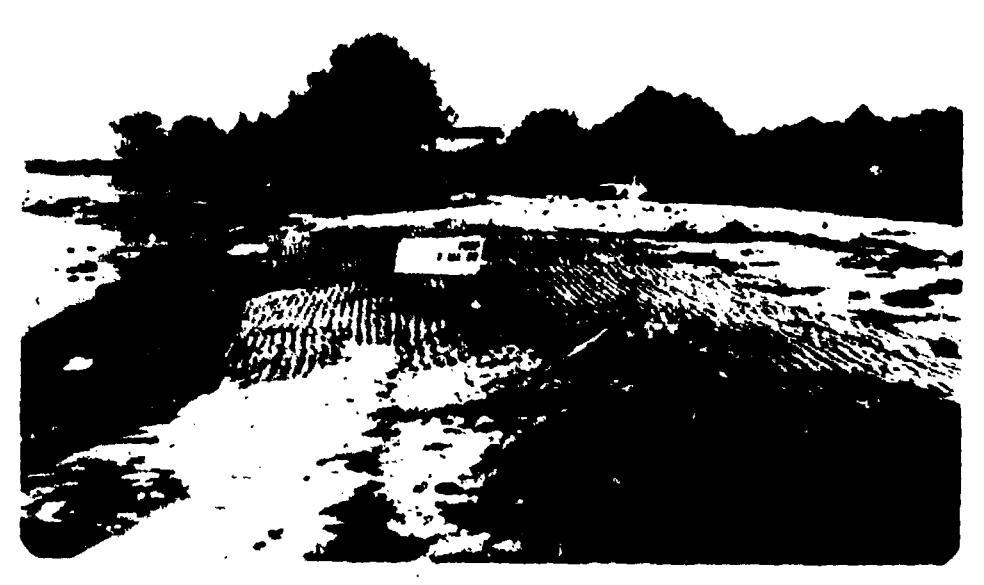
<u>2</u> <u>Performance</u>. Several blocks were removed from the revetment during the first 6 months of monitoring. First, a 6-square foot section of blocks was removed by vandals, leaving the filter cloth intact (Fig. 2-172). The wave action of the April 1980 storm displaced a 3- by 7foot area of blocks. By May 1980, approximately 65 square feet of blocks was either loose or missing (Fig. 2-173). Despite the missing blocks in this structure, progressive damage had not occurred to the adjacent blocks as of June 1980. A storm in May 1980, which caused a lake stage of about 4.7 feet NGVD, did not damage the structure.

Figure 2-173. Scattered areas of blocks are missing after storm, device 2, Fontainebleau State Park, Louisiana, 9 May 1980.

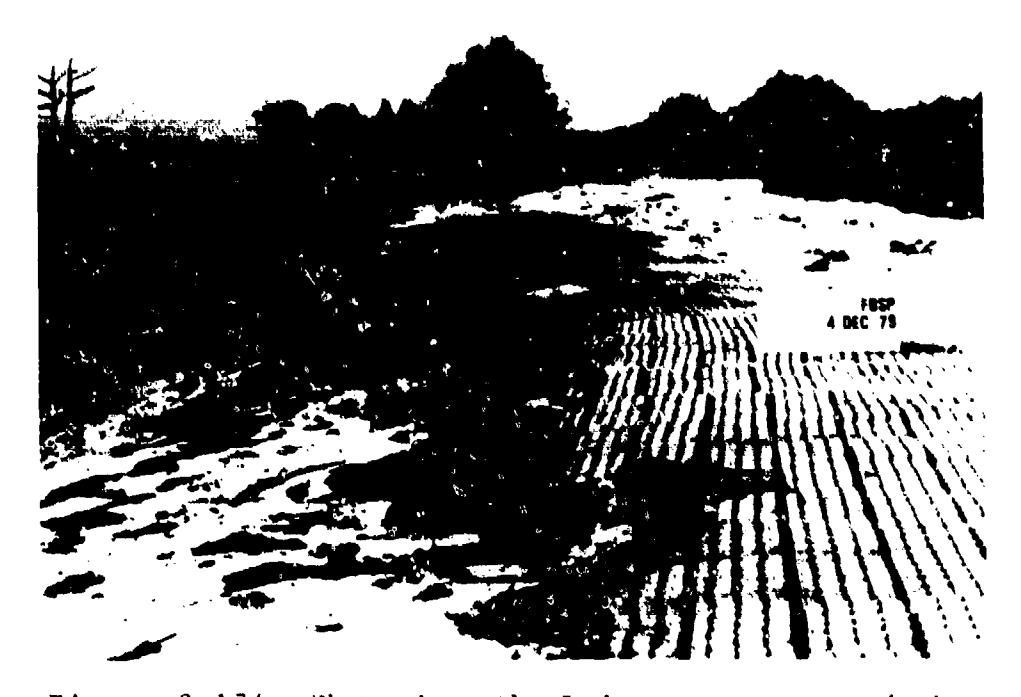
<u>2</u> <u>Performance</u>. A month after construction, pieces of the carrier-strip filter cloth were protruding up between the mats (Fig. 2-174). The carrier strip is an integral part of the underside of each mat, and each mat has extra strips at each end for placing the wat. The revetment suffered no structural damage during the April 1980 storm, but the southern lakeward toe settled into the lake bottom. The objective of using filter panels and articulated mats is to allow the revetment to settle uniformly. Also, some of the construction blocks used to anchor the landward slope of the filter-cloth panel were exposed as a result of wave action washing the sand toward the marsh. As of June 1980, this structure had performed very well with no structural damage.

Figure 2-174. Photo shows the Jumbo-mat revetment, device 3, in the foreground. Note the filter-cloth carrier strip used for placing the mats, Fontainebleau State Park, Louisiana, 4 December 1979.

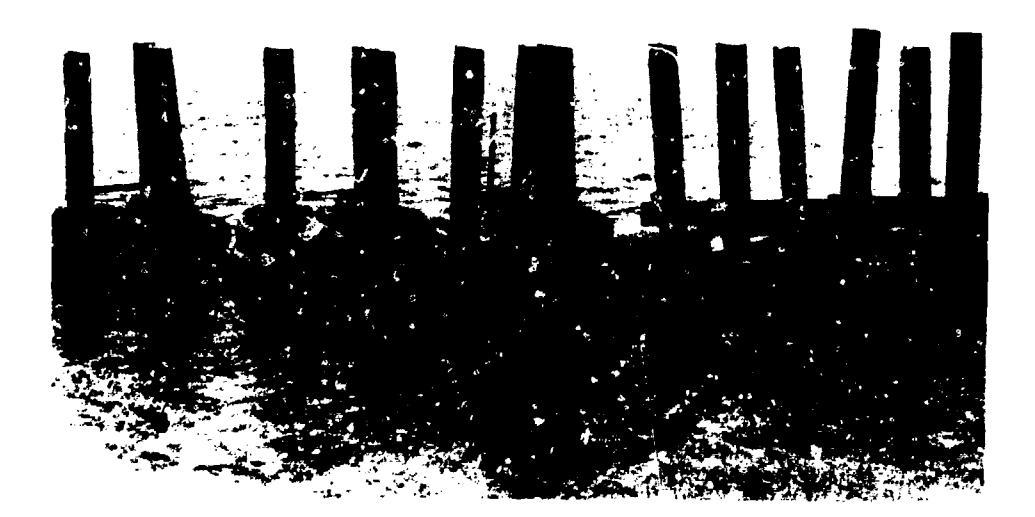
However, the prebanding operation was suspended because of the difficulty of handling the heavy stacks. Tires were then placed singly from a platform built on a crawler tractor. Timber wales and cables, used to fasten the piles together (Fig. 2-178), were installed with the aid of a small aluminum boat. Construction was completed on 2 November 1979. Cost data are given in Table 2-34.

Figure 2-178. Piles fastened together with cables and timber wales, device 6, Fontainebleau State Park, Louisiana, 15 February 1980.

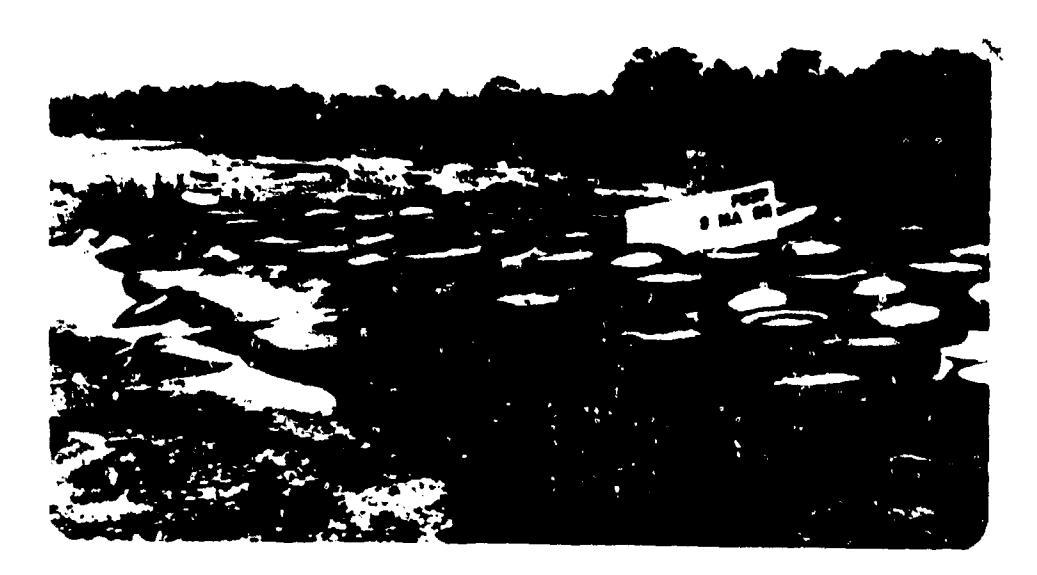
<u>2</u> Performance. Two months after construction, the spaces between the bottom three rows of tires were filled with sand (Fig. 2-187). Vegetation sprouted in between the tires, but the survival rate was low. The Dutch toe settled as a result of toe scour and wave action. This is the purpose of the Dutch toe. After the storm of 13 April 1980, 50 percent of the tires were displaced by wave action (Fig. 2-188). As of June 1980, the structure was still intact, but a scarp had developed at the shoreline. At this point, the structure still protected the shore despite its damaged condition.

Figure 2-188. After the storm, the tires and Dutch toe were displaced, device 9, Fontainebleau State Park, Louisiana, 9 May 1980.

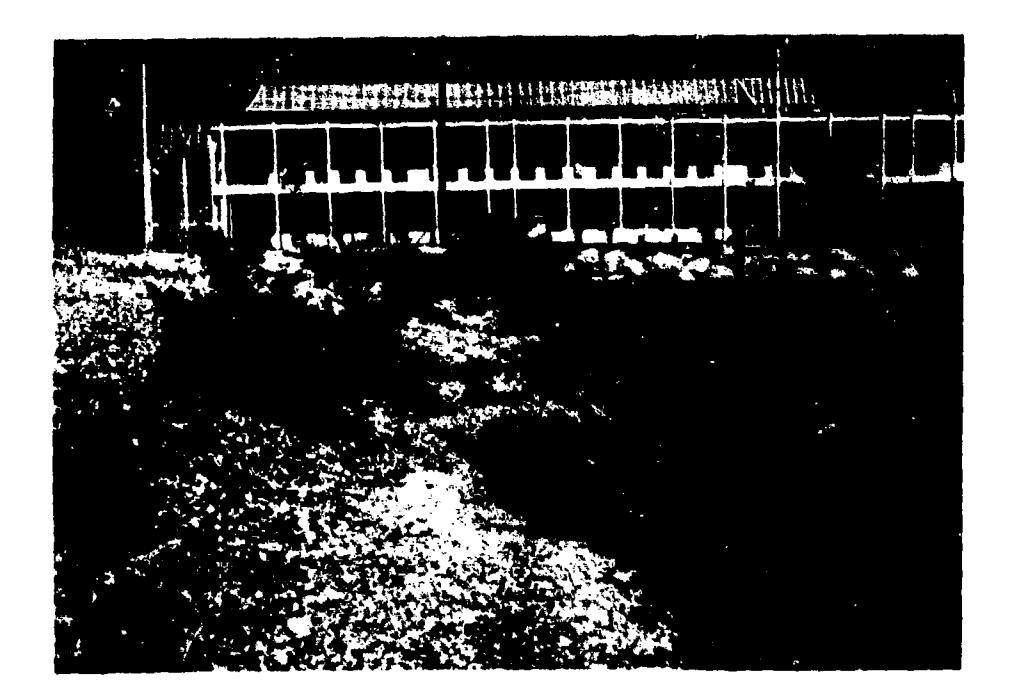
Figure 2-203. Section A, Key West, Florida, 12 March 1980.

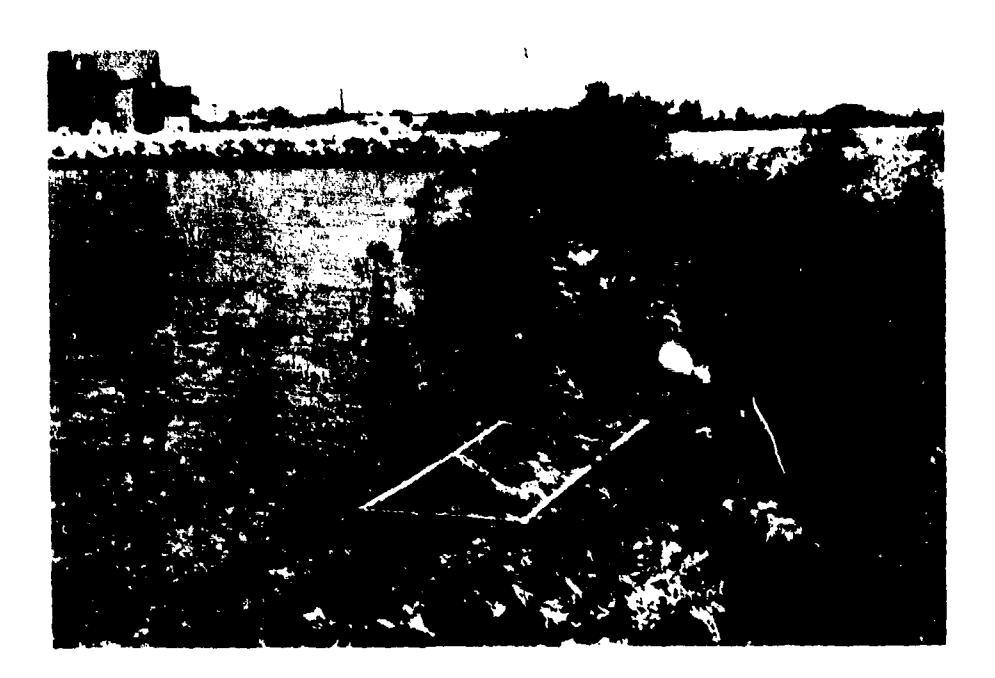
Figure 2-204. Section B at initial monitoring visit, Key West, Florida, 3 June 1979.

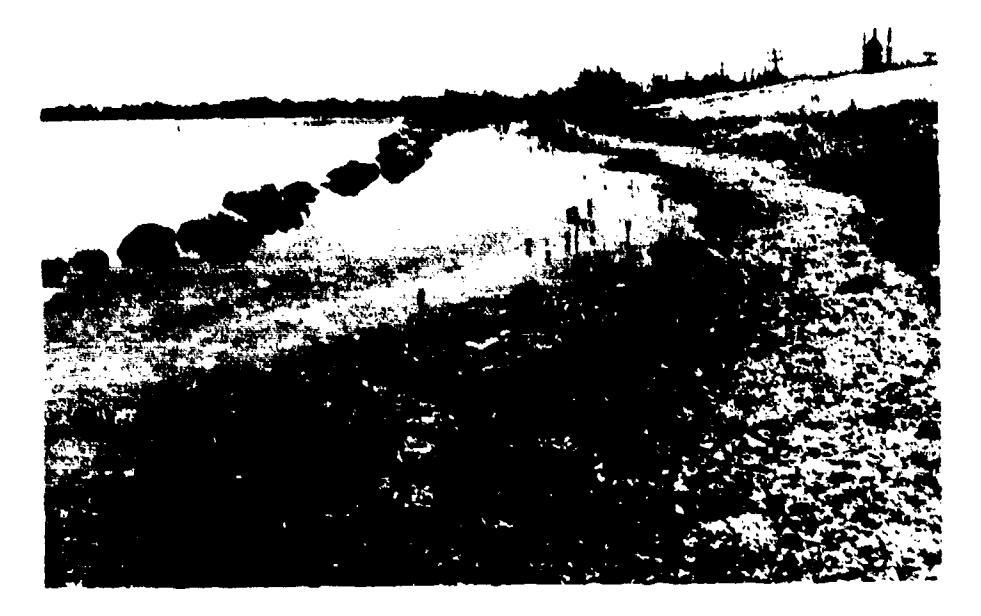
Figure 2-212. View of section E, Key West, Florida, 3 July 1979.

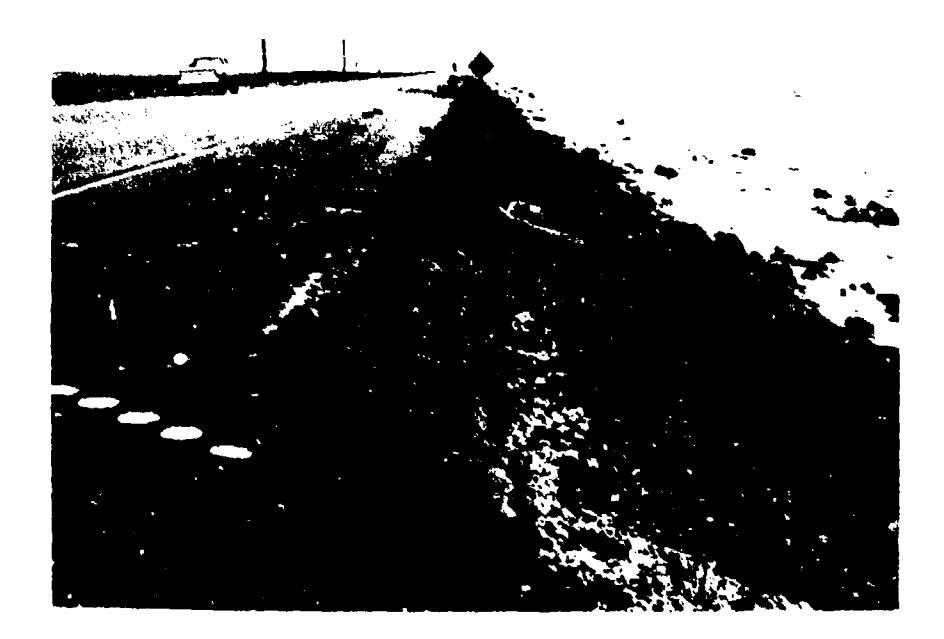
Damage to the revetment seemed to be initiated at the top where a construction joint connected the pervious concrete Gobi blocks to the impervious cement shoulder. Settlement of the shoulder trench due to inadequate compaction allowed the blocks to drop away from the soil-cement shoulder. Apparently, uplift pressures transmitted through the joint then lifted and destroyed large segments of the shoulder (Fig. 2-218). After the joint and shoulder had failed, loss of sand from underneath the revetment caused the remaining blocks to dislodge under the action of breaking waves and wave runup.

Figure 2-218. Shoulder destruction due to uplift pressures transmitted through joint, Holly Beach, Louisiana, 26 July 1979.

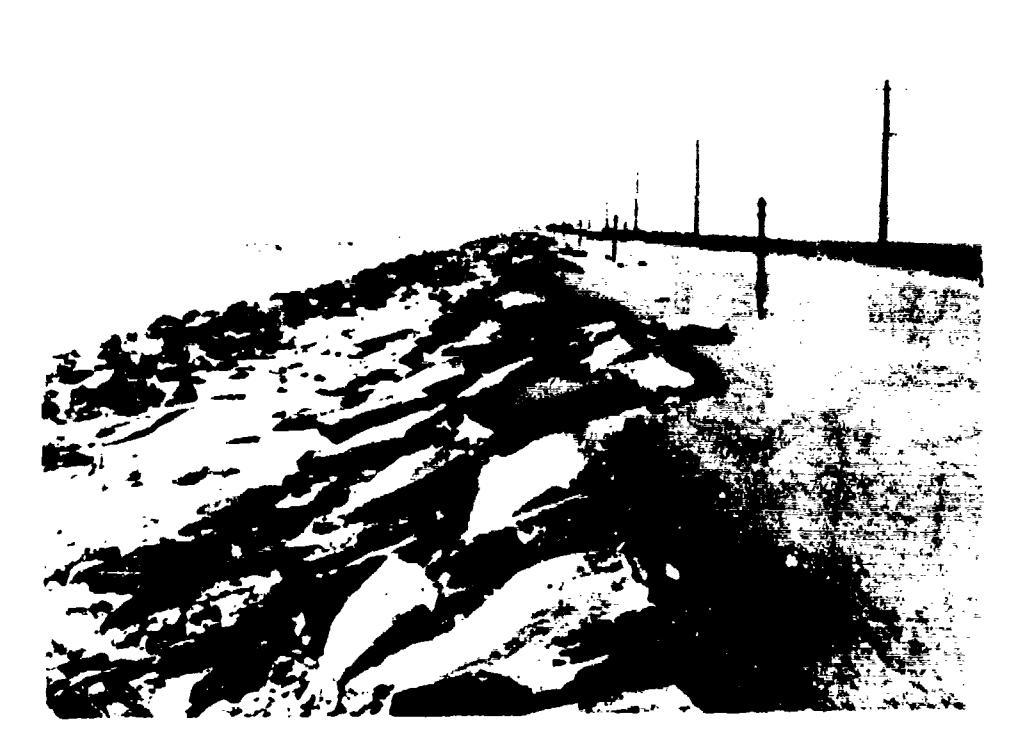
This project was not designed to withstand hurricane attack but rather to reduce maintenance required as a result of damage to the highway and shoulder by less severe storms. To this extent, the Gobi-mat revetment performed its intended function and protected State Highway 82. Had the revetment not been built, the sand chenier on which the road was built could have been severely eroded. Even during Tropical Storm Claudette, when several thousand square feet of shoulder was damaged or displaced, less than 1,000 square feet of roadway was damaged. As of April 1980, damage along parts of the revetment continued toward the traffic lanes and large sections of soil-cement have been displaced by wave action (Fig. 2-227).

Figure 2-227. During high tides, wave attack and runup undercut road shoulder due to displacement of filter cloth, Holly Beach, Louisiana, 16 April 1980.

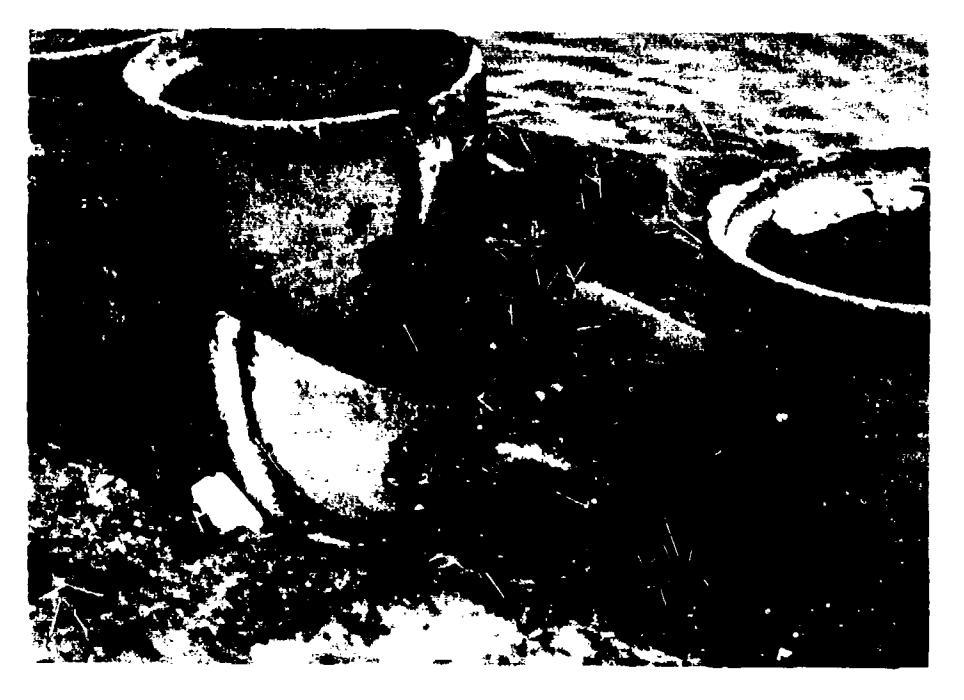
(3) <u>Performance</u>. During July 1979, storm waves caused some degradation of structural materials. The structure was overtopped and a 25-foot-long segment failed, destroying one pipe (Fig. 2-229). Several pipes underwent moderate displacement, and gaps between the pipes allowed some backfill erosion to occur (Fig. 2-230). For the next 4 months, minor deterioration of the structure continued along the segments breached during the storm.

Figure 2-229. Destroyed pipe along bulkhead, Beach City, Texas, 17 August 1979.

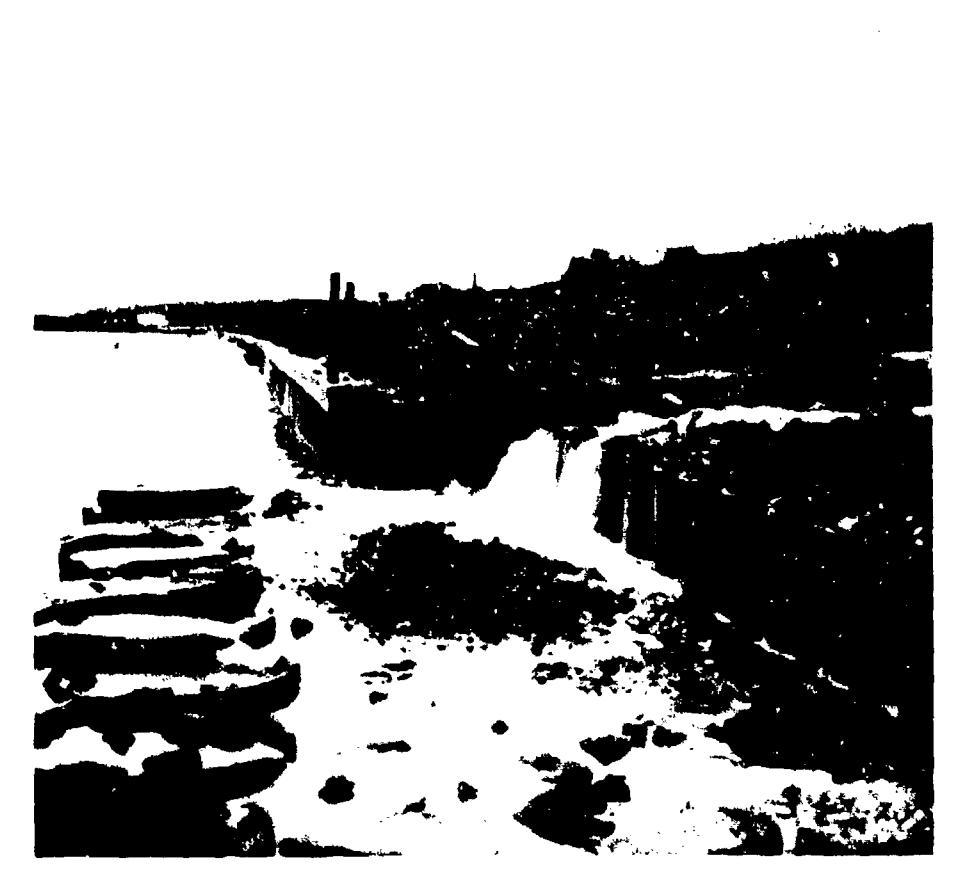
During the January 1980 site visit, a rain shower (aused damages due to inadequate drainage (Figs. 2-233 and 2-234). In February 1980, capping of the structure with a 2- to 4-inch concrete cap, placed on top of and behind the pipe structure, was begun (Fig. 2-235). At this time, it was noted that a large hole had been washed out near a drainpipe at the southwest end of the shoreline (Figs. 2-236 and 2-237). In March 1980, the washed-

Figure 2-233. Drainage during rain showers, Beach City, Texas, 22 January 1980.
