### LOW COST SHORE PROTECTION

A Report on the Shoreline Erosion Control Demonstration Program (Section 54 Program)

Office, Chief of Engineers U.S. Army Corps of Engineers Washington, D.C. 20314

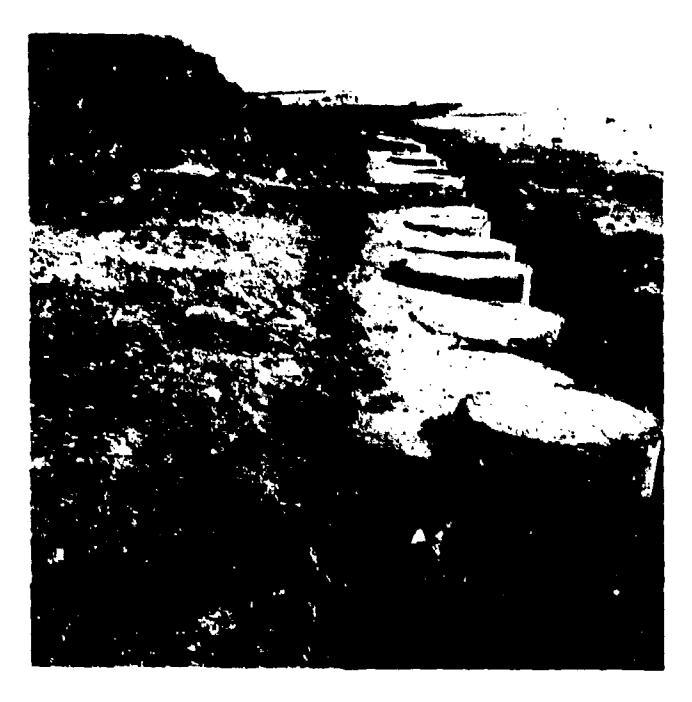
Figure 2-235. Concrete cap on top of and behind pipe structure, Beach City, Texas, 26 February 1980.

During the January 1980 site visit, a rain shower (aused damages due to inadequate drainage (Figs. 2-233 and 2-234). In February 1980, capping of the structure with a 2- to 4-inch concrete cap, placed on top of and behind the pipe structure, was begun (Fig. 2-235). At this time, it was noted that a large hole had been washed out near a drainpipe at the southwest end of the shoreline (Figs. 2-236 and 2-237). In March 1980, the washed-

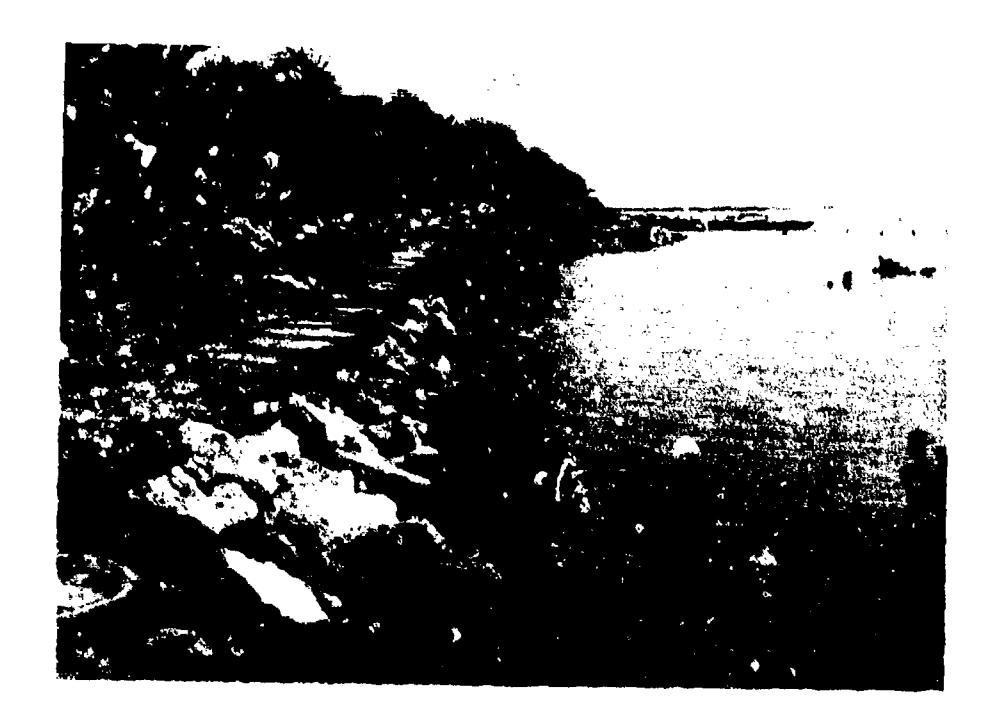
Figure 2-239. Broken concrete placed as toe protection, Beach City, Texas, 31 March 1980.

out hole was filled with concrete rubble. Also in March, concrete rubble was placed as toe protection in an effort to control toe scour occurring along some sections of the device (Figs. 2-238 and 2-239). In April 1980, additional broken concrete was placed at the toe of the structure for protection. As of May 1980 no additional structural damage had occurred.

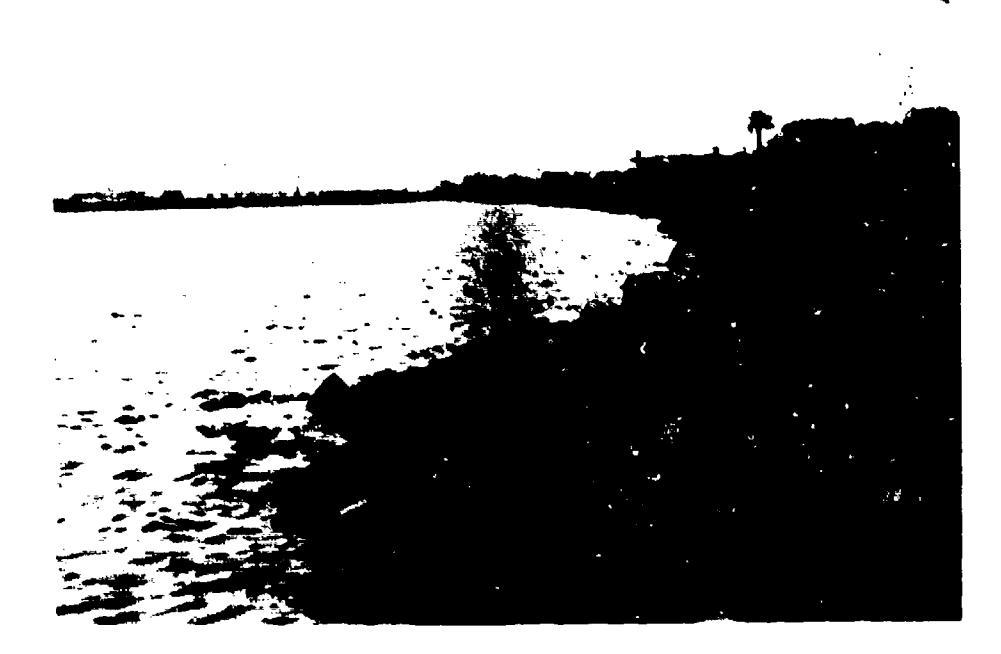
Figure 2-242. Typical segment of the riprap, Shoreacres, Texas, 19 July 1979.

1979; however, no noticeable changes were observed. The riprap has performed well functionally, preventing shoreline recession. In May 1980, the bank sloughed slightly in a few places, but caused no significant damage. Profiles of similar concrete rubble revetments are shown in Section III; the profiles through the revetment at Shoreacres are shown in Figure 3-43. Profiles show no erosion at the site.

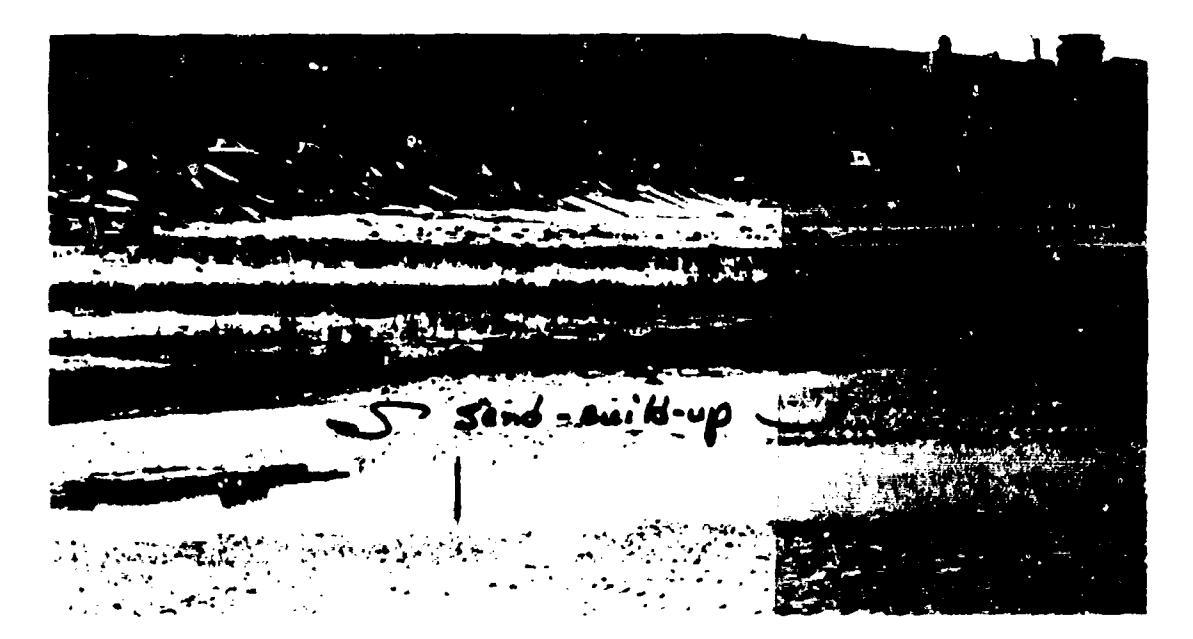
Figure 2-258. Accretion on bayside of device 2, Alameda, California, 2 May 1980.

Despite the subsidence of parts of the breakwater, it continued to function as a low sill, retaining a fillet of sand cast over its crest by waves and protecting the device 3 vegetation plantings from wave damage. Sand accretion was most noticeable in the southwest corner adjacent to the groin. The nonuniform accretion of sand caused the formation of a small tidal pool in the planted area (Fig. 2-255). Considerable erosion occurred along the bank behind devices 2 and 3, attributed to the material being disturbed during construction. Emergency rubble was placed on the bank in November 1979 (Fig. 2-257). By May 1980, considerable shoaling (up to 1 foot or more) had occurred on the bayside of the breakwater (Fig. 2-258).

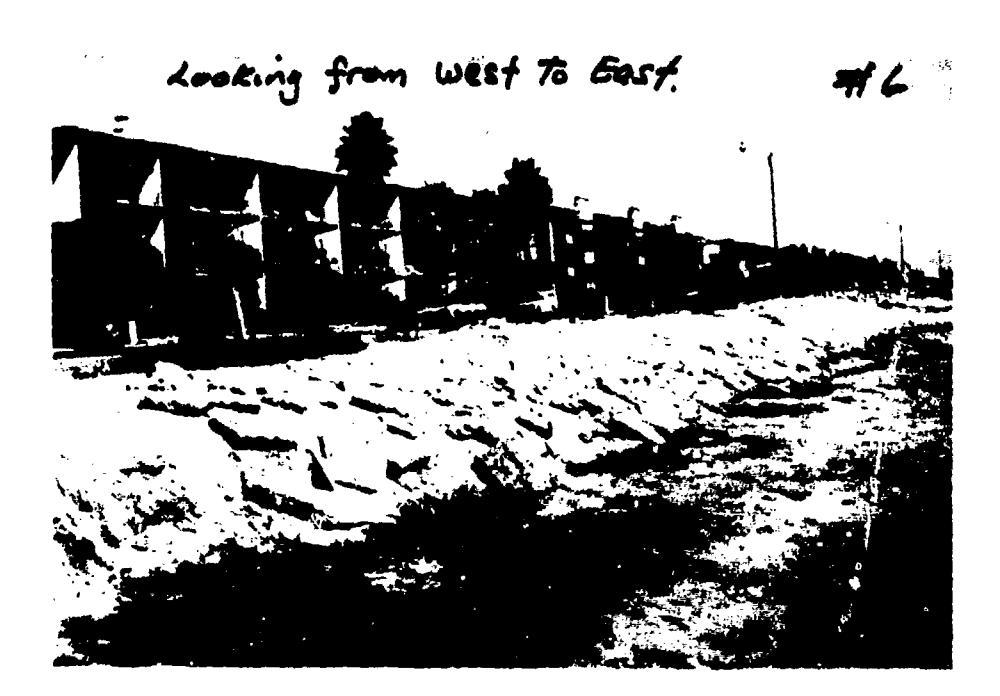
Figure 2-273. Rubble revetment with filter cloth, device 6, Alameda, California, 5 September 1979.

<u>2</u> Performance. This 75-foot revetment, completed after the March 1979 storm, suffered only minor structural damage. Some of the sand placed over the filter cloth was washed away and some bank erosion occurred on the updrift side, but not enough to cause significant profile changes. Except for erosion of bluff material from behind the unprotected west end of the revetment, the structure adequately protected the bluff from wave erosion (Figs. 2-272 and 2-273) until February 1980 when the structure collapsed as a result of wave attack exposing the filter cloth and displacing most of the rubble (Fig. 2-274). As of May 1980 there was no severe erosion in the area.

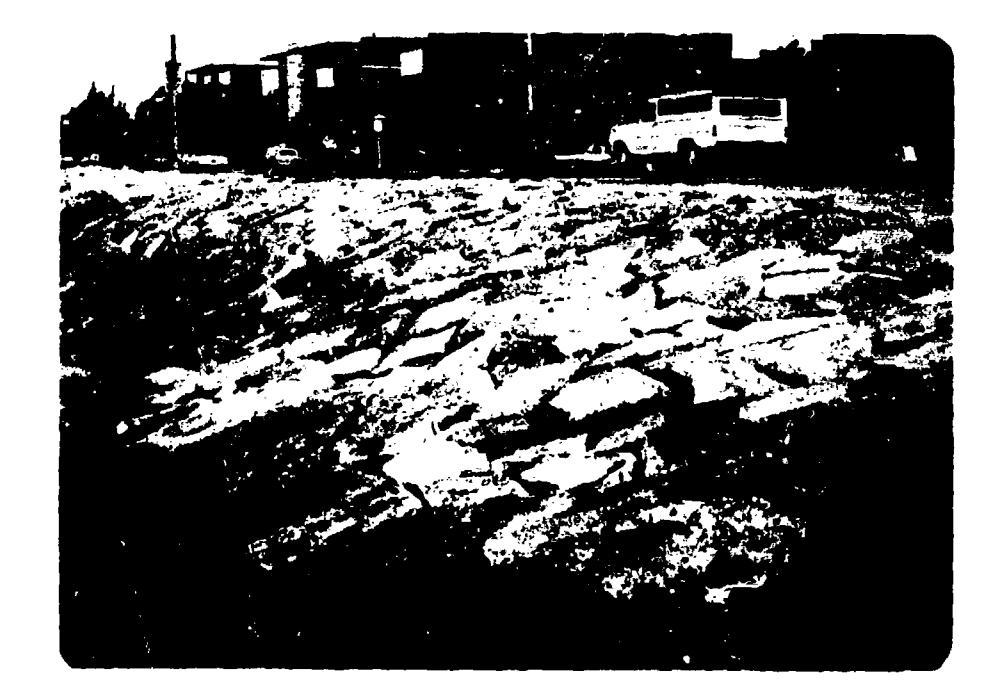
Figure 2-275. Sized rubble revetment with filter cloth, device 7, Alameda, California, 21 June 1979.

<u>2</u> <u>Performance</u>. The 75-foot revetment, completed after the March 1979 storm, was undamaged with no significant loss of retained sand (Figs. 2-275 and 2-276). The buildup of sand in front of the revetment due to the groin action of device 8 prevented direct impact of waves on the structure, and wave uprush deposited a considerable amount of sand on its face, nearly blanketing the rubble. This additional sand buildup prevented device 7 from being damaged by the February 1980 storm waves (as at device 6 with no sand buildup) (Fig. 2-277). The profiles through device 7, compared with those through similar devices, are shown in Section III, Figure 3-43. The profiles of March 1979 and September 1979 show the accretion of sand in front of the structure. Some erosion was present at the junction of devices 7 and 8.

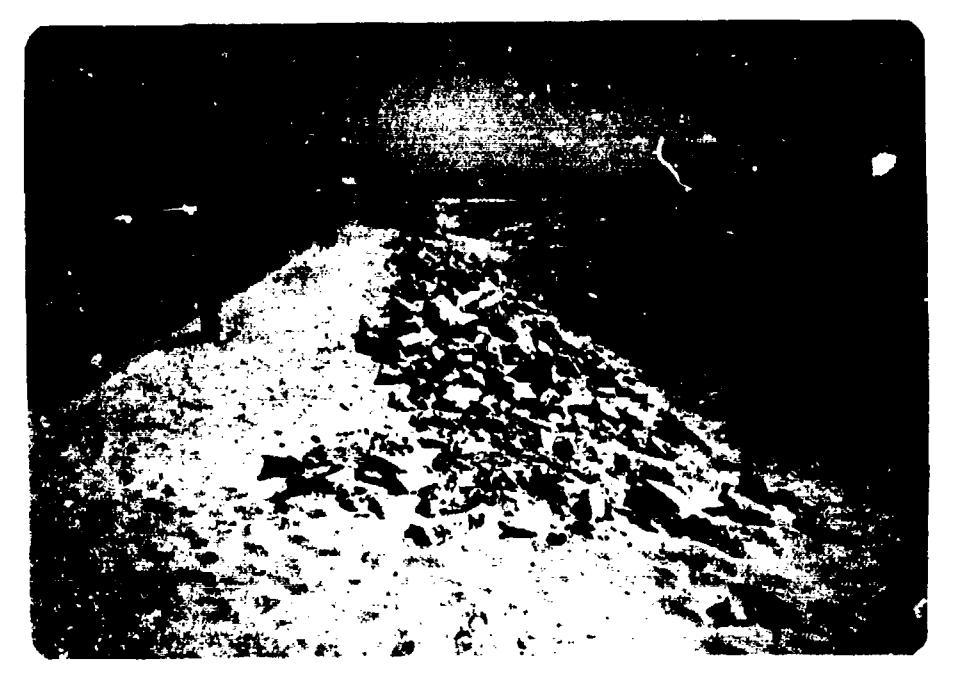
<u>2</u> <u>Performance</u>. This 75 feet of rubble revetment just east of device 8 was also fronted by the perched beach. The revetment cross section remained as installed, with no significant structural degradation (Fig. 2-284) until February 1980 when the structure was significantly damaged by storm waves. Although some rubble remained on the bank, a large amount was carried completely off the bank (Fig. 2-285).

Figure 2-284. Rubble revetment with filter cloth and perched beach, device 9, Alameda, California, 7 September 1979.

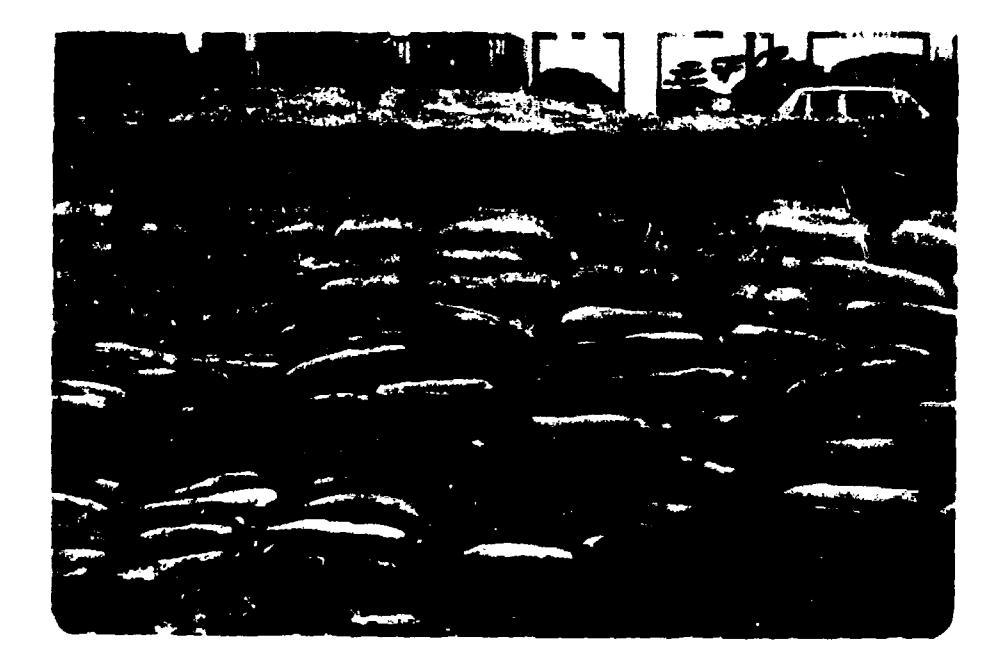
<u>2</u> Performance. Devices 11 to 14, lacking the partial protection of a perched beach, were severely damaged. No filter cloth was used behind device 11, and as sand was pumped through voids in the revetment and scoured from under its toe, the Sand Pillows began to slump and slide down the slope (Fig. 2-289). An inspection after the March 1979 storm revealed that the Sand-Pillow fabric was intact but that sand was lost through the mouths of bags because the twine used in sewing the bags shut was broken or cut. During the next few months the cross section continued to change. The Sand-Pillow fabric deteriorated, more bag sand was lost, and by June 1979 the entire structure was washed out (Figs. 2-290 and 2-291). The city of Alameda then placed rubble in the damaged area as an emergency measure to stop further erosion (Fig. 2-292).

Figure 2-289. Acrylic Sand-Pillow revetment, dry sandfill, device 11, Alameda, California, 28 March 1979.

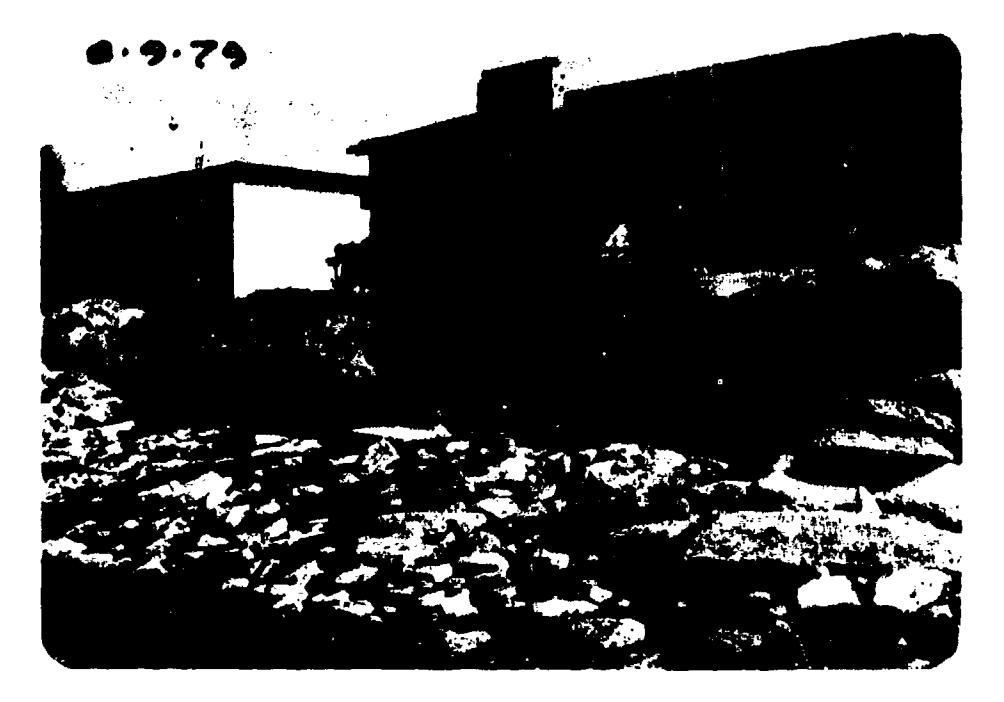
Figure 2-291. Acrylic Sand-Pillow revetment, dry sandfill device 11, Alameda, California, 9 August 1979.

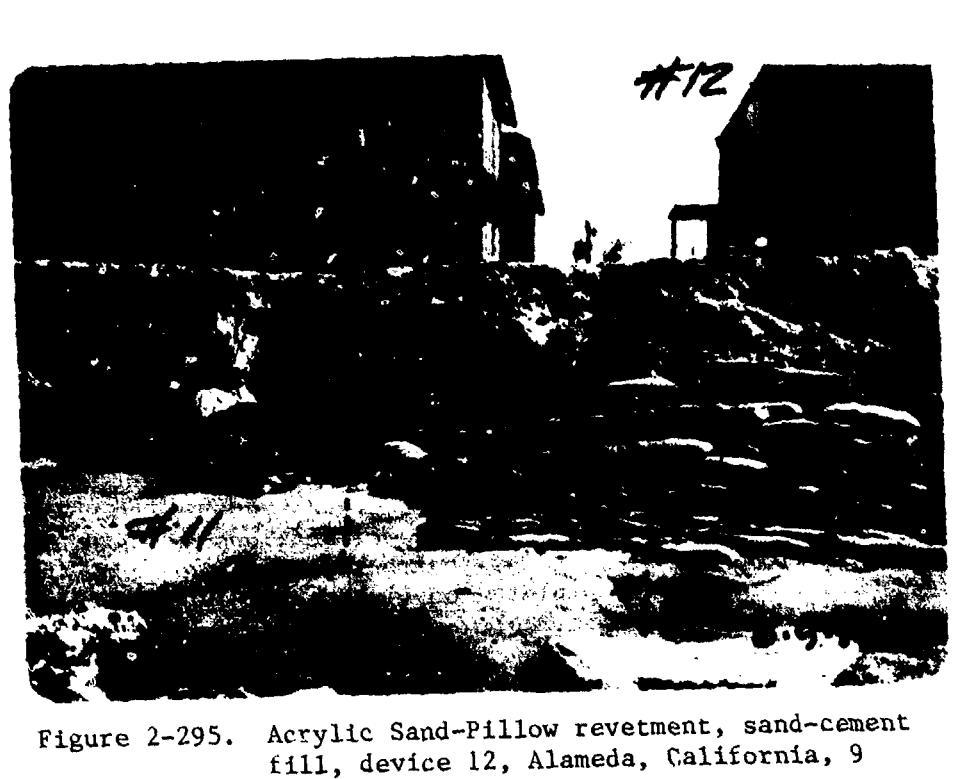
<u>2</u> <u>Performance</u>. An inspection of the revetment after the March 1979 storm revealed that about 50 percent of the sand-cement pillows remained (Fig. 2-293). When the embankment gave way, some of the pillows cracked, hastening loss of retained material. Except for this cracking, damage to the revetment units was prevented by the hardened cement in the fill mixture which allowed the pillows to maintain their shape after the fabric had deteriorated (Figs. 2-294 and 2-295).

Acrylic Sand-Pillow revetment, sand-cement fill, device 12, Alameda, California, 9 August 1979.

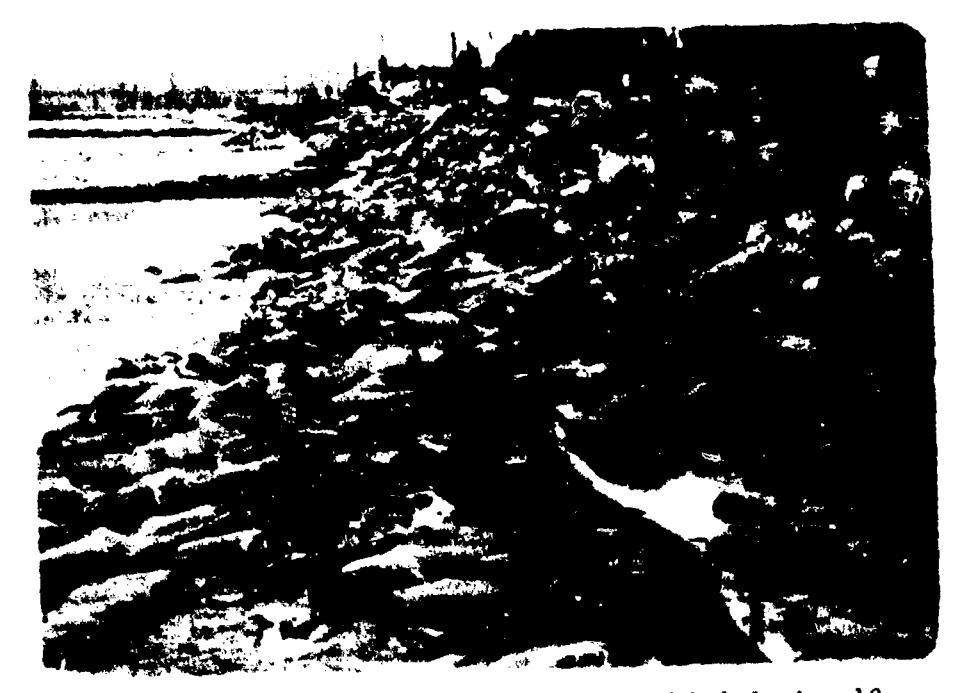
Although the individual pillows held their shape, displacement of the pillows under wave attack made the entire structure ineffective as a revetment. The mound of units that was ultimately left along the toe of the bluff provided some protection, but not enough to prevent continued bluff recession. In February 1980 the bluff erosion was severe enough to require the placement of emergency rubble behind the pillows (Fig. 2-296).

Figure 2-296. Emergency rubble placed behind device 12, Alameda, California, 20 February 1980.

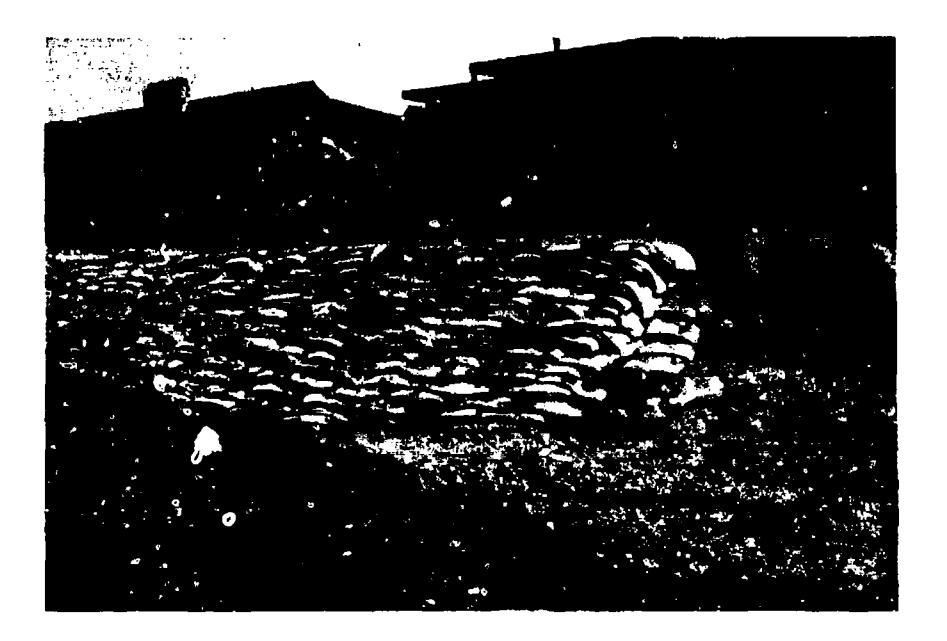
<u>2</u> Performance. During the March 1979 storm, device 14 suffered less damage than any of the other exposed sandbag revetments, and its cross section remained stable for about 3 additional months. As Figure 2-300 shows, the eastern end of the revetment was still unharmed, but by July 1979 the burlap bags were degrading in strength, ripping open, and losing their sandfill (Fig. 2-301). After the bag material failed, the erosion rate increased rapidly and the revetment was completely washed out in early October 1979 (Fig. 2-302).

Figure 2-300. Burlap-sandbag revetment iry sandfill, device 14, Alameda, California, 21 June 1979.

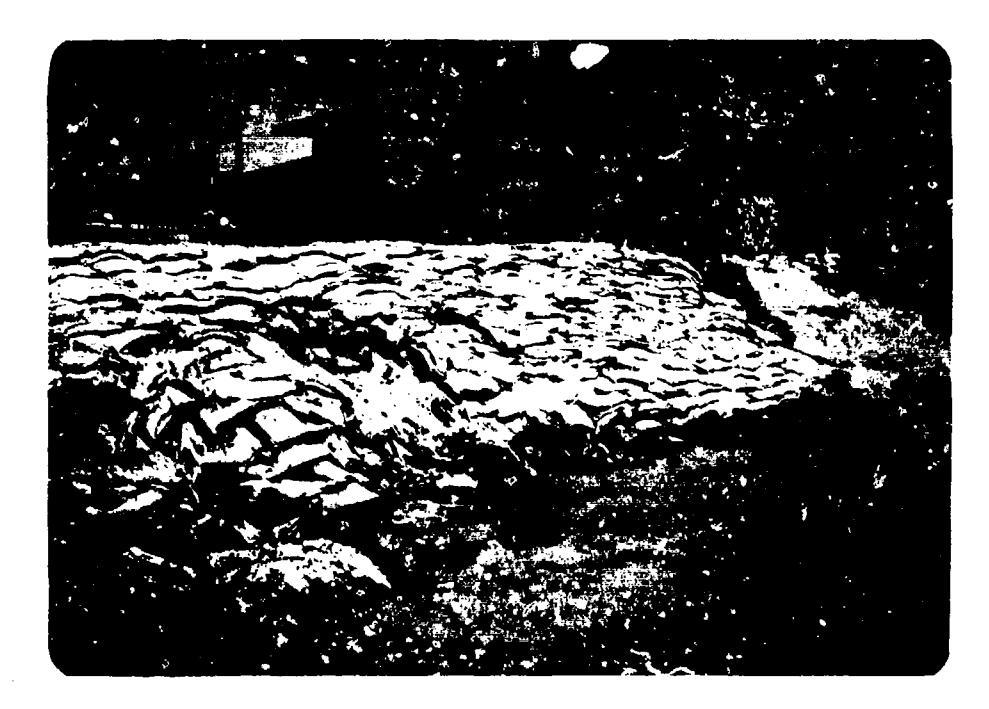
Figure 2-301. Burlap-sandbag revetment, dry sandfill, device 14, Alameda, California, 18 July 1979.

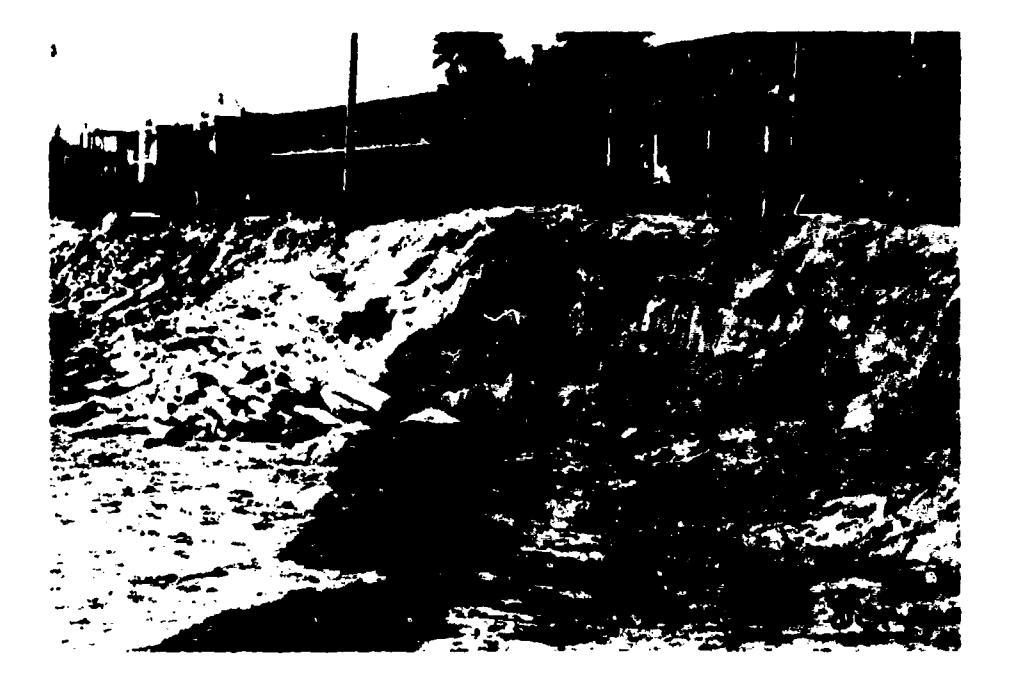
Figure 2-302. Burlap-sandbag revetment, dry sandfill, device 14, Alameda, California, 5 October 1979.

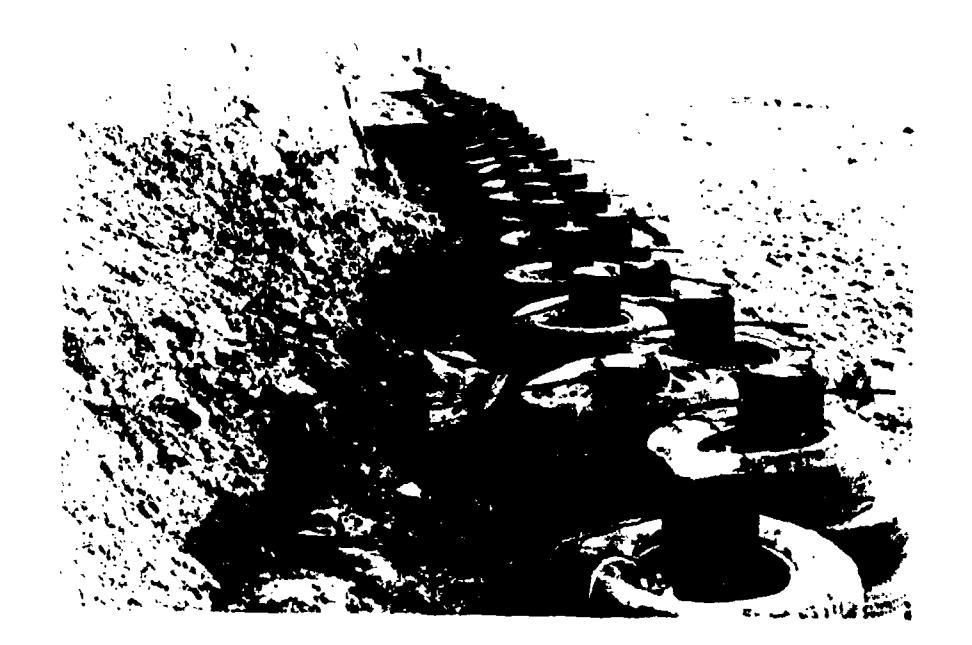
The western part of device 3bW (used-tire bulkhead without filter material) suffered significant erosion of the silty sand backfill material (Fig. 2-345), but the structure did not appear to be in immediate danger of failing. In device 3aE (used-tire bulkhead without filter) the pit-run gravel used for backfill was apparently coarse enough to prevent rapid erosion of the material from behind the tires (Fig. 2-346). Devices 3aW and 3bE (used-tire bulkheads with cloth and gravel filters, respectively) were not damaged except for a 1foot-deep by 2-foot-wide scour area (topsoil) behind 3bE (Fig. 2-347). Most of the gravel was washed from the tires all along device 3, and a tire settlement of 6 to 10 inches occurred (probably because the tires flattened as the gravel washed out).

Figure 2-345. Erosion of the sand backfill from behind device 3bW, Oak Harbor, 14 February 1979.

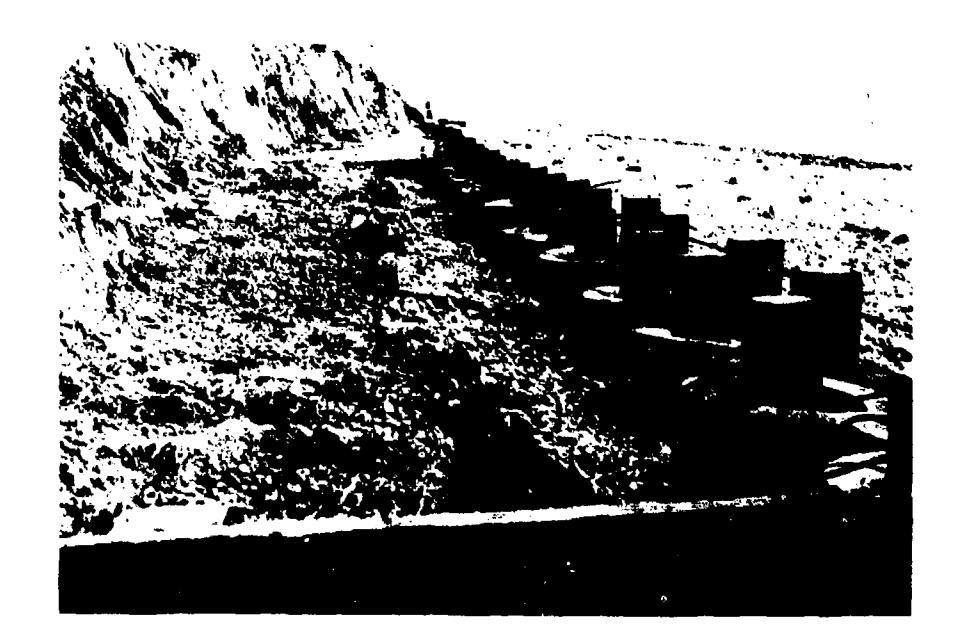
Figure 2-347. Scour trench behind device 3bE (with a gravel filter), Oak Harbor, 14 February 1979.

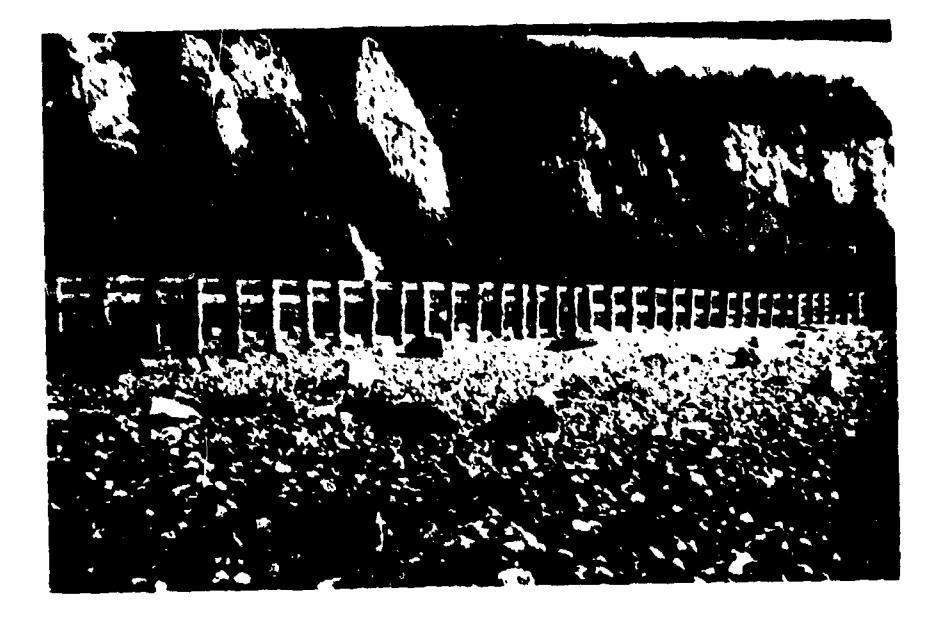
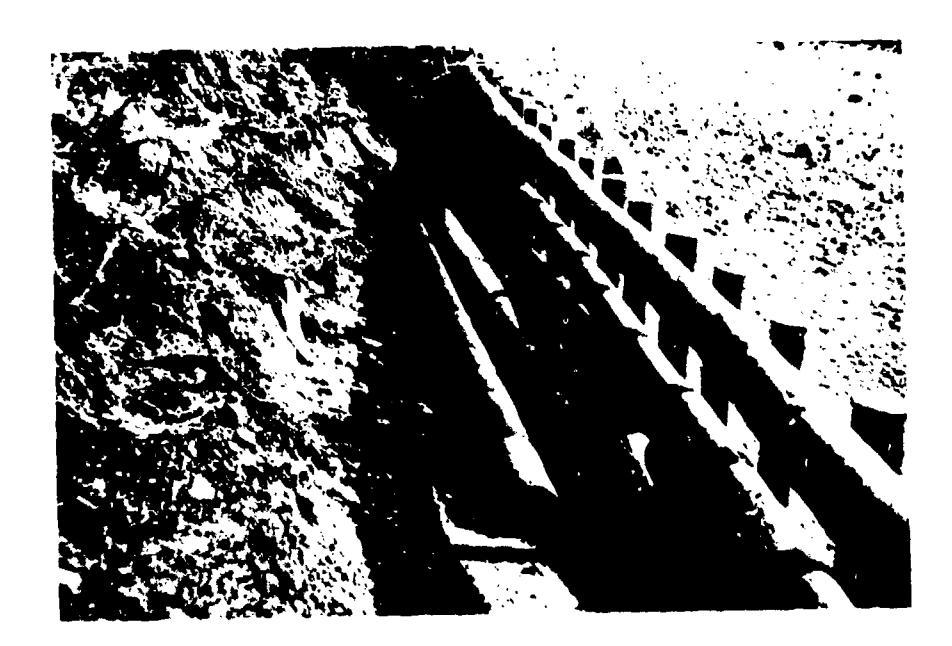
Device 4 (timber bulkhead) was damaged extensively; device 4a (horizontal logs) was essentially destroyed. All backfill material was washed out, and a number of the horizontal logs were removed (Figs. 2-348 and 2-349). The western part of device 4a had no filter, and the fine (silty sand) backfill material was easily washed through the logs. Apparently the gravel filter material in the eastern part of device 4a was undersized and was washed through voids between the logs. Once a breach in the filter had been established, the backfill material (pit-run gravel) escaped. A small void under the separation bulkhead between 4aW and 4bE allowed about 20 cubic yards of material to escape from behind 4bE (treated plank bulkhead with cloth filter) (Fig. 2-350). In device 4bW (treated planks without filter material), all of the silty sand backfill (about 110 cubic yards) was eroded (Fig. 2-351). Much of the toe protection was displaced along device 4b, exposing a gap of 1 to 2 inches below the bottom plank, which allowed the backfill to escape. The destruction of devices 4aW and 4bW exposed the separation bulkheads on each end of 4bE.

Figure 2-348. Extensive damage to device 4a, Oak Harbor, 14 February 1978.

Figure 2-349. Backfill completely washed out from behind device 4a, Oak Harbor, 14 February 1978.

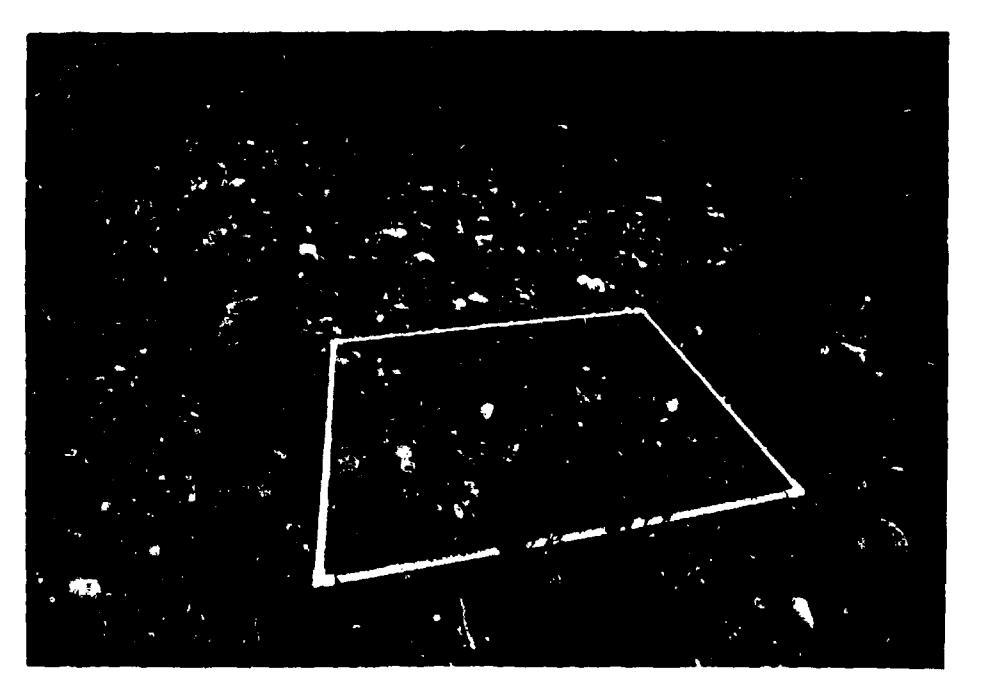
(d) <u>Vegetation Plantings</u>. Success of plantings at this site was low due to extrem: weather and the damage to the structures below the plantings (Figs. 2-352 and 2-353). The severe storm in February 1979 removed the backfilled material in areas behind devices 3b, 4a, and 4b, and these could not be sampled. The area behind device 2a was also not sampled as repair to the structure deposited a layer of gravel cobble over the plantings. It was seeded with large variety tall wheatgrass in September 1979, but sampling was not performed until 1980.

Figure 2-352. Destroyed vegetation area behind the gabion revetment, Oak Harbor.

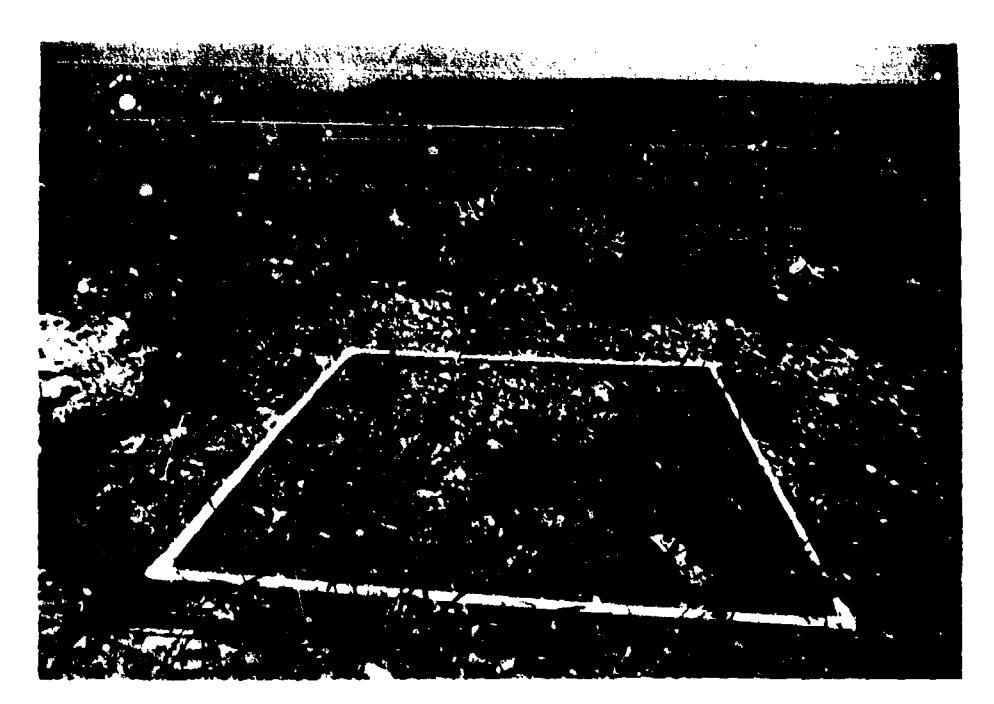
Figure 2-353. Vegetation plantings behind the used-tire bulkhead, Oak Harbor.

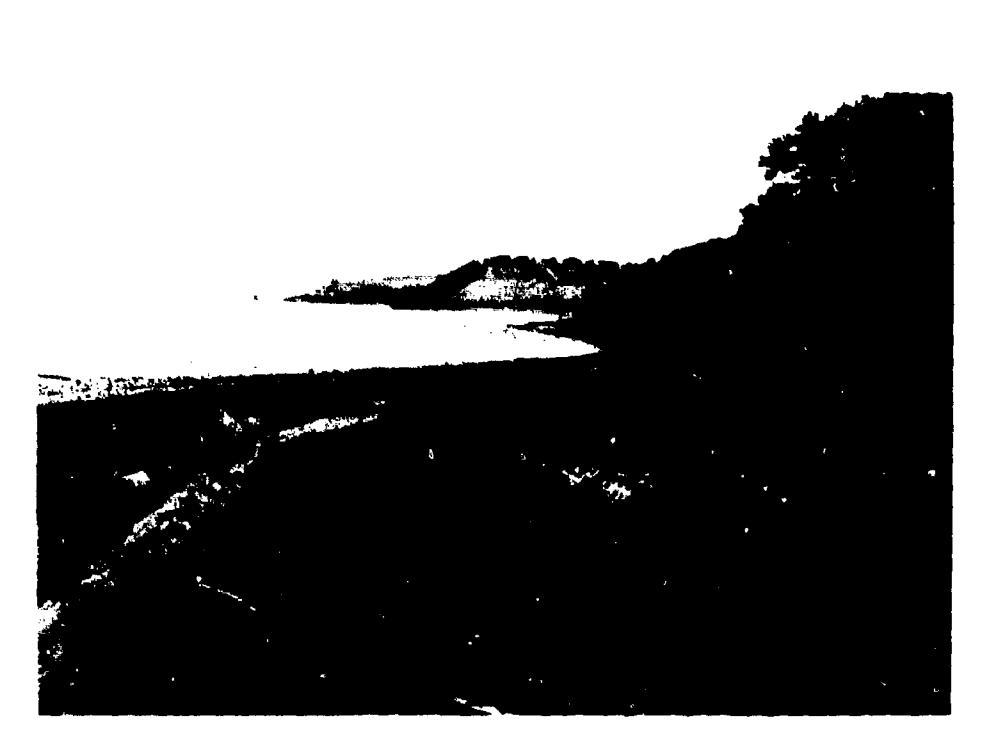
(3) <u>Performance</u>. After 1 year of monitoring, the heavily used recreation beach continues to protect the park and sewage facilities. The beach has also prevented further deterioration of the timber bulkhead protecting the park area (Figs. 2-364 and 2-365). Volume calculations of erosion and accretion show that both trends are present at the site (Table 2-94). Erosion has occurred primarily from station 0+00 to 2+00 and from station 6+00 to 12+50. Major accretion areas range from station 2+00 to 6+00 and from station 12+50 to 19+00. The net accretion of nearly 4,000 cubic yards between the 1979 and 1980 surveys is an anomaly, in view of the long-term record of continuous erosion at this site. A longer monitoring period is needed to develop a better account of littoral movement in this area. Profiles of the eroding sections show a minor

Figure 2-364. Sunnyside Beach from the park center looking north, 29 May 1980,

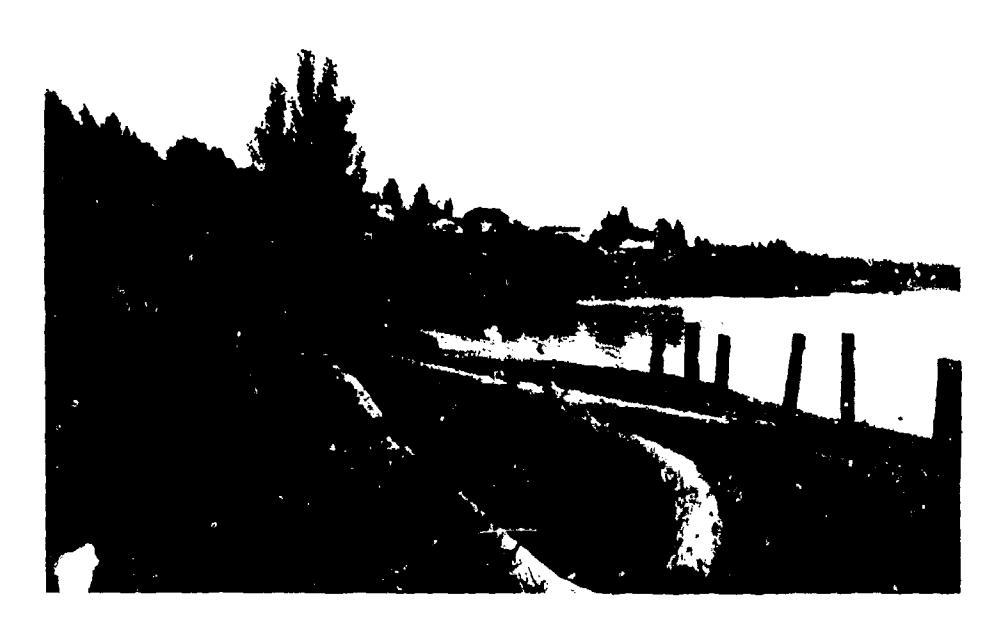
Figure 2-365. Sunnyside Beach from the park center looking south, 29 May 1980.

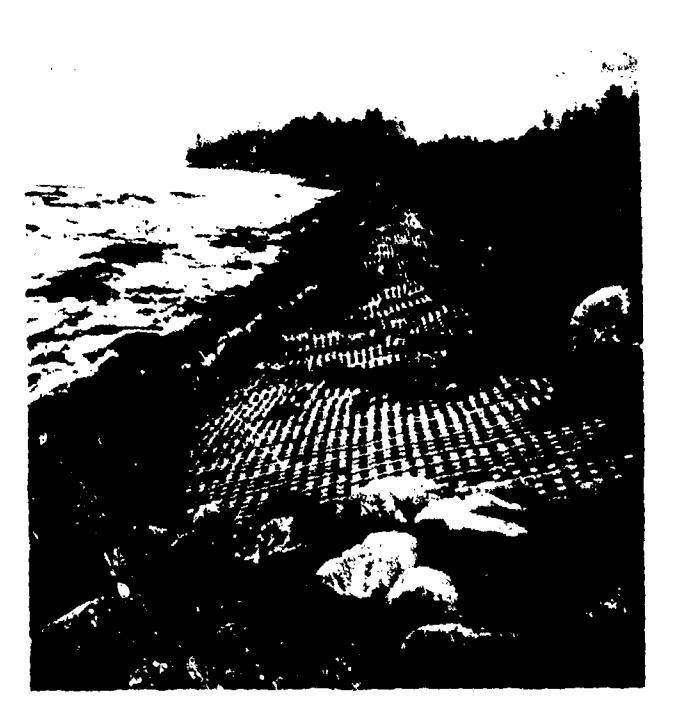
(a) Device 1 (Turfblock Revetment). A 2-day storm in early November 1978 generated waves of design height in Lake Superior that damaged the Turfblock revetment. Waves apparently overtopped the structure and displaced many of the individually placed units. The overtopping waves may also have transported material around or through the nonwoven filter fabric. The loss of base material could cause uneven settling of the Turfblocks, making them susceptible to displacement. The resulting rough and irregular cross section increased the likelihood for debris to lodge on the revetment (Fig. 2-402). Figure 2-403 (taken in May 1979) shows that only a small segment at the west end of the revetment remained intact. By September 1979 only minor changes were detectable since the November 1978 storm. Abrasion of the corners and edges of the blocks due to wave-borne debris impact became more obvious, and the filter cloth in exposed areas began to show wear. The runup of waves on this revetment was higher than on any of the others. By May 1980 a significant amount of accretion had occurred along the entire beach. The sand covered most of the abraded Turfblocks that were previously on the foreshore. The bank behind the blocks was considerably more eroded than it was in September 1979 (Fig. 2-404). Some of the exposed blocks deteriorated significantly (Fig. 2-405).

Figure 2-403. Intact western segment of the Turfblock revetment, Port Wing, Wisconsin, 7 May 1979.

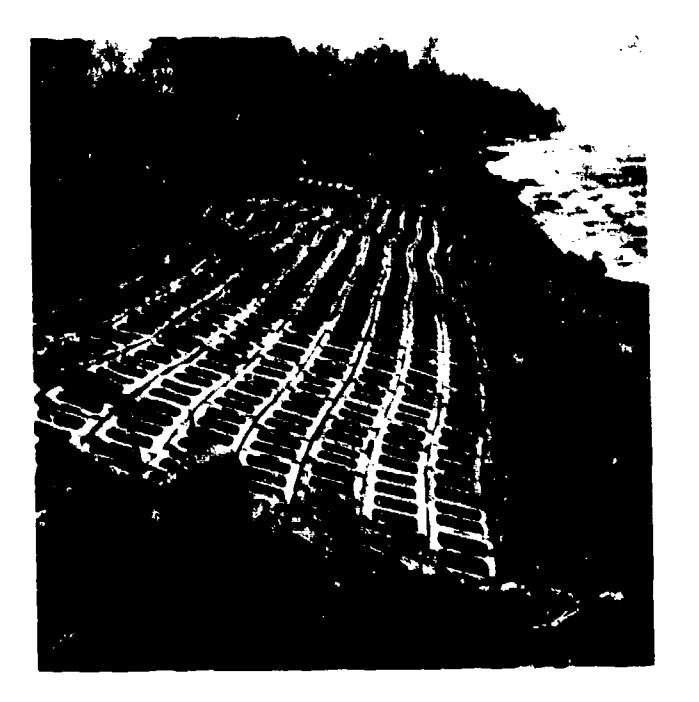
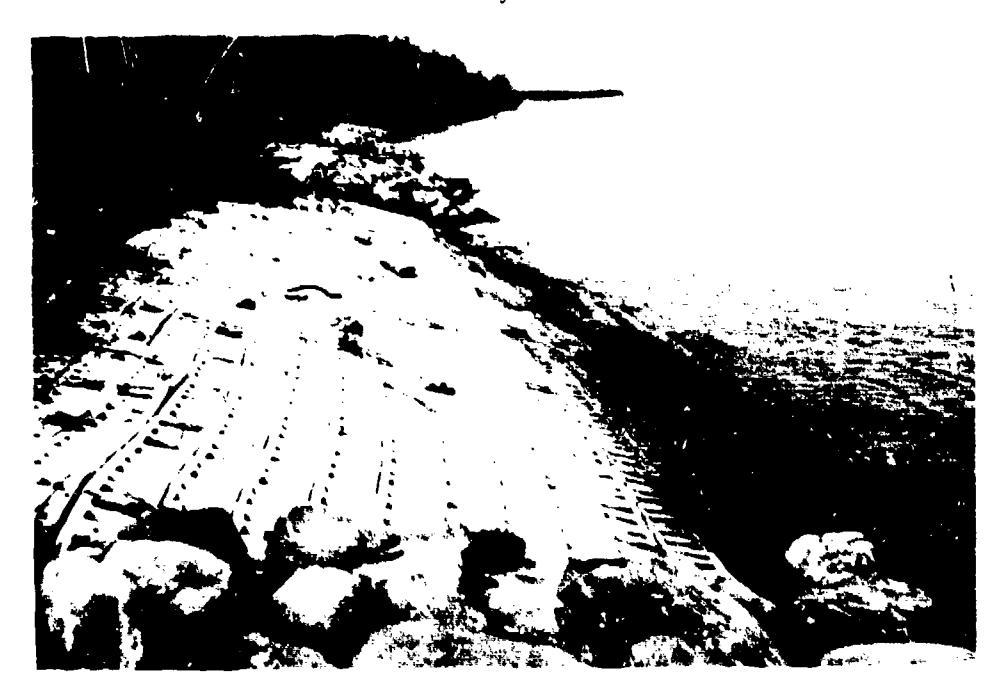
(c) <u>Device 3 (Large Concrete-Block Revetment)</u>. The structural performance of this revetment was quice similar to that of device 2, with the overall revetment remaining intact and relatively undamaged (Figs. 2-409 and 2-410). The flexible nature and low weight of the tires make them difficult to permanently fasten together.

Figure 2-409. Large concrete-block revetment, device 3, Port Wing, Wisconsin, 7 May 1979.

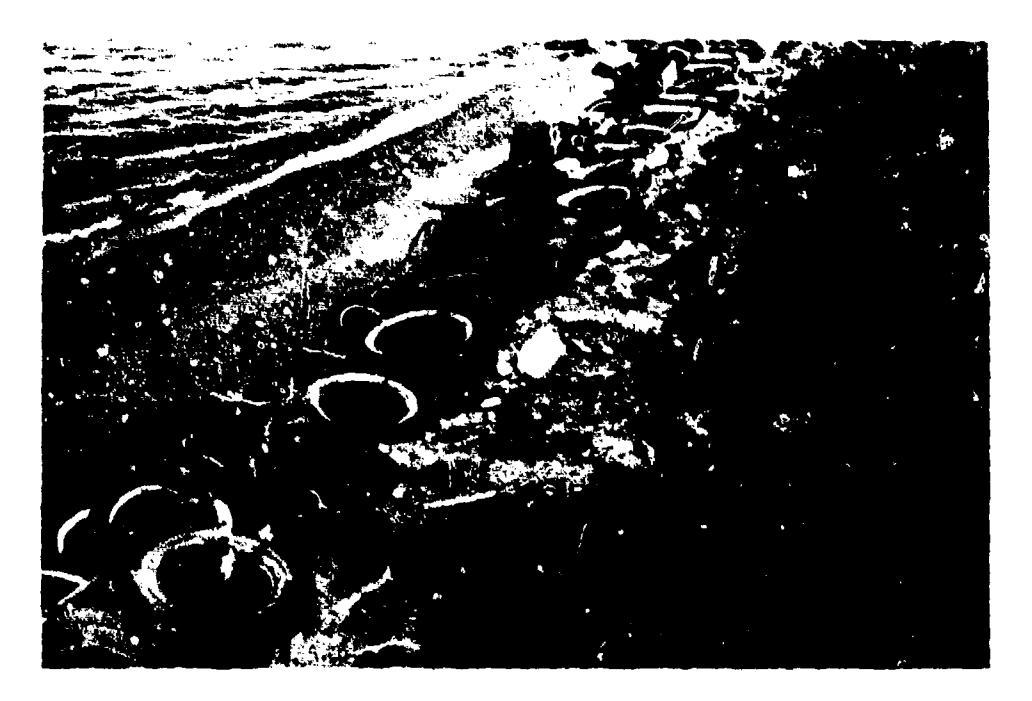
(d) <u>Device 4 (Used-Tire Bulkhead</u>). Although the tires did not deteriorate, the general configuration of the bulkhead underwent considerable change. Within 1 month after completion, many of the tires had separated from the structure and most of the granular fill had been washed out (Fig. 2-411). It became apparent that the tire-interconnecting devices were inadequate for holding the structure together. By the September 1979 inspection, so many tires had broken loose that a major storm could have caused severe structural damage. By May 1980, although the beach had accreted significantly, erosion occurred behind the tires (Fig. 2-412). Profiles through the used-tire bulkhead are shown in Figure 3-18 (see Sec. III), compared with those through similar devices. Comparison of the profiles of June 1979 and October 1979 shows a small amount of accretion in front of the tire stack and minor erosion behind it. No 1980 survey data were submitted, but the photos adequately depict the performance of the structure.

Figure 2-412. Device 4 as of 13 May 1980, Port Wing, Wisconsin.
