### LOW COST SHORE PROTECTION

A Report on the Shoreline Erosion Control Demonstration Program (Section 54 Program)

Office, Chief of Engineers U.S. Army Corps of Engineers Washington, D.C. 20314

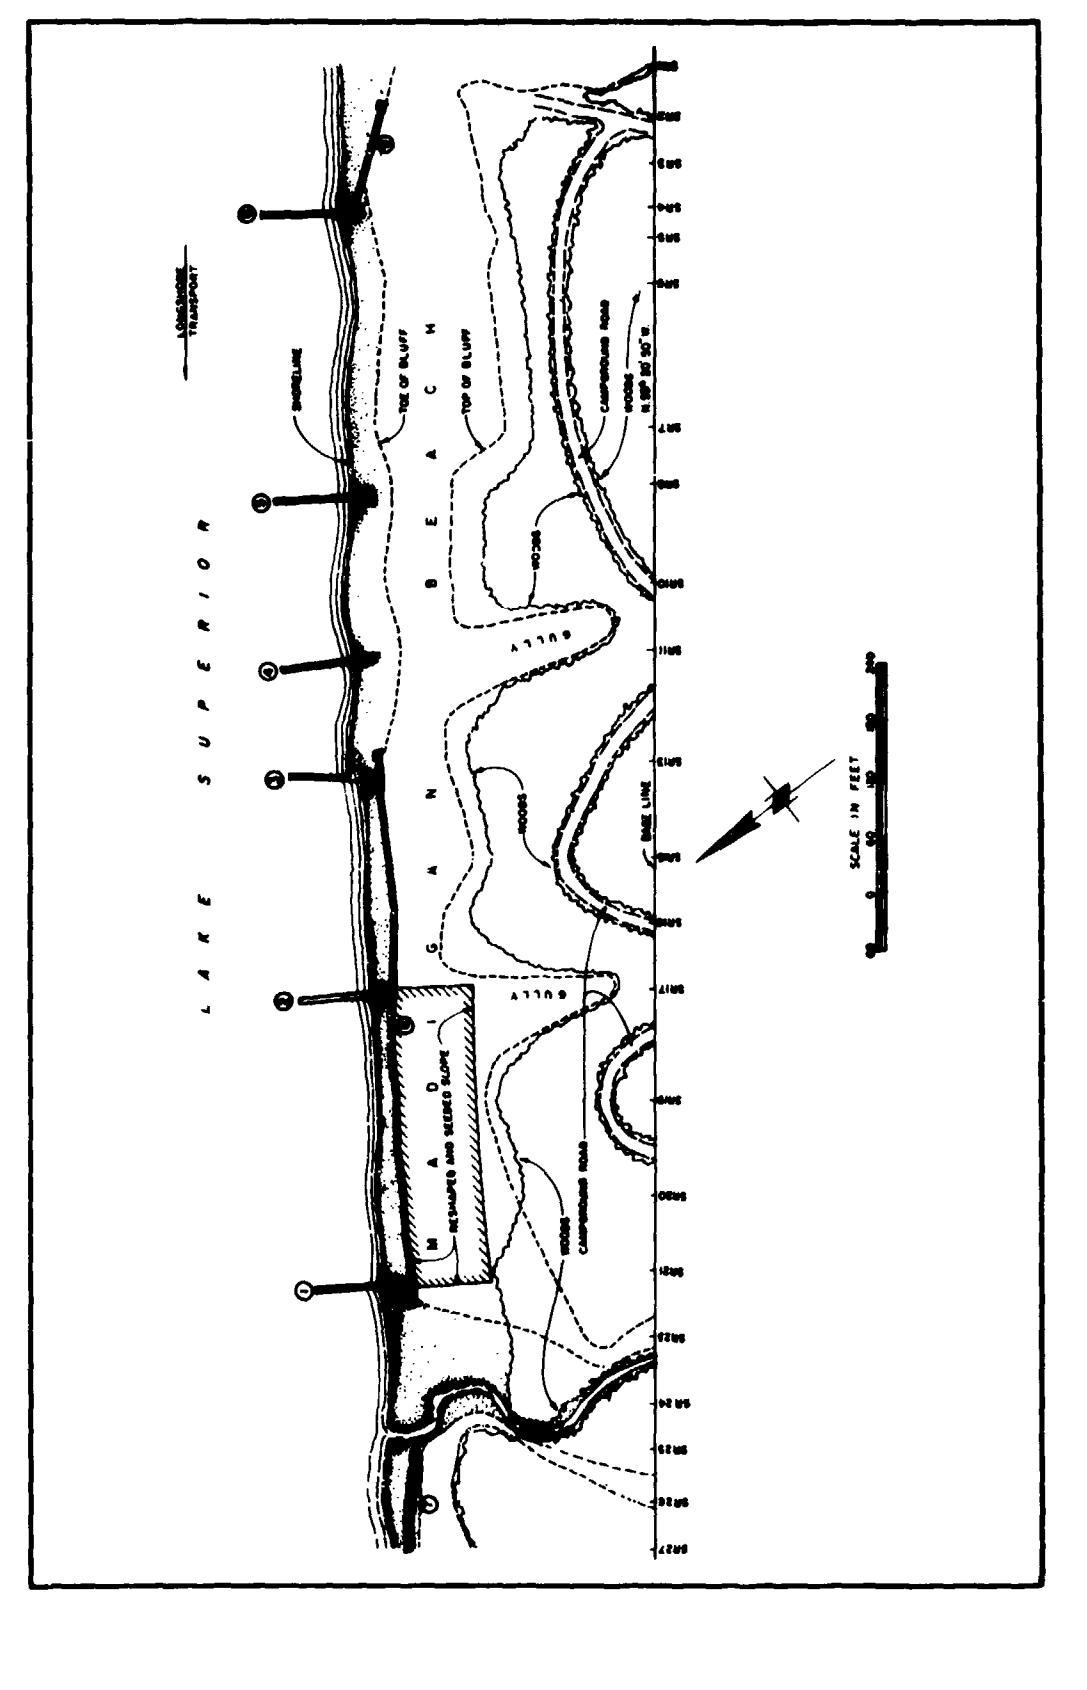
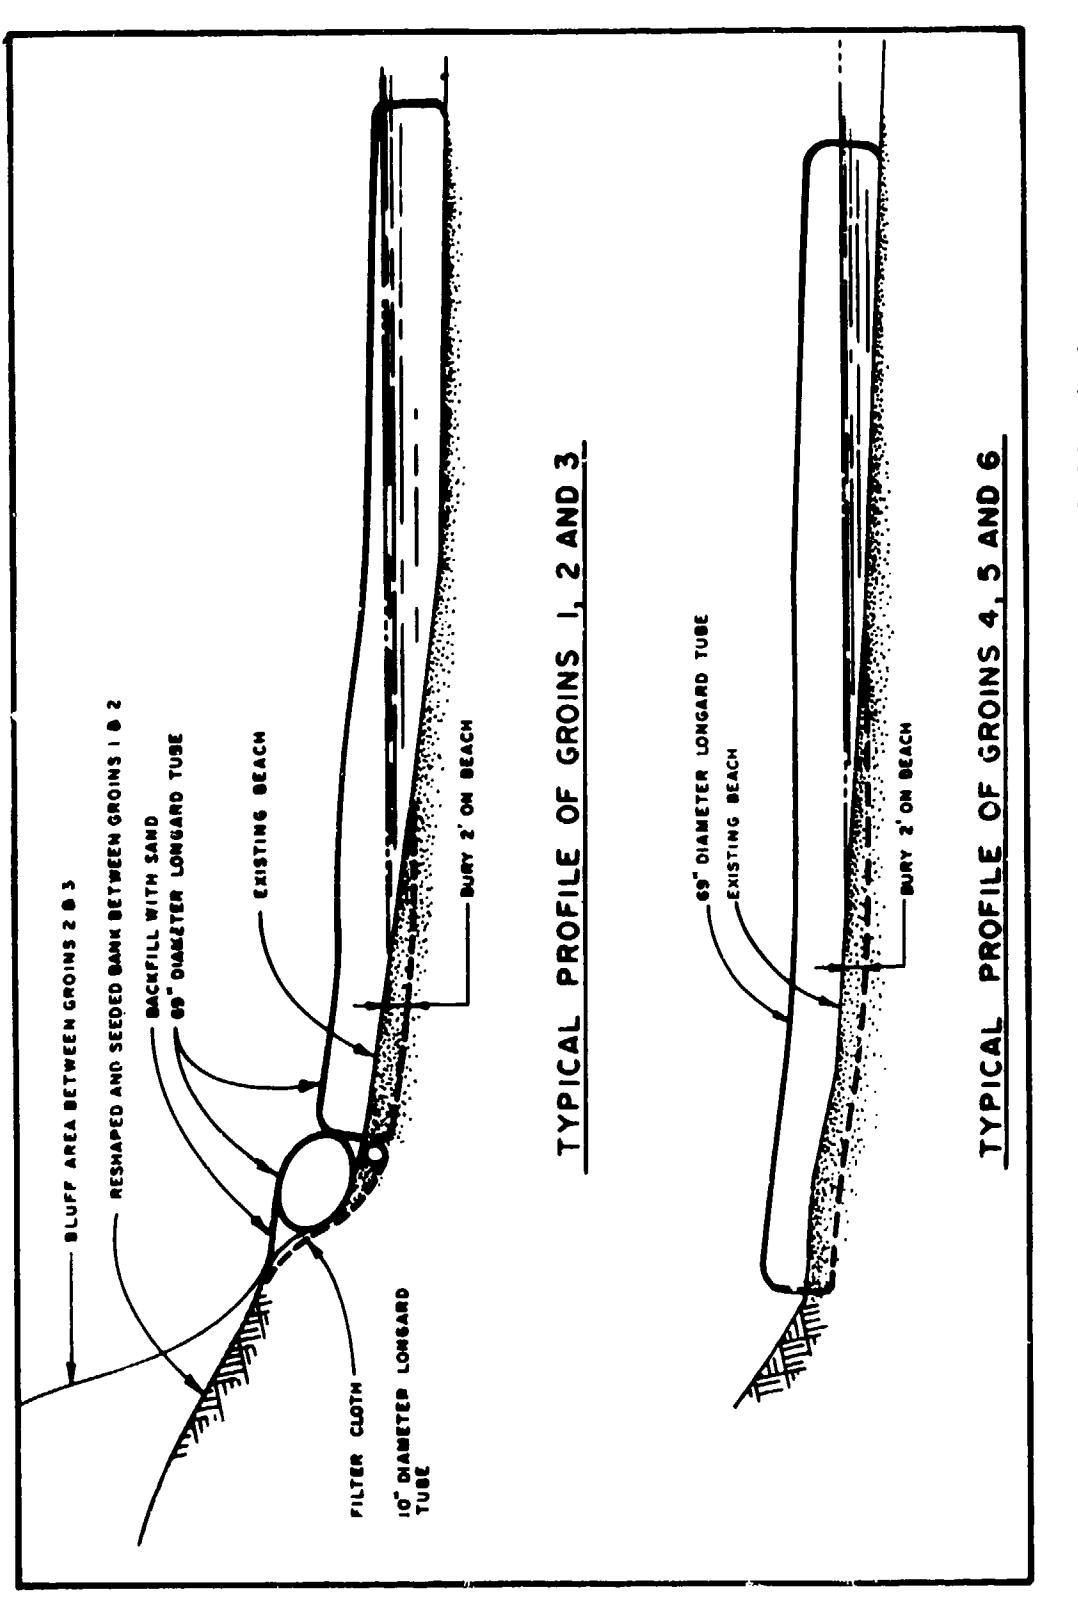
Figure 2-438. Profiles of groins 1 to 6 at Ashland site.

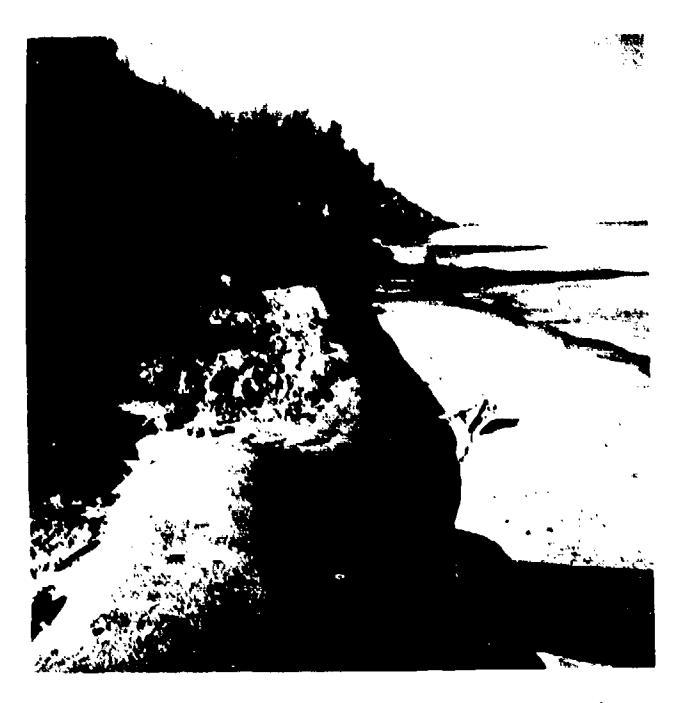
(h) Device 8 (Central Seawall). Although the central seawall was impacted by earthslides similar to those affecting device 7. the seawall initially held its original position better. The initial site visit on 31 October 1978 revealed some settlement and lakeward bulging of the Longard tubes, but no overall displacement (Fig. 2-471). Although the west-end bulkhead was nearly destroyed (Fig. 2-472), the abutment at the east end remained in good condition. After the 1979 spring thaw, the structural integrity of the seawall was still intact; however, the protective epoxy coating had begun flaking off in many places (Fig. 2-473). By the 25 September 1979 visit, the movement of the seawall segment between groins 2 and 3 had become apparent (Fig. 2-474). Further erosion of the beach during the October storms allowed the tube to 1011 lakeward, leaving a gap between the seawall and the bluff. Earthslides also pushed the seawall lakeward. This section of the seawall had settled, allowing overtopping waves to erode backfill and slumped bluff material. The erosion rate had increased substantially, exposing the underlying filter cloth (Figs. 2-475 and 2-476). By May 1980 accretion on the beach prevented most waves from reaching the tube, although storm waves had apparently thrown sand on the berm behind i. (Fig. 2-477).

Figure 2-471. Longard tube of central seawall between groins 2 and 3, Ashland, Wisconsin, 31 October 1978.

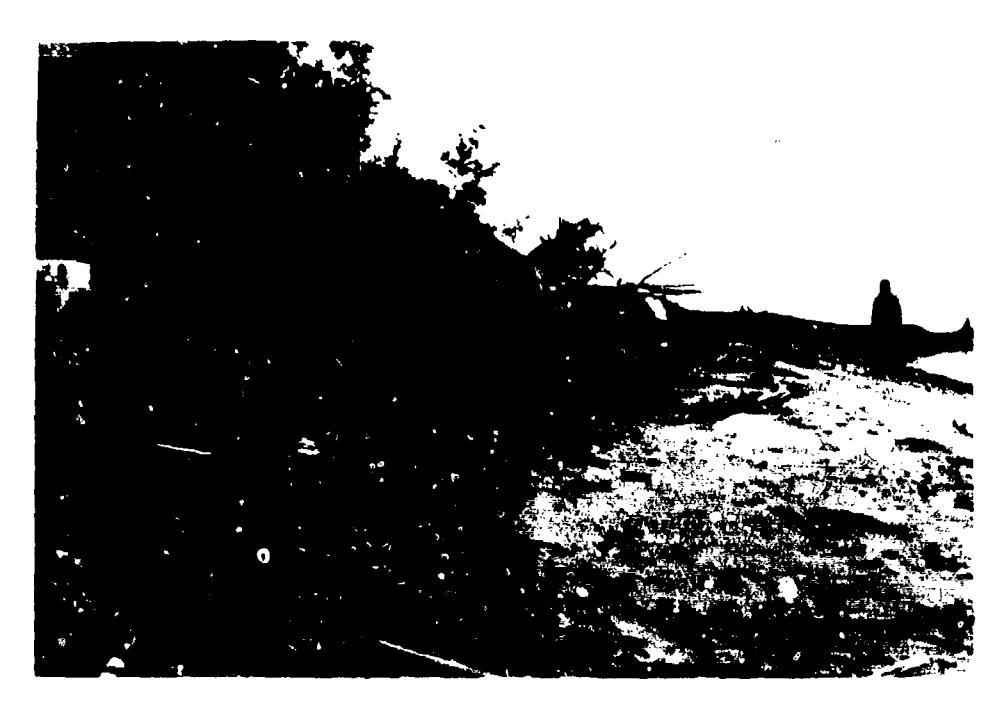
(i) Device 9 (East Seawall). This Longard tube with its protective epoxy coating withstood the environmental forces well. An October 1978 photo showed debris scattered along the seawall and a small pile of sand which had spilled from a hole in the side of the tube (Fig. 2-478). However, over the next 9 months, the jole did not enlarge and little additional interior sand was lost. By July 1979 the western end of the tube had rolled slightly lakeward, but there was no overall displacement of the seawall; the timber abutment at the east end remained in good condition (Fig. 2-479). The hole in the Longard tube eventually increased in size, and by August 1979 the loss of interior sand became more apparent (Fig. 2-480). At that time several additional small holes were discovered, apparently caused by vandalism; however, the punctures did not enlarge and therefore presented no problem (Fig. 2-481). As of May 1980 the structure still remained intact.

Figure 2-480. Sand loss from puncture hole in the east seawall, Ashland, Wisconsin, 16 August 1979.

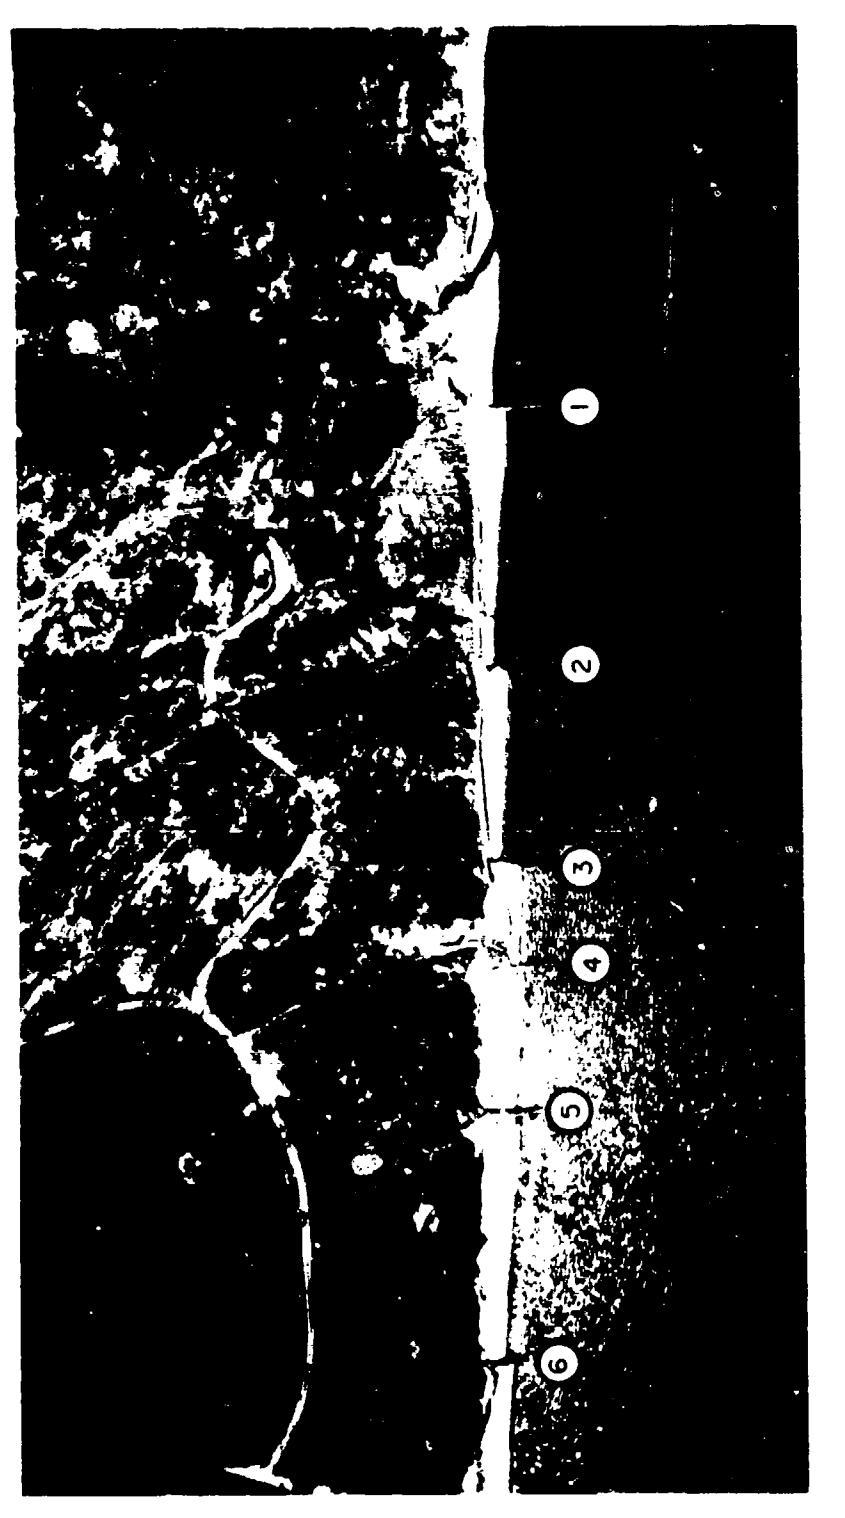
primarily due to a seasonal increase in littoral drift (the result of a change in lake level, wave climate, or amount of sediment provided by streams). Figures 2-482 and 2-483 show the sand accumulations. Groins 1 and 3, however, did trap sediment as shown in Fig. 2-484.

Sand accumulation on the updrift sides of the groins, Ashland, Wisconsin, 24 May 1979. Figure 2-482.

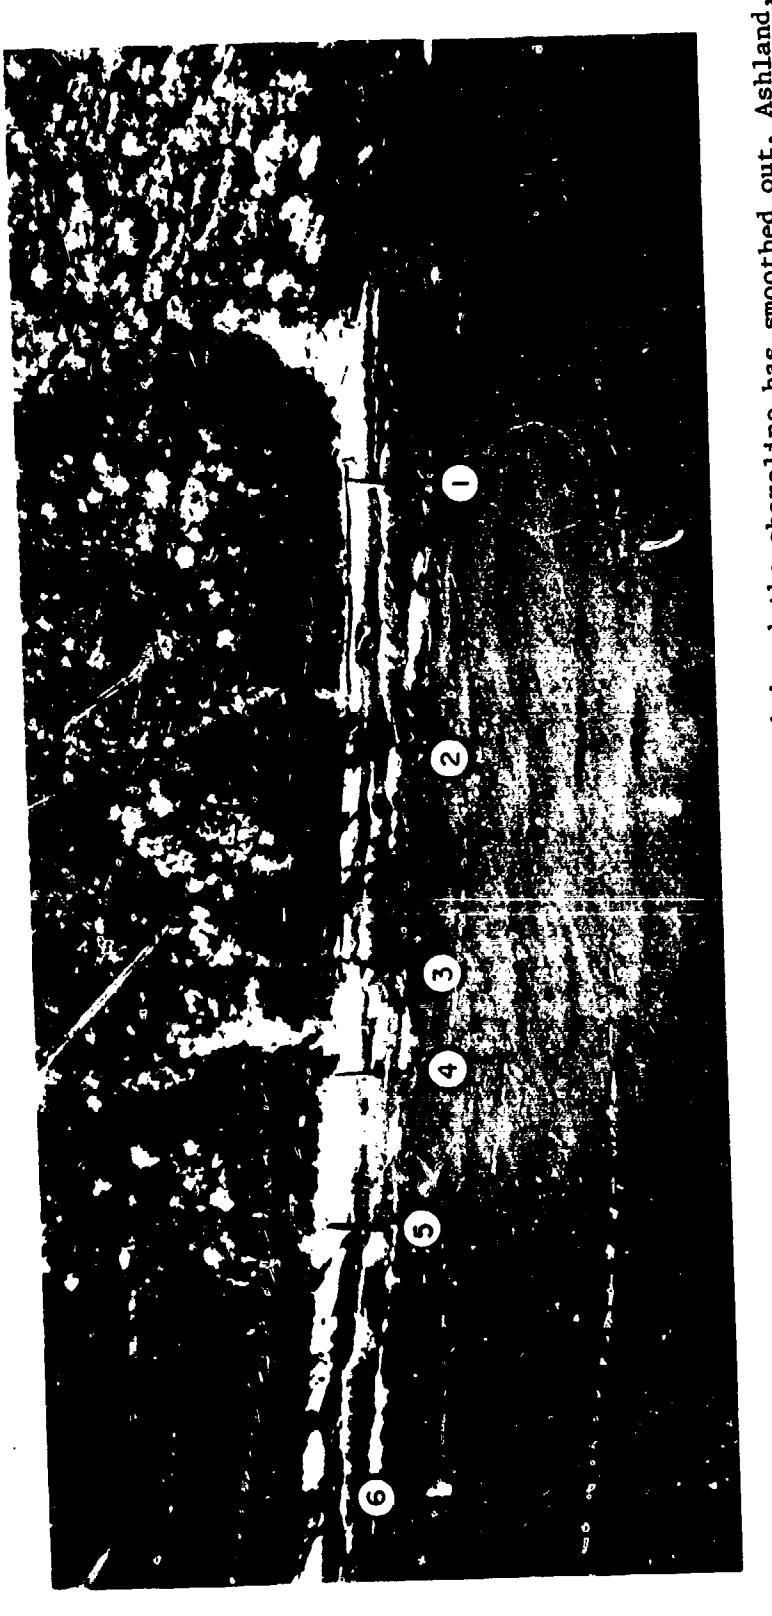
Most of the sand fillet material has eroded and the shoreline has smoothed out, Ashland, Wisconsin, 17 October 1979. Figure 2-483.

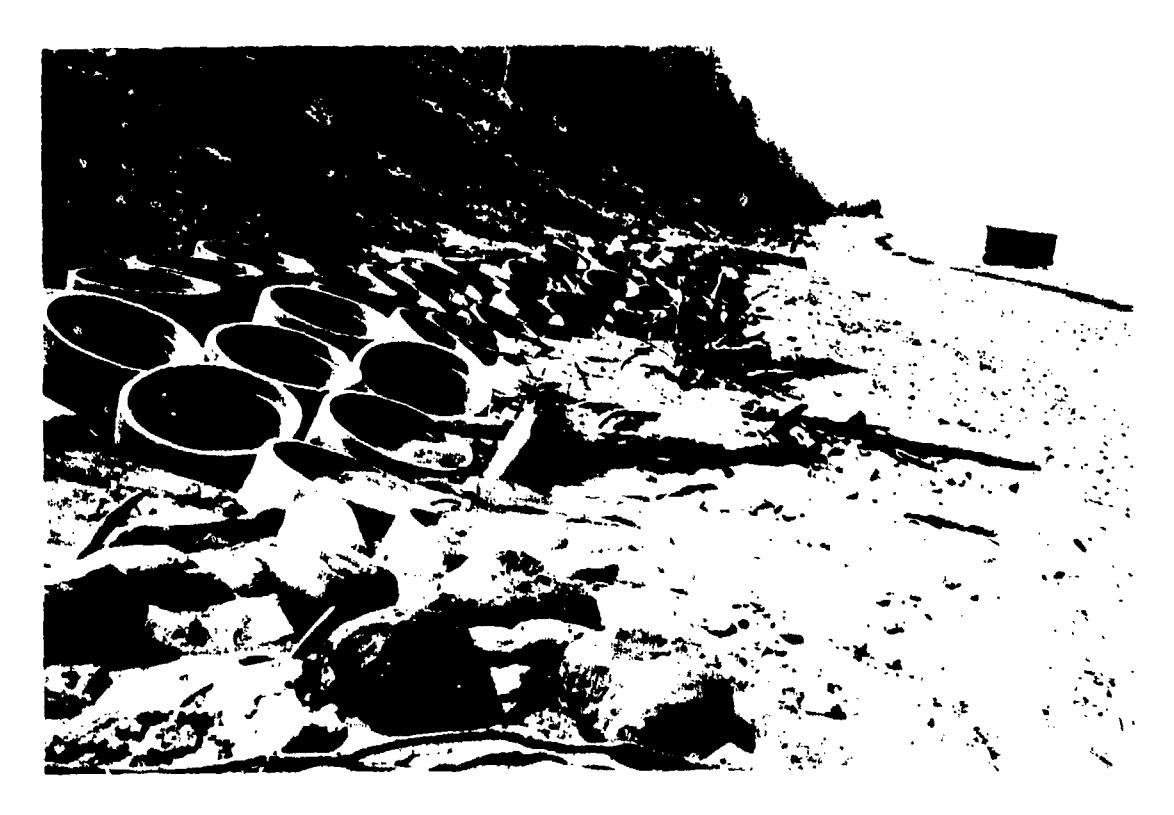
(b) <u>Performance</u>. During the first year, most of the rings remained stable. The eastern segment of the revetment was forced upward along its landward edge, apparently as a result of subgrade upheaval due to surcharge loading imposed by the slumping bluff. However, the western end remained in its original position. Some of the lower rows were covered with beach sand, and rings farther up the slope continued to fill with sand (Fig. 2-489).

Figure 2-489. Nami rings after 7 months of service, note displacement and sandfill, Little Girls Point, Michigan, 21 May 1975 (from Brater, Armstrong, and McGill, 1975).

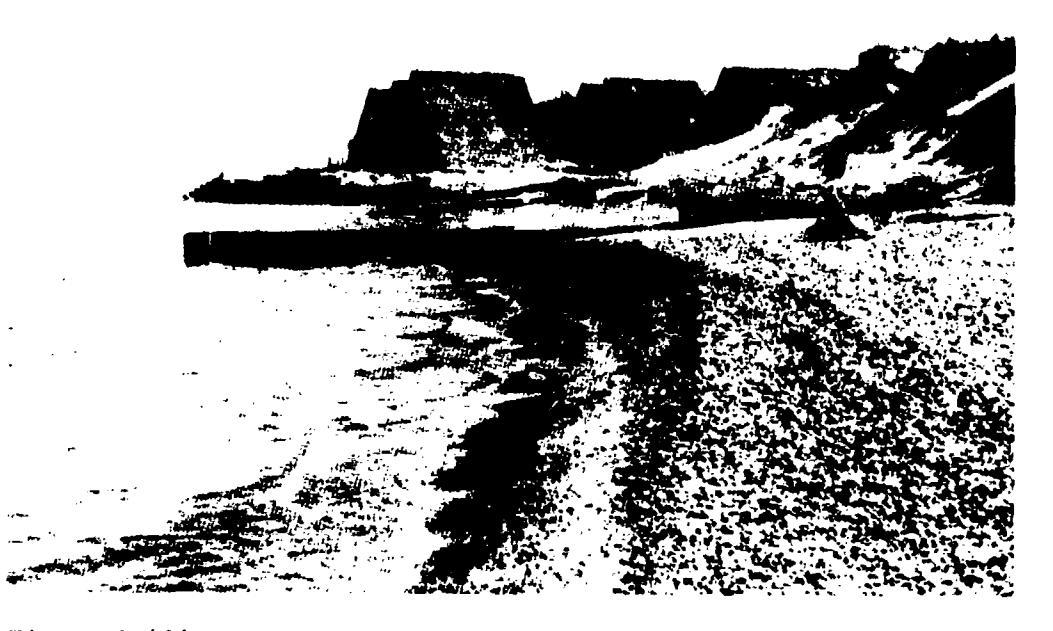
The timber groin performed well and showed no sign of deterioration (Fig. 2-494), thus providing additional evidence that wood is an excellent material for groin construction in the Great Lakes. An impervious timberpile groin is an old and proven means of shore protection in areas where there is adequate littoral drift moving predominantly in one direction. The relatively wide spacing between the groins did not reduce their functional effectiveness, and the system has protected the site by trapping sand and raising the beach profile. Much of the sand retained by the Longard tube before it failed is still on the beach, and it together with that retained by the timber groin is still protecting the bluff, although some minor slumping has occured. This slumping is probably due to factors other than simply wave attack, such as wind erosion or heavy foot traffic on the bluff.

Figure 2-494. Timber groin in good condition, Lincoln, Township, Michigan, 6 May 1976 (from Brater, Armstrong, and McGill, 1977).

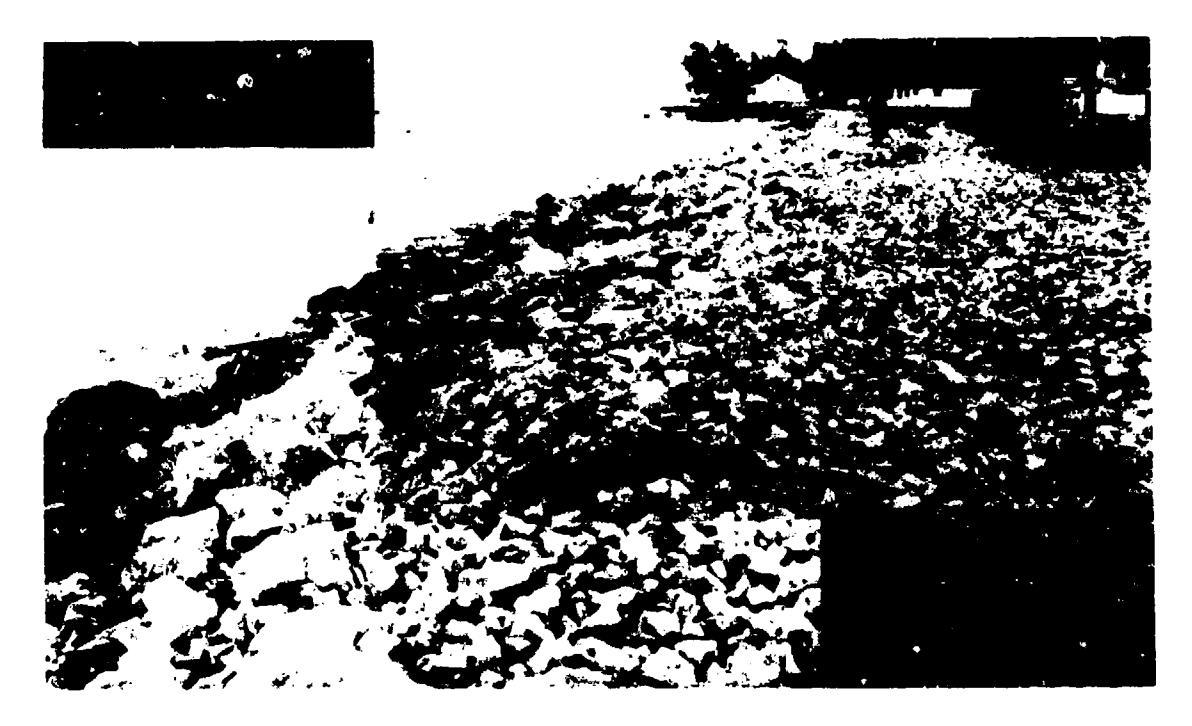
Figure 2-506. South end of revetment, Tawas Point, Michigan, 9 October 1979.

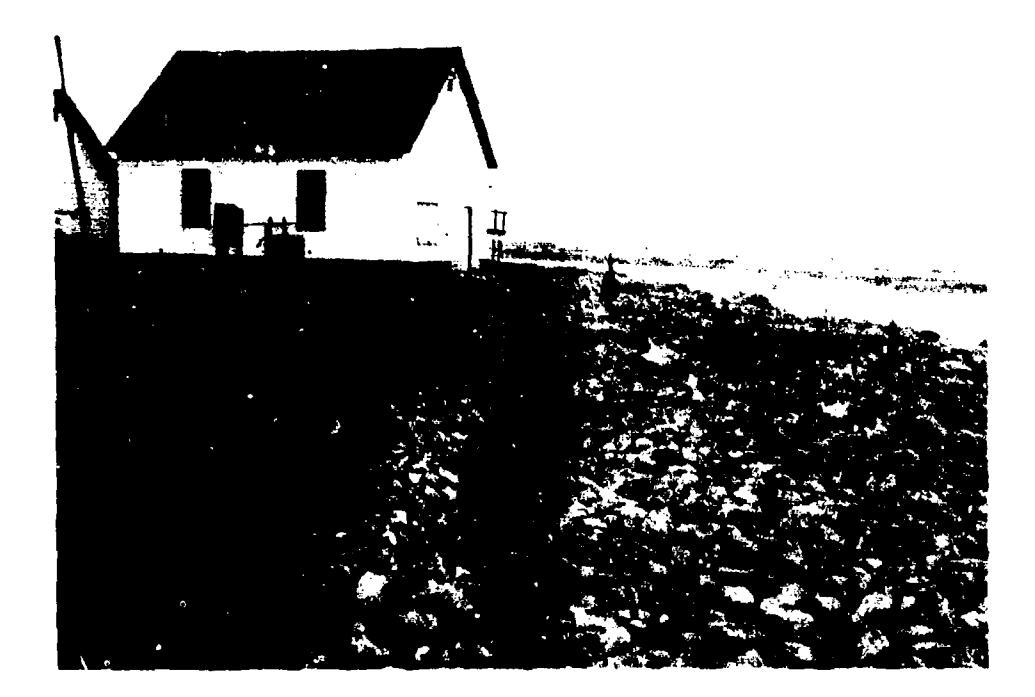
(3) Performance. Although only minor storms occurred during the first 2 years, slight slumping and shifting of the rock was evident. At the conclusion of monitoring by the State of Michigan in 1976, the structure was considered to have been very effective in protecting the shoreline. Although slight additional movement of rocks occurred after 1976, the rock revetment is still performing well, preventing further shoreline recession at the site. When monitoring under the Federal program began in September 1979, little further shifting of the rocks was apparent; however, in October 1979, a shallow depression (about 3 to 6 inches deep) along the landward edge of the revetment was noted (Fig. 2-506). This was apparently due to a slight settlement or shifting of rocks along the back of the revetment. On 26 November 1979, 39-knot winds from the south-southeast produced waves 8 feet high at the Tawas site (compared to an average sustained wave height of 4 feet during the 2 weeks before the initial visit on 4 September 1979). The 5 December 1979 visit revealed no significant changes since the October visit; this very effectively demonstrated the structural adequacy of the revetment. By 4 January 1980, the depression along the landward edge of the revetment had deepened to about 1 foot (Figs. 2-508 and 2-509). At

Figure 2-509. Looking north at depression along back of revetment, Tawas Point, Michigan, 4 January 1980.

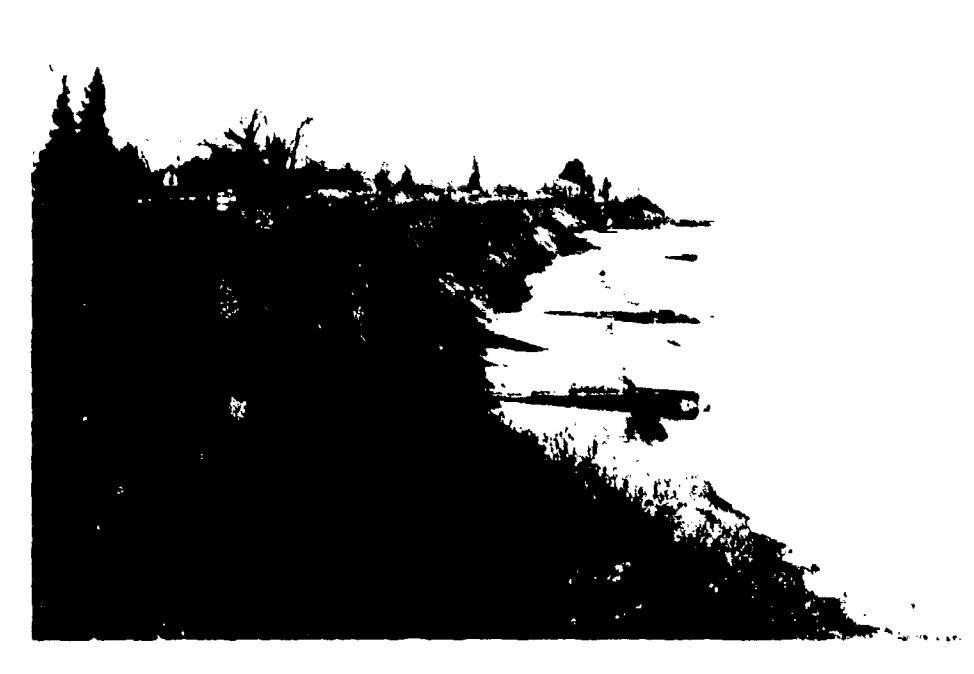
Figure 2-521. View of site looking north, Sanilac Section 26, Michigan, 26 December 1979.

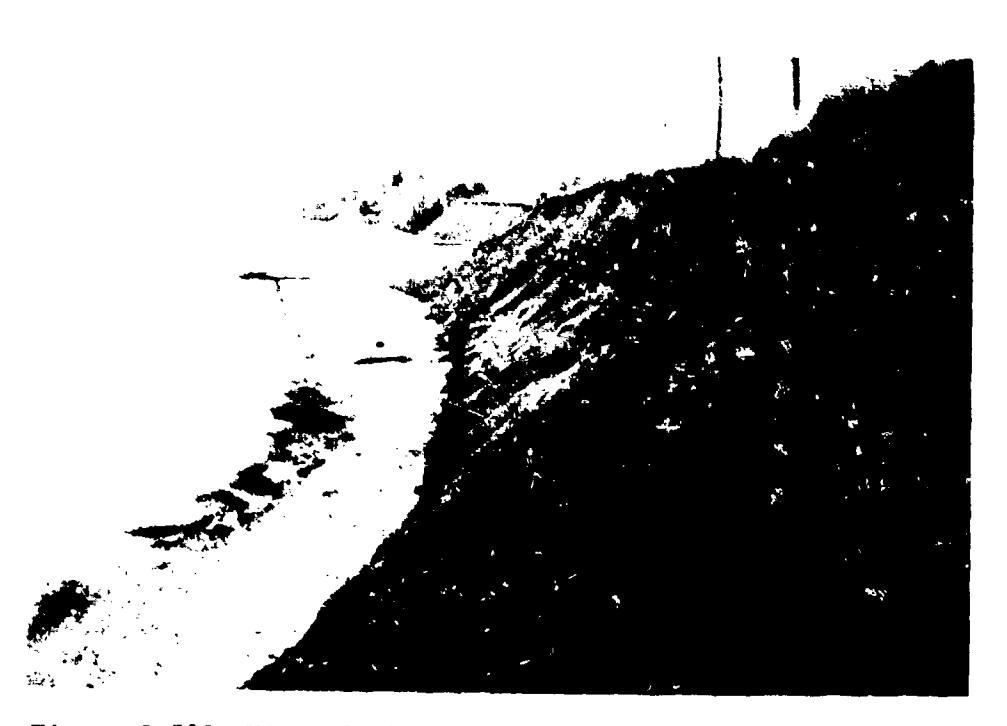
Figure 2-522. View of site looking south, Sanilac Section 26, Michigan, 26 December 1979.

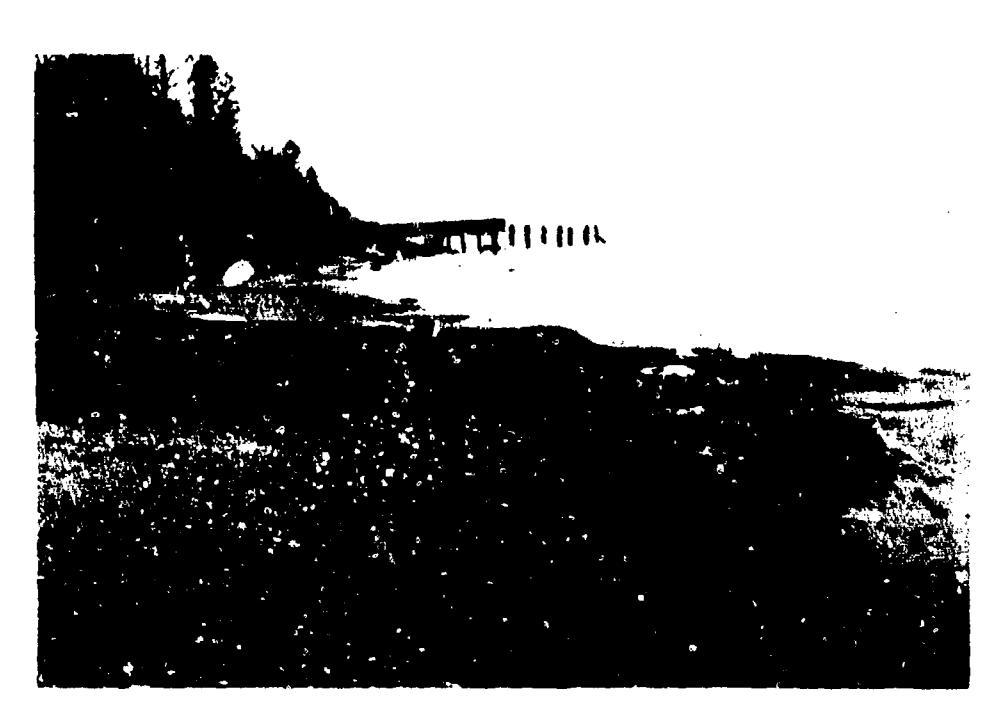
Figure 2-525. Two 40-inch-diameter Longard tubes, Sanilac Section Michigan, 26 December 1979.

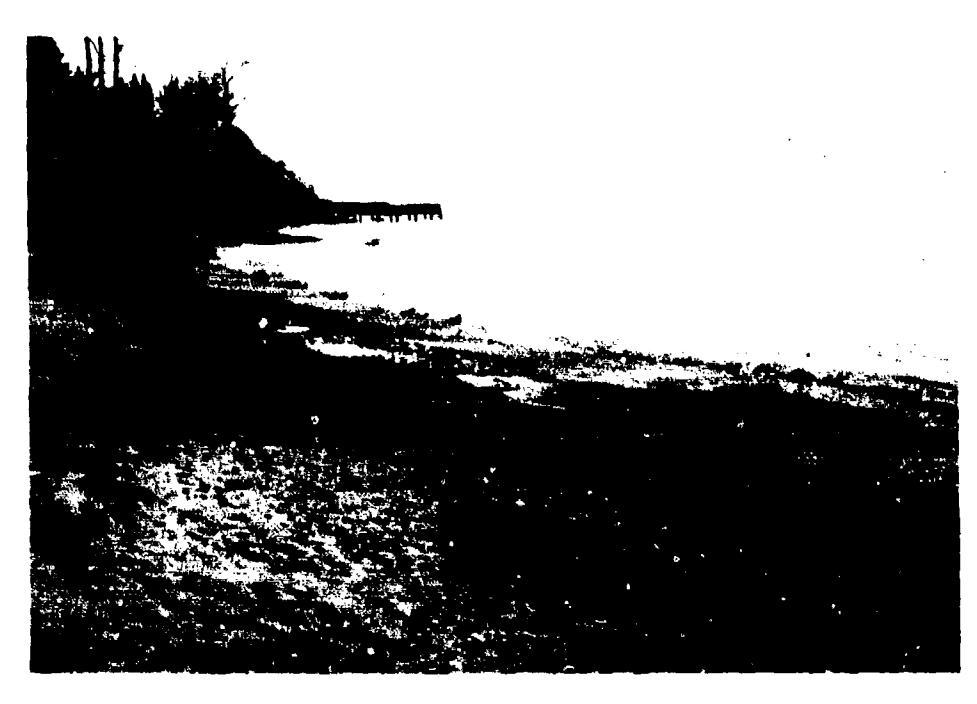
Figure 2-529. Loss of sand from 69-inch-diameter Longard tube, Sanilac Section 26, Michigan, 26 December 1979.

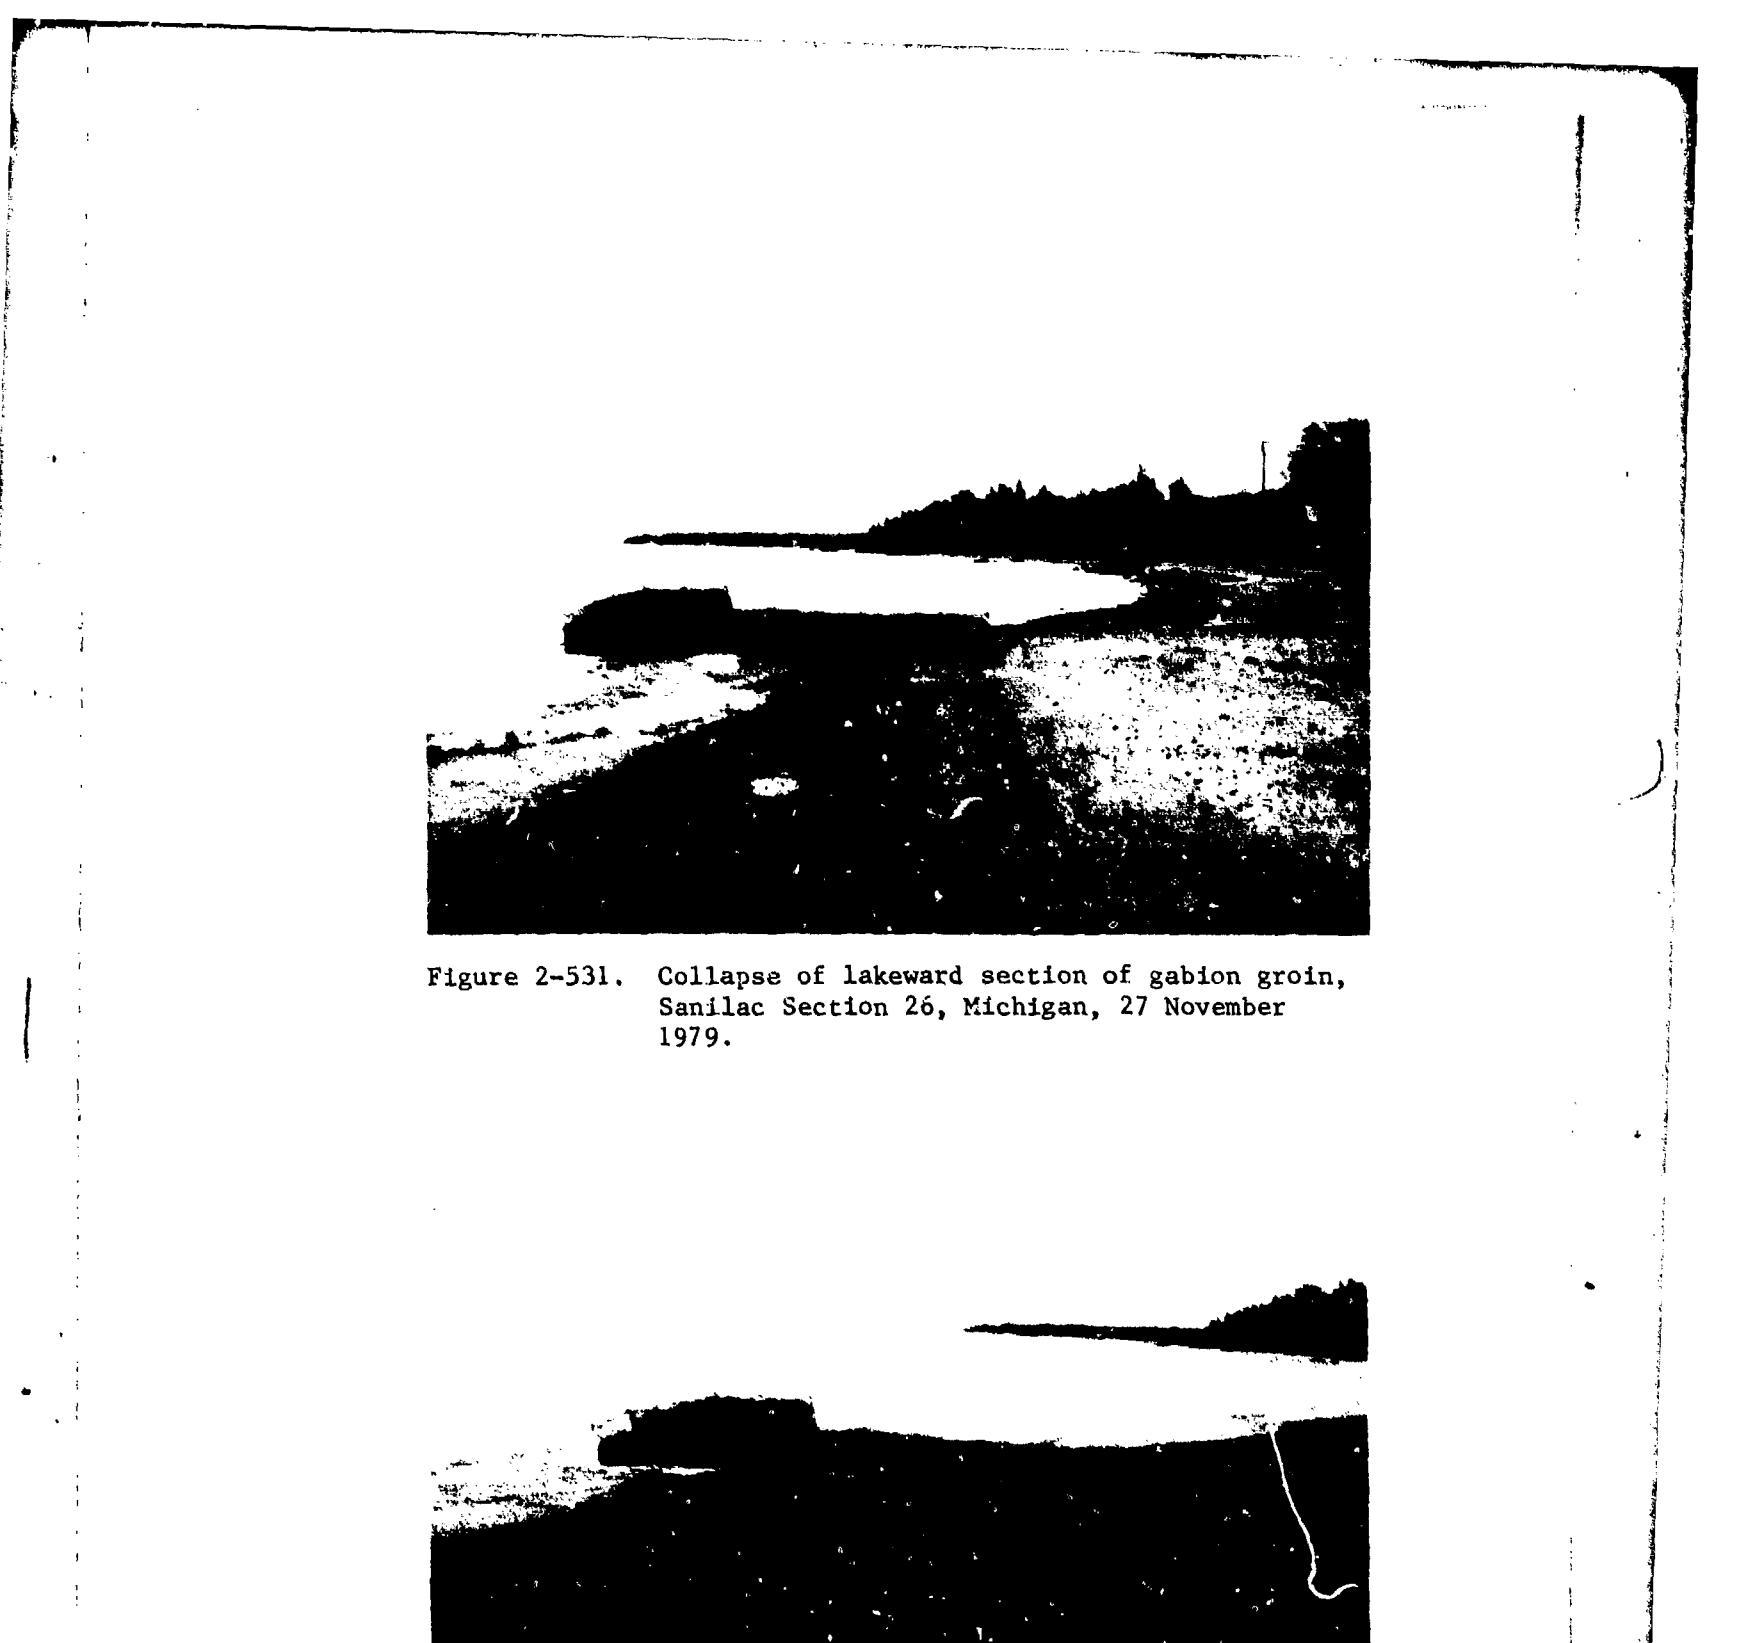
years after installation, was due primarily to the tendency of the bluff material to adjust to a more stable slope. Bottom scour at the lakeward end of the gabion groin increased to the extent that this section of the groin began to collapse in fall 1979 (Figs. 2-531 and 2-532). Settlement of the rockfill inside the baskets was evident at that time. Although the bluff was unstable and slumping was evident at the November 1979 visit, both the beach and bluff were farther lakeward at this structure than on the downdrift side (Fig. 2-523). This was considered indicative of the effective performance of this structure. In December 1979, the beach profile appeared to be about 0.3 foot lower to the north and up to about 0.5 foot lower to the south of the structure than it had been during the previous visits. No additional bluff slumping was evident at the December visit. The first two tiers of baskeds were fully exposed, and the third tier was exposed on the south side. In May 1980, the beach profile was 0.5 foot higher to the north and 1.0 foot higher to the south of the structure.

Figure 2-532. Loss of rock from collapsed section of gabion groin, Sanilac Section 26, Michigan, 26 December 1979.

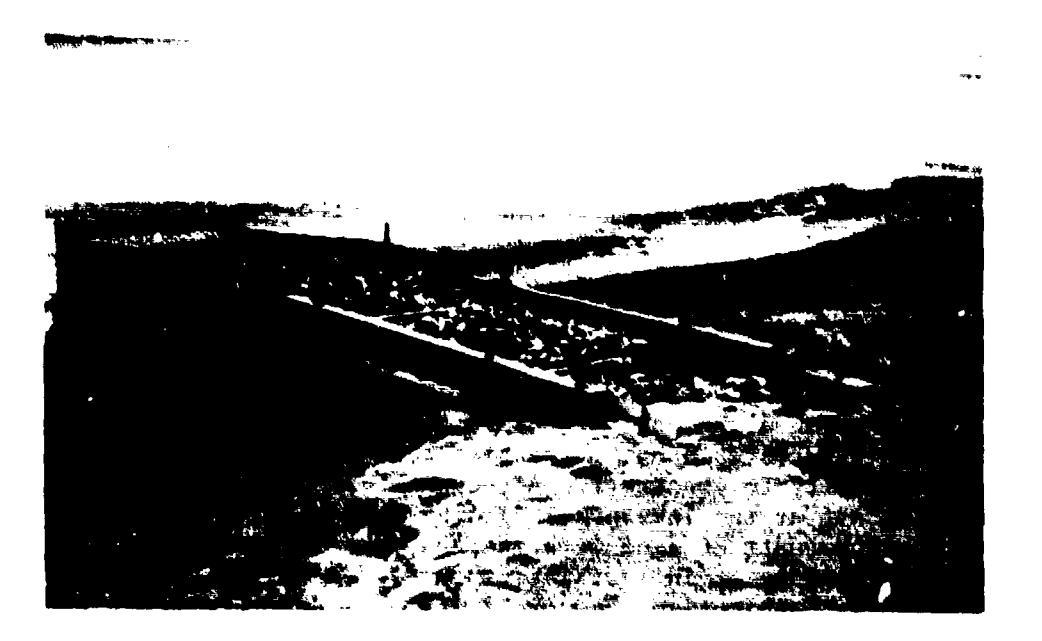
(b) <u>Performance</u>. The effectiveness of the timber-crib groin was not assessed by the State of Michigan because of insufficient monitoring time. The November 1979 visit by the District monitor revealed that the rockrill level at the lakeward end was about 1 to 1.5 feet below the top of the crib (Fig. 2-537). This could have resulted from settlement, loss of rock due to wave action, or vandalism. By December 1979, rocks in the lakeward section were about 2 feet below the top of the crib (Fig. 2-538). The crib was exposed only to midbeach in November 1979, but 1 month later it was exposed back to the top of the slope, indicating a lower beach profile. The bluff appeared to be stable. By April 1980, the beach had narrowed significantly, especially north of the groin. By May the beach

Figure 2-537. Settlement or loss of rockfill from timbercrib groin, Sanilac Section 26, Michigan, 27 November 1979.

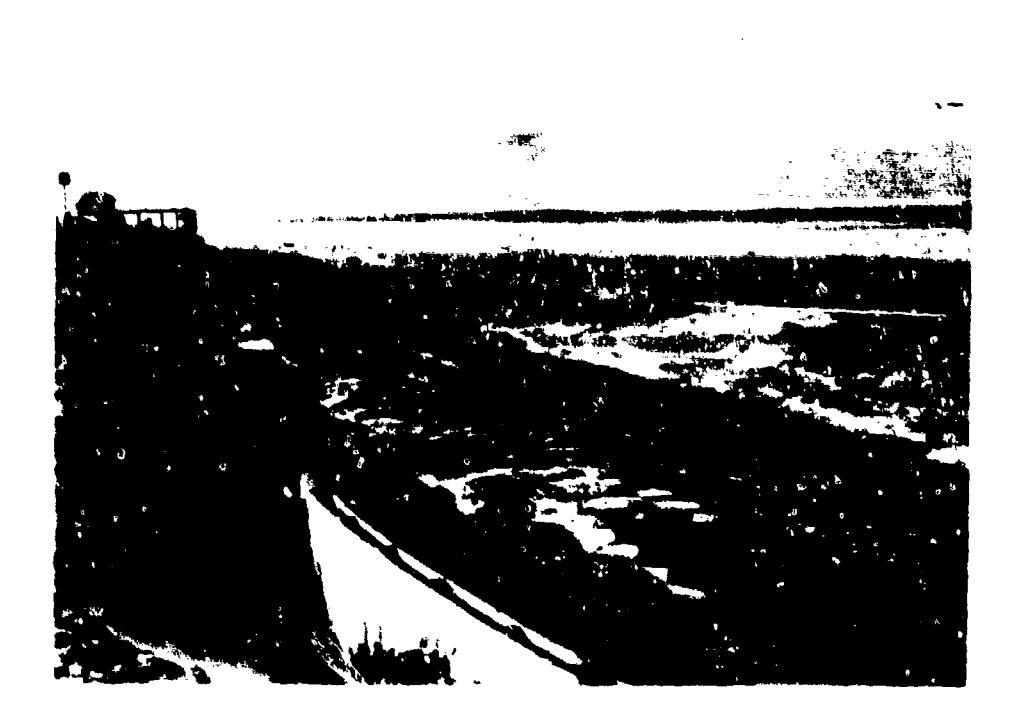
(a) Barrel Revetment. Construction of the 200-foot barrel revetment was nearly completed in September 1978 when inclement weather forced cessation of work for the winter. Many of the barrels needed to be filled to the top with sand and gravel, or capped on the upper tier (Figs. 2-546 and 2-547). The tiers were connected with four perpendicular diaphragms to create three closed cells with two open ends (upper Figure 2-543). By June 1979, considerable littoral drift was accumulating on the south side of the southern diaphram. Some gravel collected on the south sides of the remaining diaphragms, and minor erosion occurred on the downdrift sides of all diaphragms. The two northernmost cells showed evidence of beach sand and gravel filling in behind the seaward shore-parallel double row of barrels (Fig. 2-548). The tops of three of the uncapped barrels were deformed by ice pressure or debris impact. The barrels were located on the seaward row, two from the north end (Fig. 2-549), and one from the center north diaphragm (Fig. 2-550). The proposed sandbag caps were deleted from the construction schedule, and beach gravel alongside the revetments was used to top off the barrels. The construction was completed in August 1979. No other changes in structural alinement, material, or cross section were observed. The accretion and depletion patterns also remained unchanged through October 1979.

Figure 2-546. View of barrel revetment, Kotzebue, Alaska, 12 October 1978.

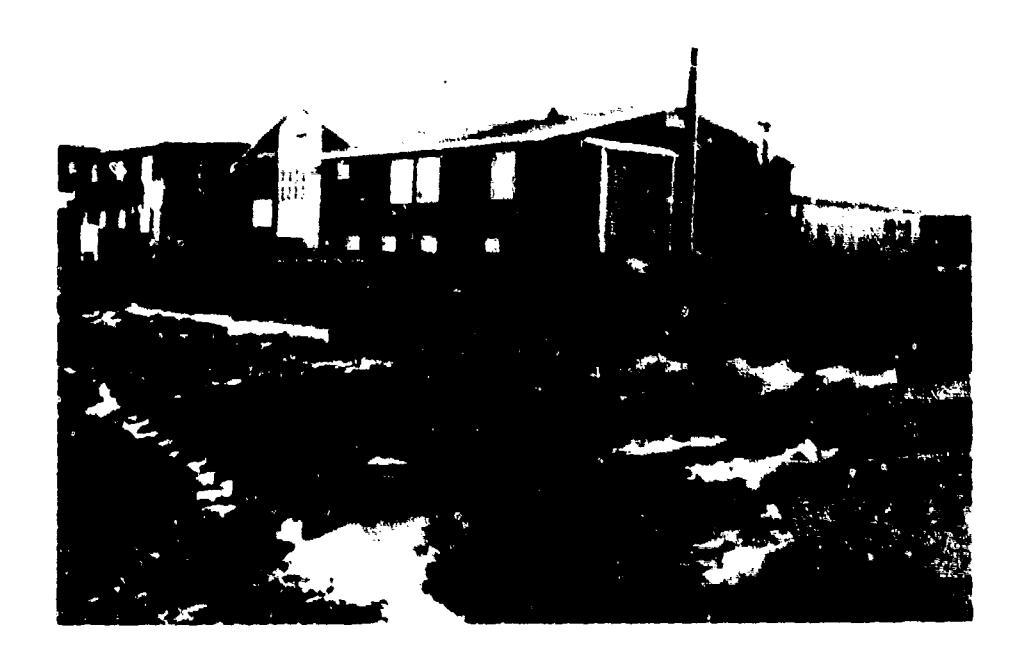
Figure 2-547. Barrel revetment shortly after initial construction, Kotzebue, Alaska, 12 October 1978.

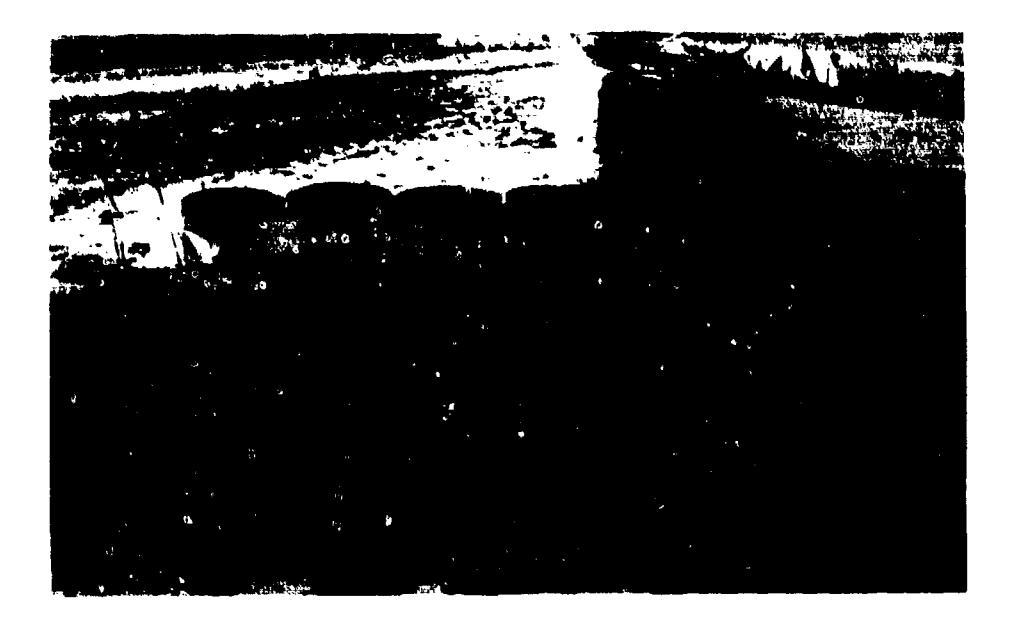
Figure 2-569. Groin D, Kotzebue, Alaska, 11 October 1978.

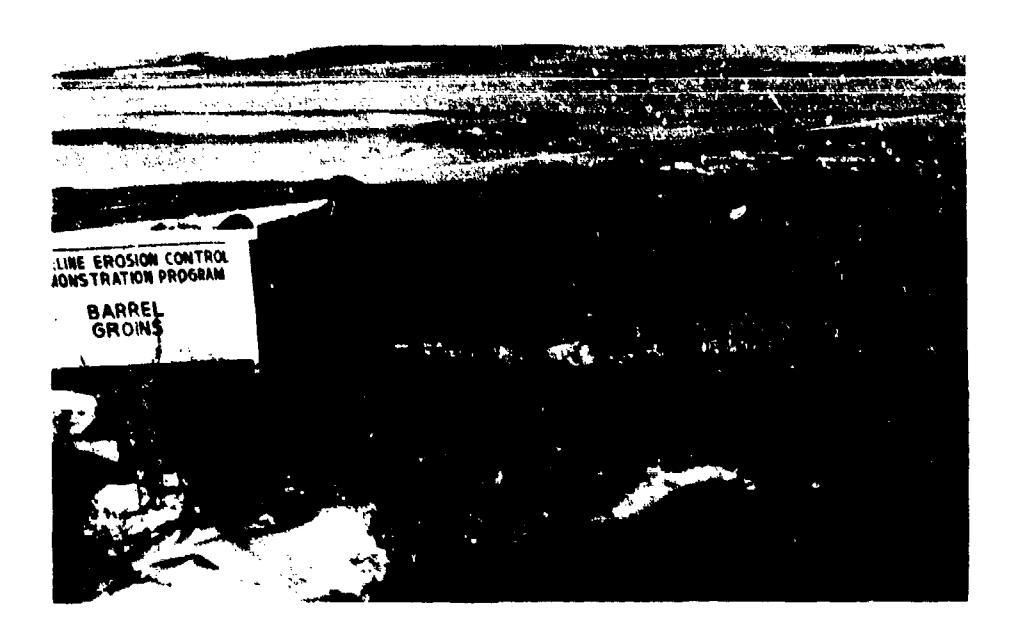
Figure 2-570. Groin E, Kotzebue, Alaska, 11 October 1978.
