### LOW COST SHORE PROTECTION

A Report on the Shoreline Erosion Control Demonstration Program (Section 54 Program)

Office, Chief of Engineers U.S. Army Corps of Engineers Washington, D.C. 20314

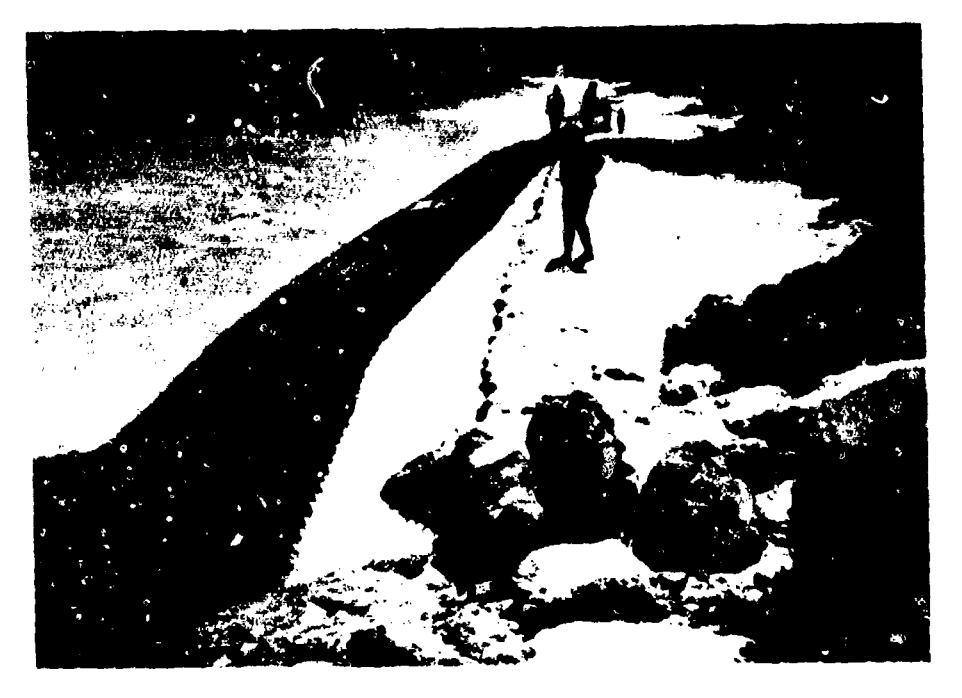
Figure 2-620. Seaward settlement of Sandgrabber, Bellows Beach, Hawaii, 5 September 1979.

Some structural performance problems developed at this site which a few comments might help to mitigate at future installations. First, since the sand at Bellows is fine grained, the settlement of the seaward side of the structure due to toe scour should have been anticipated, and bedding should have been provided or the foundation trench should have been excavated to the anticipated scour depth. Second, the Sandgrabber is not sufficiently flexible; it can be damaged by uneven settlement. This was clearly demonstrated at this site by comparing the north and south ends of the installation (Figs. 2-627 to 2-630). At the north end, the Sandgrabber settled on the adjacent, existing coral rock revetment and, due to inflexibility, was unable to conform to the scouring bottom (Fig. 2-630). As a result, the north end of the structure was damaged. This problem might have been avoided had the structure not settled as much, had the structure been more flexible, or had the north end of the Sandgrabber not been constructed such that it settled onto the rock structure. Third, if differential settlement of the Sandgrabber is anticipated, elastic "ties" of some sort might be substituted for the steel tie rods. This would eliminate the breaking of blocks that results from excessive stresses due to inflexibility of

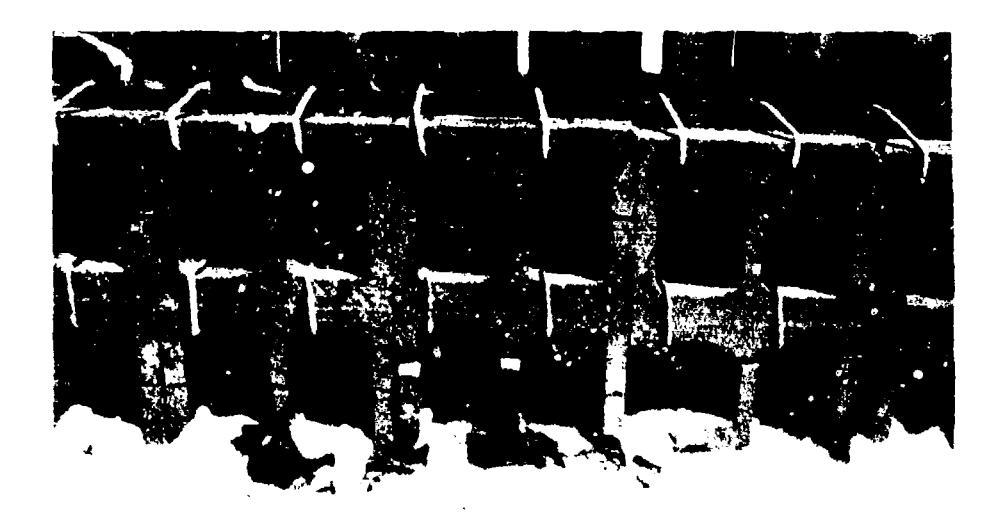
(4) <u>Performance</u>. Generally, the concrete blocks and galvanized-steel tie rods of the Sandgrabber withstood the natural forces of waves and tides. Some settlement was detected about 1 week after installation, but there was negligible differential shifting of individual blocks. One block and one tie rod were broken at the north end as the structure settled against the adjacent revetment stone (Fig. 2-619). Over the next 5 months, the structure continued to settle, rotating downward on the seaward side. This resulted in a few loose tie rods, but the blocks remained intact. During August 1979, the seaward settlement increased, with a seaward slope of 5° on the south end, 11° along the midsection, and 15° on the north end (Fig. 2-620). About eight blocks on the northern landside were broken apart by tension forces exerted by the tie rods as a result of seaward settlement (Fig. 2-621).

Figure 2-621. Broken blocks, landward side, Bellows Beach, Hawaii, 5 September 1979.

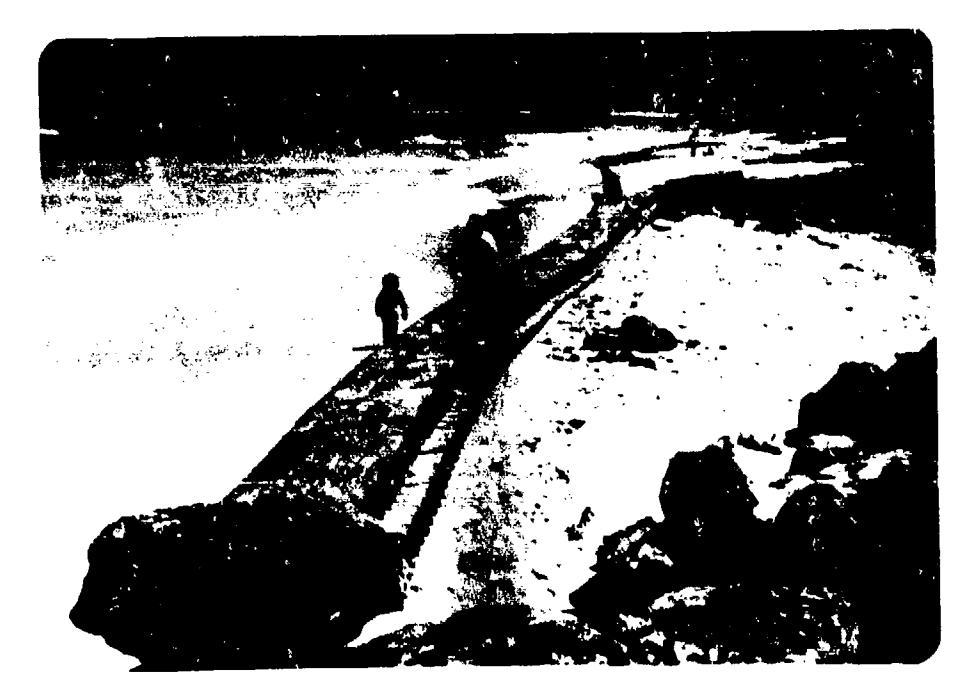
Figure 2-625. Scour beginning at the north end, Bellows Beach, Hawaii, 3 July 1979.

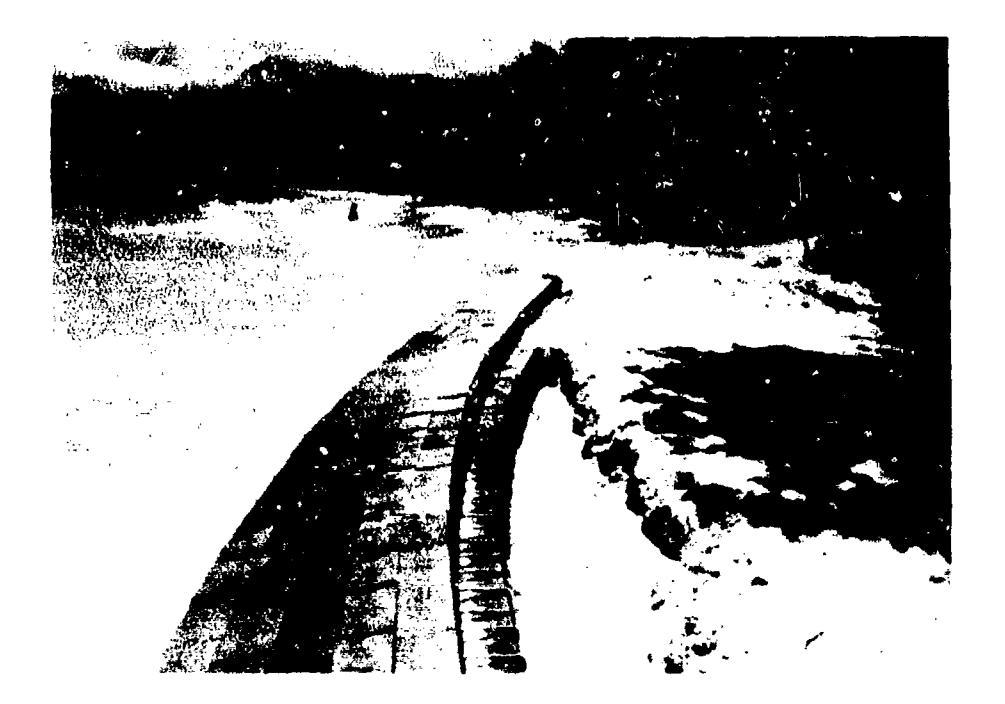
Figure 2-626. Trench working its way south landward of structure, Bellows Beach, Hawaii, 5 Sep-tember 1979.

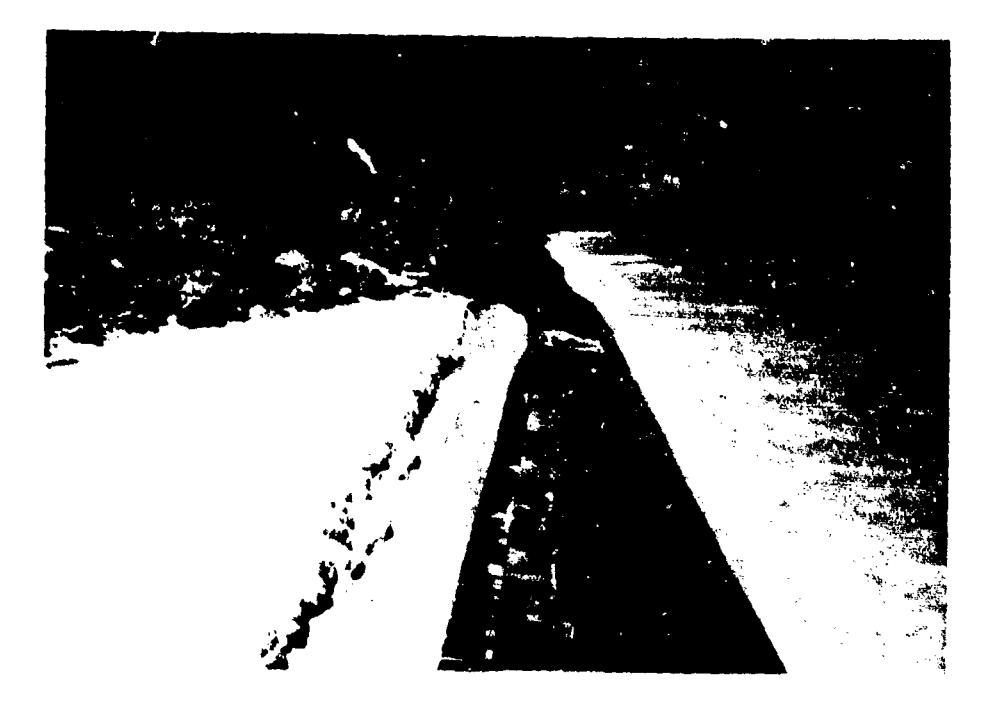
Figure 2-628. Scour trench along north end of structure, Bellows Beach Hawaii, 5 September 1979.

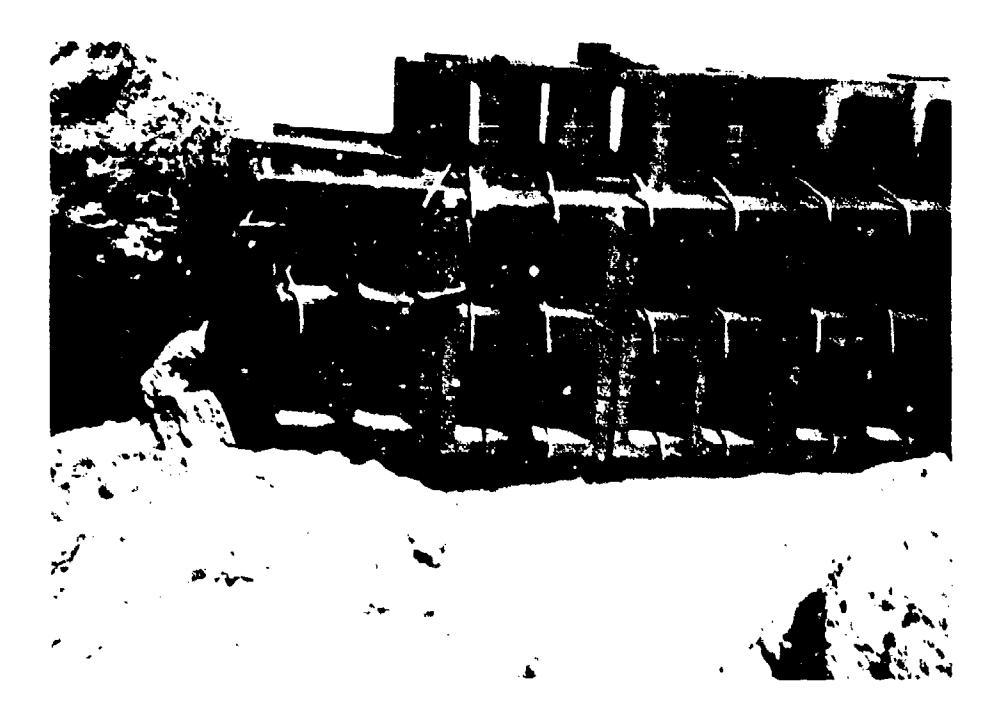
Figure 2-630. Landside of north end of Sandgrabber settling on the existing coral rock revetment, Bellows Beach, Hawaii, 5 September 1979.

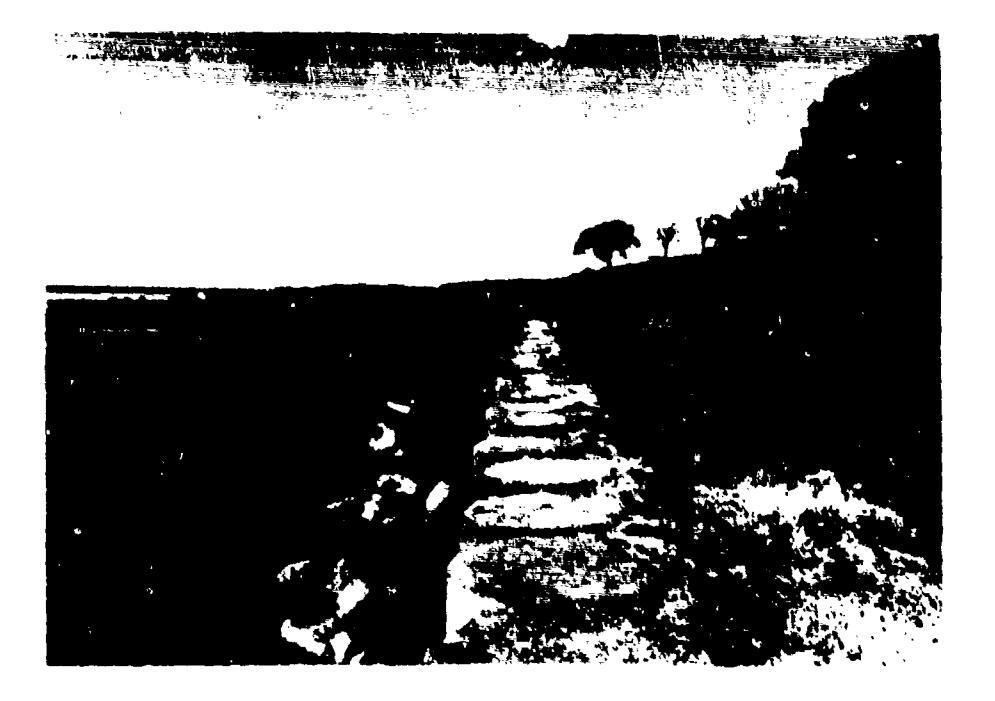
Figure 3-16. Concrete placed on top of and behind the pipe structure, McCollum Park, Beach City, Texas, 26 February 1980.

(4) Seal the tops of the pipe fills with about 2 inches of concrete grout to prevent washout by overtopping waves (Fig. 3-16).

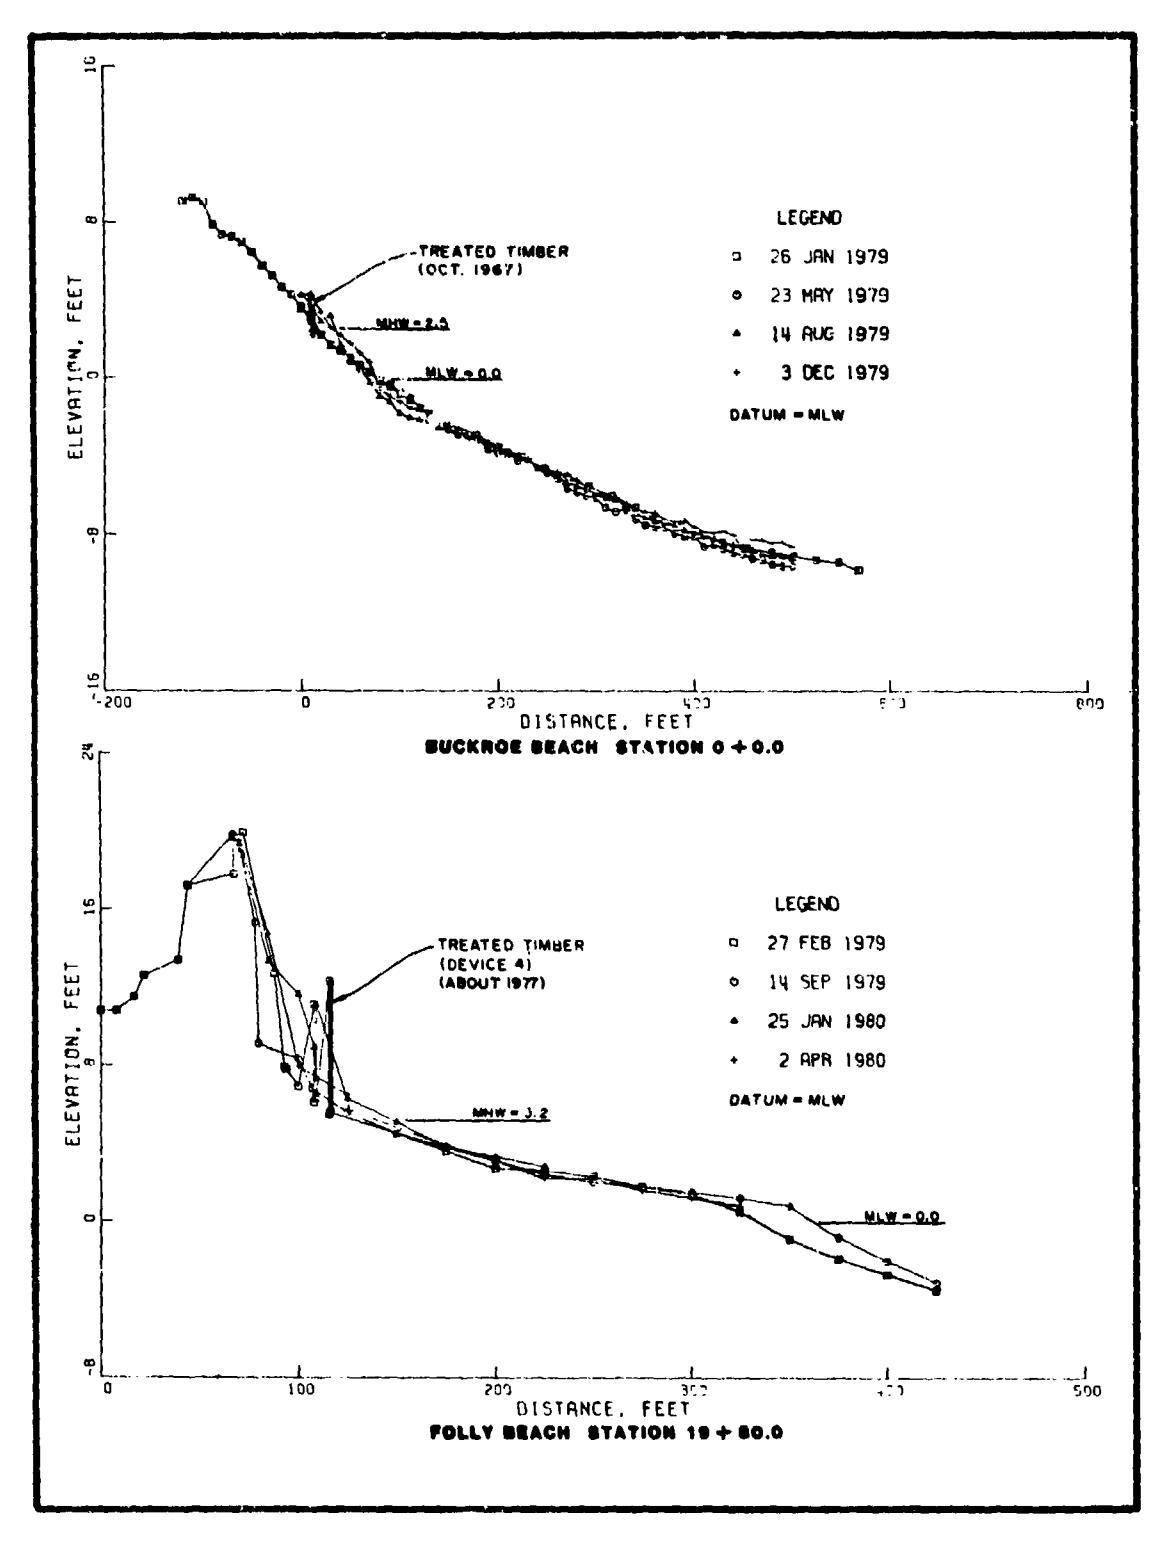
(1) <u>Treated Timber</u>. Profiles were compared at two sites where treated-timber bulkheads were monitored--Buckroe Beach, Virginia, and Folly Beach, South Carolina (Fig. 3-17) The bulkhead at Buckroe Beach was a timber sheet-pile structure which remained structurally sound throughout the monitoring period. This structure acted in conjunction with groins which maintained a protective beach berm that prevented waves from impinging directly on the bulkhead. The profiles show that the beach in front of the

bulkhead progressively accreted. This accretion is primarily due to the effect of the groins.

At Folly Beach, the bulkhead was also of timber sheet-pile construction, and it also remained structurally sound throughout the monitoring period. It performed well until September 1979 when hurricane waves overtopped and washed large quantities of material from behind the structure. The profiles show the material lost in September 1979, as well as the material replaced by January 1980.

Figure 3-17. Profiles of treated-timber bulkheads.

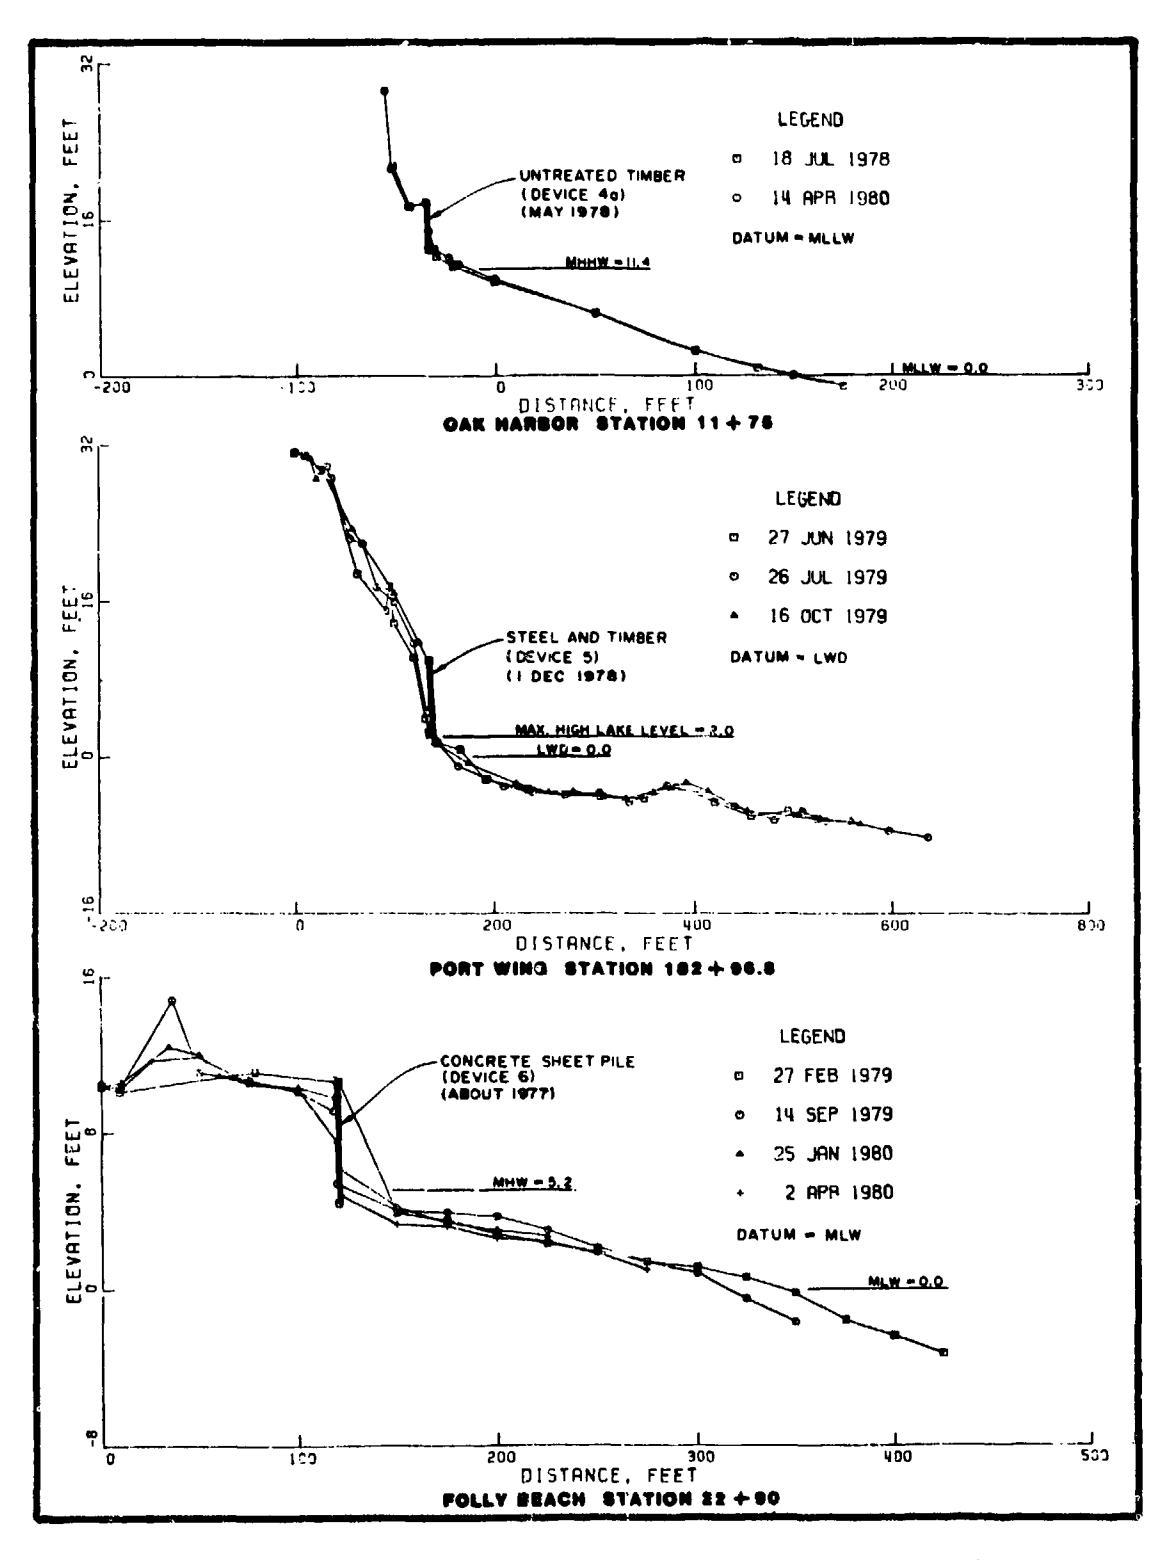
(3) Untreated Timber, Steel and Timber, and Concrete Sheet Pile. The untreated-timber bulkhead at Oak Harbor, Washington, was completely destroyed by wave action soon after its construction, and fill material behind the structure was removed. Figure 3-19 shows that although the structure was damaged and fill was lost, serious erosion of the bank behind it did not occur.

The steel and timber bulkhead at Port Wing, Wisconsin, suffered no damage during the monitoring period, and the profiles show that the structure adequately protected the bank, as no erosion was evident. The upper-bank aberrations in the profiles are due to grading work in progress. The bank was seeded in late July 1979.

The concrete sheet-pile bulkhead at Folly Beach, South Carolina, suffered some damage during Hurricane David in September 1979, and material behind the structure was removed by wave action, as shown by the profiles. New fill was later placed behind the structure, as shown by the April 1980 profile.

Figure 3-19. Profiles of untreated timber, steel and timber, and concrete sheet-pile bulkheads.

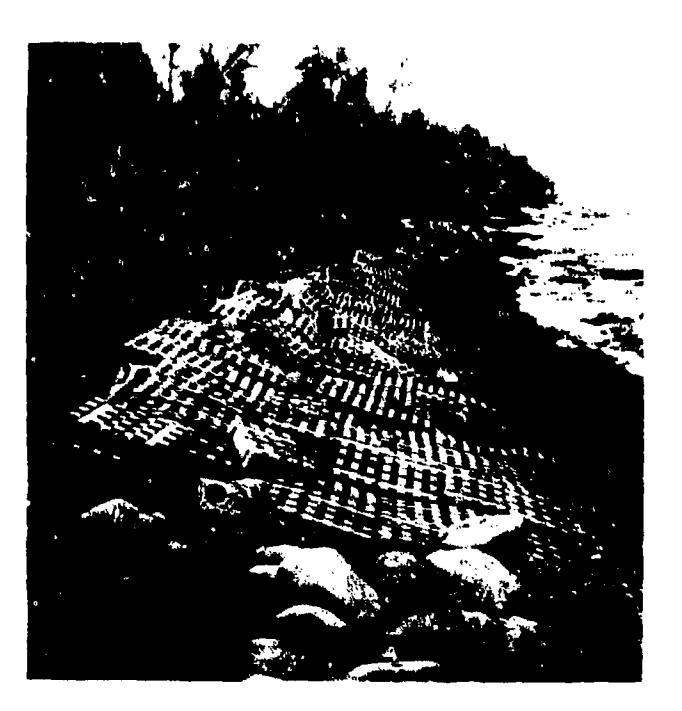
(2) Turfblocks. Turfblocks (Monoslabs) were used only at the Port Wing, Wisconsin, demonstration site in a revetment constructed in November 1978. The modules were placed over nonwoven filter cloth on a uncompacted granular fill containing large stones graded to a 1 on 3 slope. A few days after installation, the revetment was overtopped and badly damaged by storm waves on Lake Superior. After the storm, the modules were found to have been irregularly displaced and were covered with debris but not broken; the filter cloth was exposed in many places and the embankment slope was irregular, with evidence of sloughing in some areas. During the next 18 months, the revetment sustained little further damage, but displaced modules in the upper levels allowed high waves to erode the upper bank in a few places, and exposed surfaces of modules in the lower levels were severely abraded by wave-borne debris and cobbles (Fig. 3-23). Exposed areas of filter cloth had deteriorated badly. Poor subgrade preparation and possible filter cloth clogging was largely responsible for module displacement, and the abrasion due to cobble bombardment was not necessarily the result of defective concrete in the modules. Therefore, this one demonstration was not considered a fair test of the Turfblock revetment system. With proper installation in a less severe environment, there appears to be no reason why the system should not perform about as well as Jumbo blocks.

Figure 3-23. Displacement of Turfblocks, Port Wing, Wisconsin, 7 May 1979.

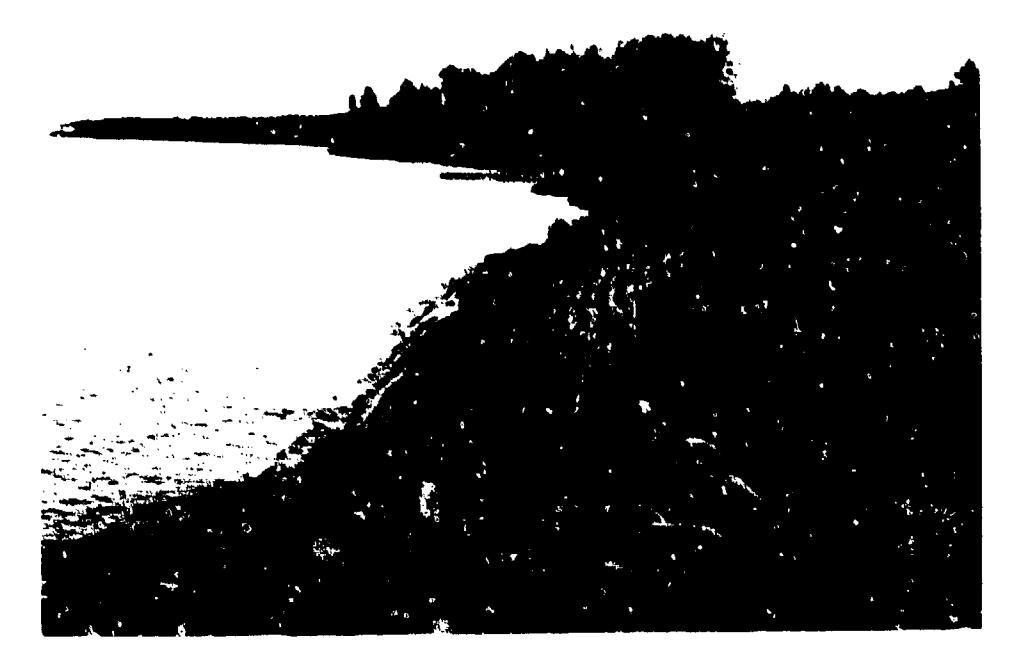
interlock. The control-block revetment was constructed in October 1978 of blocks laid on nonwoven filter cloth with their long axes parallel to the shoreline. The blocks settled irregularly on the uncompacted fill, probably because of the large stones it contained, and rows of blocks were misalined after the November 1978 storm that also damaged the Turfblock revetment. Because of their greater thickness act the interlocks, however, they were less susceptible to overtuning by waves. Revetments of both block widths remained essentially intact during the next 18 months and continued to protect the upper bank (Fig. 3-24). Apparently, the width of the block did not affect its performance. As with the Turfblocks, however, exposed control blocks in the lower levels were severely abraded.

Figure 3-24. The control blocks holding very well at Port Wing, Wisconsin, 16 August 1979.

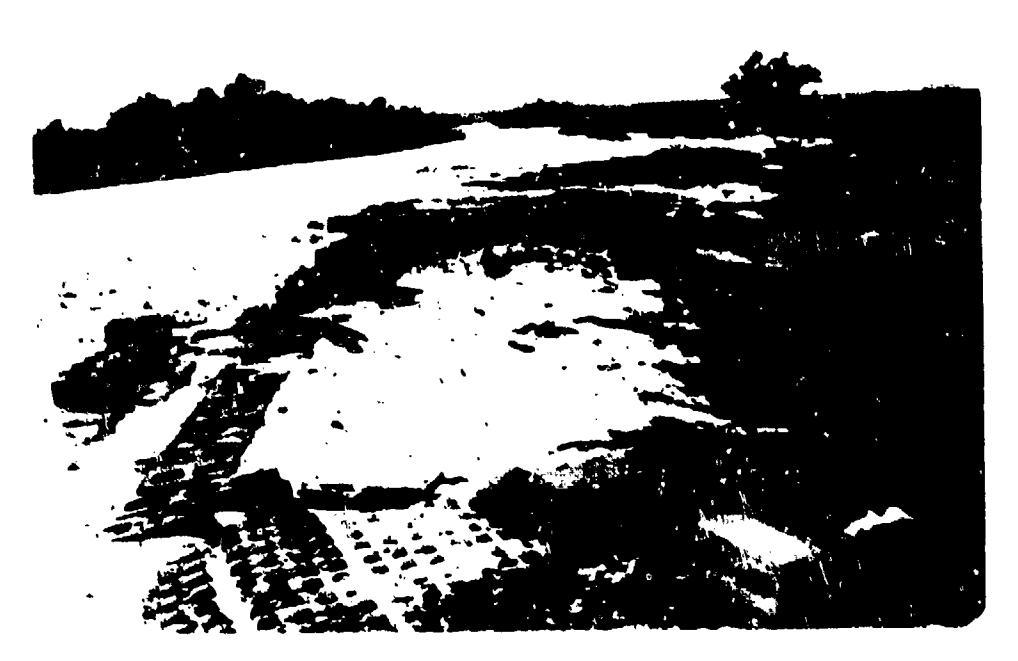
Figure 3-26. Most of the replacement blocks, mistakenly placed parallel to shoreline, were displaced during April storm, Fontainebleau, Louisiana, 12 June 1980.

perpendicular to the choreline, and (2) that they should not be used in areas where their theft seems likely. Although they appeared to be less stable than control blocks, cost and availability are factors that may affect the choice of module type. Both types are thicker and blockier than Gobi blocks and Turfblocks, and therefore should be more stable in a revetment.

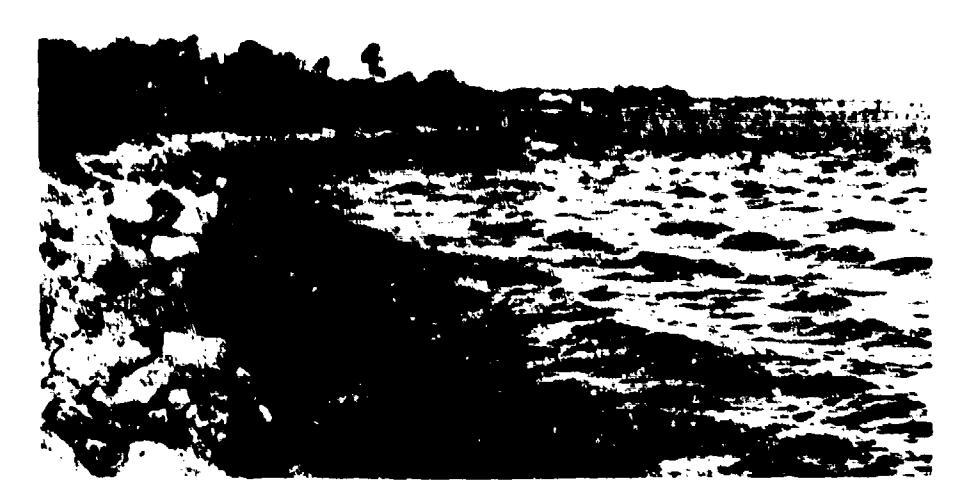
Concrete Rubble. Revetments constructed of concrete rubble ь. were monitored at three sites--Shoreacres, Texas; Alameda, California; and Folly Beach, South Carolina. The Shoreacres installation was a monitoring site; the revetment consisted of 3,100 feet of park shoreline protected from erosion by concrete rubble dumped as a riprap along the base of the low shore bluff (Fig. 3-27). No filter material was used, but the rubble was broken into a good gradation of sizes. Apparently, the thickness of the rubble riprap was adequate to allow it to form its own filter of smaller pieces of rubble retained by the heavier pieces that remained as armor on the exposed slope; the finer pieces in the outer layers were washed out of the section by wave action. This type of construction wastes rubble material, and may not work well if the rubble does not have a good gradation of smaller sizes. In other areas where this type of riprap has been attempted, wave action has washed the retained embankment through the voids in the rubble, leaving a windrow of riprap material deteriorating in the wave zone while shore erosion continued unabated behind the structure. This did not happen at Shoreacres, probably for two reasons: (1) the exceptional thickness of the riprap, and (2) the relatively mild wave climate of the area.

Figure 3-27. The concrete riprap is performing well at Shoreacres, Texas, 26 February 1980.

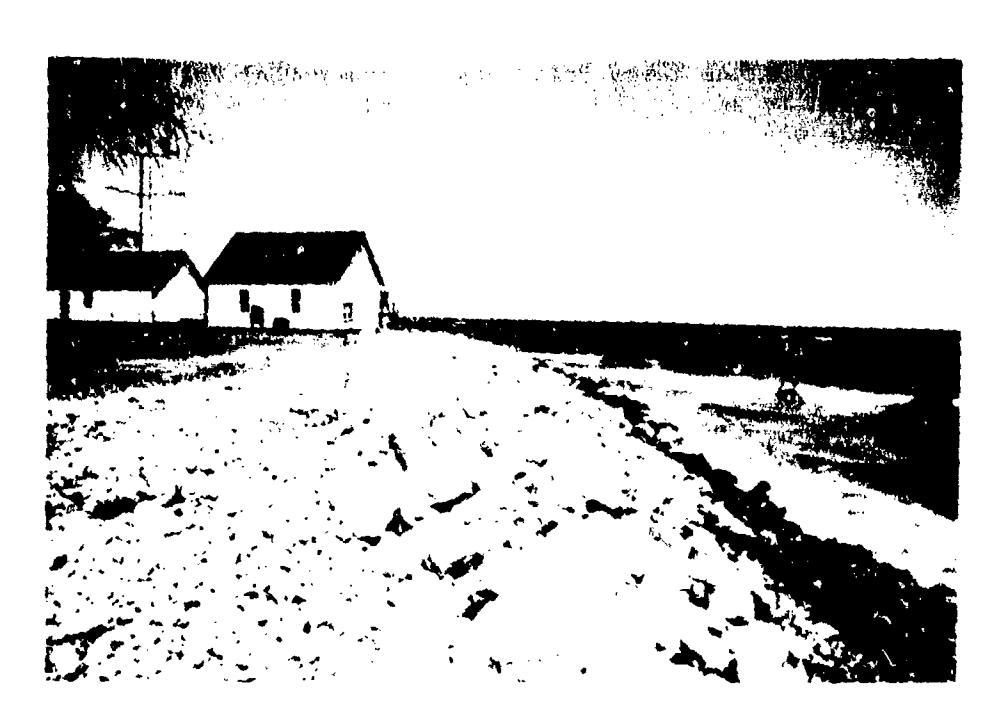
Tawas Point, armored with 100-pound stone, lies on a 1 on 3 slope with an underlayer of 4- to 10-inch stone acting as a filter. A control section tested the effect of omitting armor stone in the upper part of the revetment, which is subjected only to wave uprush. The entire structure, including the control section, survived storm waves that were reported to have breaking wave heights of up to 8 feet (although it is questionable whether they broke directly on the structure). There was no apparent damage to the structure nor to the bluff behind it (Fig. 3-30).

Figure 3-30. The stone riprap holding very well at Tawas Point, Michigan, 16 April 1980.

Continued monitoring of the Tawas Point and reconstructed Folly beach revetments is needed to assess their adequacy under more prolonged subjection to their particular wave environments.

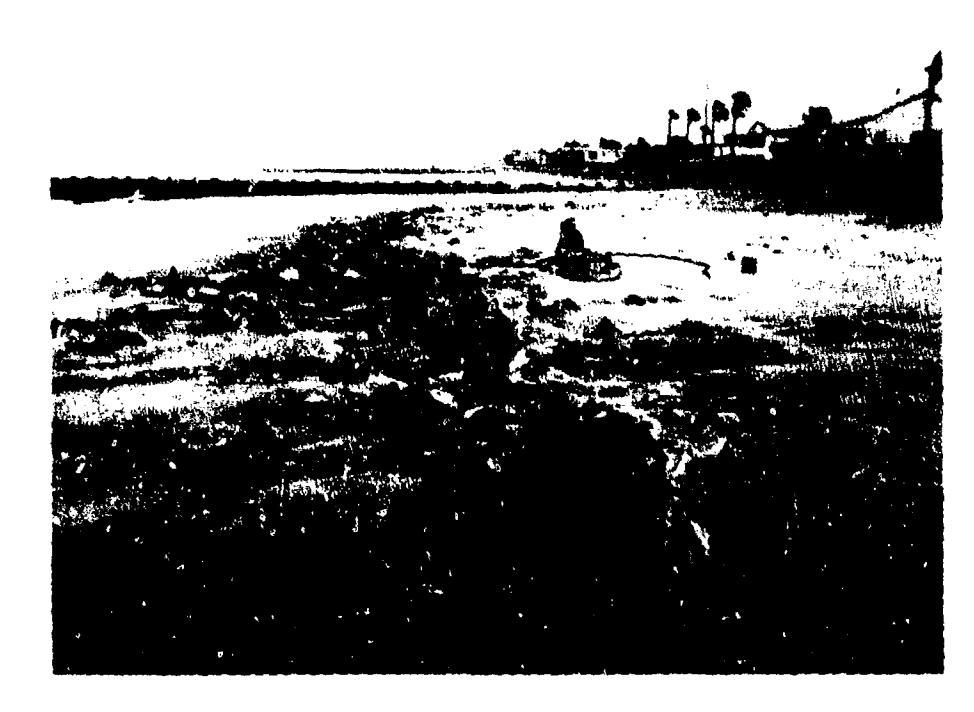
At Folly Beach, five stone riprap revetments were laid on 1 on 2 graded slopes. Each was constructed of "two-man" stone (about 100 to 200 pounds) in a layer two stones thick, placed on Polyfilter-X filter cloth. The revetments sustained little damage from normal wave action, although some stones were displaced and the filter cloth was exposed. However, each of these five revetments was destroyed by Hurricane David (Fig. 3-31). Stones in the 350-foot revetment in area 4 were not widely dispersed by the hurricane waves, as were the stones in the other revetments. This was because the high, steep bluff behind the revetment prevented the waves from carrying the stones over the top of the structure, and they fell back down the slope, protecting the bluff toe but exposing the upper bluif face.

Figure 3-31. Destruction of riprap revetment at Folly Beach, South Carolina, 15 September 1979.

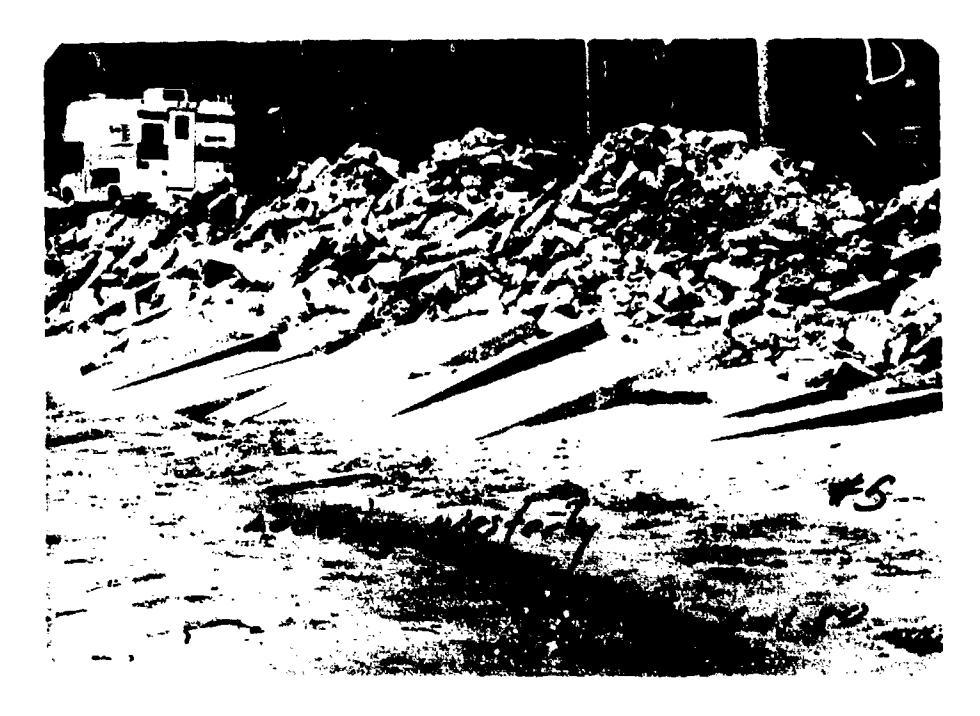
d. <u>Concrete Slabs</u>. This type of revetment was demonstrated at only one site-Alameda, California. The large slabs, 15 feet long, were laid against a  $60^{\circ}$  slope covered with a sheet of Mirafi-140 filter cloth. The toe was entrenched about 2 feet into the built sand. Wave action overtopped the revetment repeatedly, saturating the sand slope and washing out the backfill. Within a few months all 12 slabs were lying almost flat on the beach (Fig. 3-32). No attempt was made to restore the section.

Figure 3-32. The concrete slabs lying almost flat on the beach, Alameda, California, 11 April 1980.

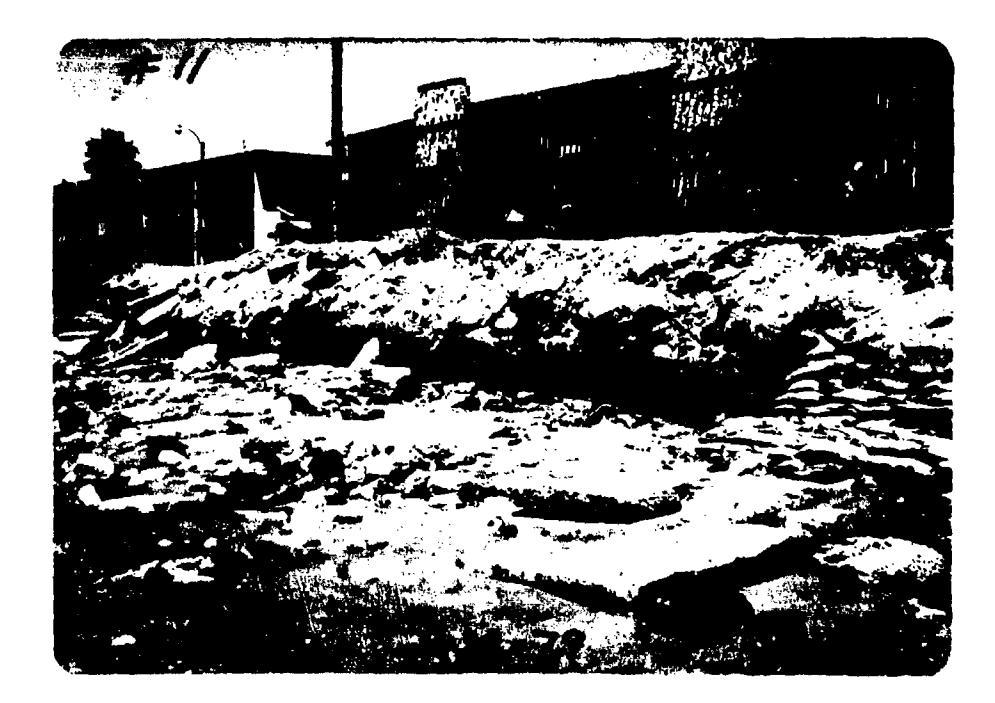
Device 11 was installed about 100 feet downdrift of the device 8 perched beach at Alameda. The sill surrounding and retaining the device 8 beachfill acted as a groin, preventing littoral nourishment from reaching the device 11 area. As a result, the beach fronting device 11 became progressively lower with time. Within a few months, the toe was undercut and the lower tiers of bags slid downward, exposing gaps of unprotected embankment farther up the slope. Also, it was noted that the closure twine in many of the bags had broken, allowing sand to spill out and cause collapse of these bags. Wave action during high tides then removed the embankment material from behind the bags, hastening the collapse of the entire structure. The erosion seemed to occur both at the toe and along the top of the embankment. As the Sand fillows slid, erosion of the embankment increased. After about 6 months, all of the bags were down on the beach, and most were empty (Fig. 3-33). The bag fabric had not deteriorated.

Figure 3-33. Device 11 (left) failed completely, and subsequent erosion of the bank occurred, Alameda, California, 18 July 1979.

(c) Sand-cement fill provides some degree of structural safety with sandbag construction. However, if filled only with sand, a nondegrading fabic such as the acrylic material in the Sand Pillows should be used, and closure twine should be sufficiently strong and durable to make the bag closure as secure as the fabric material itself.

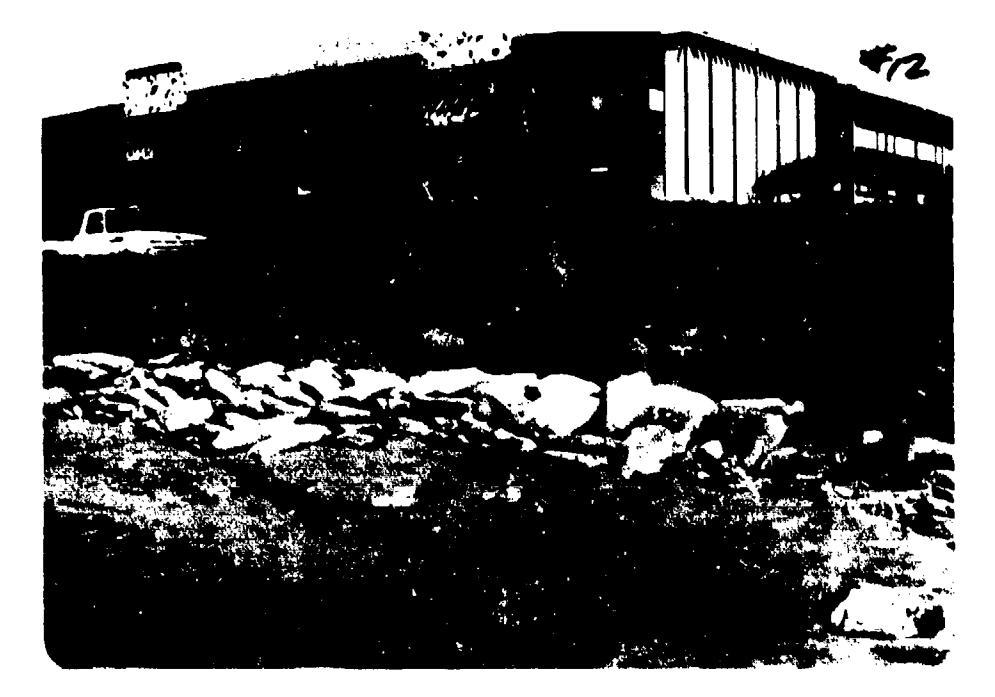
(2) <u>Device 12</u>. This revetment was identical to device 11 except that the Sand Pillows were filled with a lean (8-to-1) sand-cement mixture. As a result, the Sand-Pillow modules generally held their shape (although some did crack), but toe scour and bank erosion behind the modules eventually rendered the revetment ineffective. Within 1 year, all of the modules were in a windrow on the beach, and erosion of the embankment behind them continued virtually unabated, although the modules on the beach did absorb a small amount of wave energy (Fig. 3-34).

Figure 3-34. Sand-Pillow revetment of device 12 in a windrow while erosion of embankment continued, Alameda, California, 7 February 1980.

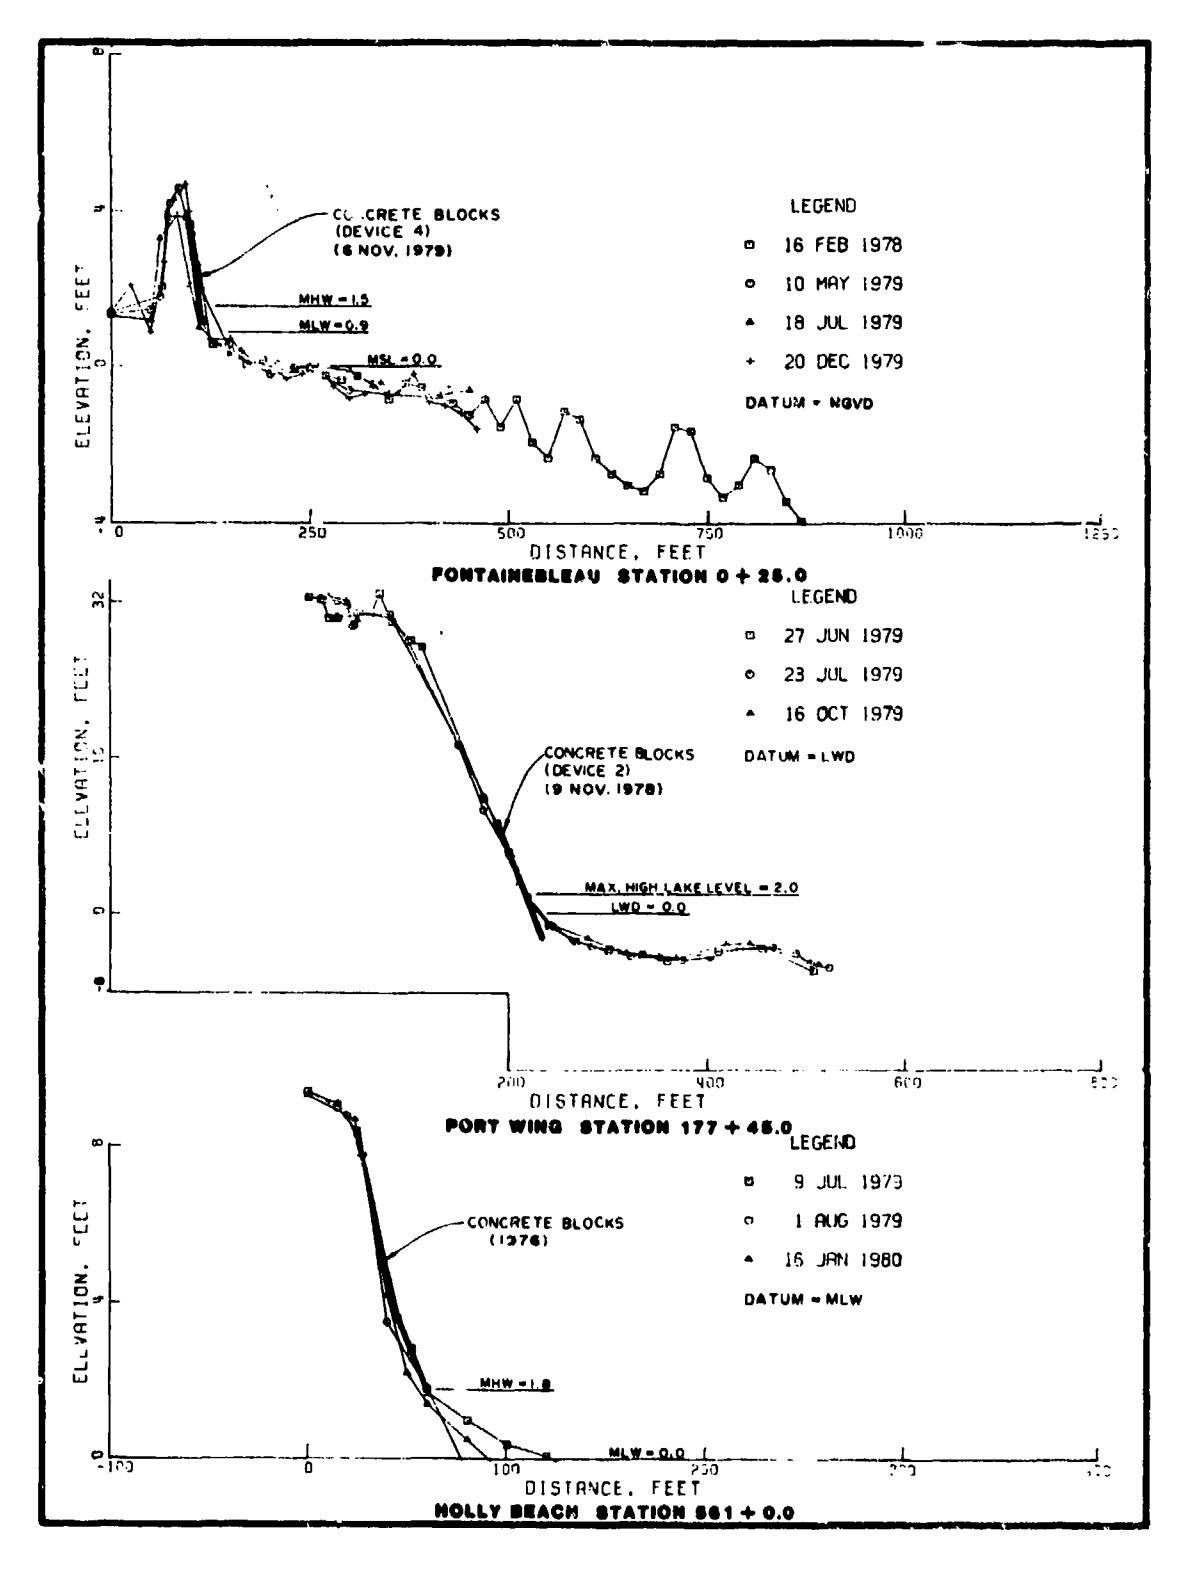
Figure 3-42. Profiles of concrete-block revetments.

Comparative profiles of similar devices were included in Section III. Profiles through the concrete block revetment are shown in Figure 3-42. Shoreline erosion of 10 to 15 feet is indicated by a comparison of the 9 July 1979 with the 16 January 1980 profiles.

At Fontainebleau the profiles are at device 3, a revetment of standard construction blocks. The structure was damaged by vandalism and problems were encountered with displacement of blocks with their long axes placed parallel

At Port Wing, the profiles are at device 2, a revetment of small control blocks. This revetment, despite some settlement and damage from storms, remained essentially intact throughout the monitoring period. The profiles show that this structure adequately prevented bank erosion. The survey data only cover a period of 3 months, not enough time to determine the effectiveness of the structure.

At Holly Beach, the profiles are typical of 4 miles of Gobi-block revetment. This revetment was damaged, rebuilt, and extended after it was first constructed in 1970. The revetment was damaged in September 1979 by storm waves, and some erosion on the bank occurred. The profiles only cover a 6month period (July 1979 to January 1980), but these dates include the September storm, and some erosion is apparent, particularly in front of the structure.

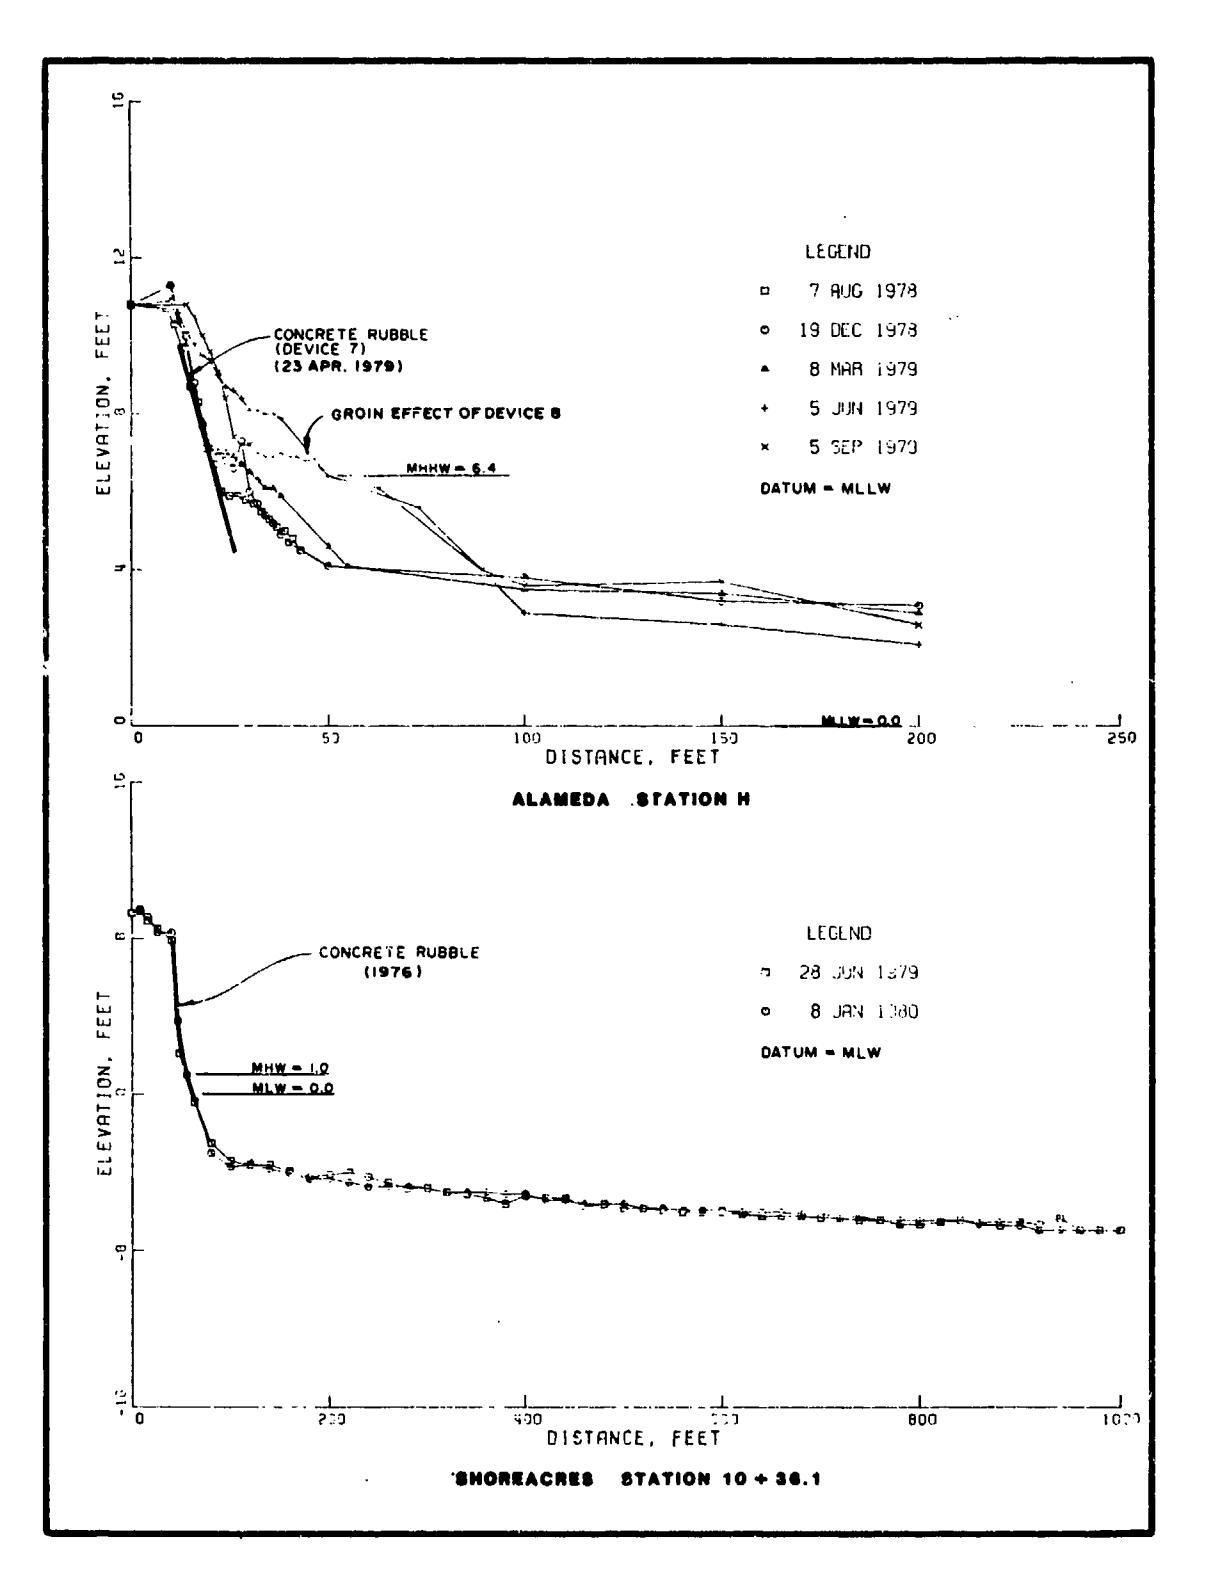
Figure 3-43. Profiles of concrete-rubble revetments.

1979; however, no noticeable changes were observed. The riprap has performed well functionally, preventing shoreline recession. In May 1980, the bank sloughed slightly in a few places, but caused no significant damage. Profiles of similar concrete rubble revetments are shown in Section III; the profiles through the revetment at Shoreacres are shown in Figure 3-43. Profiles show no erosion at the site.

The concrete-rubble revetment (device 7) at Alameda survived the monitoring period without much structural damage, but this is attributed to the fact that the structure was protected by a fillet of sand trapped in the lee of a sandbag sill. The profiles show the accretion in front of the revetment which protected it from damage. Other concrete-rubble revetments which were exposed to wave action were destroyed at Alameda. Therefore, the Shoreacres revetment was a more effective device in protecting the beach; however, this effectiveness is site-sensitive.
