### LOW COST SHORE PROTECTION

A Report on the Shoreline Erosion Control Demonstration Program (Section 54 Program)

Office, Chief of Engineers U.S. Army Corps of Engineers Washington, D.C. 20314

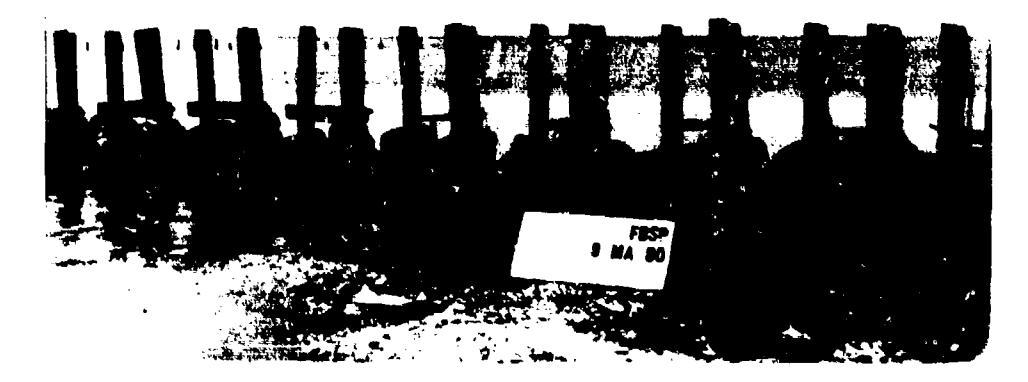
Figure 3-49. Timber-tire breakwater attenuates waves effectively and shows no evidence of deterioration, Fontainebleau, Louisiana, 9 May 1980.

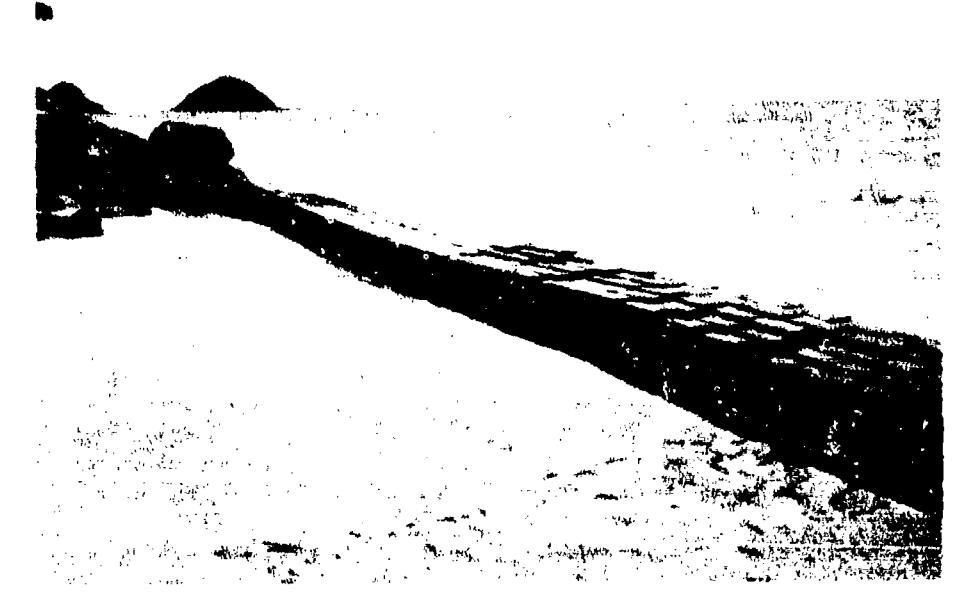
The Basin Baycu and Hawaii Sandgrabbers accumulated sand quickly (Figs. 3-68 and 3-69), while accretion was slow at Folly Beach. A number of common problems developed at each of the project sites. The first, which deals with downdrift erosion, was readily observed at the Kualoa site. To the extent that the Sandgrabber withdraws sand from the littoral budget, it deprives the downdrift beaches of their normal sand nourishment. This results in accelerated erosion downdrift of the structure, with the rate depending on the volume of sand in littoral transport and its speed in the downdrift direction. The littoral system at Kualoa was already deficient when the Sandgrabber was installed. The structure managed to halt the erosion at the site, but at the cost of excessive loss of downcoast beach (Fig. 3-70).

Figure 3-69. Sand accumulation behind Sandgrabber at bellows Beach, Hawaii, 8 November 1979.

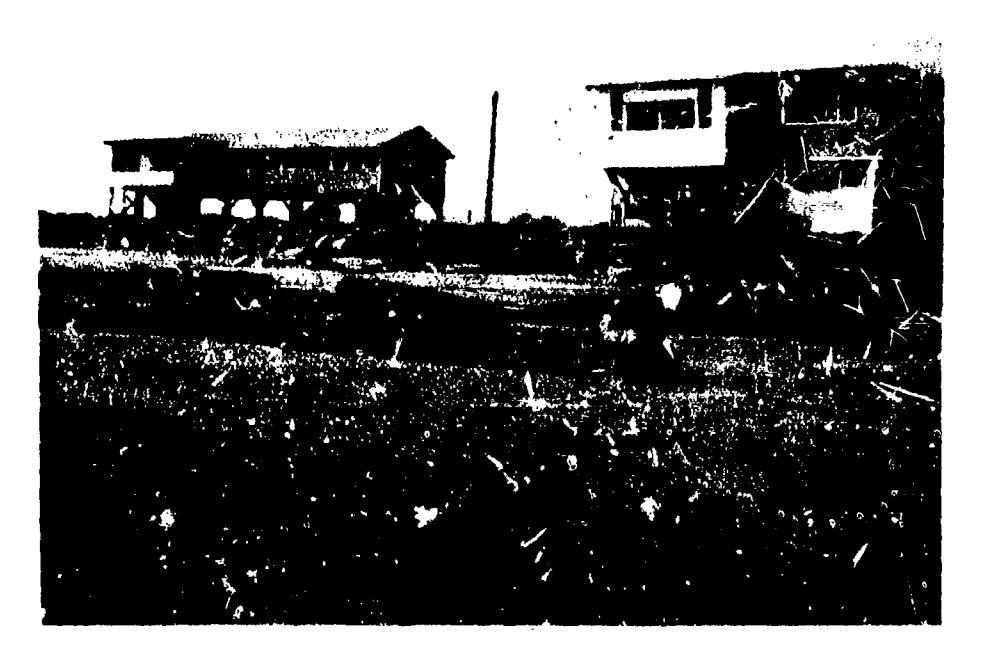
Structural degradation of the Sandgrabber usually begins with toe scour. As sand is lost, the seaward side of the structure rotates downward. If the toe scour is uniform and the structure rotates as a whole, no damage occurs. If scour is not uniform, the differential rotation from block to block results in some blocks being displaced in the section. The U-ties were designed to allow for a certain amount of differential displacement; however, as the displacement exceeds the allowable, the stress of the U-ties against the concrete cracks or breaks the blocks. As weak concrete will hasten this block before construction to assure that they meet building block standards. Block breakage occurred at each of the project sites, but the damage was severe only at Folly Beach, where more thar half of the blocks in the seaward row of the top tier were lost (Fig. 3-71).

Figure 3-71. The top tier of the seaward row of the Sandgrabber in area 3 lost over half of its blocks, Folly Beach, South Carolina, 5 March 1980.

Several precautions are suggested to reduce block breakage. Periodic tie-bar adjustment might help prevent breakage in zones of differential settlement. Installing the blocks in a trench excavated to the anticipated toe scour depth should prevent structure rotations. Elastic ties instead of the galvanized-steel ties might provide additional flexibility, allowing smooth transitions and conformations to grade changes. Synthetic, elastic ties of some type would also eliminate corrosion problems. Cloth or gravel filters were not tested, but properly installed under a Sandgrabber they might deter scouring and promote uniform settling. The flanking erosion at the south end of the Kualoa installation might have been prevented by gradually curving the end of the structure well back into the bank (Fig. 3-70). This would have necessitated some excavation, but it would have obviated the need for the supplemental tieback structure, which had to be added later.

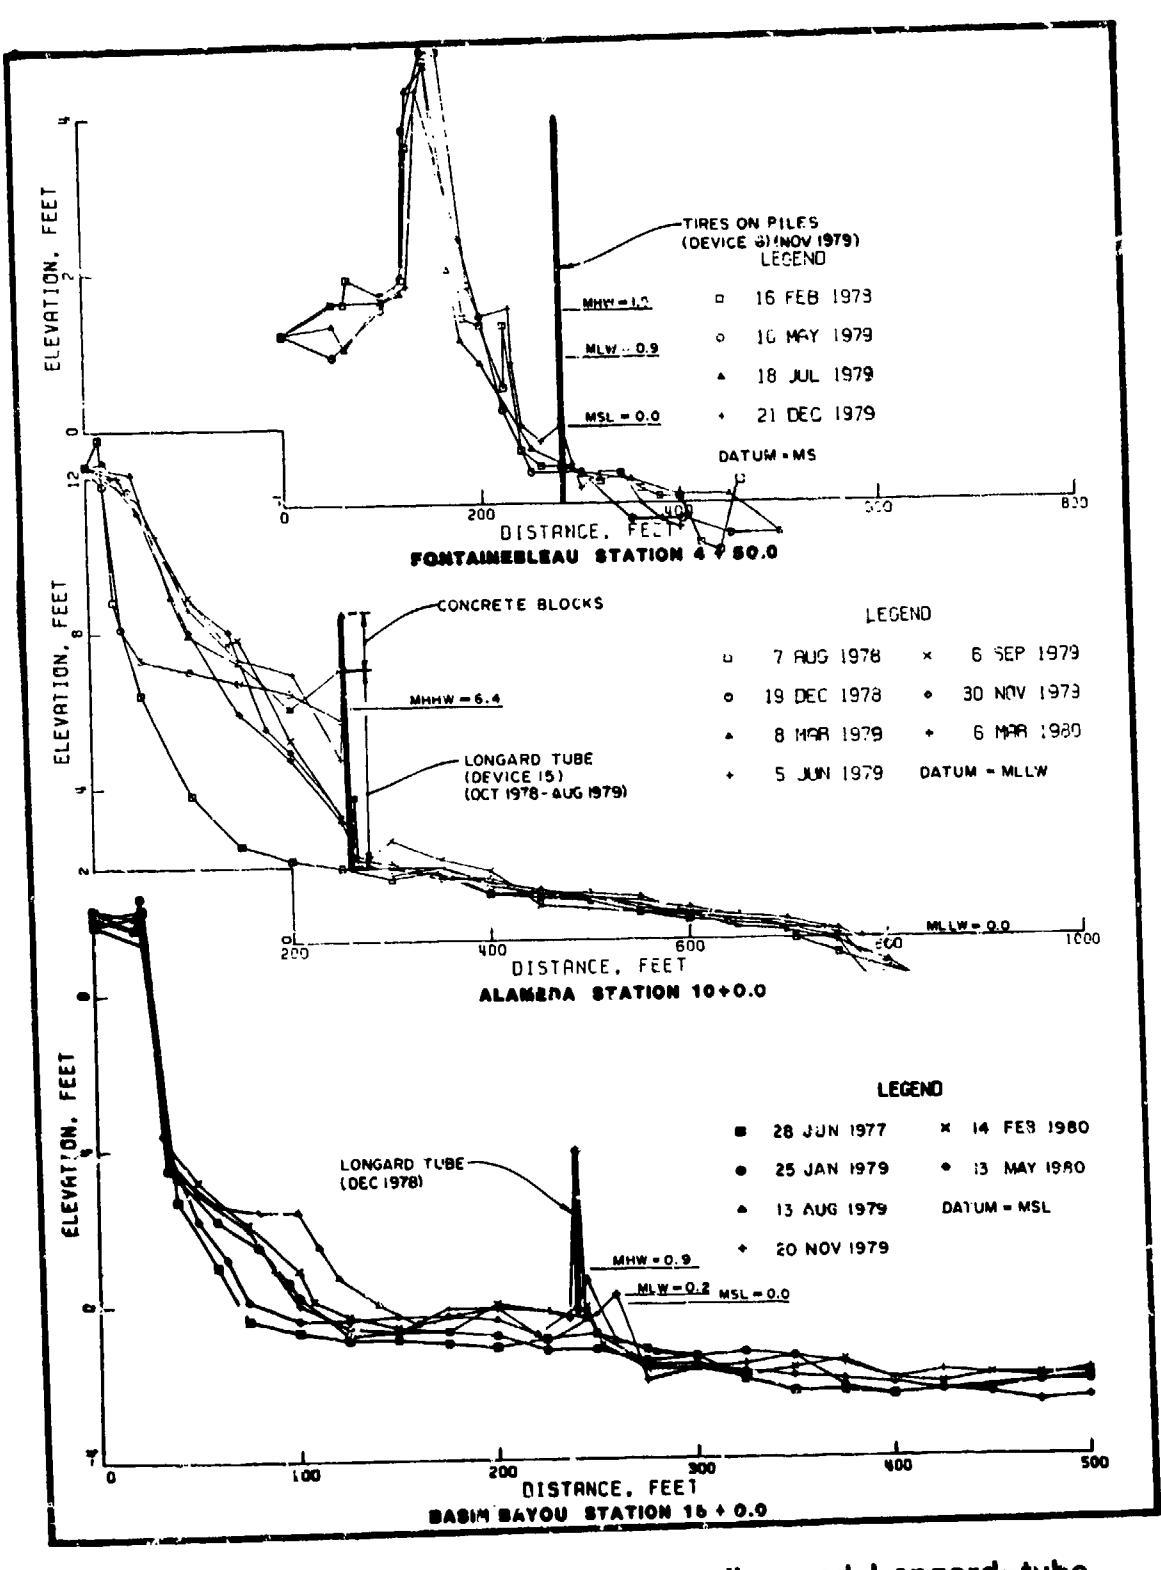
At Fontainebleau State Park, Louisiana, a breakwater was constructed of closely spaced timber piles driven into the lake bottom with tires stacked 4 feet high on each pile. This device adequately attenuated waves, and performed without any structural deterioration. The profiles at this site are somewhat erratic, but they show some accretion in lee of the structure.

A Longard-tube breakwater was demonstrated at Alameda, California. This structure was damaged by vandals and eventually could no longer retain the manmade sand tombolo that had been placed in its lee. Construction of this structure was completed in October 1978. The profiles show accretion in lee of the breakwater while the structure was intact, from December 1978 to June 1979. After June 1979, corresponding with the degradation of the structure, erosion of the tombolo continued through the remainder of the monitoring period.

Figure 3-75. Profiles of tires on piles and Longard-tube breakwaters.

Another Longard-tube breakwater was demonstrated at Basin Bayou, Florida. This structure was also damaged by vandals, although not as badly as at Alameda. This damage halted the formation of a tombolo which had been formerly in the breakwater's lee. The profiles for this site show that progressive accretion was evident just behind the structure. On the beach, however, the trend was more erratic with accretion from August 1977 through August 1979 followed by erosion thereafter. A new Longard tube was placed at the site in May 1980, but as this was the end of the monitoring period its effectiveness cannot be determined. Because Longard tubes are susceptible to damage by vandals (which seems to be unavoidable), the stacked tire on pole breakwater appears to be a more effective device in protecting the beach from erosion. Longard tubes work well, but once damaged their lifetime is greatly reduced.

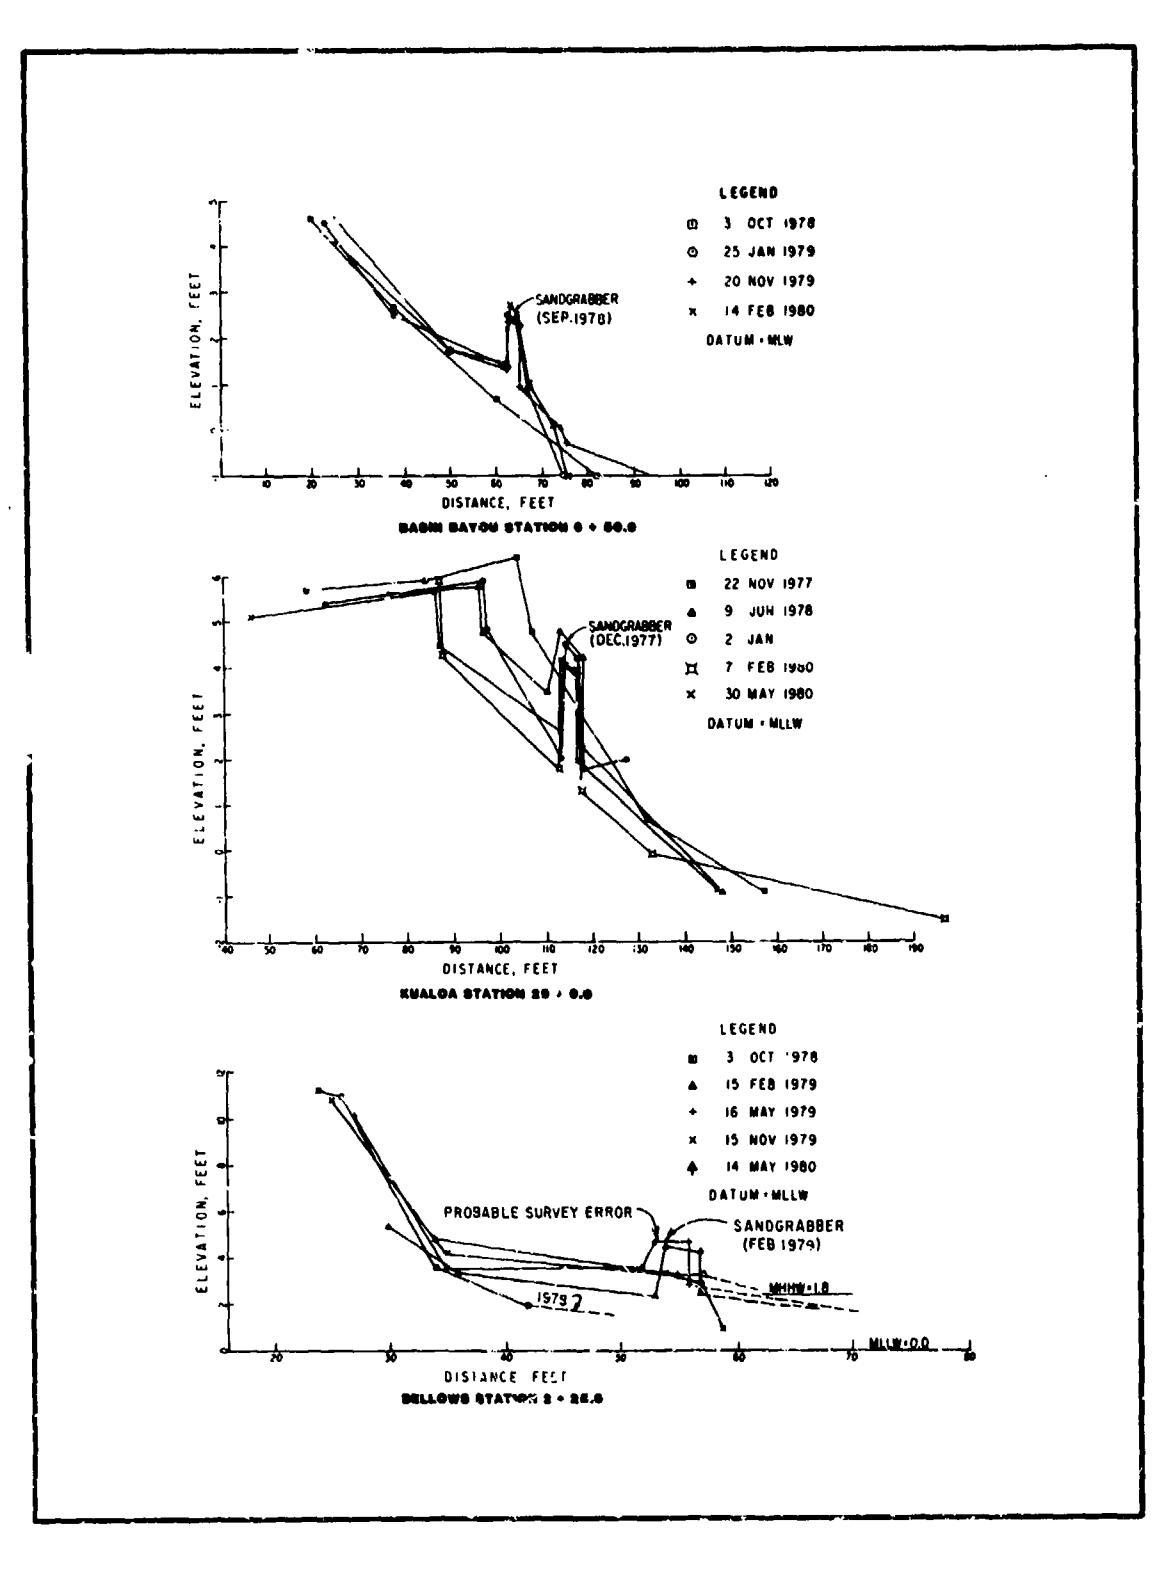
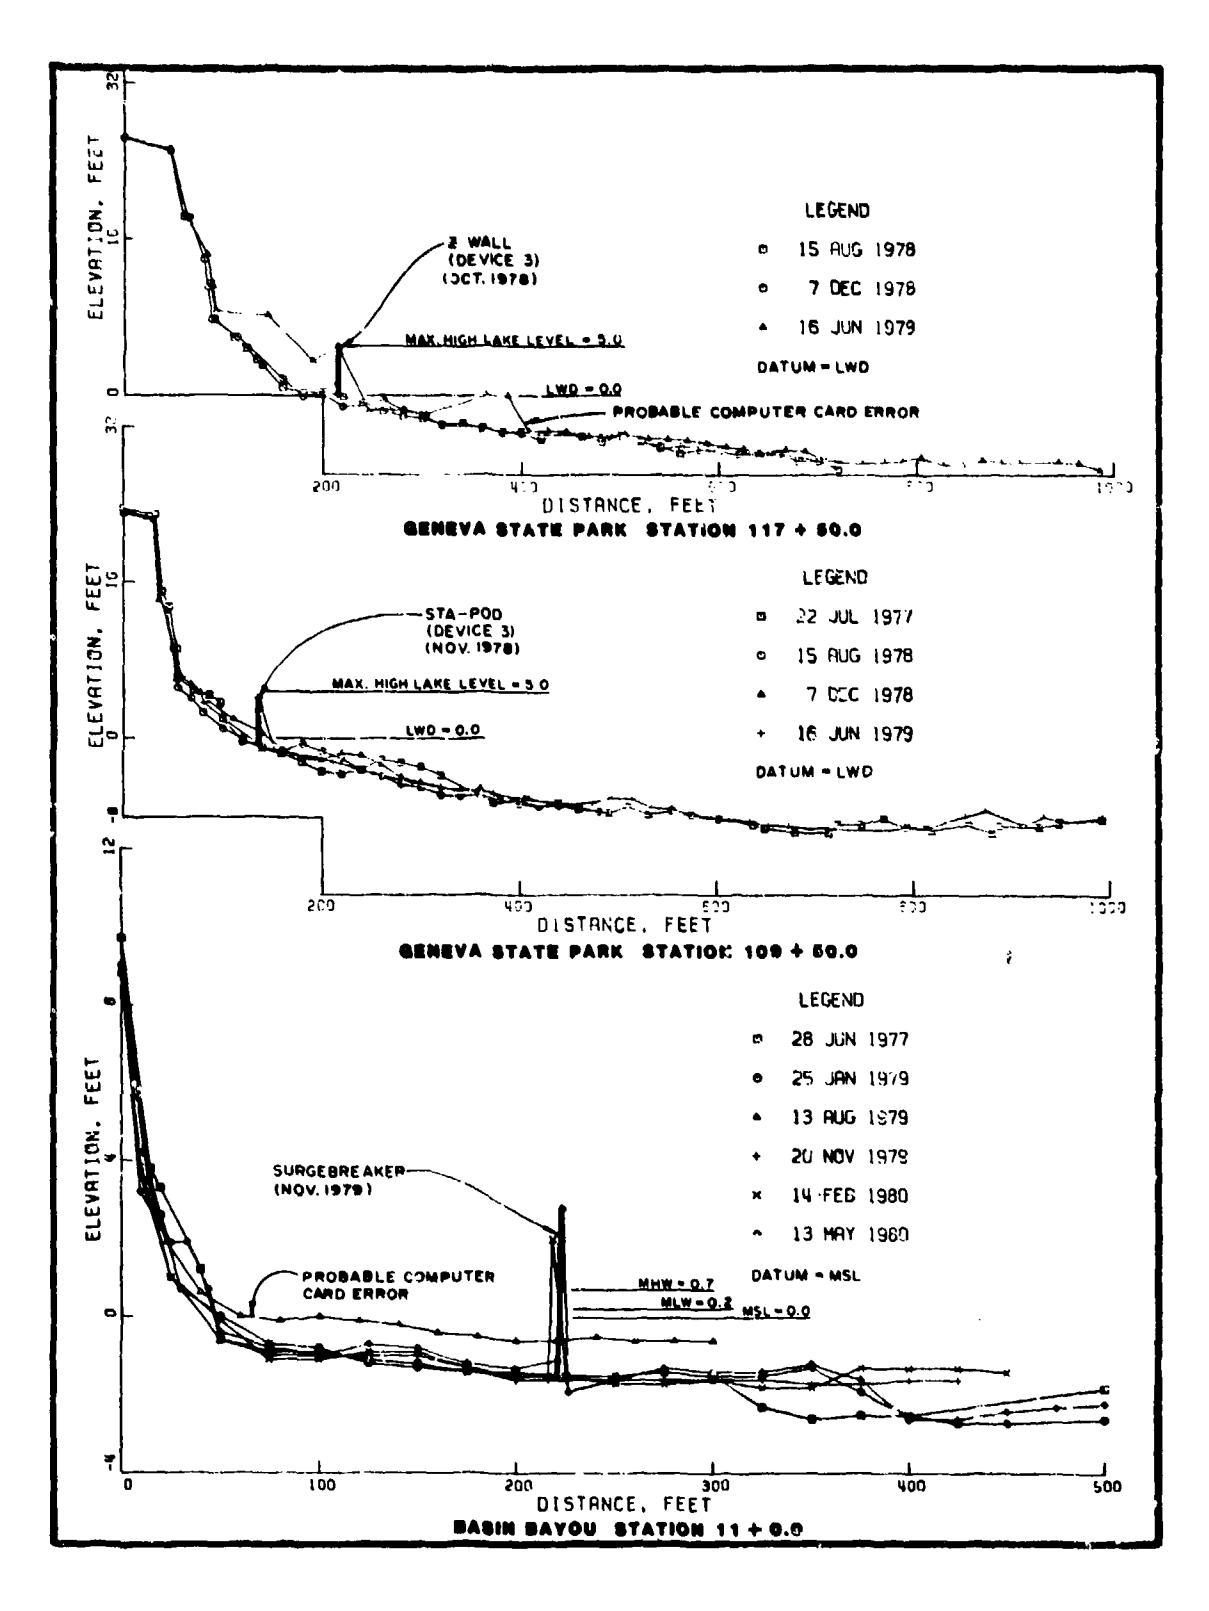
(5) <u>Sandgrabber</u>. A profile analysis was done on Sandgrabbers at three sites--Basin Bayou, Florida; Kualoa, Hawaii; and Bellows Air Force Station, Hawaii. The profiles for these sites are shown in Figure 3-79. At Basin Bayou, the structure suffered some damage, attributed to erosion of sand from under the toe causing seaward rotation of the structure and block breakage. The profiles show that sand has been trapped by the structure, but variations in the sand level behind the structure has also been present.

The Sandgrabber at Kualoa, although structurally damaged, maintained its shape while settling throughout the monitoring period. Although the profiles do not show it clearly, the Sandgrabber trapped saud both in front of and behind the structure throughout the period, but in doing so, caused considerable downdrift erosion.

The Sandgrabber at Bellows Air Force Station also trapped sand at the beach in its immediate vicinity. This structure, like the other Sandgrabbers, also suffered from toe scour and subsequent nonuniform settlement. The accretion present at the Bellows Sandgrabber (shown in the profiles) was not to the detriment of adjacent beaches as at Kualoa. This was due to the predominantly onshore-offshore littoral transport at the site.

Figure 3-79. Profiles of Sandgrabbers.

The profiles show that the Sandgrabbers all suffered from differential settlement due to toe scour. The Bellows Beach Sandgrabber appeared to be most successful in that it did not cause downdrift erosion.

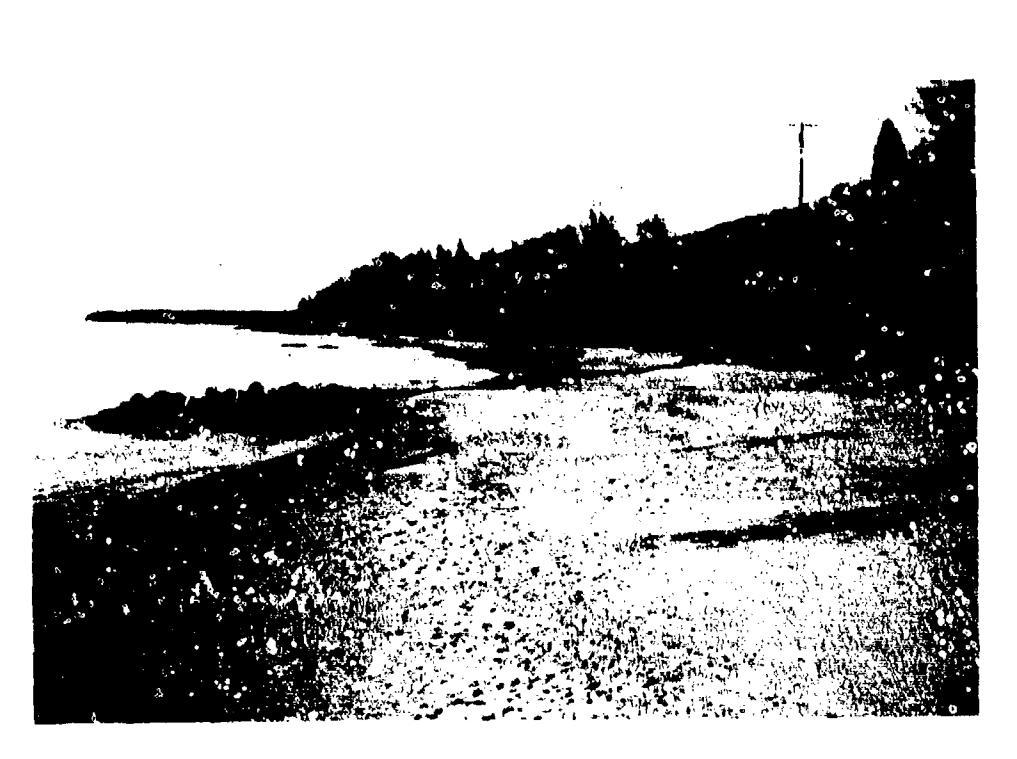
h. <u>Rock Asphalt Mastic</u>. Piled rock covered with asphalt was used as a groin at one site Sanilac Section 26, Michigan. Stone was dumped to form the core, and hot asphalt mastic was poured into the voids to seal and bind the structure. Only minor structural damage occurred. Some stones were dislodged and a piece of the northern corner of the lakeward end broke off; however, this did not affect the functional effectiveness of the groin. Performance was good. The groin trapped sand, forming a wide fillet (Fig. 3-97). Adjacent beaches were extended, which aided in halting bluff recession. Anticipated scour about the downdrift side of the groin was not observed and settlement was nominal. The amorphous quality of the asphalt mastic allows the structure to adjust to settlement without lows of structural integrity. However, this device cost \$154 per linear foot when built and the use of asphalt in a groin in 1980 would probably be a prohibitive expense.

Figure 3-97. Rock asphalt mastic groin at Sanilac Section 26, Michigan, 27 November 1979.
