CHAZY LAKE DAM

INVENTORY No. NY 236

PHASE I INSPECTION REPORT
NATIONAL DAM SAFETY PROGRAM

AUGUST 1981

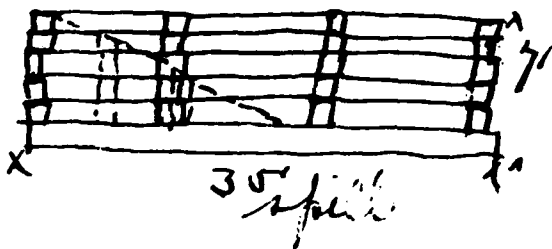
spill all washed out.
new dam needed.
