Special Report 81-31

December 1981

ROOF MOISTURE SURVEY: RESERVE CENTER GARAGE, GRENIER FIELD, MANCHESTER, N.H.

Prepared for
DIRECTORATE OF FACILITIES AND HOUSING
FORT DEVENS, MASSACHUSETTS

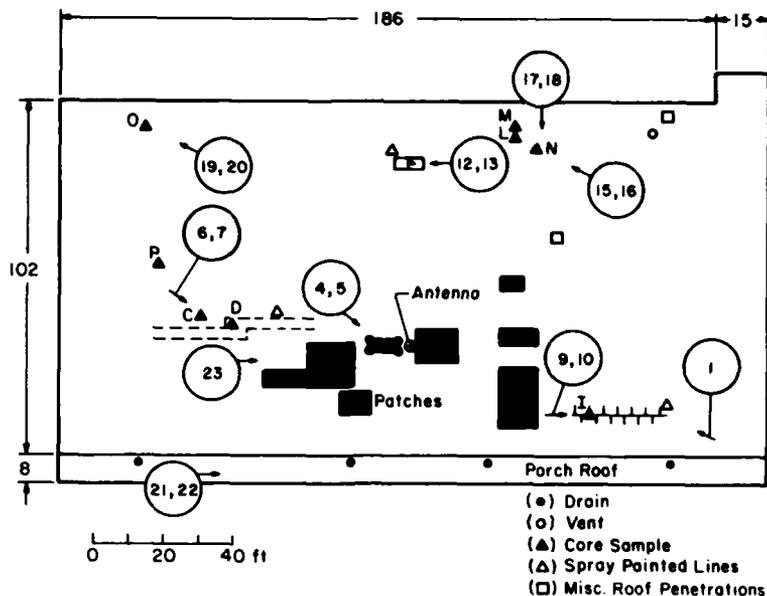
Figure 2. Plan view of roof. Circled numbers refer to figures in this report; arrows indicate viewing direction.

plastic bags and returned to the laboratory where they were weighed, oven dried at 120°F and reweighed. Moisture contents thus determined are presented in Table 1 and the thickness of each component is presented in Table 2. Sample locations are shown in Figure 2 along with the viewing direction of each photograph and thermogram included in this report.

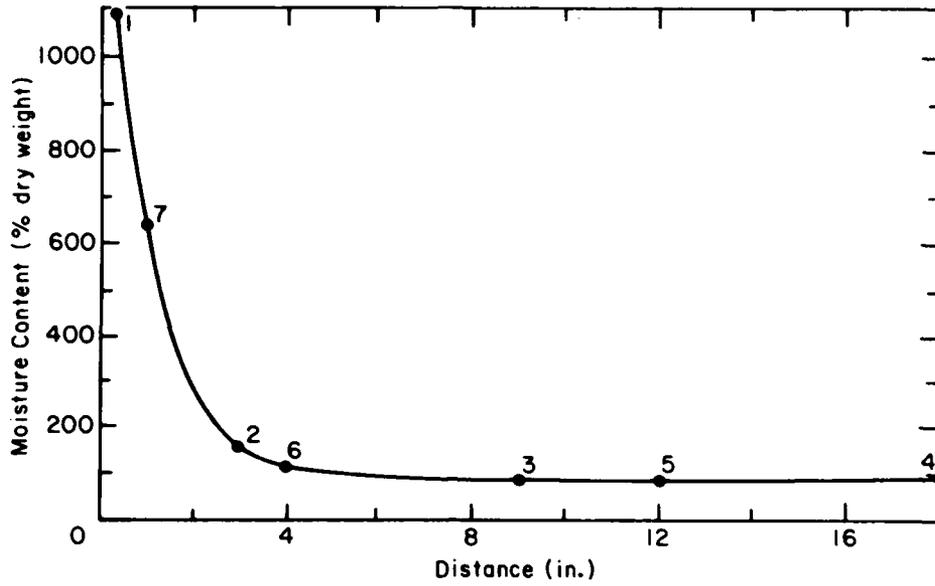
Figure 14. Variation of moisture content in urethane insulation with distance from edge of board.

Figures 12 and 13 show a thermogram and photograph, respectively, of another area where a well-defined board outline was present. Samples of the urethane insulation were taken where shown in Figure 13 to determine the variation of moisture content with distance from the edge of the board. These samples were knife-cut cubes about 1-1/2 in. on a side. Their moisture contents are presented in Table 3. Figure 14 shows that extra moisture was concentrated near the edges of the board. This created the dramatic thermal outlines shown in Figure 9 and 12.
