**MISSOURI RIVER**

**GAVINS POINT DAM - LEWIS AND CLARK LAKE  
NEBRASKA AND SOUTH DAKOTA**

**EMBANKMENT CRITERIA AND  
PERFORMANCE REPORT**

**OMAHA DISTRICT**

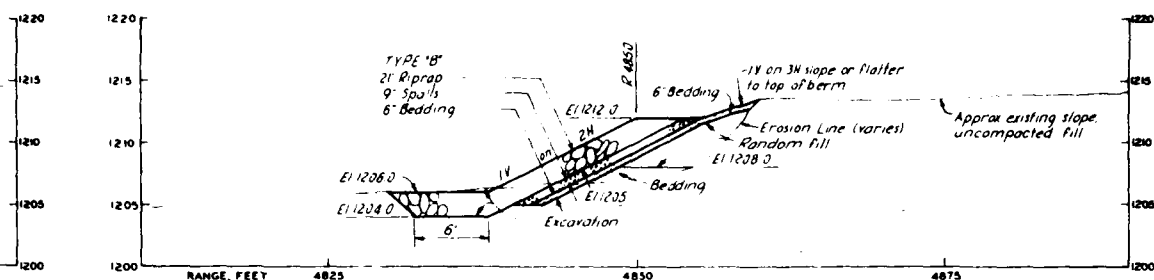
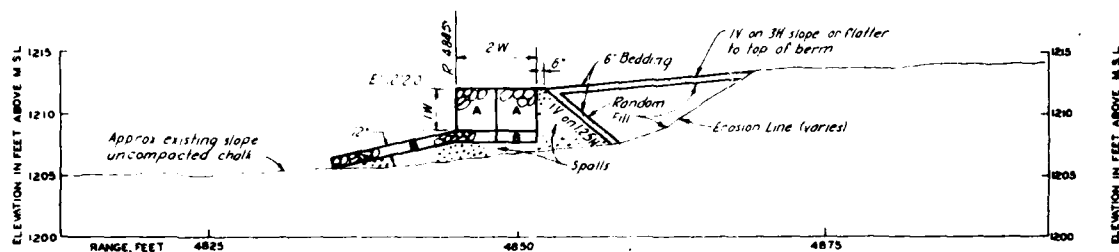
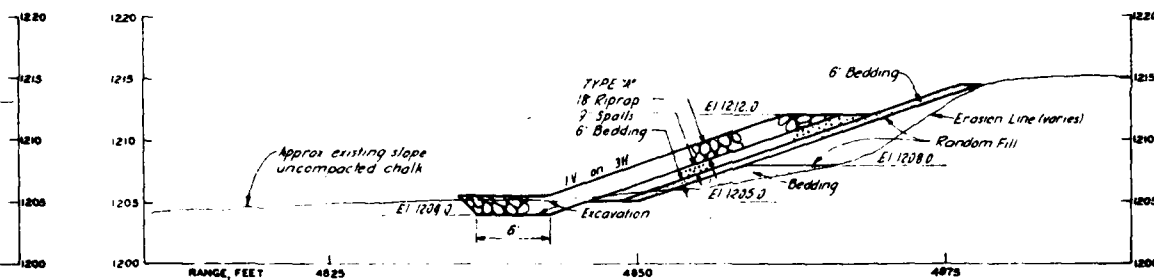
placed at a rate of 4.0 tons per lineal foot of scarp. The test section included layered riprap on 1V on 2H and 1V on 3H slopes, gabions, dumped quarried boulders, and dumped field boulders. The layered 1V on 2H riprap showed signs of excessive stone displacement within two years after placement and was almost completely washed out by 1979 at which time the 500-foot section was protected with dumped quarried stone placed at a rate of 1.25 tons per lineal foot. Included in this repair work was the placement of quarried stones to repair several small isolated severely damaged areas along the dumped field boulder protection.

4850  
TYPICAL FILL SECTION - IV ON 2H (TEST AREA)  
STA 48+00 THRU STA 53+00

**TYPICAL SECTION - GABION PROTECTION (TEST AREA)**  
BLOCK AND APRON TYPE - STA. 55+30 THRU 58+00

**TYPICAL FILL SECTION - IV ON 3H RIPRAP PROTECTION**

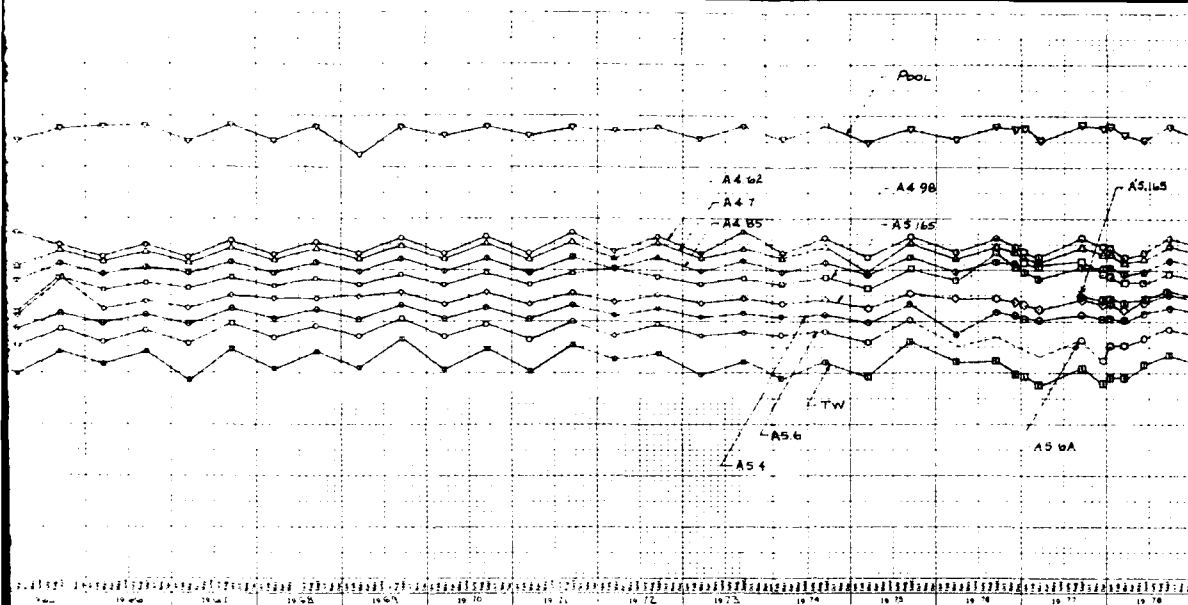
#### PIEZOMETER EFFECTIVENESS TESTS

| PIEZ. NO. | DATE | RESULTS | ACTION |
|---|---|---|---|
| A 5.6A | " | Replaced | A 5.6 A |

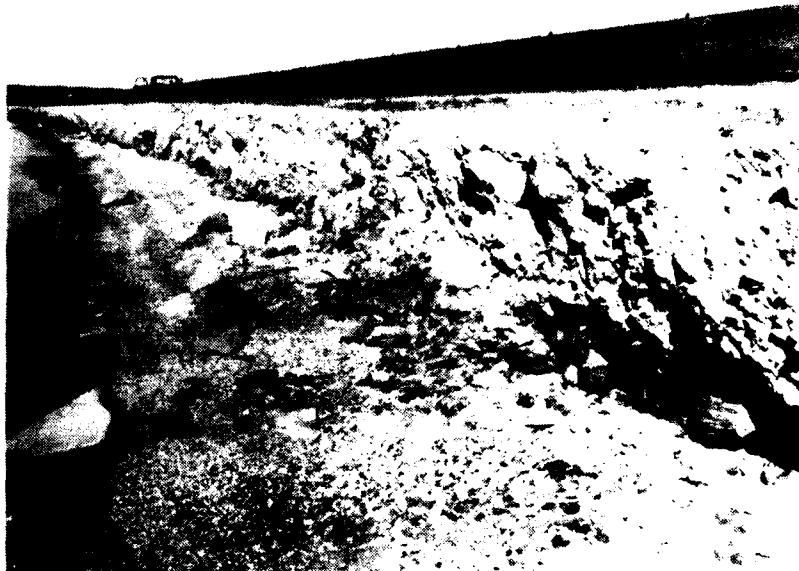
Photo No. 25 - Wave erosion scarp along embankment upstream  
chalk berm. Oct 1966.

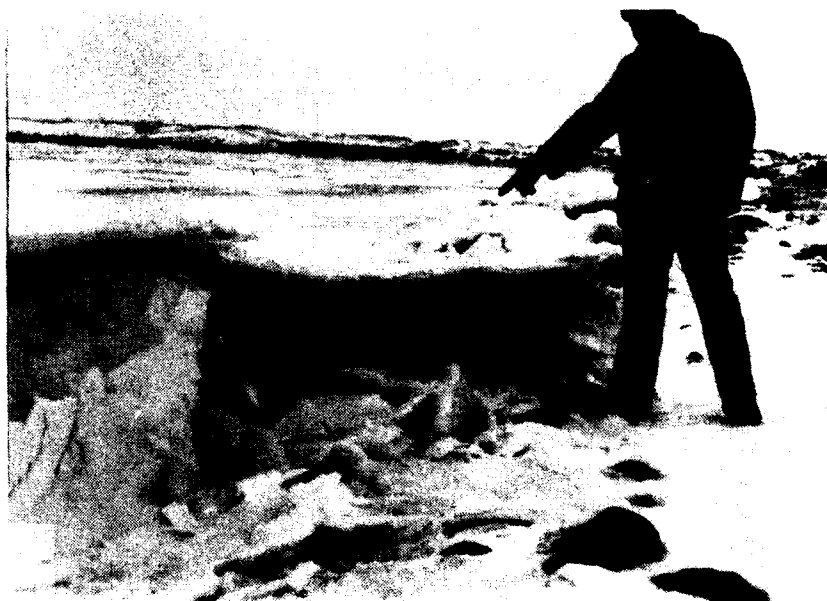
Photo No. 26 - Reservoir ice thrust against riprap along embank-  
ment upstream berm. Mar 1976.
