EXPERIMENTAL POLYURETHANE FOAM ROOF SYSTEMS - II(U)  
NAVAL CIVIL ENGINEERING LAB PORT HUENEME CA  
R L ALUMBAUGH ET AL. JAN 83 CEL-TN-1656

TITLE: EXPERIMENTAL POLYURETHANE FOAM  
ROOF SYSTEMS - II

AUTHOR: R. L. Alumbaugh, J. R. Keeton, and E. F. Humm

DATE: January 1983

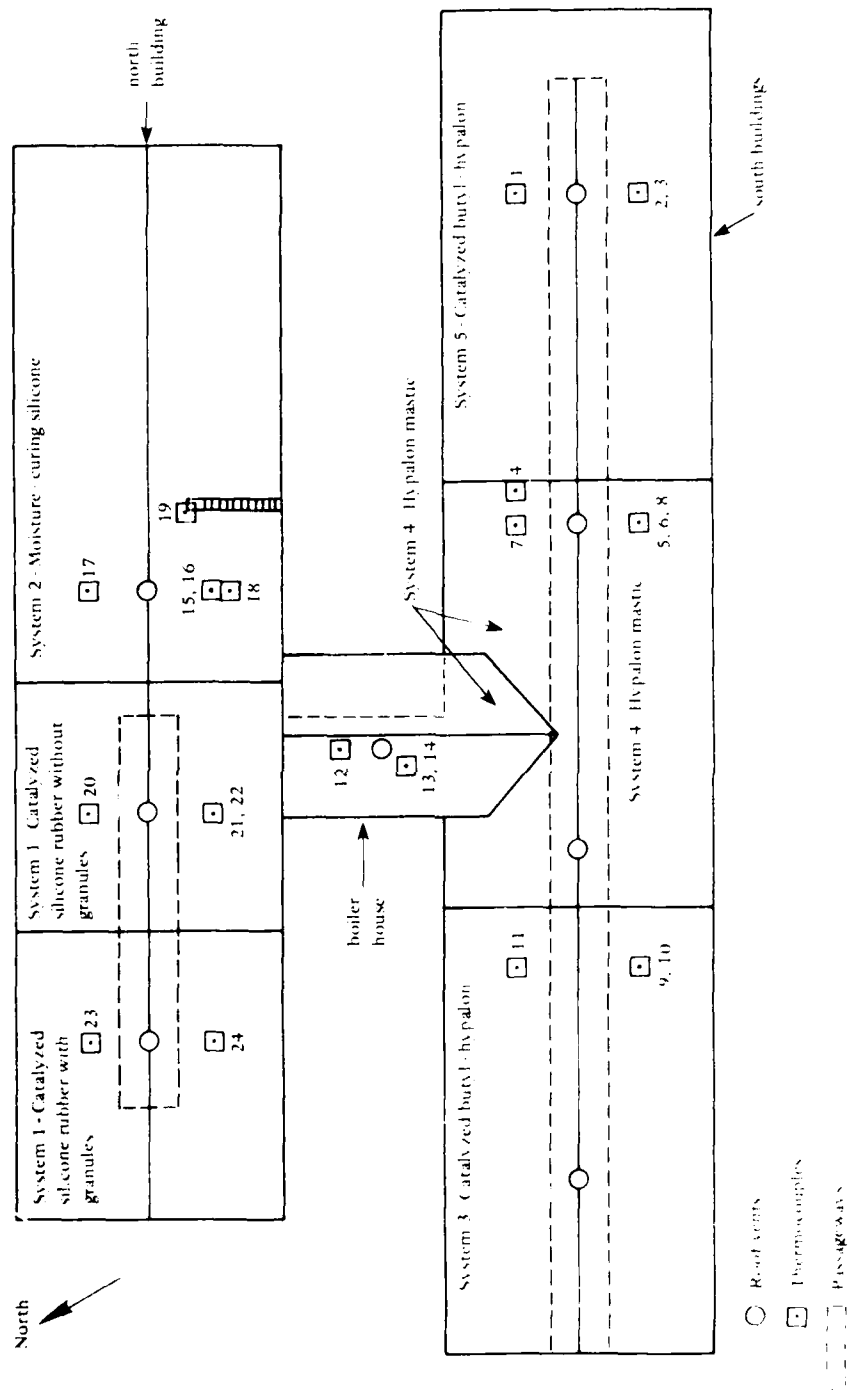
Figure 1. Layout of air conditioning and coating systems on Reserve Center buildings

The original coating Systems 3, 4, and 5 on the south building (see Figure 1) were all classed as impermeable to passage of water and water vapor. Systems 3 and 5 were catalyzed butyl-hypalon, and System 4 was hypalon mastic. System 3 was a poor quality coating system which deteriorated rapidly and was providing very poor protection to the foam when it was recoated in 1976.

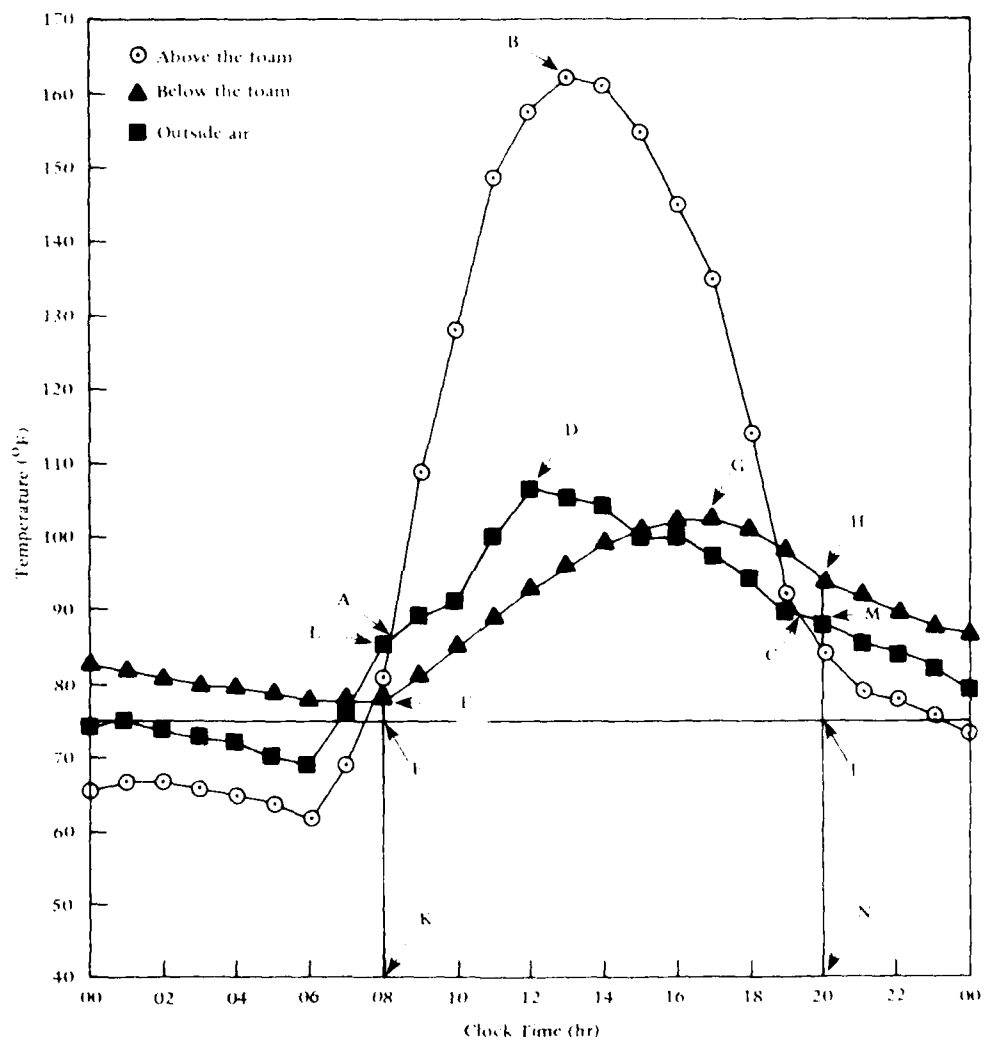
Figure 21. Temperatures in moisture curing silicone section with granules (System 6) for July 13, 1979.

As stated before, temperature readings were automatically recorded hourly on the hour. Figure 21 is a typical plot of hourly temperatures for July 13, 1979 in the moisture-curing silicone section with granules (System 6). The time-temperature envelope is determined by measuring the area under each of the curves with respect to selected datum lines. With the assumption that the temperatures a roof experiences result from exposure to the sun, then the outside air temperature (solid squares in Figure 21) is a measure of the intensity of the sun for a given day influenced directly by clouds and windspeed. Accordingly then, the area ABCDA in Figure 21 can be called a measure of the "solar heat response," since this area represents how much the temperature on top of the foam (open circles) exceeds the outside temperature (solid squares) in the day-time hours of highest solar intensity (i.e., between 0800 and 2000). The solid triangles in Figure 21 are the temperatures just below the foam. Assuming that 75°F is a reasonable room temperature for summer

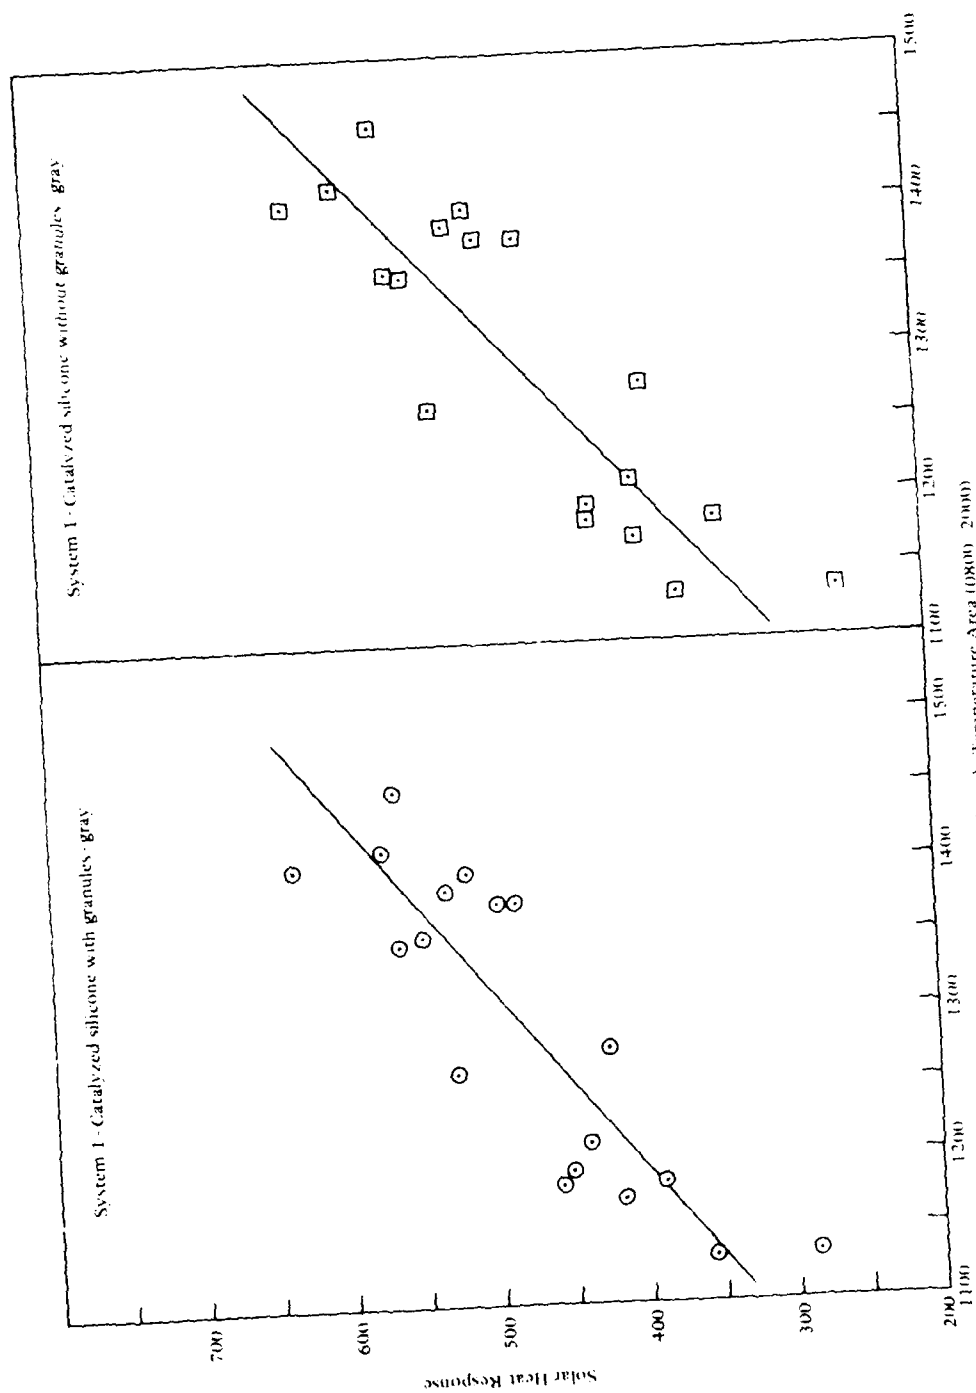
Figure 22 Solar heat response on catalyzed silicone roof sections.

Figure 22 shows solar heat response for the System 1 sections. The lines drawn are approximate least squares lines for the points shown. They are drawn only to indicate trends and do not imply that they are representative of all possible points of solar heat response. The only difference in the top surfaces of the two sections shown in Figure 22 is that the left portion has granules and the right portion does not. Points plotted in Figure 22 are listed in Columns 2 and 3 of Table 6.

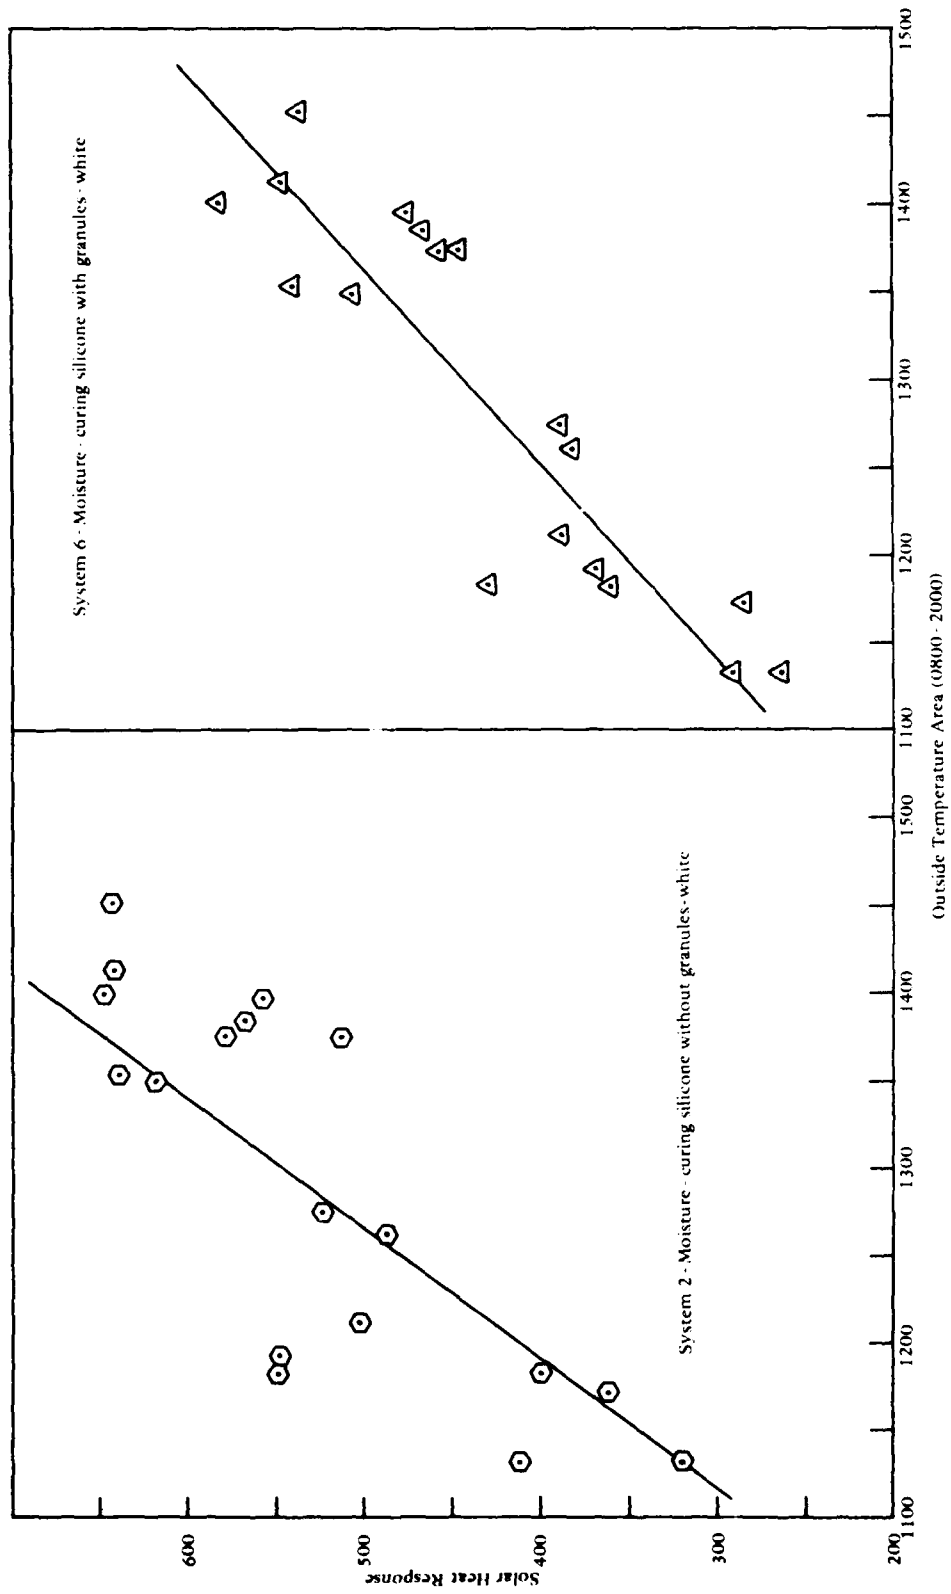
Figure 23. Solar heat response on moisture - curing silicone roof sections.

Solar heat response for Systems 2 and 6 (both moisture-curing silicone) are shown in Figure 23. The top surface of System 6 has granules, and System 2 does not. Points plotted in Figure 23 are listed in Columns 4 and 5 of Table 6. Figure 24 shows solar heat response for Systems 7 and 8. Points plotted are listed in Columns 6 and 7 of Table 6.

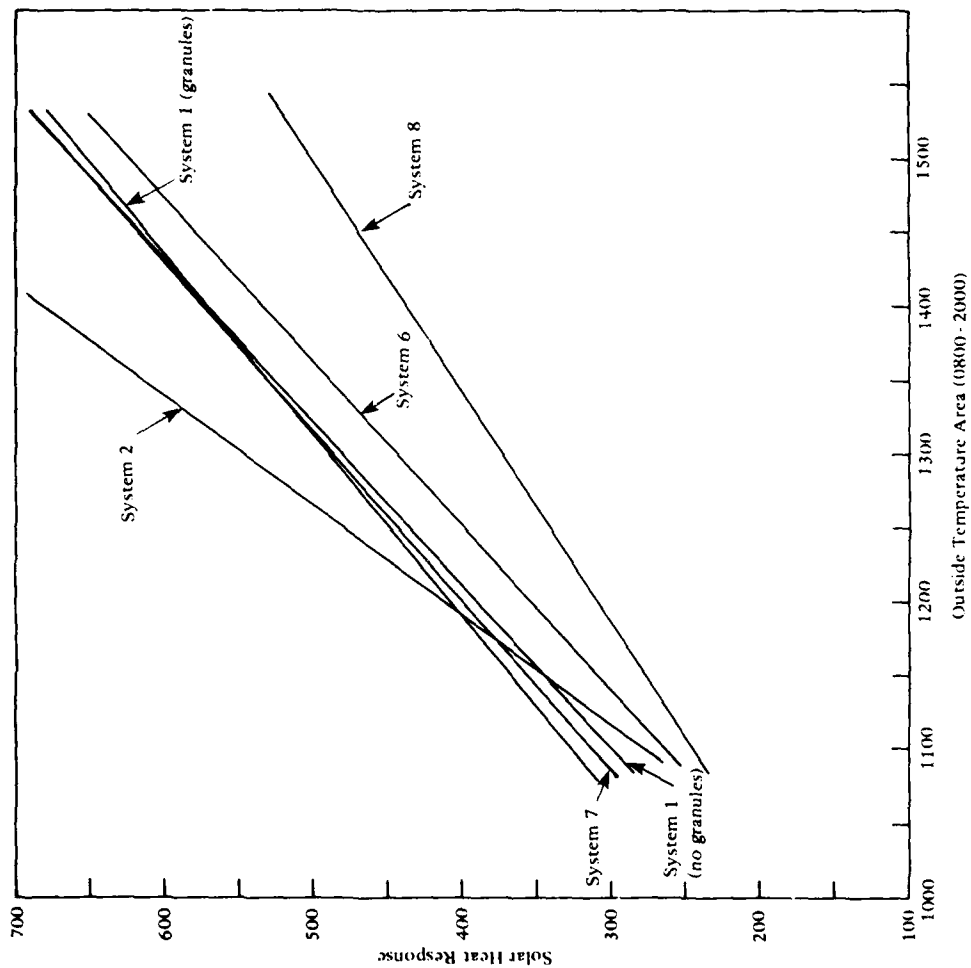
Figure 25. Solar heat response on all roofs, summers of 1978, 1979, 1980.

Figure 25 shows all the least squares lines from Figures 22-24. System 8, white catalyzed urethane with white granules, shows the lowest values of solar heat response. This coating system maintained its original white color longer than any of the other coatings. The highest values were in System 2, moisture-curing silicone without granules. Although this coating system was originally white, the silicone top surface soon began to soil and within a few months it had become a dingy gray. When the coatings were first sprayed, roof temperatures at the top surface (above the foam) were about 20° to 30°F cooler in the white silicone of System 2 than in the gray catalyzed silicone of System 1. In a few months, however, the top surface temperatures were almost the same in the two coatings, due to the darkening of the moisture-curing silicone of System 2.

The second lowest solar heat response in Figure 25 was in System 6 which is the same moisture-curing silicone used in System 2, the difference between the two systems being the white roofing granules applied in System 6. Graying of the top surface of System 6 has been much less severe than in System 2, partly because the white roofing granules do not discolor and partly because the presence of the granules reduces the exposed surface area of the silicone. Figure 25 indicates that all three of the gray coating systems (1 with and without granules, and 7 without granules) show about the same values of solar heat response. It should be emphasized that solar heat response is a direct measure of the effect of the sun's heat upon the roof.

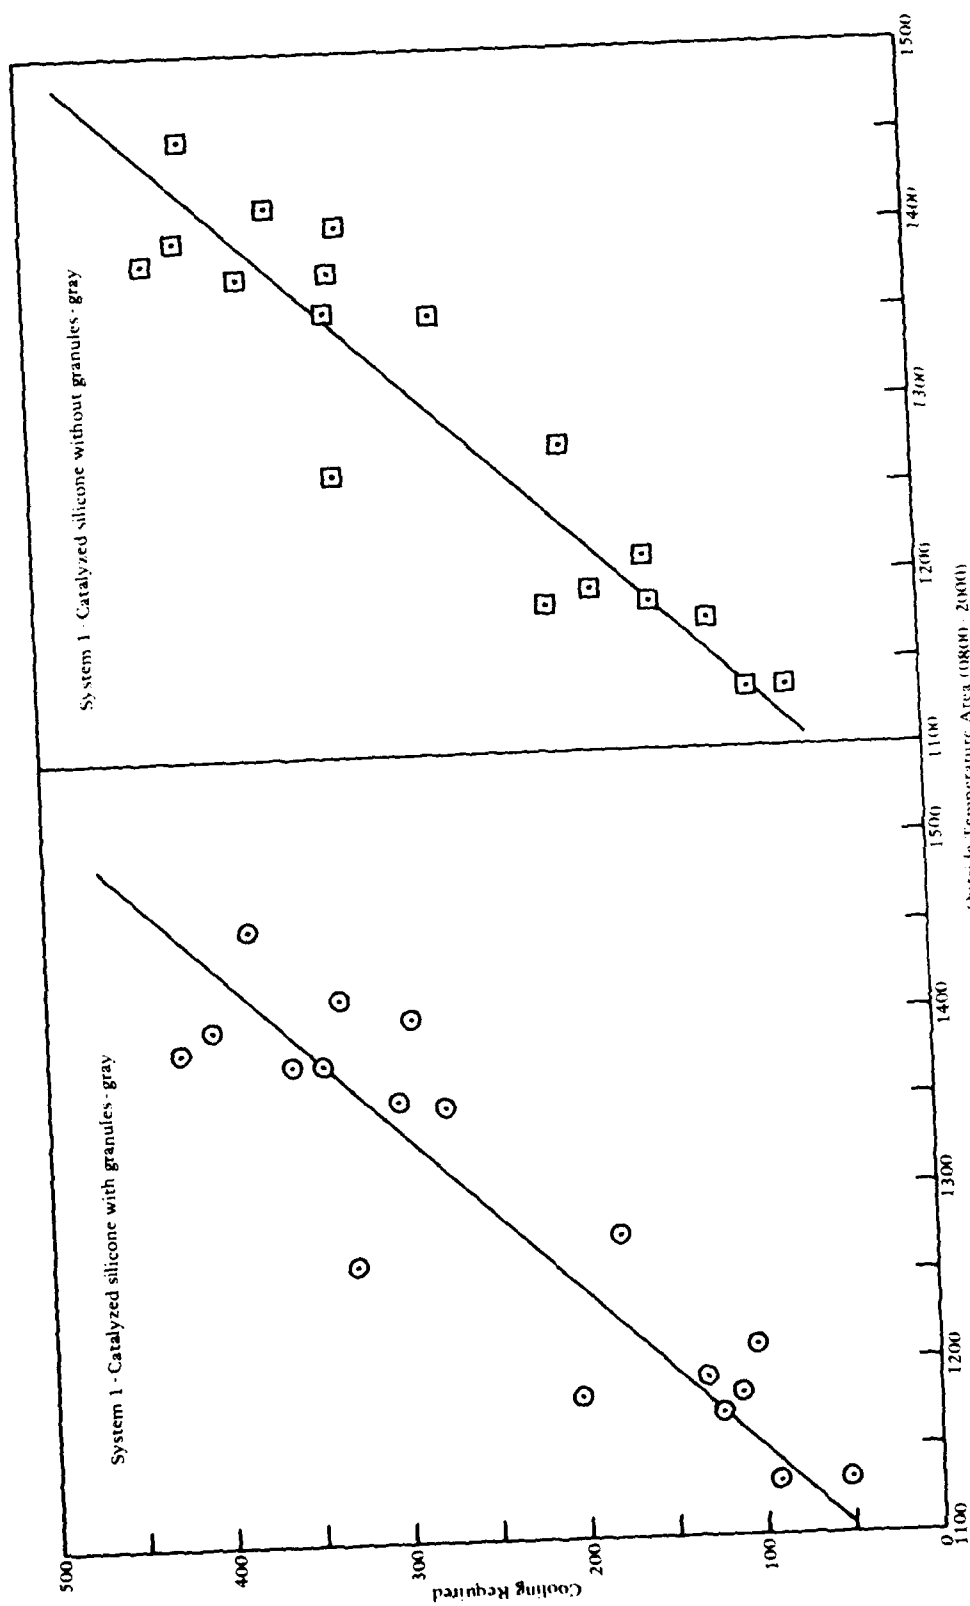
Figure 26. Cooling required on catalyzed silicone roof sections

Cooling Required. Figure 26 shows cooling required on System 1 sections. As before, the lines drawn are approximate least square lines for plotted points, taken from Columns 8 and 9 of Table 6. Cooling required on Systems 2 and 6 are presented in Figure 27; points plotted are taken from Columns 10 and 11 of Table 6. Figure 28 shows cooling required on Systems 7 and 8, taken from Columns 12 and 13 of Table 6. Least-squares lines of cooling required for all sections are shown in Figure 29. System 7, aluminum-gray catalyzed urethane without granules, indicates the least cooling required of all sections and System 2 shows the most, although variation among them is not very wide.

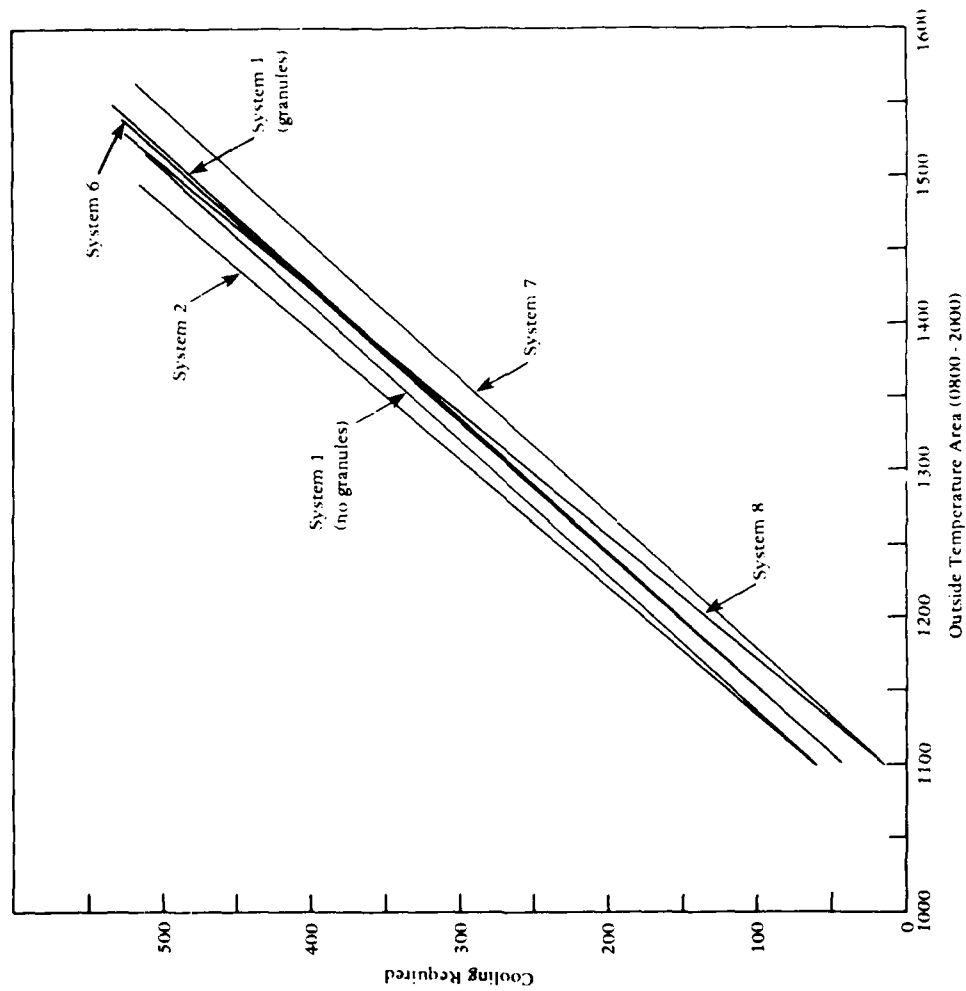
Figure 29. Cooling required on 4" roofs, summers of 1978, 1979, 1980.

The relationships shown in Figure 29 reflect interplay between the reaction of the roof system to the sun's heat, as measured by solar heat response, and the insulating efficiency or thermal resistance (R) of the foam in each roof section. The last column of Table 5 shows thermal resistance (R) in each section: the higher the R-value, the greater the insulating characteristics of the material. System 7 has the highest R-value and the lowest cooling required in spite of a moderate solar heat response. In Table 5, System 8 has the second highest R-value. System 8 indicates the lowest solar heat response in Figure 25 but shows a moderate value of cooling required in Figure 29. System 1, with and without granules, shows the lowest R-values in Table 5 but shows moderate values of both solar heat response in Figure 25 and cooling required in Figure 29. System 2 (without granules) indicates a relatively low R-value in Table 5, and shows the highest solar heat response and cooling required. System 6 indicates a moderate R-value in Table 5 but shows the second lowest solar heat response and a moderate cooling required.
