RIPPOWAM RIVER BASIN
STAMFORD CONNECTICUT

N. STAMFORD RESERVOIR DAM

CT. 00048

PHASE I INSPECTION REPORT
NATIONAL DAM INSPECTION PROGRAM

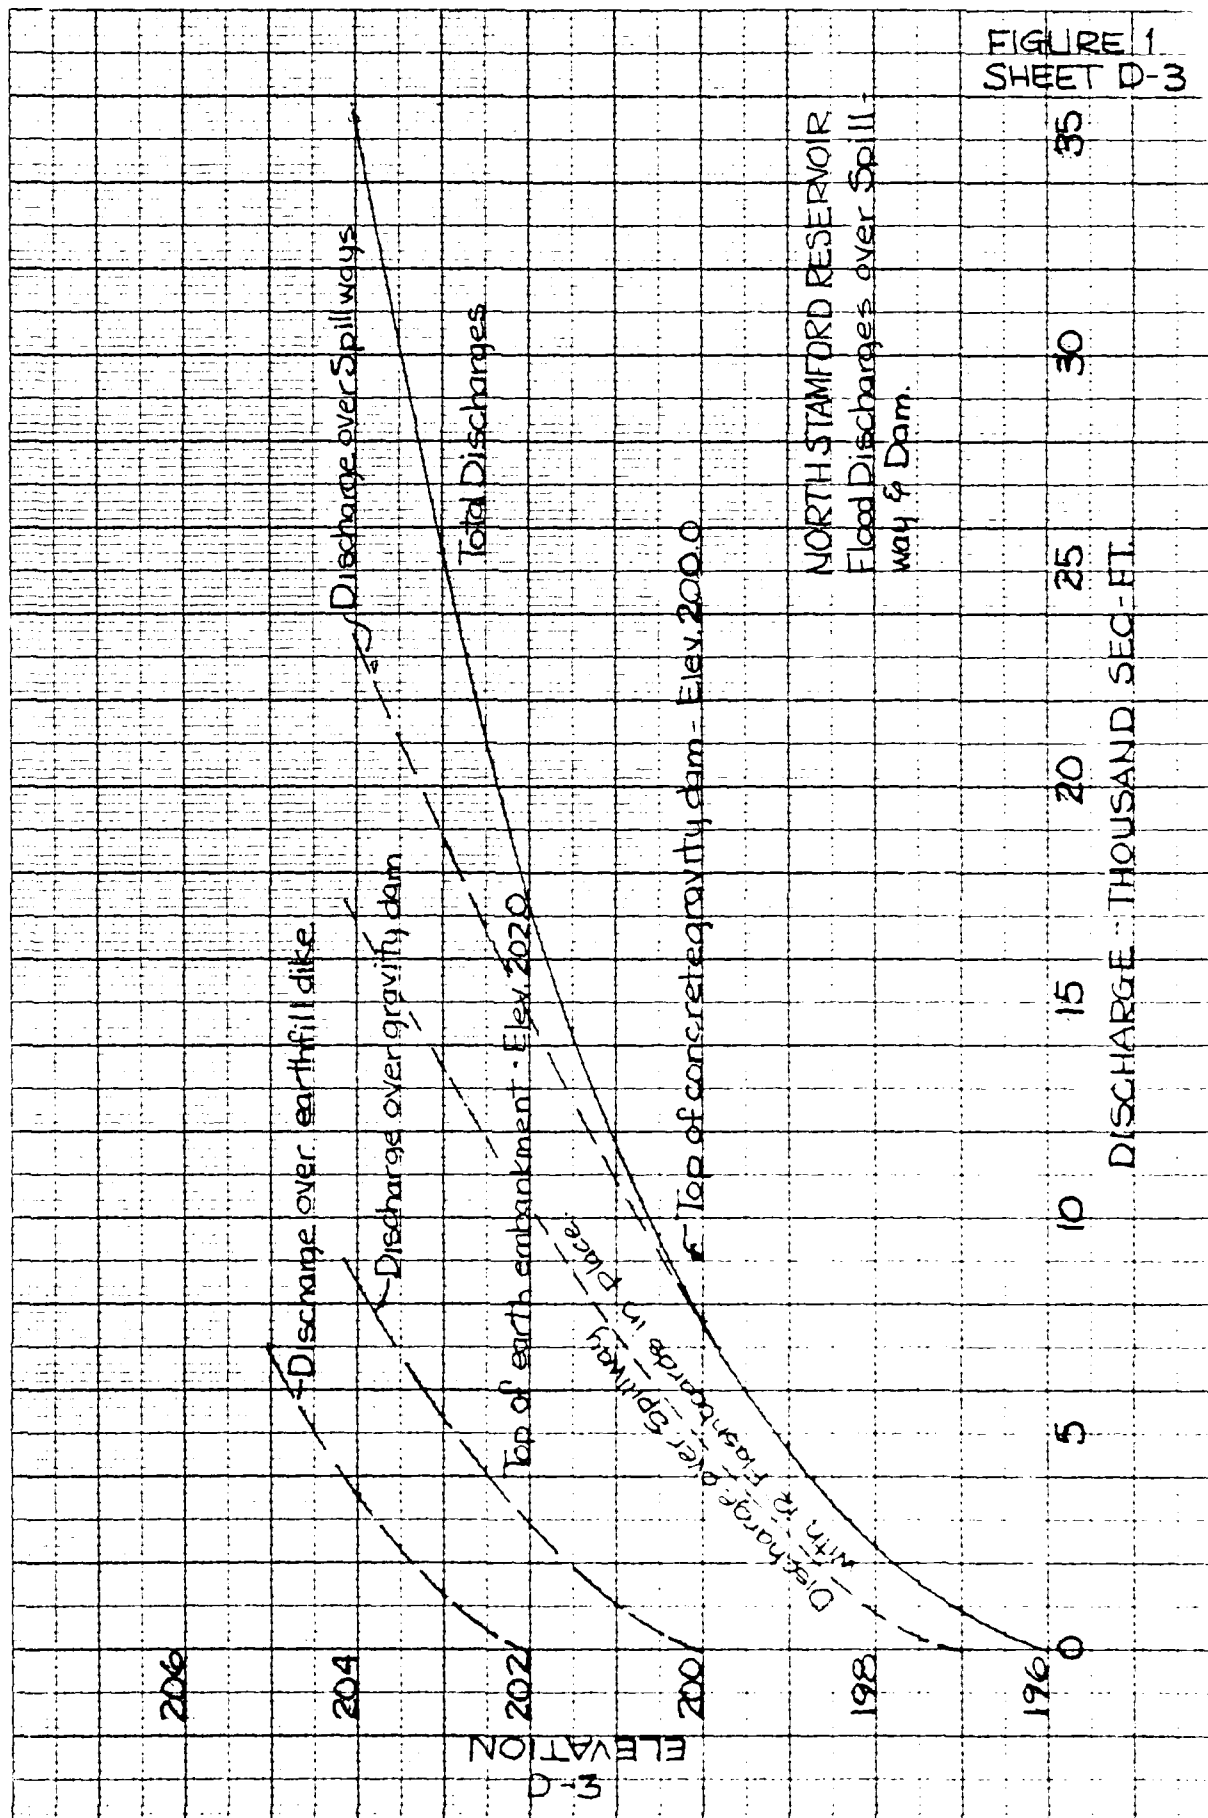
FIGURE 1
SHEET D-3

A spillway discharge curve has been prepared for the spillways as they presently exist. A discharge curve for outflows through the spillways and over the dam and dike are shown on Figure 1, Sheet D-3, Appendix D. Computations are shown on Sheet D-4. Pertinent discharges are as follows:

With the flashboards in place, the capacity of the spillway is accordingly reduced. A discharge curve for the spillway with 12 in. flashboards installed is shown on Figure 1, Sheet D-3. It will be noted that, with the reservoir level at the top of the gravity dam, elevation 200, the spillway discharge will be about 4,800 cfs, or 65 percent of that for the unobstructed crest. With the reservoir at the top of the earth dike, elevation 202, the spillway discharge will be about 10,400 cfs. or 70 percent of that of an unobstructed crest.

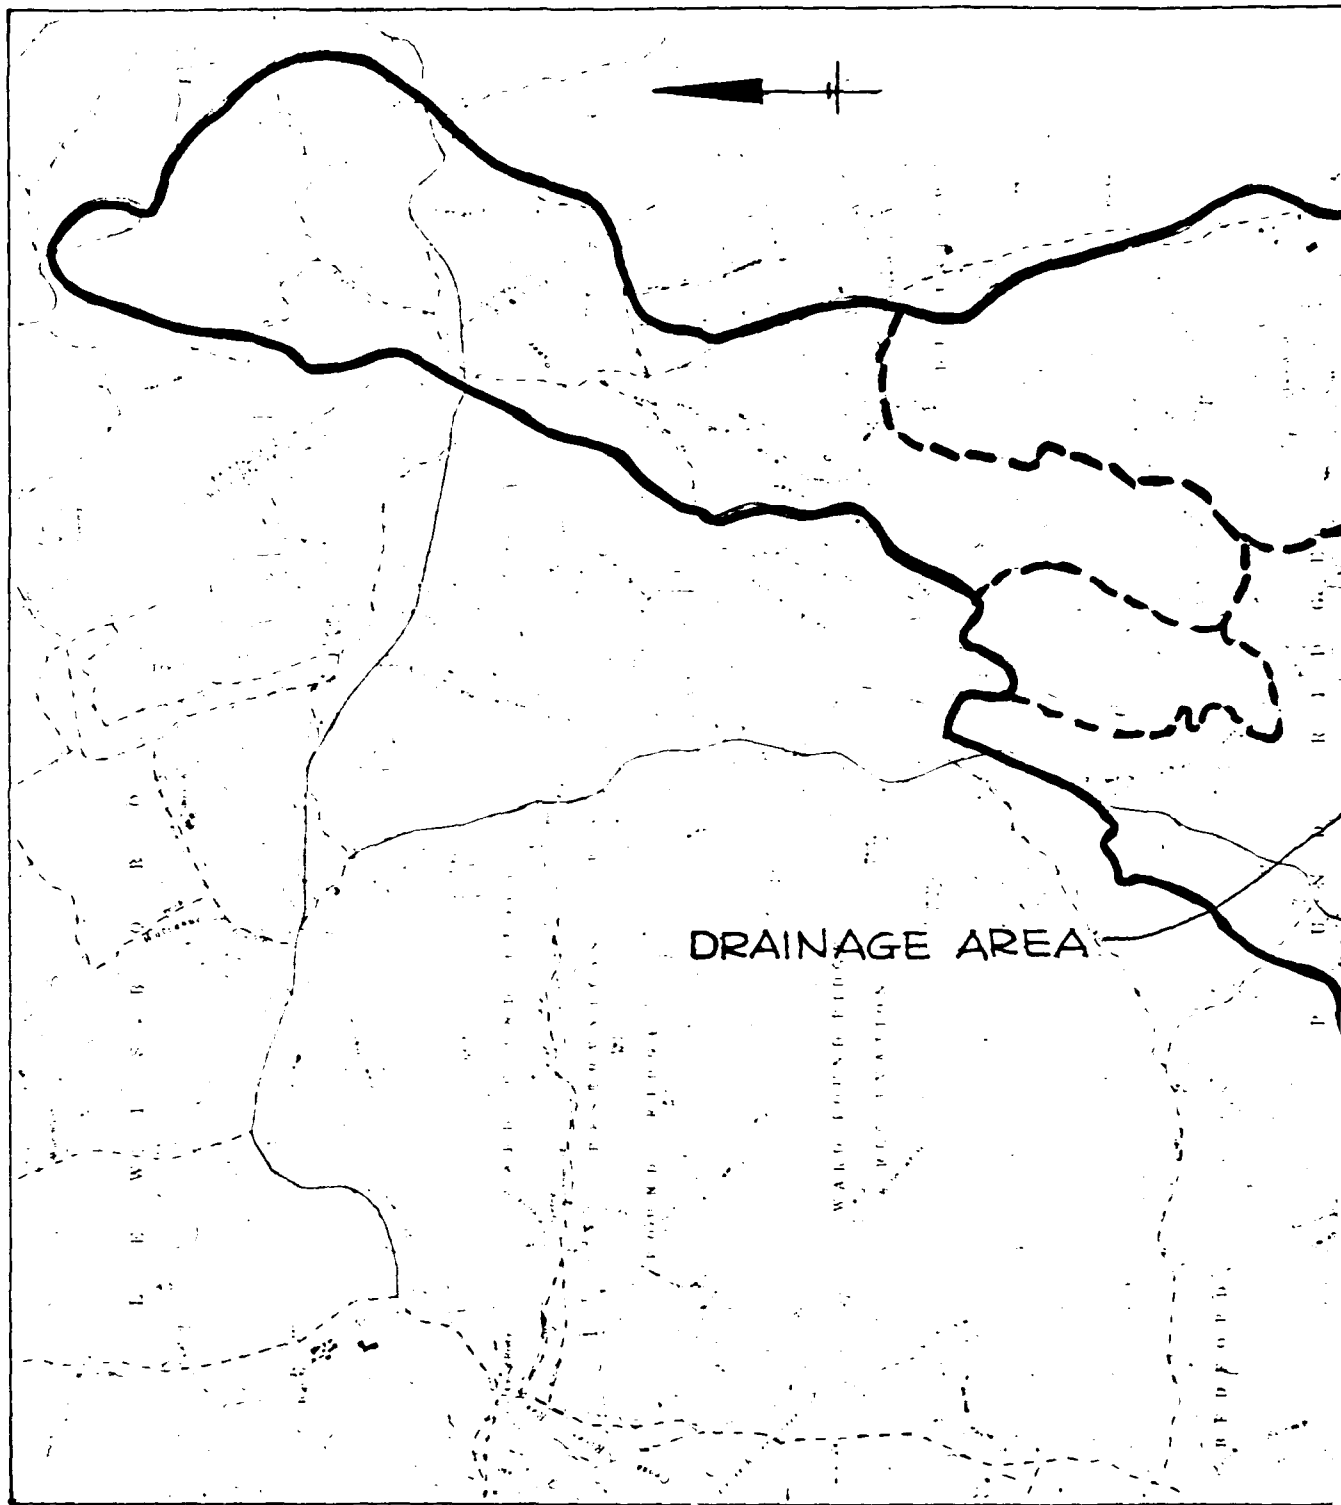
AREA OF POTENTIAL
FLOODING

Since an overtopping of the gravity dam could wash away the fill at the toe of the dam, its resistance against sliding and overturning could be reduced and a failure of a portion of this dam could conceivably occur. With the water at the top of the dam, a breach outflow as suggested in the NED March 1978 Guidance Report, with an assumed failure width of about 100 ft., would produce a flood wave of about 42,500 cfs. (See computations on Sheet D-16). The spillway discharge of 6,900 cfs. added to the breach outflow would give a discharge downstream of about 49,400 cfs. The stage-discharge for the river reach immediately before the breach shows that a depth of less than 10 ft. would prevail down river above the Merritt Parkway crossing. After the breach, the stage-discharge for a flow of about 50,000 cfs. shows that this depth would increase to more than 25 ft. At this depth, the valley storage will capture about 1,000 acre-ft. of the outflow, somewhat diminishing the flood wave downstream. However, more than 20 homes and several commercial establishments are well within the flood plain for such a discharge. Delineated on Figure 4, Sheet D-17 (Quad sheet graphic), is the approximate area which could be flooded by a breach failure of the concrete dam.
