BLACKSTONE RIVER BASIN
MILLBURY, MASSACHUSETTS

RAMSHORN POND DAM
MA 00145

**PHASE I INSPECTION REPORT
NATIONAL DAM INSPECTION PROGRAM**

JULY 1978

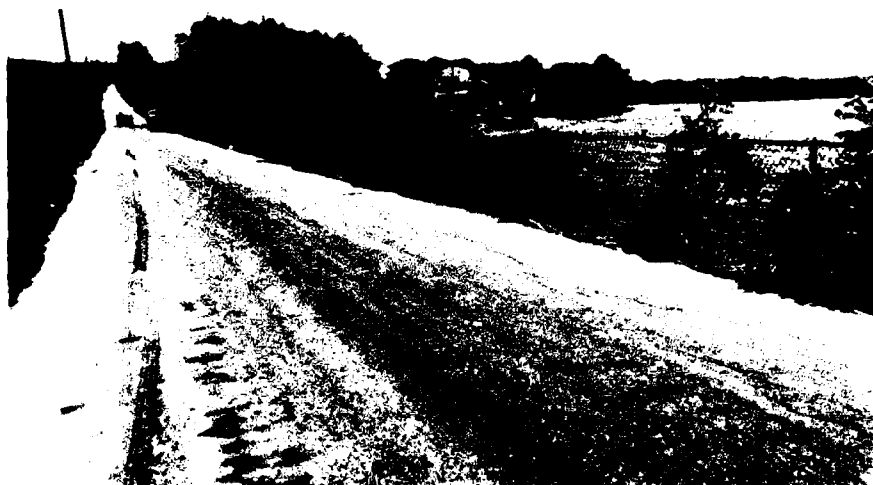
DAM CREST (DOLAN ROAD) AND RAMSHORN POND

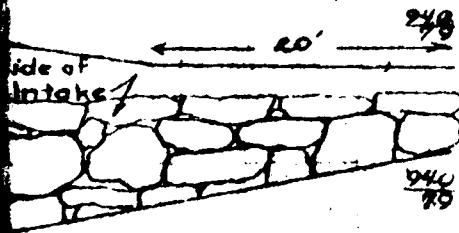
FIGURE B-3

NOTE: ELEVATIONS ON SPILLWAY TAKEN DURING METCALF & EDDY
FIELD INSPECTION, JUNE 12, 1978.

ASSUMED BENCHMARK ELEVATION 627 MSL,
TOP OF SPILLWAY FLASHBOARDS REFERENCED
TO BM30.00 (ELEV. 633.5).

* NOTES AND ELEVATIONS ADDED BY METCALF & EDDY.
