# LYNN RESERVOIR DAM

MA 01285

## PHASE I INSPECTION REPORT NATIONAL DAM INSPECTION PROGRAM

JULY, 1981

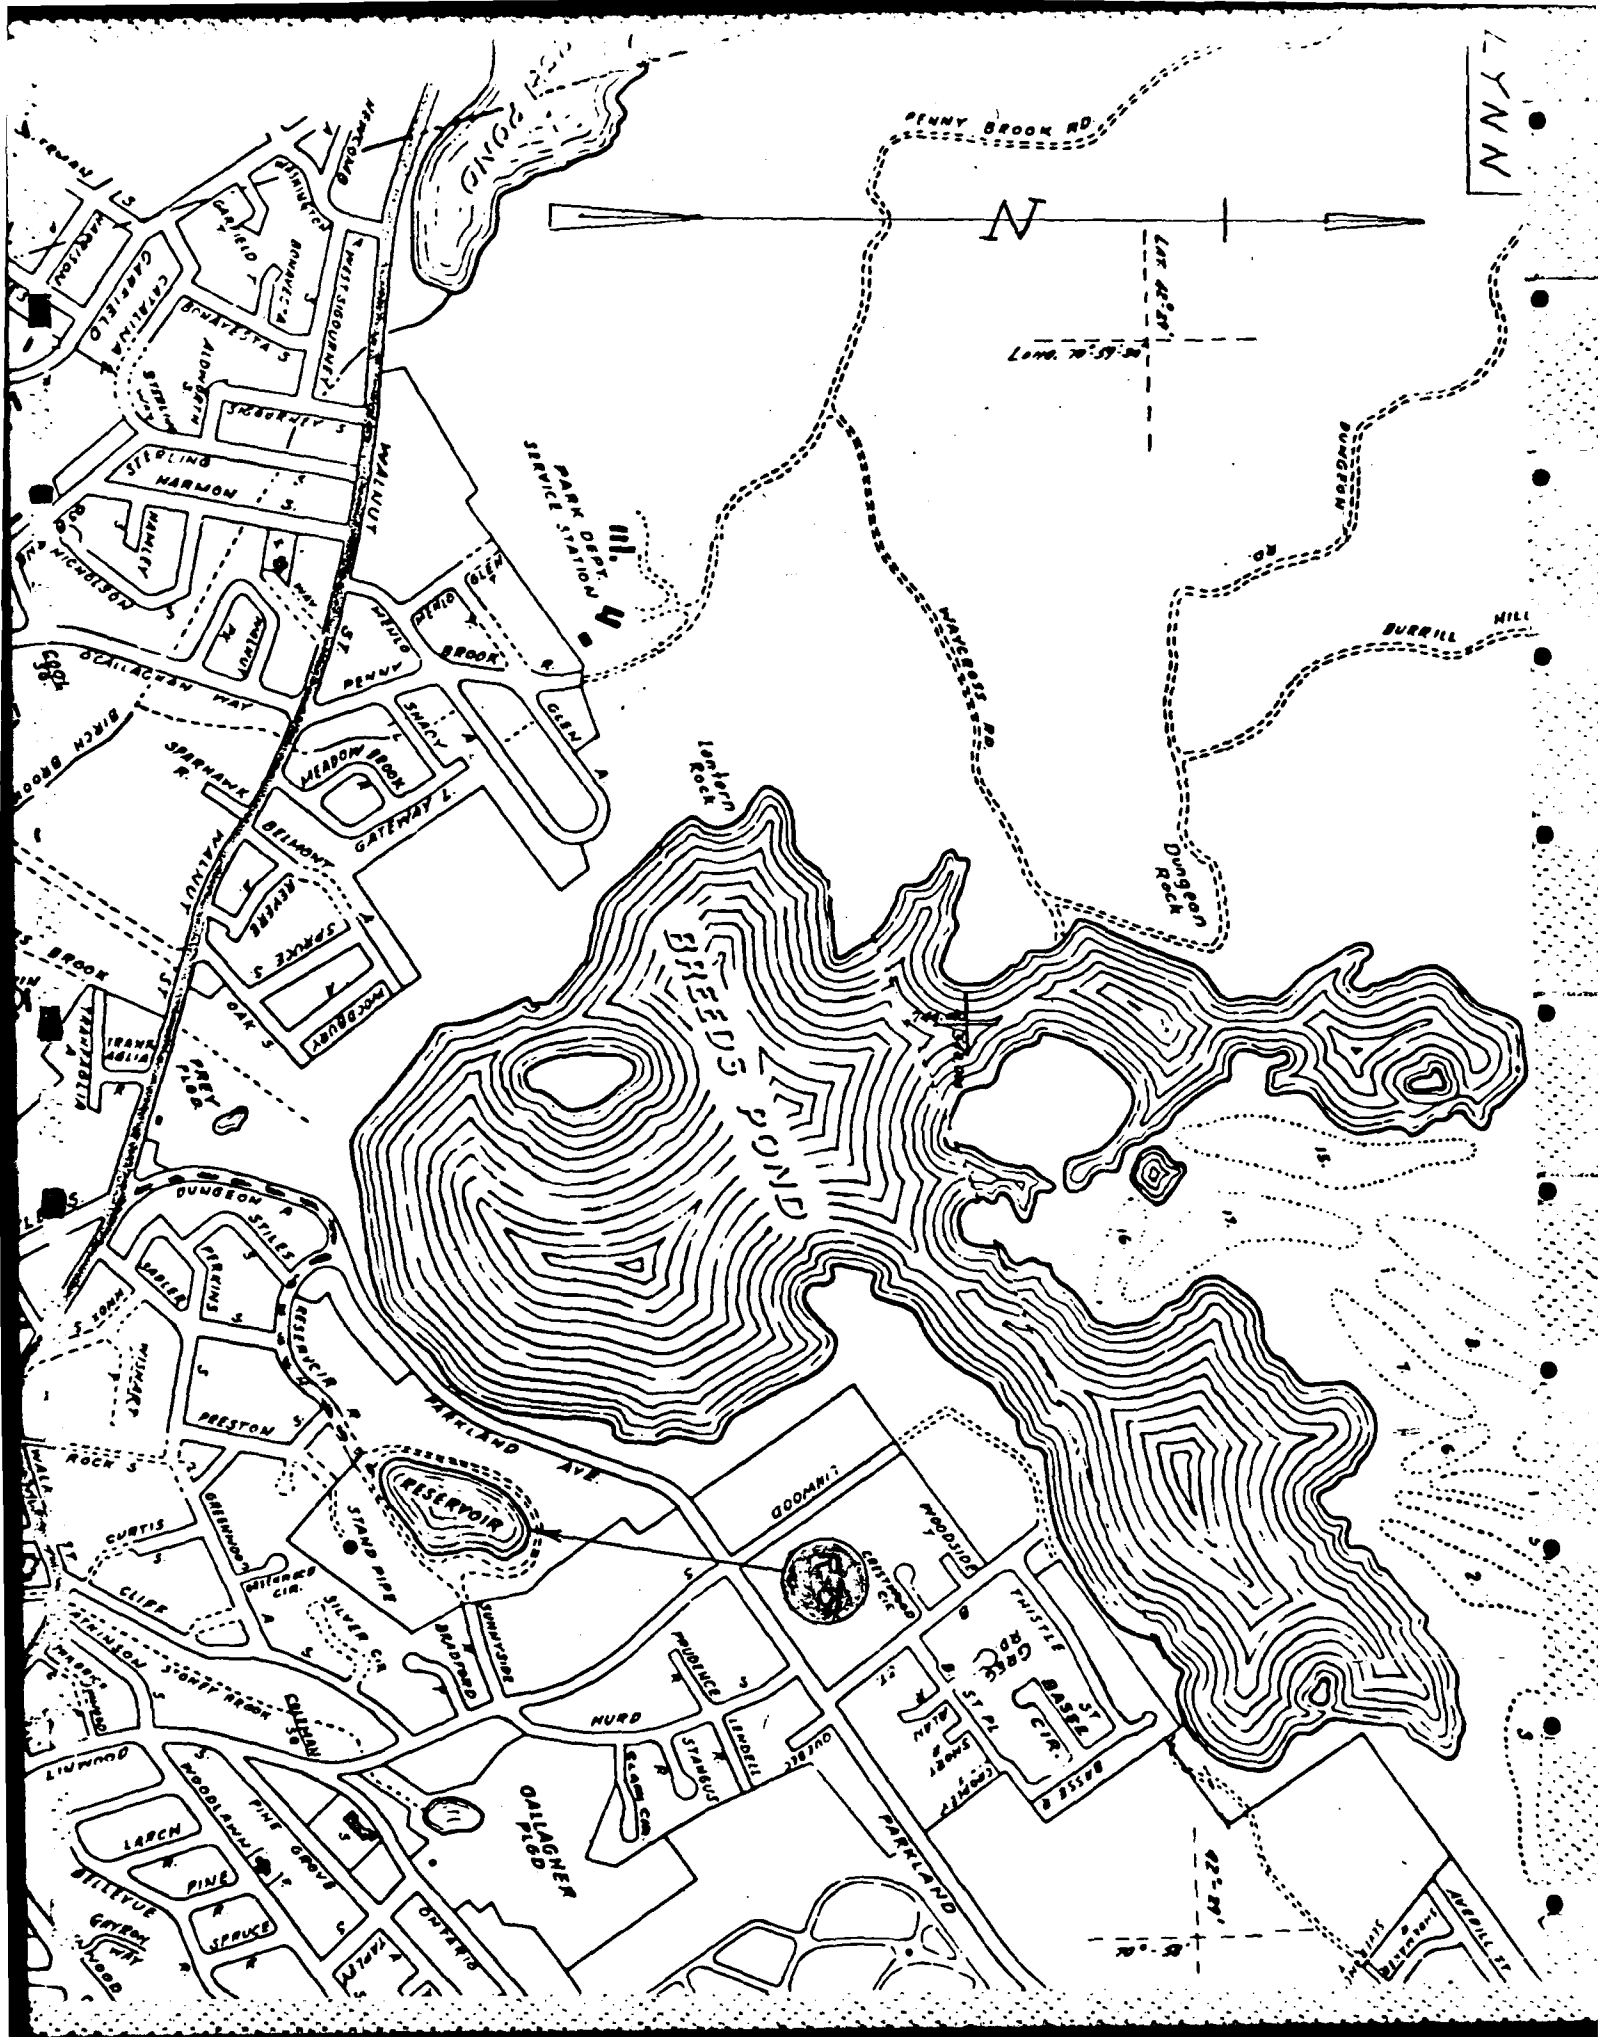
1964 March 1965. P.D.K. & K.M.J. Insp. Trees and brush growing in rip-  
rap should be removed.

1964 Report to Co. Comm. Trees and brush growing in riprap and on  
outside banks should be removed.
