TODD LAKE DAM

NH 00288

PHASE I INSPECTION REPORT  
NATIONAL DAM INSPECTION PROGRAM

AUGUST 1978

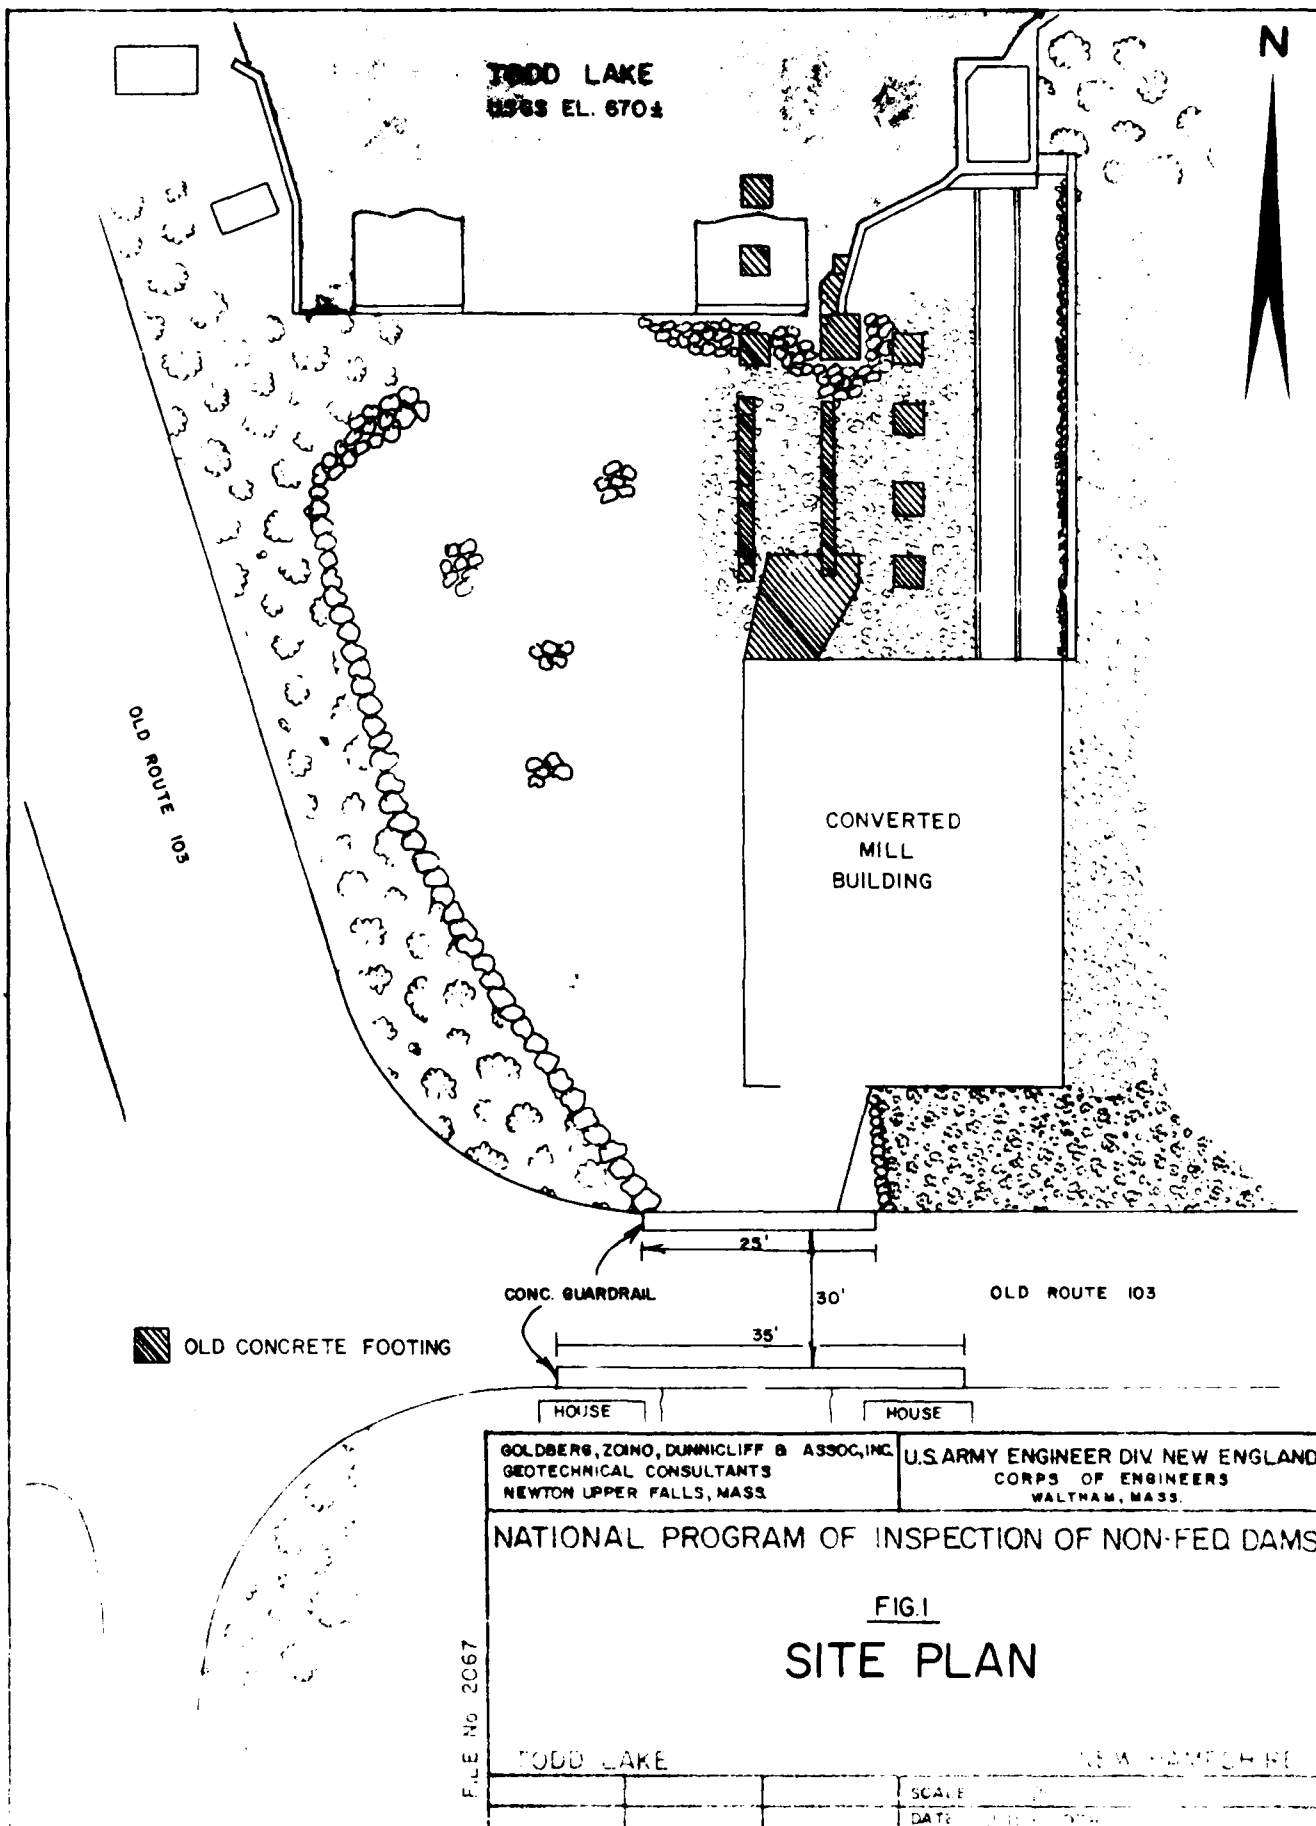
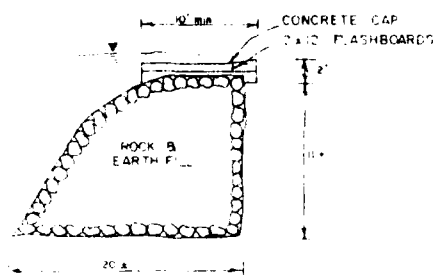
FIG. 2

The dam consists essentially of a gravity rock wall and earth fill structure with a base width estimated at 20 feet and a maximum height of 16.5 ft. (Figure 2). A concrete spillway covers the gravity structure over its entire 57 foot length and has two 12 foot long depressed sections, one near each end, which permit the installation of 12 inch flashboards (Figure 2). The left abutment incorporates the dam's outlet works which consist of a concrete box with two inlets and one outlet. Stop-logs at one time regulated flow through the outlet which then led into a now boarded up 5.8 foot diameter wooden penstock (Figure 3). The previous owner has sealed both inlets, probably by boarding, one of which is on the right side. No special hazard is believed to attend the penstock. The outlet works originally provided flow for the operation of a saw mill complex, only part of which remains today, having been converted into a one family home. Old concrete footings for the mill buildings still exist around the dam. The wooden penstock runs into the converted mill building, as does the small amount of water which leaks through the boarded up outlet works. A concrete lined channel carries this flow under the house. A concrete arch bridge permits flow under old Route 103 approximately 100 feet downstream of the dam.

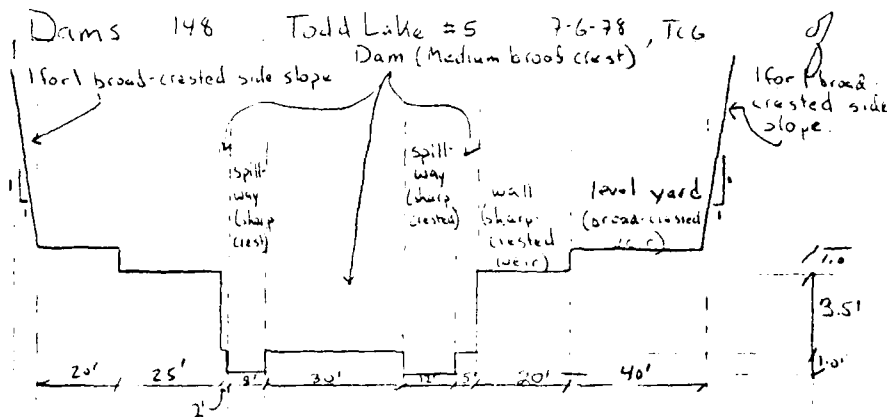
Elevation of Todd Lake Dam.

Since flow depends only on length and weir type, we could replace that dam with this "equivalent structure" and get the same stage-Discharge relationship.

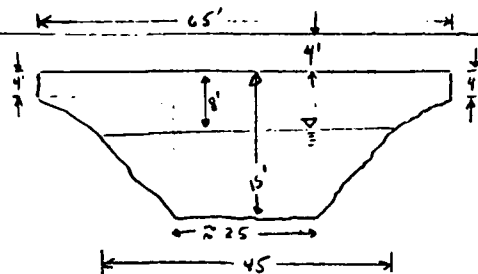
SOME CONSIDERATION MUST BE GIVEN TO WHETHER OR NOT THE NEW RITE 103 HIGHWAY EMBANKMENT WHICH FOLLOWS THE ALIGNMENT OF THE OLD RAILROAD WILL SERVE AS A DAM AND THIS REDUCE THE PEAK FLOW THAT REACHES THE TODD LAKE DAM. A CROSS SECTION AT THE HIGHWAY BRIDGE WAS TAKEN ON 7/12/78.

GIVEN THE LARGE OPENING  $\approx 750 \text{ FT}^2$  AND THE LIMITED FREEBOARD OVER THE BRIDGE GOING TO PRESSURE FLOW, IT IS UNLIKELY THAT A SIGNIFICANT REDUCTION IN FLOW WOULD RESULT FROM THE BRIDGE.
