MRL-R-956

WELD REPAIR OF CRACKED DEFA CANNON MOUNT FRAMES

J.C. Ritter, R.H. Phillips and B.F. Dixon

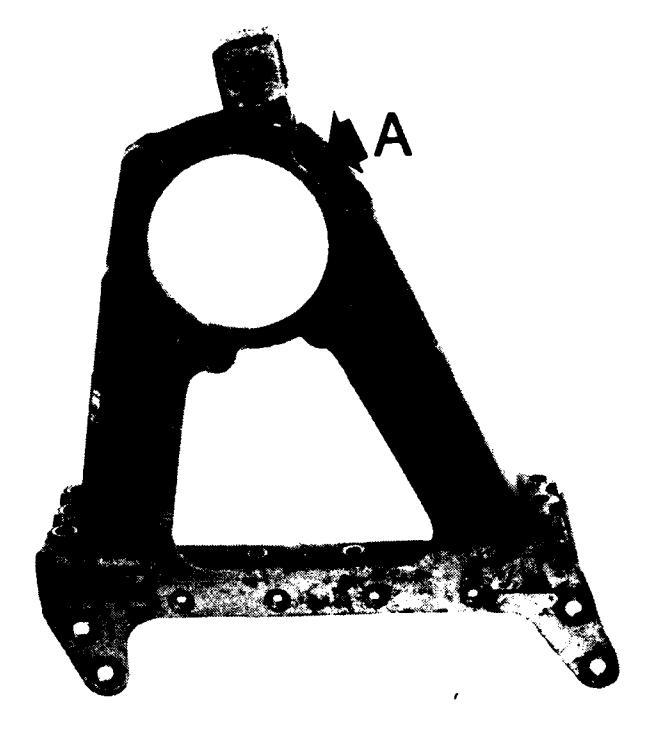
FIGURE 7

When broken open, the crack was found to extend some 8 mm into the section. It exhibited features characteristics of fatigue: at low magnification a generally flat, slightly fragmented surface (Fig. 7) with a few prominent progression markings. Scanning electron microscopy (SEM) at high magnification revealed many areas of striation markings relatively free from mechanical damage, and of noticeably uniform spacing (Fig. 8 (a)). A single origin at the surface of the section permitted reliable crack length measurement to any point.

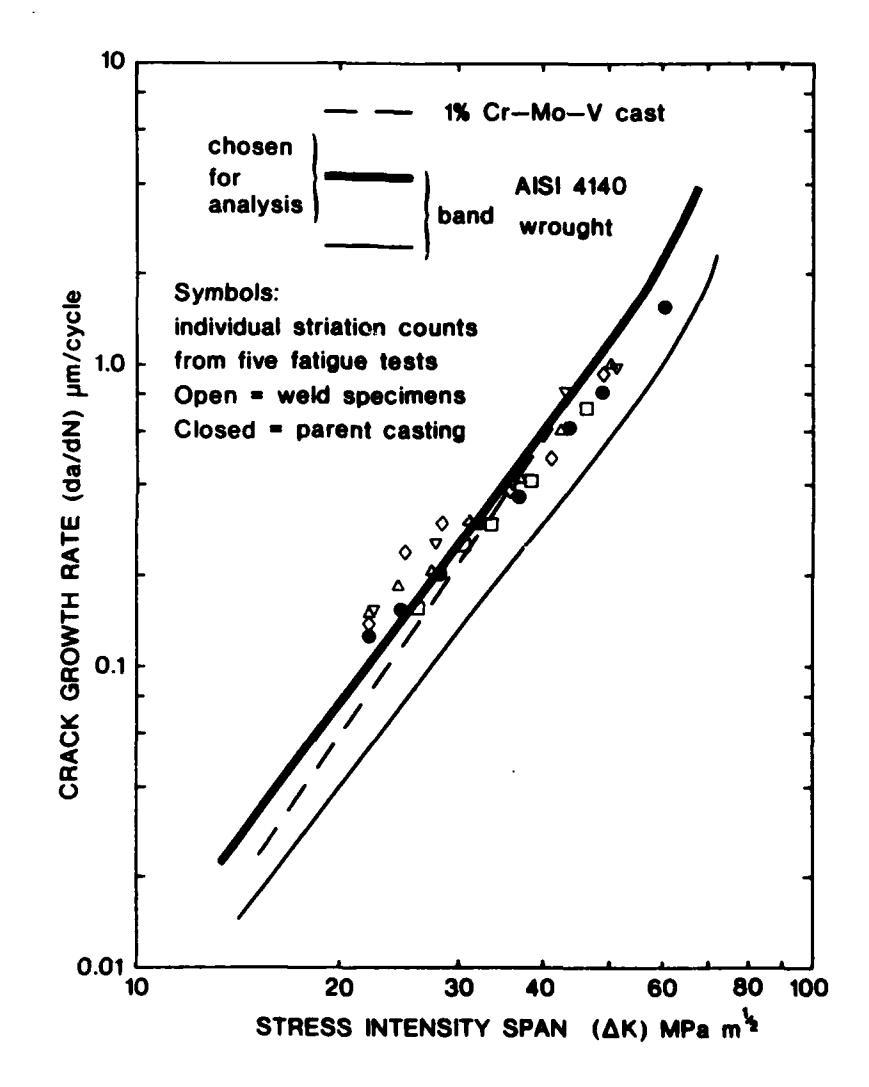
Data on fatigue crack growth rate, taken from the literature, tended to be similar for both wrought and cast low alloy steels of the Cr-Mo type, provided that they were tempered to about the same yield strength and the fatigue tests were conducted in air and with similar R values\*. Of the results used in Fig. 9 [4,5], the upper-bound curve (shown as a bold line) was adopted for analysis, to make allowance for significant shrinkage porosity in the casting (Fig. 10). The presence of such porosity would have had the effect of raising the overall macroscopic crack growth rate above that indicated by the striation spacings because of numerous local jumps across the voids.

single crack having the same total depth. The results of five tests covering parent casting and weld HAZ, over a wide range of loads, are superimposed on Fig. 9.

Fatigue crack growth rate data for 1% Cr low alloy steels. The 1% Cr-Mo-V cast steel is after Haigh [4] and the band for AISI 4140 is after Thielen and Fine [5]. Test data points are from four welded specimens (open symbols) and one parent specimen (closed symbol).
