# SAN NICOLAS ISLAND BARGE LANDING SITE SURVEY

FPO-1-79(3)  
NOVEMBER 1978

OCEAN ENGINEERING AND CONSTRUCTION PROJECT OFFICE  
CHESAPEAKE DIVISION  
NAVAL FACILITIES ENGINEERING COMMAND  
WASHINGTON, D.C. 20374

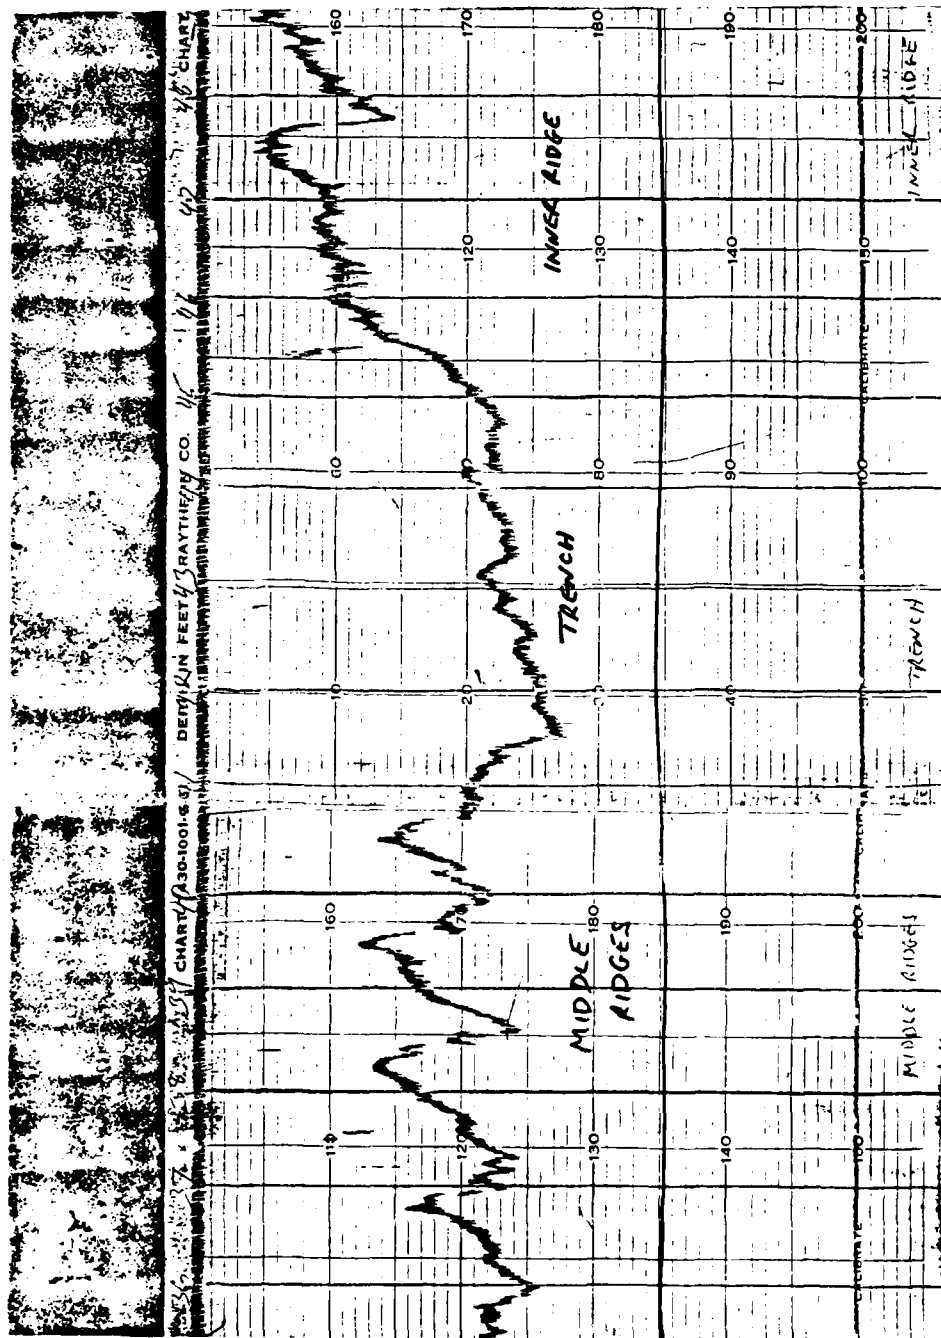
Figure 8. Fathometer Record Sample - Ridge Transect  
(Showing the Middle Ridges, the Trench, and  
the Inner Ridge).

Figure 8: A run across the ridges in the western portion of the site survey area. Note that the ridges are steeper on the landward side than on the seaward side. (The left of the picture is seaward.)
