Report of the  
**PRESIDENTIAL  
COMMISSION**

*on the Space Shuttle  
Challenger Accident*

*Report to the President*

June 6th, 1986  
Washington, D.C.

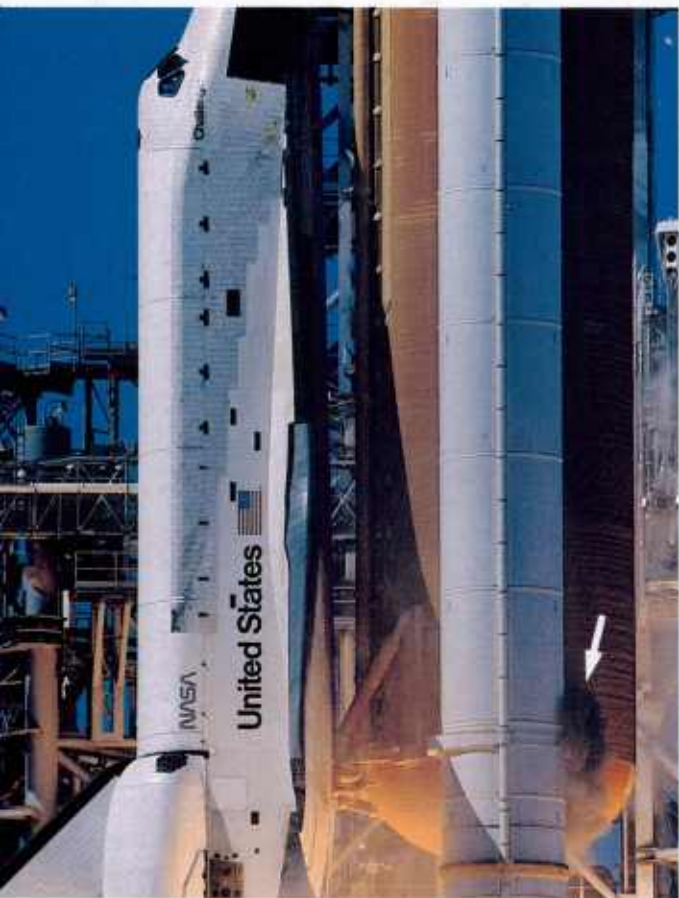
Immediately after solid rocket motor ignition, dark smoke (arrows) swirled out between the right hand booster and the External Tank. The smoke's origin, behavior and duration was approximated by visual analysis and computer enhancement of film from five camera locations. Consensus: smoke was first discernible at .678 seconds Mission Elapsed Time in the vicinity of the right booster's aft field joint.

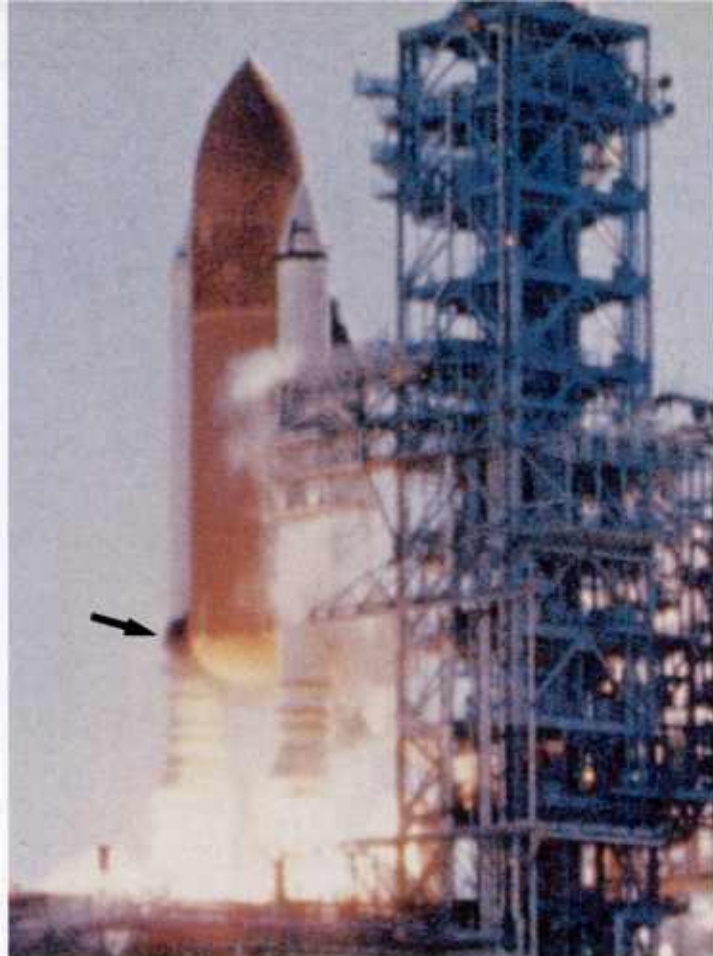
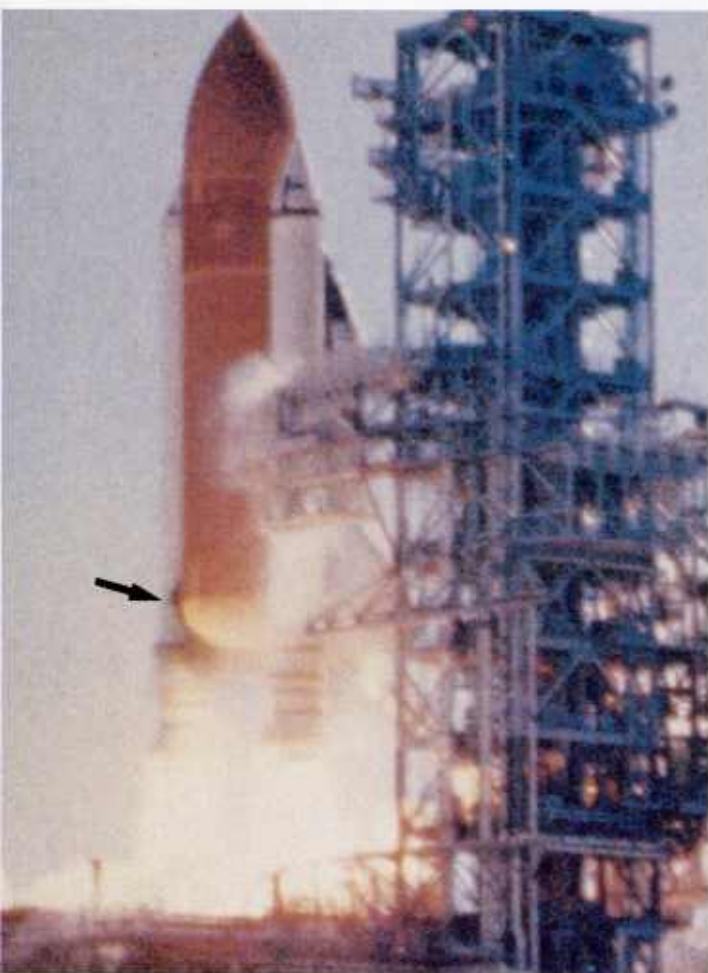
Multiple smoke puffs are visible in the photo above (arrows). They began at .836 seconds and continued through 2.500 seconds, occurring about 4 times a second. Upward motion of the vehicle caused the smoke to drift downward and blur into a single cloud. Smoke source is shown in the computer generated drawing (far right).

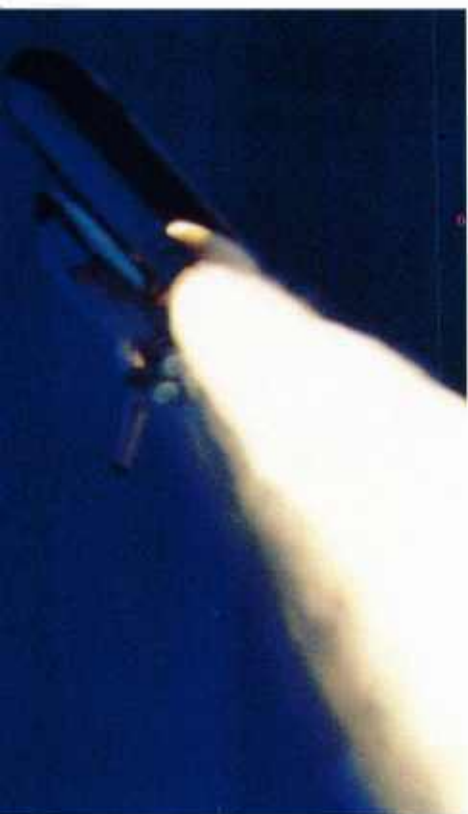
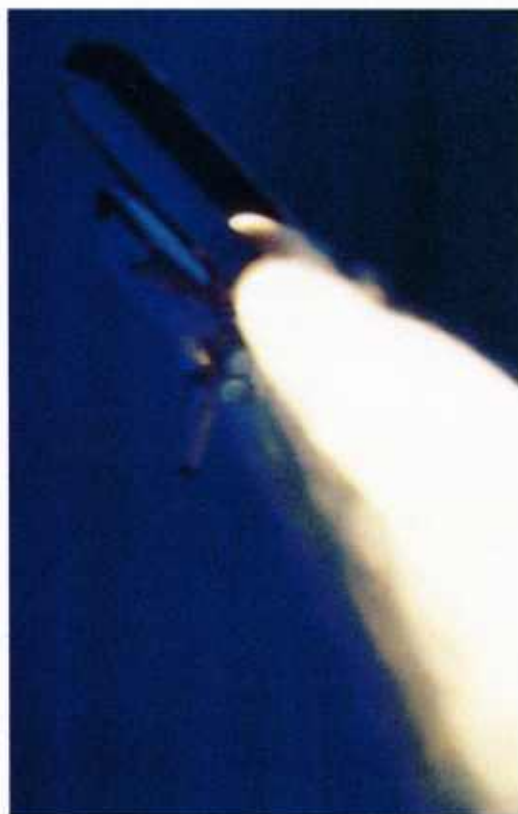
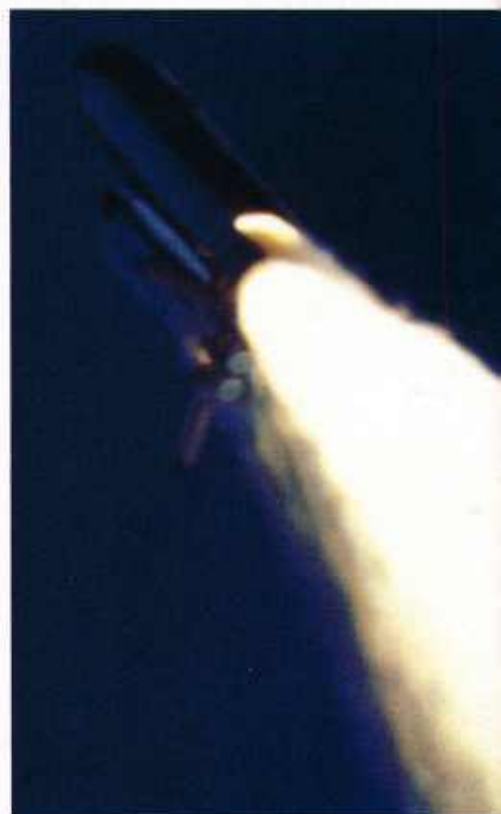
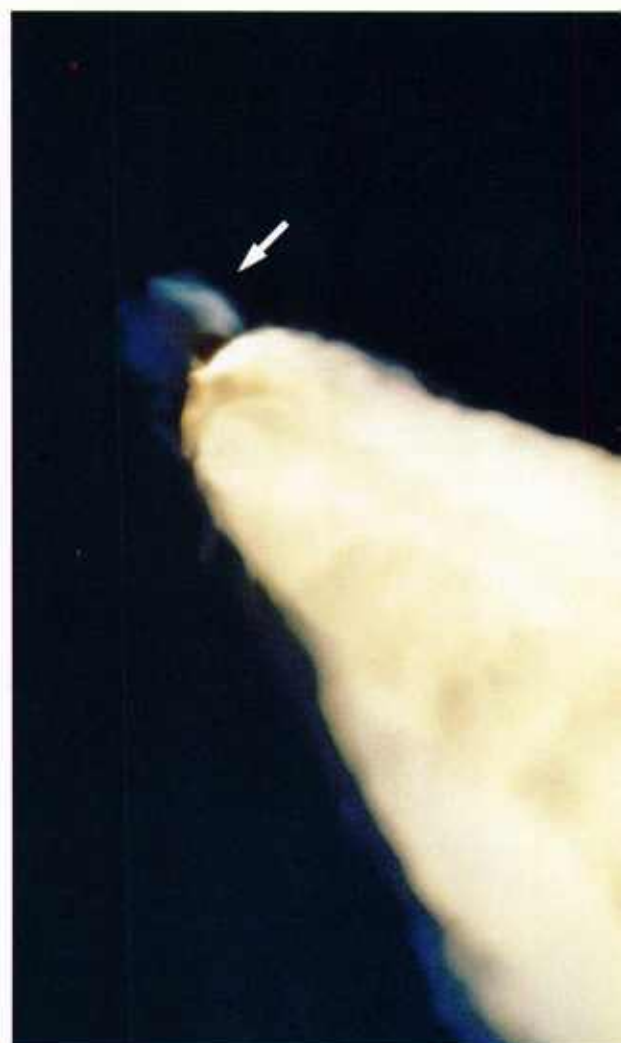
Camera views indicate the beginning of rupture of the liquid hydrogen and liquid oxygen tanks within the External Tank. A small flash (arrows above) intensified rapidly, then diminished. A second flash,

attributed to rupture of the liquid oxygen tank, occurred above the booster/tank forward attachment (below left) and grew in milliseconds to the maximum size indicated in the computer drawing.

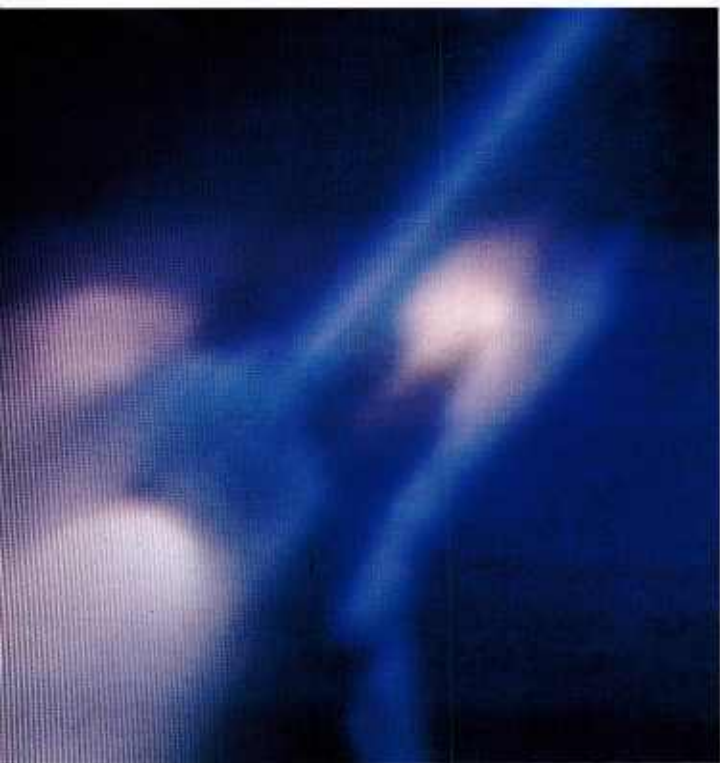
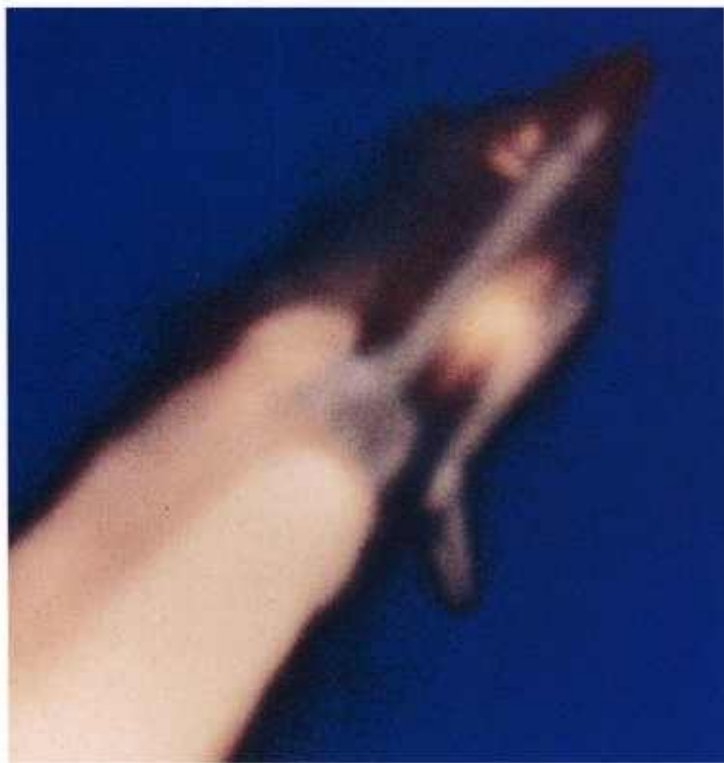
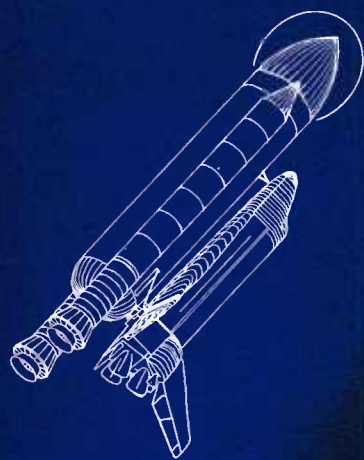
Structural breakup of the vehicle began at approximately 73 seconds. Fire spread very rapidly. Above, a bright flash (arrow) is evident near the nose of the Orbiter, suggesting spillage and ignition of the spacecraft's reaction control system propellants. At left, the two Solid Rocket Boosters thrust away from the fire, crisscrossing to form a "V." The right booster—identifiable by its failure plume—now to the left of its counterpart. At right, the boosters diverge farther; the External Tank wreckage is obscured by smoke and vapor. The Orbiter engines still firing, is visible at bottom center.

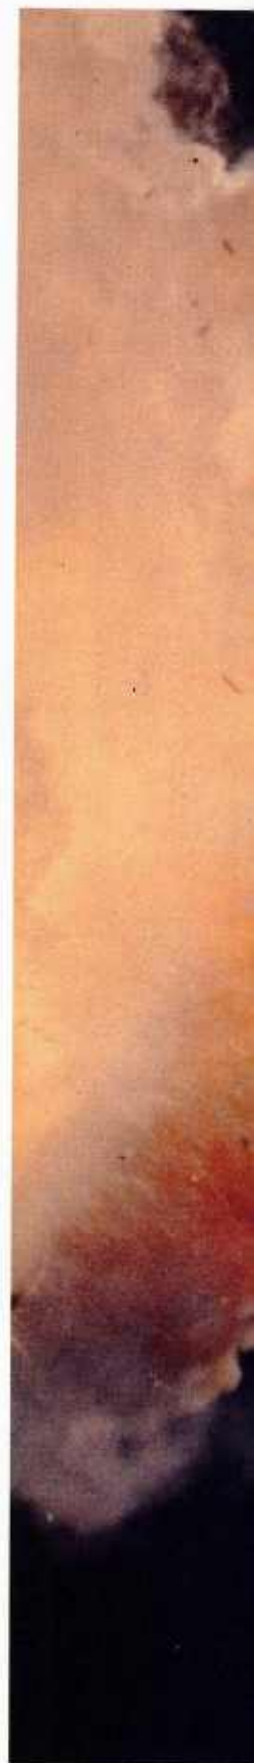
At about 76 seconds, unidentifiable fragments of the Shuttle vehicle can be seen tumbling against a background of fire, smoke and vaporized propellants from the External Tank (left). In the photo at right, the left booster (far right)

soars away, still thrusting. The reddish-brown cloud envelops the disintegrating Orbiter. The color is characteristic of the nitrogen tetroxide oxidizer in the Orbiter Reaction Control System propellant.

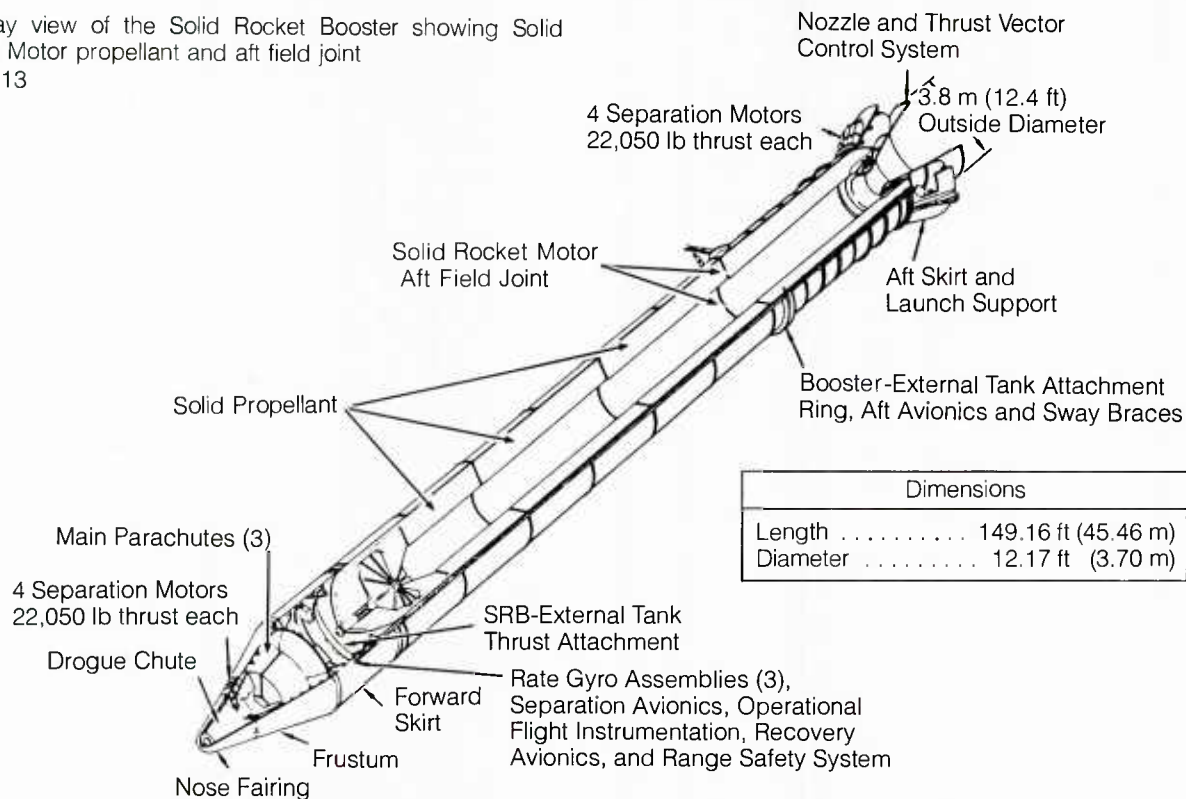
Cutaway view of the Solid Rocket Booster showing Solid Rocket Motor propellant and aft field joint  
Figure 13

The hypothesis of a membrane failure requires that the initial smoke observed at 0.678 seconds was an independent occurrence. It is an unlikely hypothesis for initiation of the accident. Fracture mechanics analysis indicates that a hole in the

case larger than one inch would cause the entire case to rupture in a few milliseconds. This would give rise to the appearance of a large longitudinal flame, an event that is contrary to the flight films.

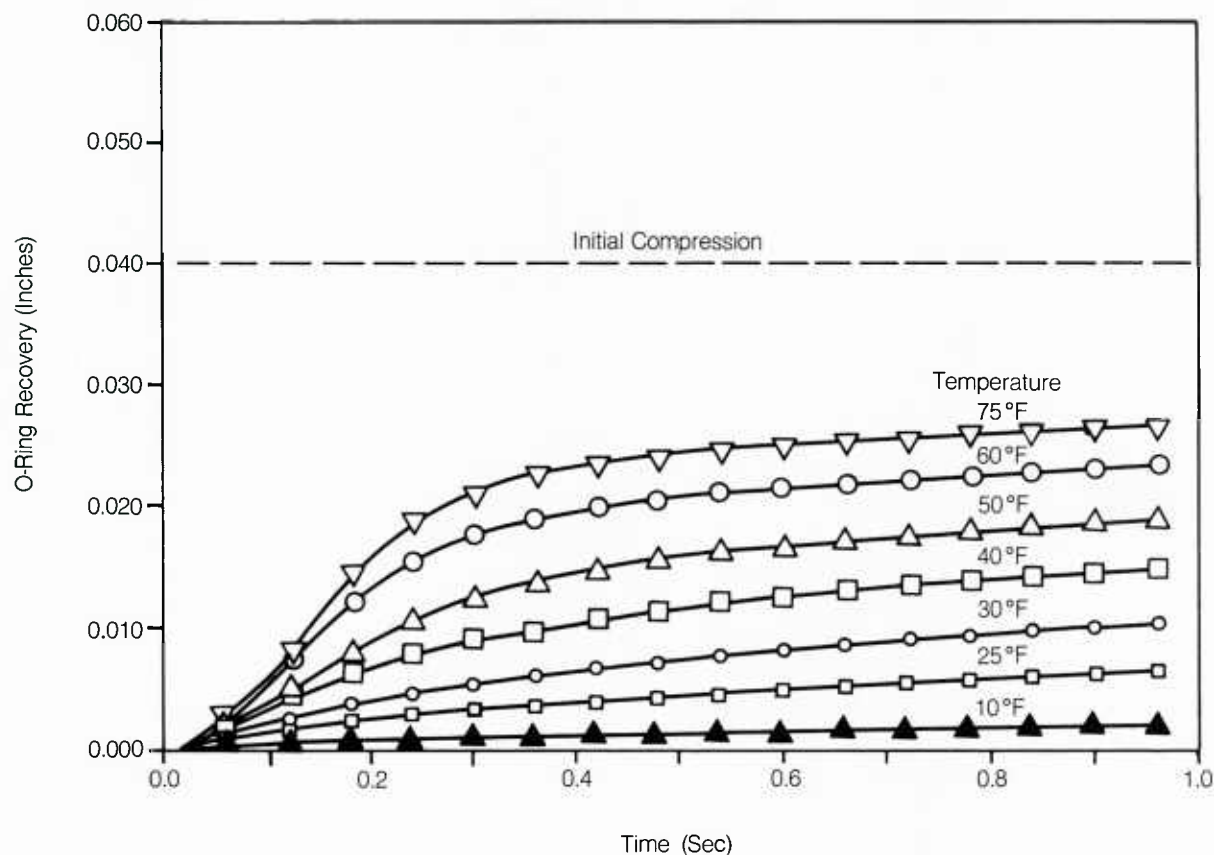
Consistent results from numerous O-ring tests have shown a resiliency degradation with reduced temperatures. Figure 23 provides O-ring recovery from 0.040 inches of initial compression versus time. This shows how quickly an O-ring will move back towards its uncompressed shape at temperatures ranging from 10 to 75 degrees Fahrenheit. When these data are compared with the gap openings versus time from Figure 17, it can be seen that the O-rings will not track or

Graph plots O-ring shape recovery in inches against time in seconds for a variety of temperatures.

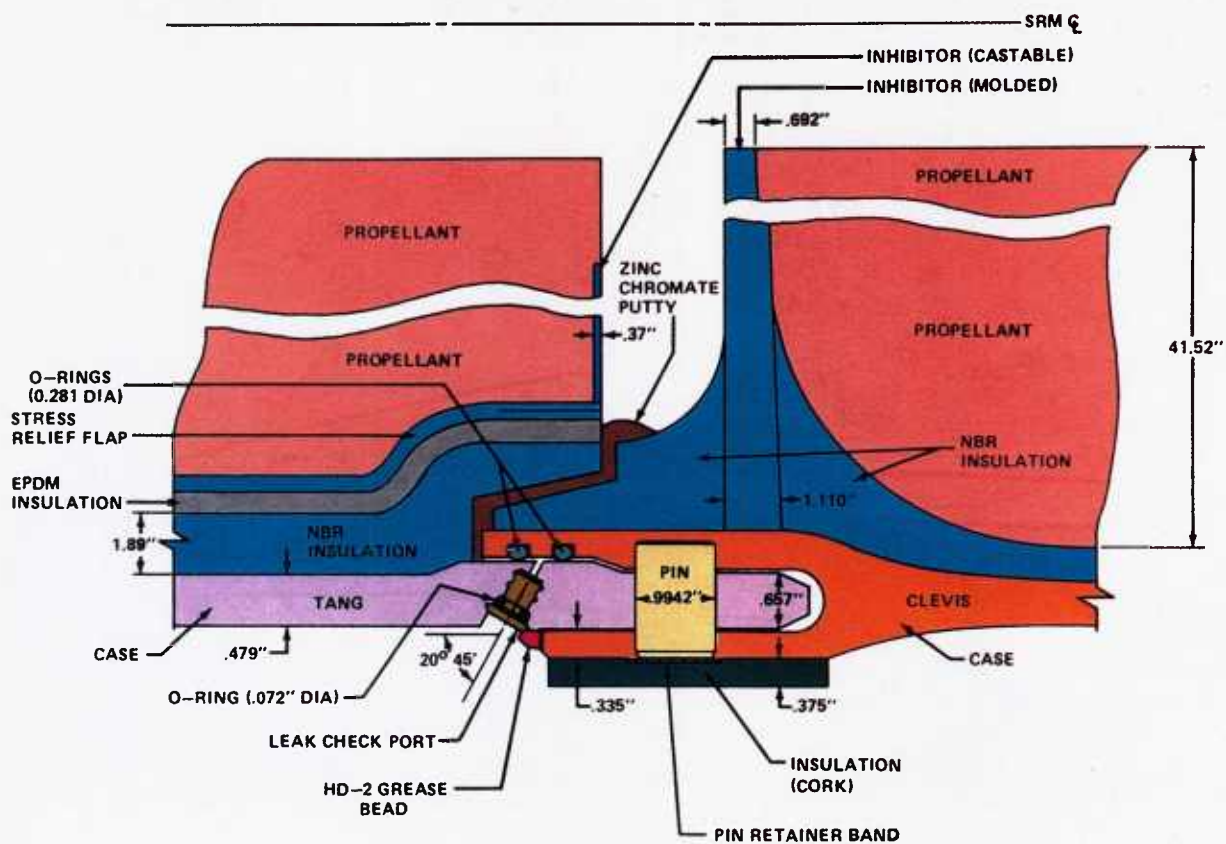
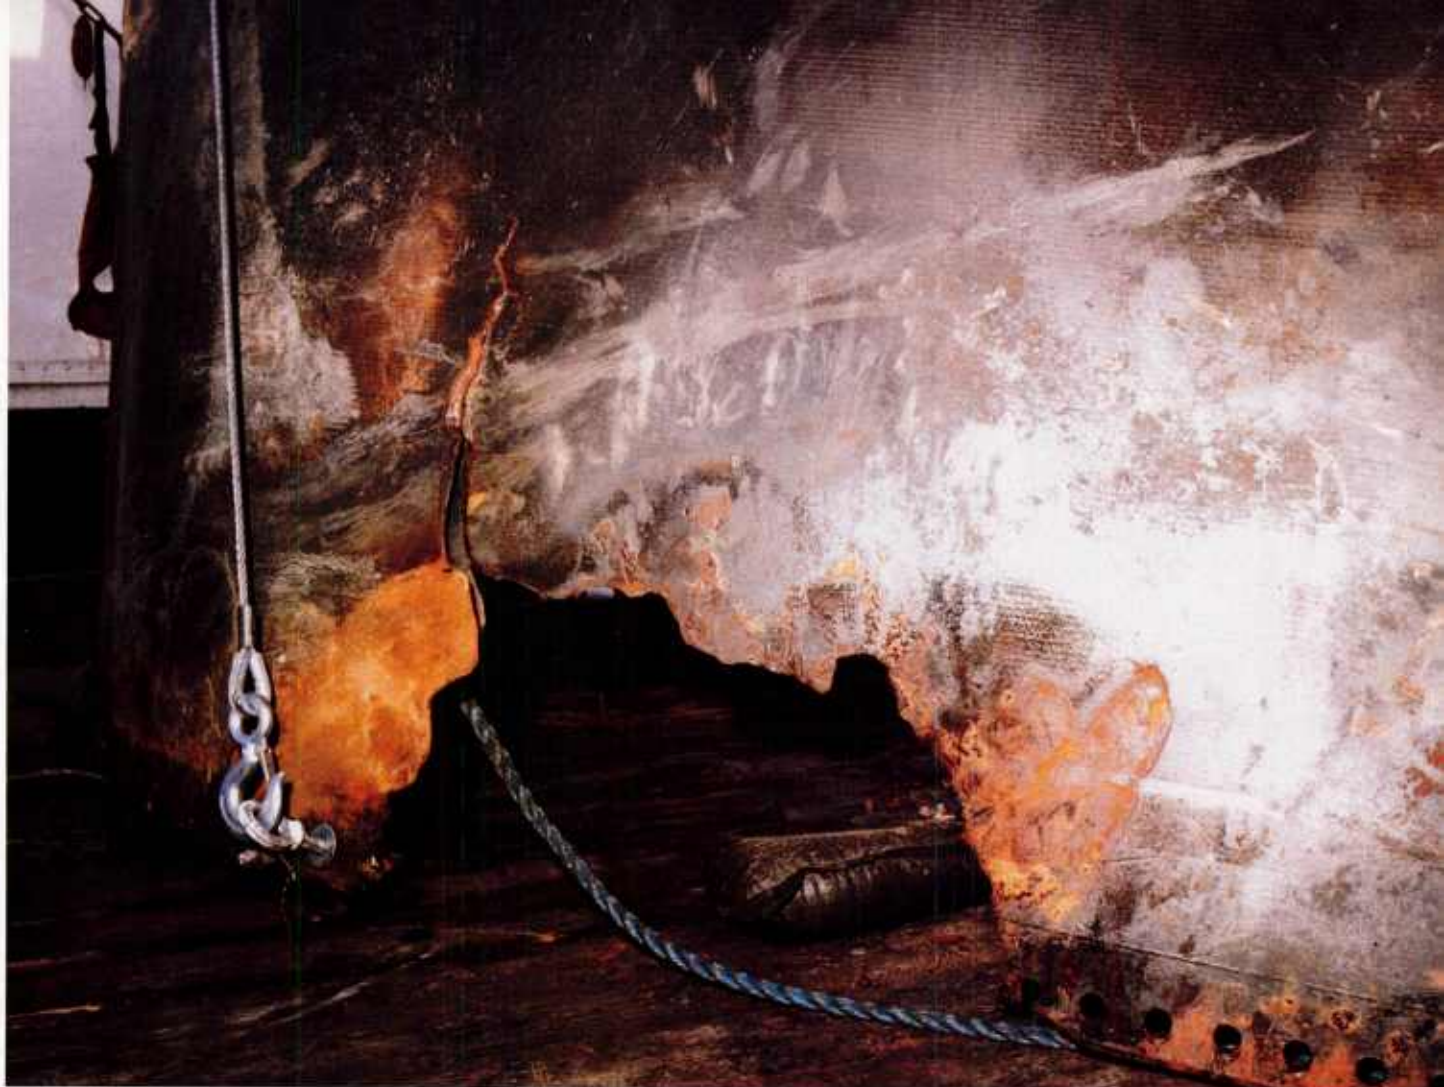
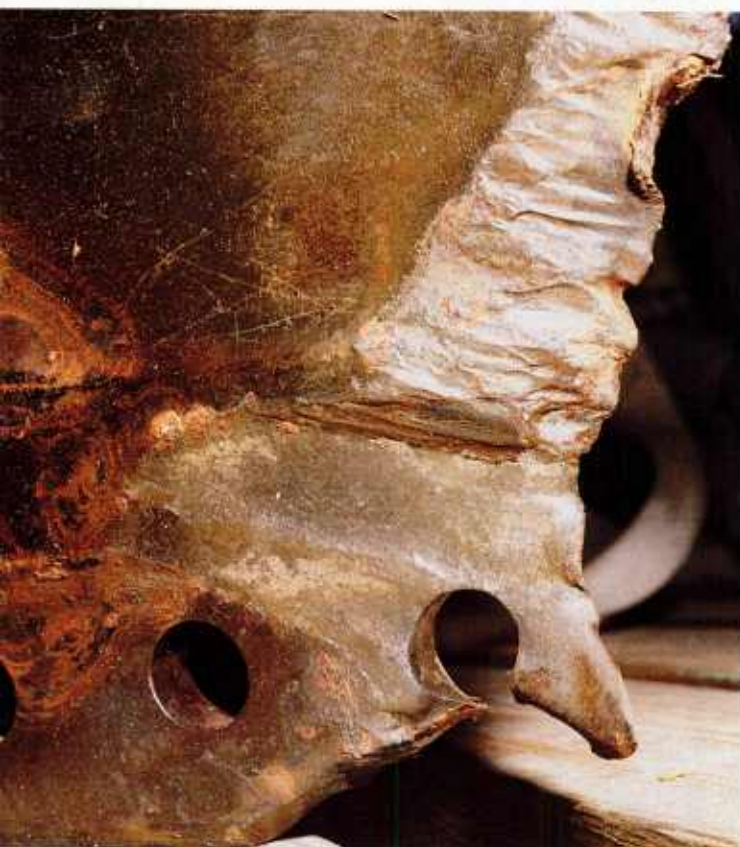
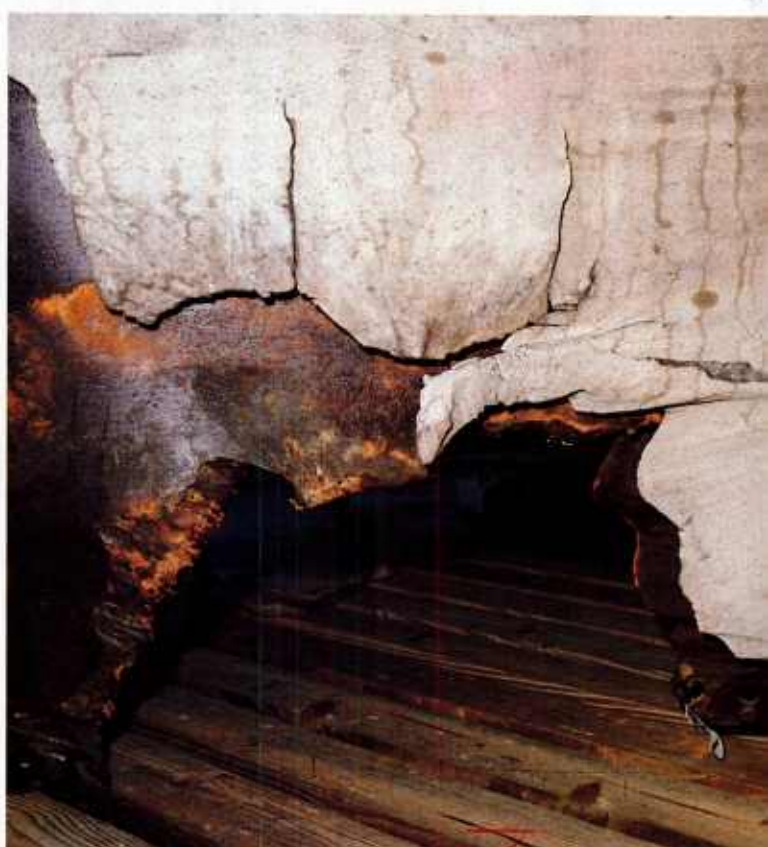
Examined at Kennedy Space Center after their recovery from the ocean, these fragments show the extent of burn through the right hand booster's aft field joint. On the left page are sections of the aft center motor segment above the joint. On the right page are sections (inverted) of the aft motor segment showing burn-hole below the joint (bracket). Except for the interior views on lower left, the camera is viewing the parts from outside the casing.
